# Fracture Analysis of a Case-Hardened Kingpin

<sup>1</sup>Totomak A.Ş., İzmir, Turkey

<sup>2</sup>İzmir Katip Çelebi University, Dept. of Materials Science and Engineering, İzmir, Turkey

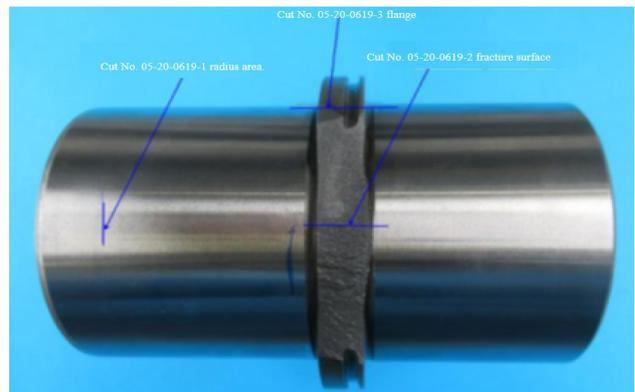
Before the macroscopic examinations, the fracture surfaces were cleaned in an ultrasonic bath, and then examined under a stereo microscope. For further investigation, samples were prepared through the examined part. The locations where samples were taken out are shown in Figure 2. The samples were taken from three different positions and have been encoded as follows: RD-Radius (05-20-0619-1), FR-Fracture surface (05-20-0619-2), and FL-Flange (05-20-0619-3). Representative coding's are given in Table 3.

**Figure 2.** The locations where samples were taken out

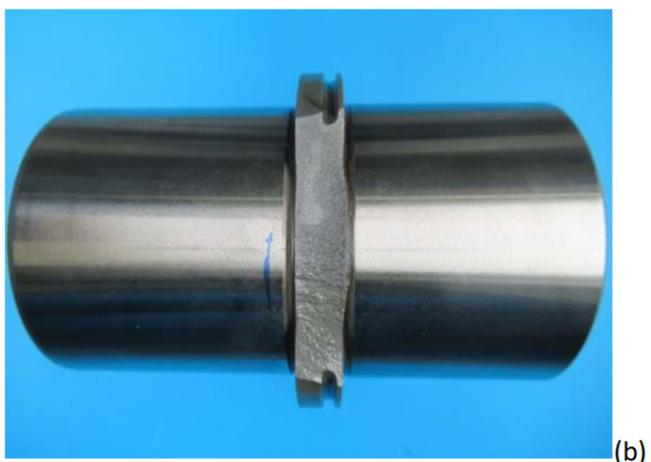
The spectral analysis, metallography and fractography studies, SEM analysis and hardness tests were carried out for the 16MnCr5 steel parts, respectively. The image of the kingpin part broken in assembly lines is shown in Figure 1. The chemical composition of the analyzed 16MnCr5 steel is shown in Table 1, and the mechanical properties are given in Table 2.

**Figure 1.** Images of the (a)original, and (b)broken kingpin part

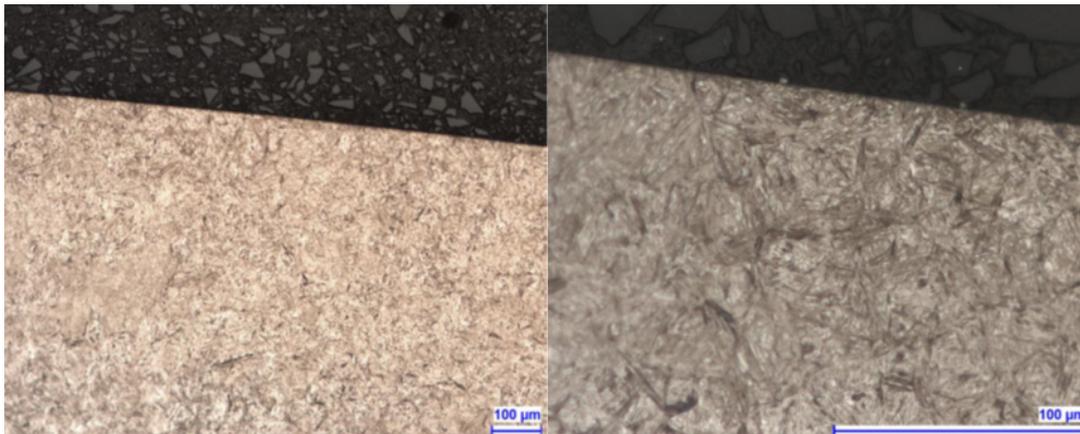
All the samples were examined from their cross-section by a light microscope. The images of the RD sample from its surface area with different magnifications have been shown in Figure 3, which present mainly the martensitic microstructure. And the microstructure belongs to the center part of the radius section containing mixed structure of bainite and coarse martensite phases which is shown in Figure 4. Moreover, the images from the cross section of the fracture surface with different magnifications have been shown in Figure 5. It is clearly shown here that the microstructure

Figure 3. Surface structure of the RD sample showing the martensitic structure

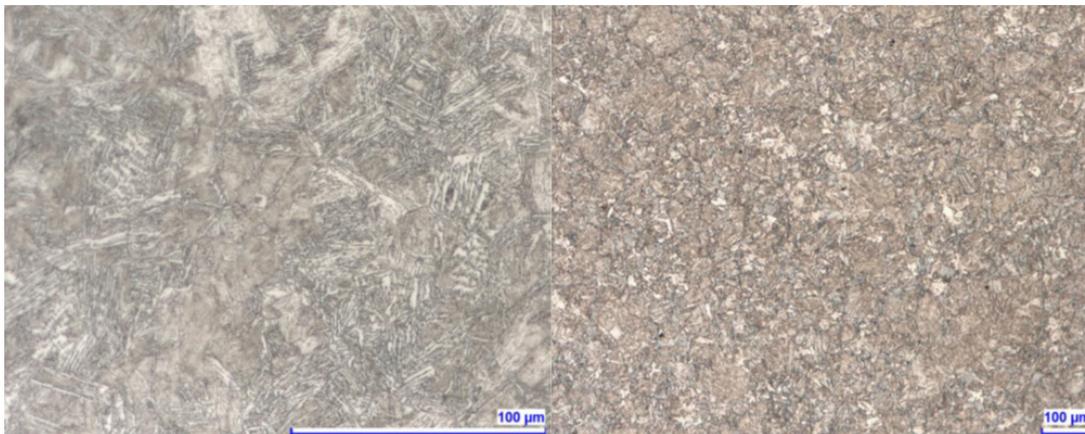
consists of a mixed structure containing bainite and coarse martensite phases.

Figure 4. Mixed structure of bainite and coarse martensite phases on the center part of RD sample

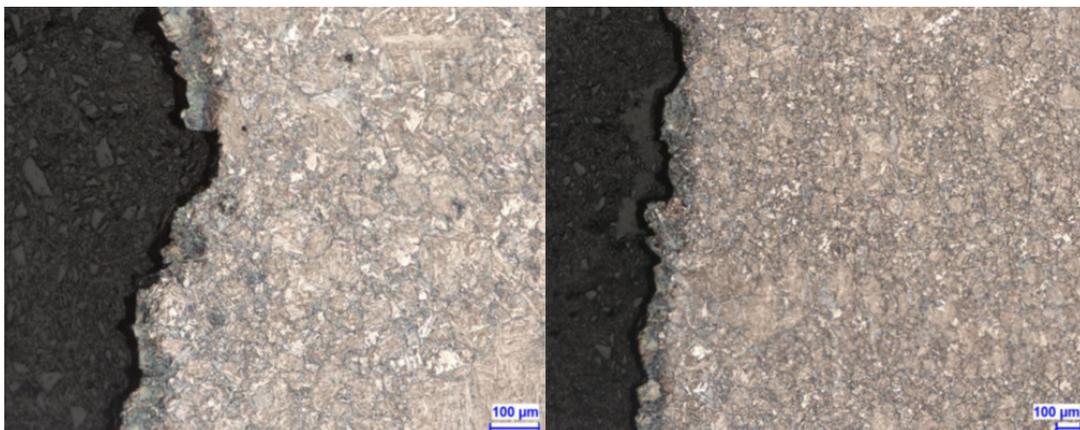
Figure 5. Images of the FR sample showing a mixed structure of bainite and coarse martensite phases

ter structure and the determined core strength, it could be predicted that the component has little ductility and toughness. This can also be concluded with the presence of a shiny surface. However, in the area where the fracture occurred (FR sample), there is a mixed structure of bainite and coarse martensite phases also in the surface zone.

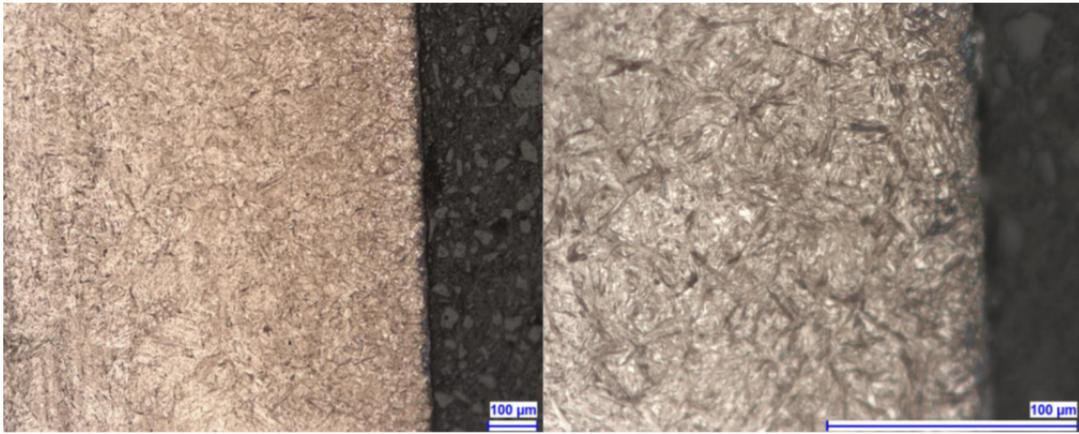
The surface area belongs to flange section contain hard martensitic structure as shown in Figure 6. And the microstructure belongs to the center part of the flange section having the mixed structure of bainite and coarse martensite phases are shown in Figure 7.

Figure 6. Surface structure of the FL sample having hard martensitic structure

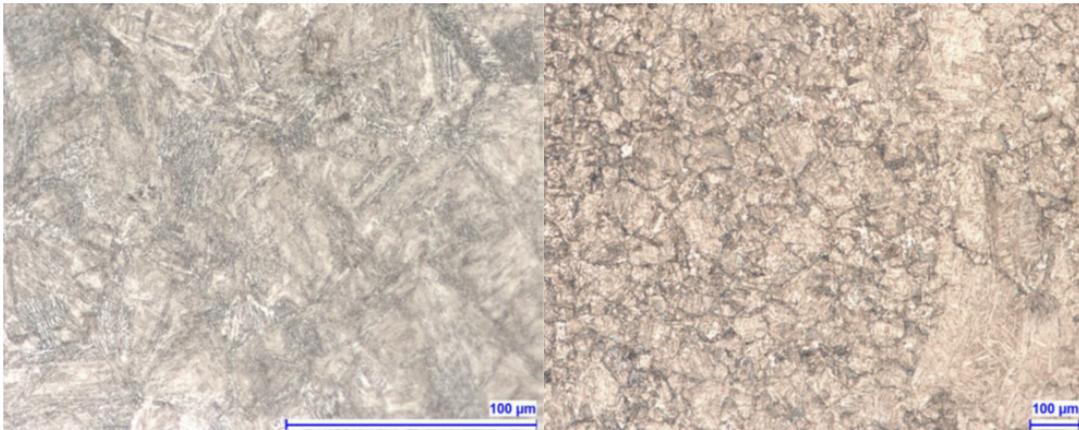
The metallographic investigations for both RD and FL samples show that there is a hard martensitic structure without any mesh or bone type carbide at the surface zones. In the center, there is an inhomogeneous mixed structure of bainite and coarse martensite phases. It can be assumed that the structure shows high strength. Based on the cen-

Figure 7. Flange area mixed structure of bainite and coarse martensite components

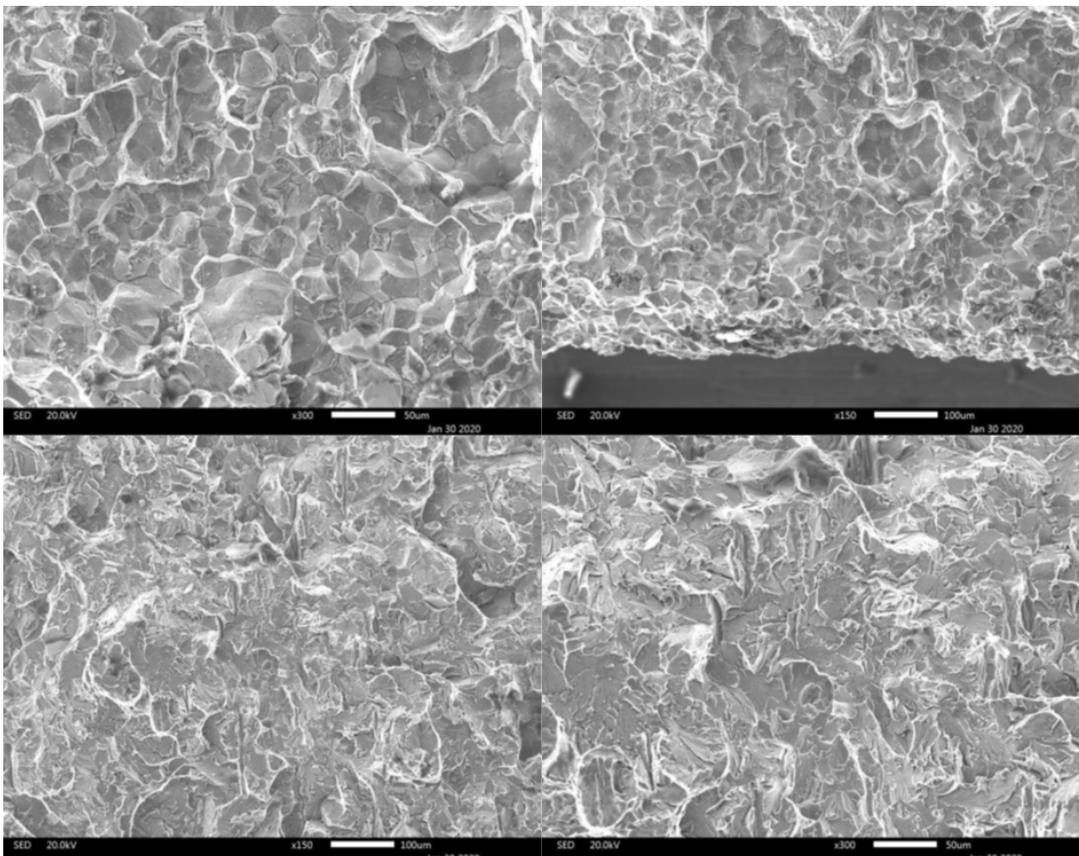
Figure 8. SEM images of different areas from the broken parts

SEM images taken from the fracture surfaces with different magnifications are shown in Figure 8. It is seen from the figure that intergranular fracture (which is a sign of brittle fracture) is valid in the surface zone. And a mixed mode with cleavage type of fracture is visible in the core center part of the sample.

failure. The only clear outcome is the presence of the brittle type of fracture mode especially in the surface part, which is concluded by the help of the SEM study. With the present structure it is to be expected that even a low dynamic load can lead to the sudden failure. Hydrogen absorption with martensitic structure causes cracks to occur on the weakest point of part, especially on the steel parts which become particularly brittle.

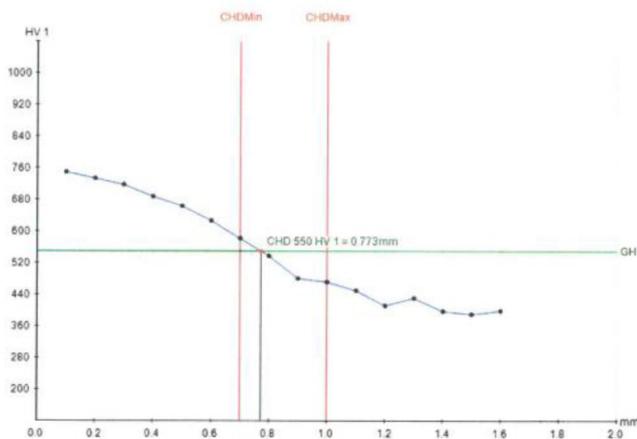
The polished cross section prepared from the radius area of the part is shown in Figure 9, and the hardness test results are given in Table 3 and Figure 10. It is known that Bainite phase is formed at slower cooling rates more than that for martensite formation and faster than that for ferrite and pearlite microstructure and martensite is formed when the cooling rate from austenitic microstructure is sufficiently fast. So, these hardness results confirm the microstructural analysis mostly.

Figure 10. Graphical hardness test results of the RD sample

Step	Result (HV)	X- Position (mm)	Y- Position (mm)	Hardness Depth 550 HV1
1	750	0,1	0	0,773 mm
2	734	0,2	0,2	
3	718	0,3	0	
4	688	0,4	0,2	
5	664	0,5	0	
6	627	0,6	0,2	
7	582	0,7	0	
8	538	0,8	0,2	
9	481	0,9	0	
10	472	1	0,2	
11	450	1,1	0	
12	412	1,2	0,2	
13	431	1,3	0	
14	398	1,4	0,2	
15	390	1,5	0	
16	399	1,6	0,2

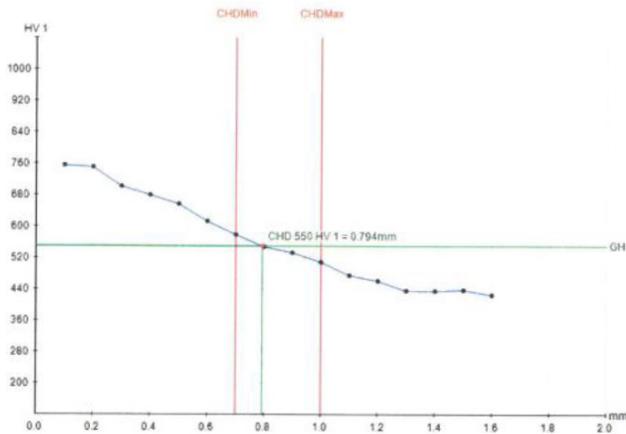
Step	Result (HV)	X- Position (mm)	Y- Position (mm)	Hardness Depth 550 HV1
1	755	0,1	0	0,794 mm
2	751	0,2	0,2	
3	702	0,3	0	
4	680	0,4	0,2	
5	657	0,5	0	
6	613	0,6	0,2	
7	579	0,7	0	
8	548	0,8	0,2	
9	533	0,9	0	
10	509	1	0,2	
11	475	1,1	0	
12	461	1,2	0,2	
13	436	1,3	0	
14	435	1,4	0,2	
15	438	1,5	0	
16	425	1,6	0,2

Figure 12. Graphical hardness test results of the FR sample
