Restoration Project of Central Cedit Mosque in Erzurum

Kevser ÇELTİK ŞAHLAN^{1,*}

Abstract

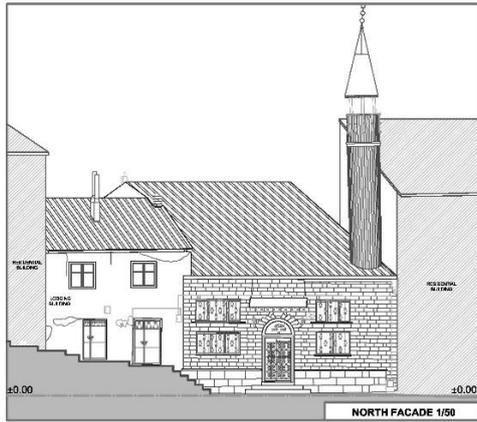
The entrance to the building, which extends in a north-south direction, is located on the north side. The mosque is located between the houses on the north facade. The interventions made over time have given it an appearance that gives the impression of a residential house rather than a mosque. The northern facade was covered with cut stones in the lower level. On the upper level, natural colored artificial stone was used on the sides of the windows and around the door, and brick red artificial stone was used on the other parts. On this façade, two vertical rectangular windows with plastic frames are symmetrically superimposed. In the centre of these windows is a rectangular door with copper inlays and an arched pediment, which is the entrance to the mosque. The porch located above the door is covered with single sloped sheet metal and has wrought iron eaves. (Figure 7).

Figure 7. North facade

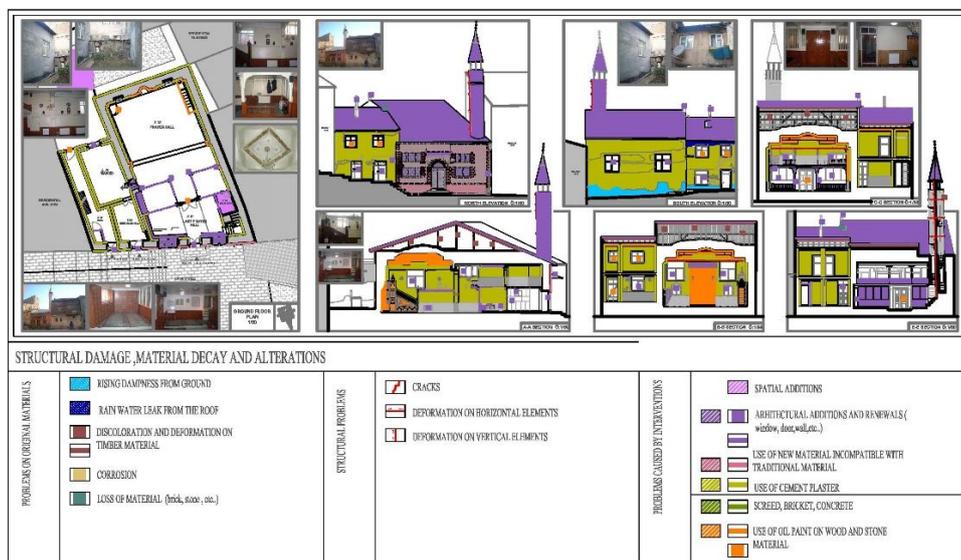
The mosque does not pose any serious preservation problems from a structural point of view. The reason is that it is still in use today and has been repaired and maintained at various times, albeit by local means. The problems identified throughout the building can be divided into three groups: Problems noted in the original fabric, structural problems, and problems resulting from interventions. Figure 9 shows the distribution of these problems among the different elements of the building.

Figure 9. Problems detected in the whole building

The mosque's biggest environmental problem is the late additions to the north facade, which is squeezed between the residential buildings. These additions made it difficult to perceive the mosque as a place of worship, as they gave it the appearance of civil architecture. One of the main issues affecting the structural elements of the mosque is that the main walls of the building are covered with cement plaster from the inside and outside. No structural damage is visible on the load-bearing walls of the building. Although it was not possible to examine the condition of the walls under the plaster, no significant structural cracks in the plaster or bending of the walls were observed. This is because the intermediate posts on which the beam sits have been removed and worn of this element.

Another noticeable problem with the mosque is the minaret. It is believed that the minaret of the building was changed later. The wooden minaret is crooked due to the empty base and the wear of the elements. It also sways due to the wind load. The unqualified sheet metal covering of the minaret also presents an appearance that is incompatible with the building. Another observed problem is that the wooden elements inside the mosque are covered with oil paint. In addition, the windows enlarged lately creates an inconsistent image in relation to the proportions of the facade.

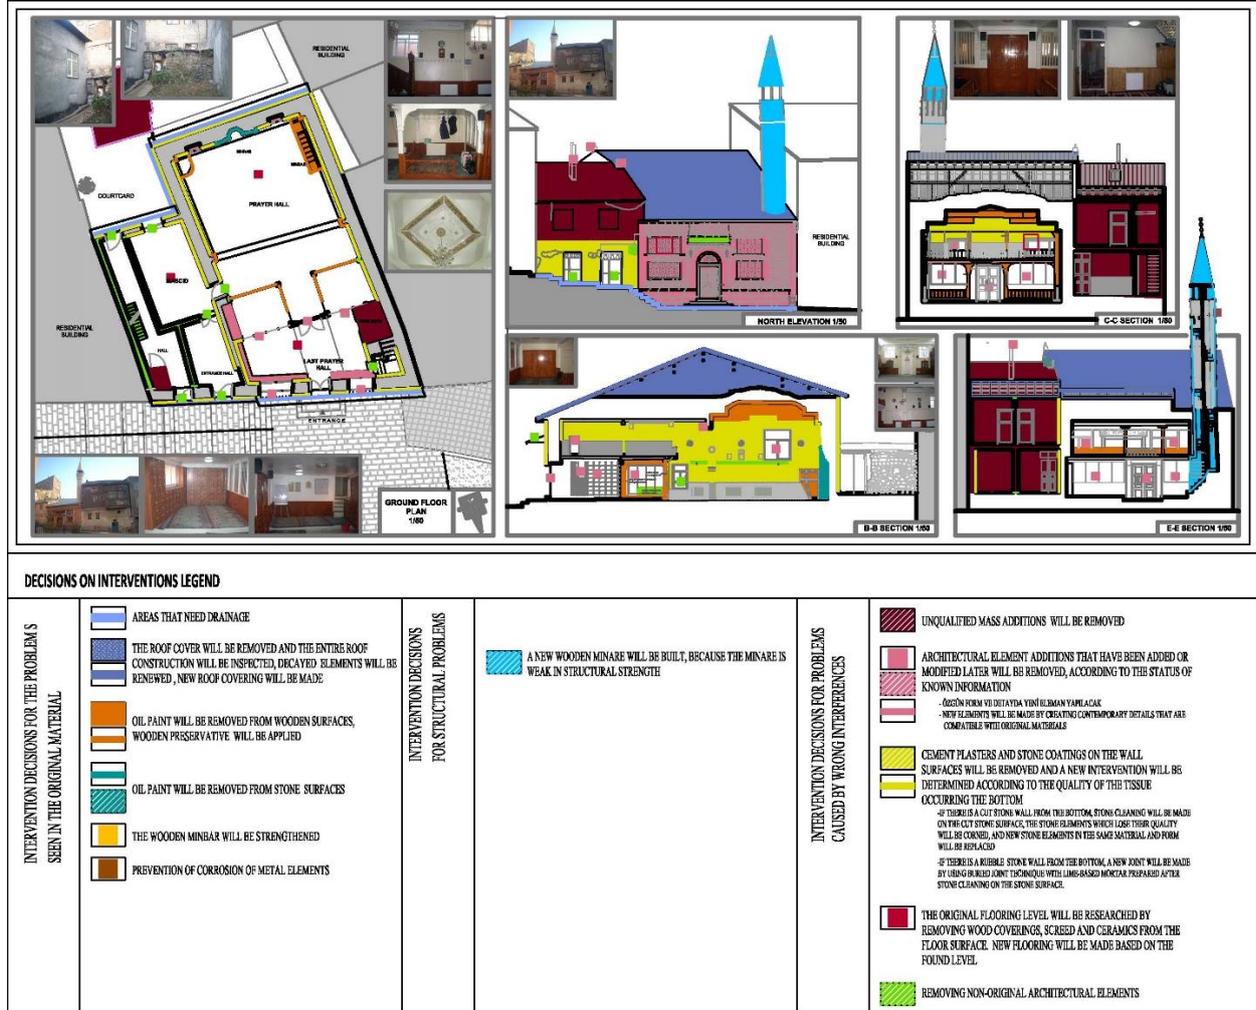
Figure 10. Intervention Decisions

Unqualified additions (last meeting place, prayer building, service building, women's praying place) that could be defined as late period additions will be removed. Unidentified late period interventions (minarets) and traces will be preserved and reinforced according to their structural context.

Traces of elements that were originally present but are no longer present/disappeared (window traces on the facade of the praying hall) will be preserved. The existing architectural elements will be removed and new elements will be produced with contemporary details compatible with the original material.

The cement plasters and screeds on the floor and wall surfaces will be removed, and a new intervention will be determined depending on the nature of the texture emanating below these materials. One of the most important problems affecting the structural elements of the mosque is that the main walls of the building are covered with cement plaster from the inside and outside. No structural damage is visible on the load-bearing walls of the building. Although it was not possible to examine the condition of the plastered walls, no significant structural cracks in the plaster or bending of the walls were observed. The main walls of the building, which are still plastered and clad, are far from their original appearance. For this reason, it is recommended that the existing plaster and stone cladding on the north façade be removed, exposing the cut stone lattice with the intervening wooden beams, as seen in the old photographs of the building. Accordingly, after cleaning the stone on the cut stone wall coming from below, the cement joints are going to be removed, the joints are going to be cleaned and new joints are going to be made using the technique of buried joints with the prepared lime-based mortar. The wooden surfaces are going to be cleaned from oil coatings.

It was found that the wooden beam that supports the dovetail ceiling extends in the east-west direction of the mosque has deformed. This is because the intermediate posts on which the beam rests have been removed and the element is worn. To fix this problem, it was proposed to remove the roof covering and replace the deformed beam in the middle with a steel "I-beam. In addition, material problems could not be fully identified because the pillar and beam system supporting the ceiling was obscured. In order to investigate and fix the problems of these elements, it is recommended to use the following method after removing the roof structure:

After removing the roof, this part will be suspended from below. The oil coating and the coating on this part will carefully be removed. The four main wooden pillars and the main beams on these pillars will be examined, and an attempt will be made to restore the beams that bend horizontally in response to the movement of the walls. The details of this intervention will be determined after the main beams can be visible when the roof will be removed. In addition, in the structure, bent wooden ceilings will be suspended, their beams will be overhauled and beam elements will be replaced in necessary places. All replaced or not replaced wooden elements are impregnated against abiotic influences (pre-protection).

Another structural problem of the mosque is seen in the minaret. It is believed that the minaret of the building was subsequently altered. The minaret is tilted due to the empty base and the wear of the elements, and it sways due to the wind load. In addition, the current unqualified coating creates an image that is not compatible with the mosque. For this reason, it was proposed to strengthen the elements of the existing minaret and replace the existing sheet metal coating with a more qualified sheet metal coating with an elegant workmanship.

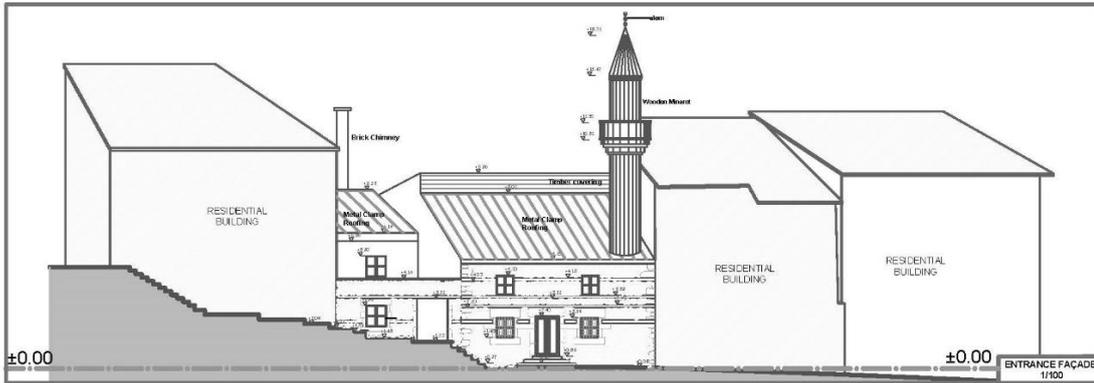
Figure 12. Restoration entrance facade

As part of the restoration project, it was proposed to preserve the original north wall of this outbuilding and expose the stone masonry by cleaning the plaster. It was proposed to demolish the other parts of the building except this wall and construct a new building, leaving a gap between the mosque and the backyard. The first floor of this new building will house the wet areas of the upper accommodation and the wet areas of the mosque (WC, ablution place). On the upper floor of the building there will be the rooms of the residence.

Between the wall of the new building and the east wall of the mosque, a passage with a pergola to the backyard was planned. Access to this passage is from the north facade through the opening created by widening the existing doorway. In the rear courtyard, an open space design with stone pavers and green areas was made and seating groups for the mosque community were installed.
