Üsküdar Electricity Factory - Nevmekan: Evaluation of The Structural System in The Context of Adaptive Reuse

Necdet Torunbalcı¹, Hilal Günay²

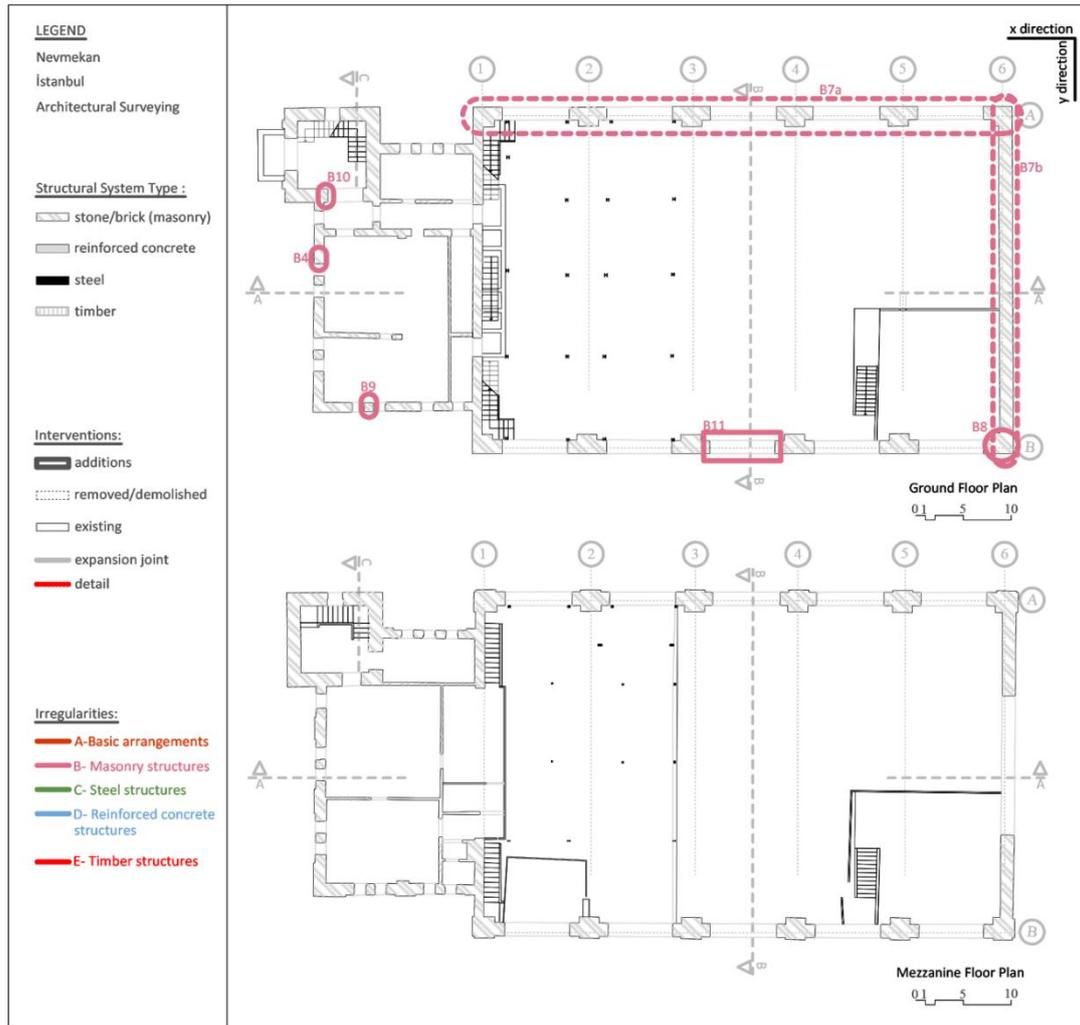
Figure 3. Üsküdar Electricity Factory architectural surveying floor plans (Adapted from Koroğlu, 2019)

The plan geometry of the building consists of a rectangular main unit and a square tower unit connected to it. The approximate dimensions are 18 m on the narrow facade and 36 m on the wide facade. The workshop unit of the building has a basement floor and a mezzanine floor, while the office unit has 2 regular floors, and the tower unit has 5 floors (Figure 3).

The building geometry is relatively close to symmetrical. The main structural system is evaluated positively in terms of being regular, simple, and composed of a single material. The absence of protrusions in the plan, and the regular distribution of structural elements are positive features horizontally. Differences in the number of storeys, partial basement, and mezzanine in the main unit are among the negatives identified vertically. Although the tower and office unit are integrated with the main unit, the fact that it settles directly on the ground should not be ignored as it may adversely affect the behavior of the building under the influence of lateral loads. On the other hand, the continuity of the structural elements and the arrangements regarding the strengths between floors are important positive criteria for the structural system according to current earthquake code (TEBC, 2018).

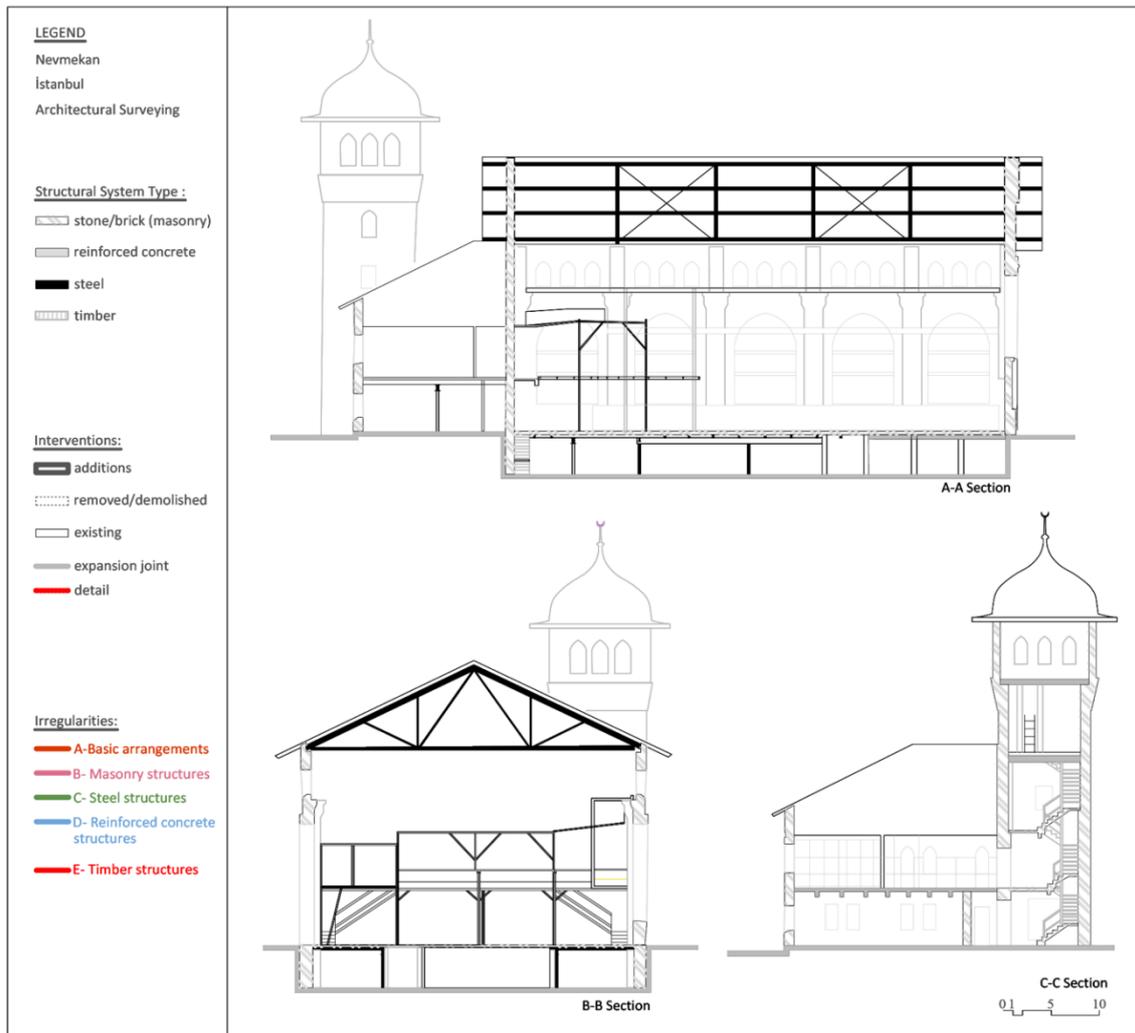
Figure 4. Architectural surveying sections of Üsküdar Electricity Factory (Adapted from Köroğlu, 2019)

The triangular truss was used in the roof (Figure 4). Welding was used in the steel truss roof connections.

The negativities observed regarding the masonry structural members are that the basement floor is organized as a partial basement only under the main unit, the masonry wall height/storey height, which is limited to 3 m in structural regulation (TEBC, 2018), is 3 times higher in this building (h:10,16 m), when evaluated in the context of the condition that the free wall lengths are supported in places in the direction perpendicular to the longitudinal direction of the wall, the unsupported wall length limit values are exceeded on long facades, that is, the masonry walls are not supported along the facade, and the values obtained by dividing the total lengths of the bearing walls, which are accepted as an important criterion against lateral loads, separately for both directions except for the gaps, in one direction by the gross floor area are 0.08 in the x direction and 0.09 in the y direction, and the limit value of $0.25.I$ (I : Building Importance Coefficient, which for this building can be taken as 1 for its current use (TEBC, 2018)). This value is of great

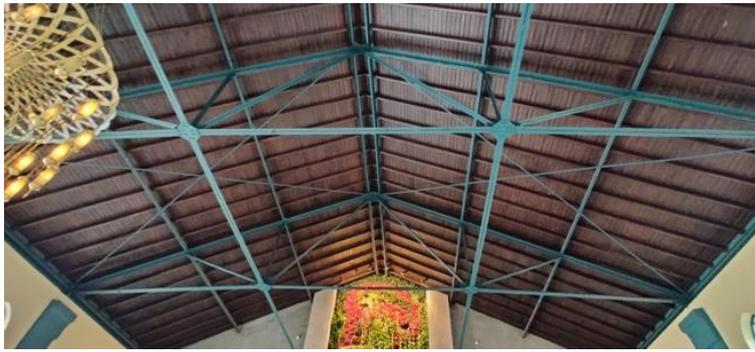
Figure 5. Restored roof structure (Torunbalcı archive, 2019)

When the restoration interventions were analyzed, it was determined that the original units of the structural system were preserved. The steel truss elements were repaired and preserved in their original form. The crane structure, which will refer to the original function of the building, is connected to the roof structural system and exhibited (Figure 5, 6). The original plan geometry and the number of storeys have also been preserved. Material damages, especially plaster damage on the masonry walls, have been repaired. The most significant change observed in the structural system is that both the design of the mezzanine floor and the materials of the structural system have completely changed. The floorings have been preserved by renewing only the damaged parts. The structural additions added to the arch floorings as period additions were also preserved through corrosion modifications.

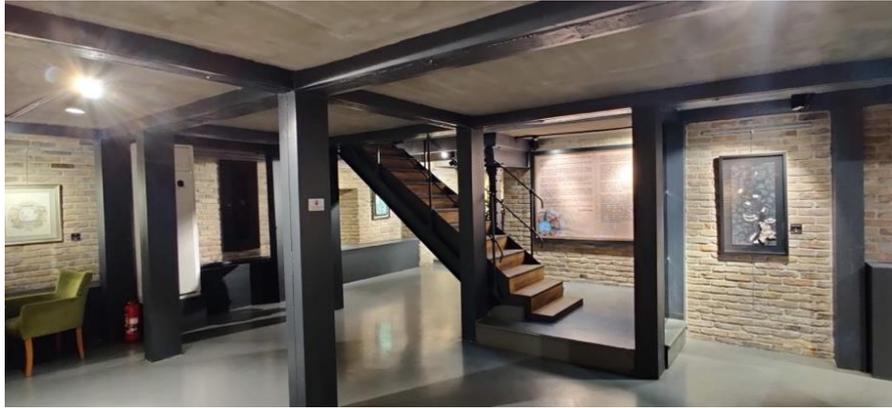
Figure 7. Status of the basement floor (Torunbalcı archive, 2019)

The reinforced concrete support elements of the basement floor, which is thought to have been added as a period annex, have been preserved (Figure 7).

The reinforced concrete support elements of the basement floor, which is thought to have been added as a period addition, have been preserved.

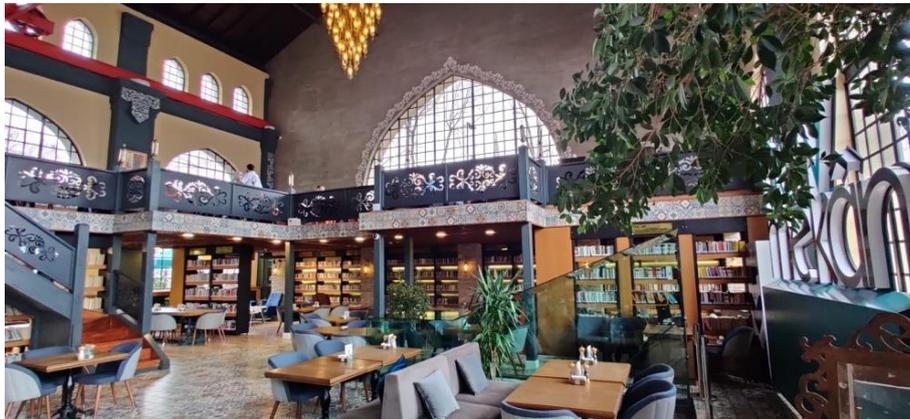
Figure 8. Status of the mezzanine floor (Torunbalcı archive, 2022)

It is observed that the restoration interventions were carried out without a major impact on the original plan scheme of the building. The floors have been preserved to a great extent by their original state. The mezzanine floor was demolished and rebuilt. In the original state, the mezzanine floor structural members were made of steel elements, whereas in the new state, they were constructed with wood materials. The lower floor of the mezzanine floor, which was rebuilt wider than its original plan dimensions, was re-functionalized as a library. In the last case, the structural members of the mezzanine floor were arranged to be independent of the original structure (Figure 8, Figure 9, Figure 10).

The most important change observed in the structural system is the complete change of both the design of the mezzanine and the materials of the structural system of the mezzanine. The mezzanine floor, which currently has a steel structural system, was re-designed, and constructed in timber and separately from the main structural system during the restoration works. The floor slabs were preserved only by renovating the damaged parts. Steel structural inserts added to the arch slabs as period additions were also preserved by making corrosion modifications.

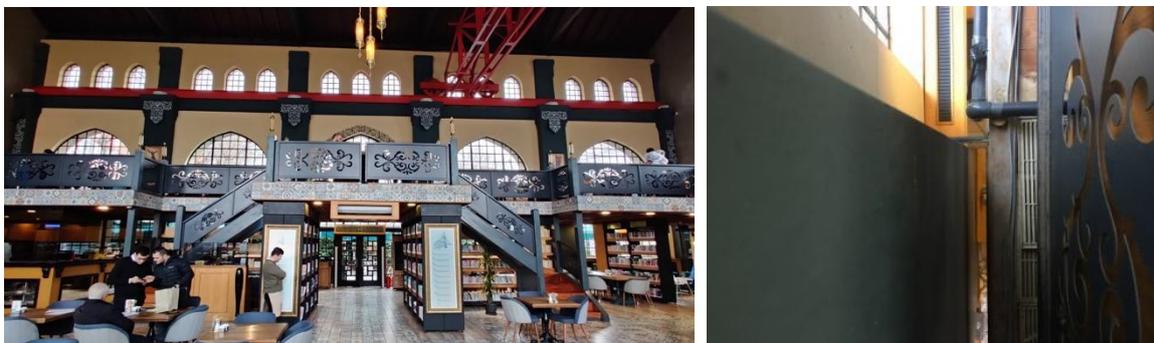
Figure 10. Mezzanine floor and masonry structural wall (Torunbalcı archive, 2019)

It was observed that there was no connection between the steel structural system and the masonry walls, and such a connection was not applied during the current restoration. The steel frame connections, truss type, connection elements, and dimensions of the trusses have been retained to be the same as the original design (Figure 10, Figure 11).

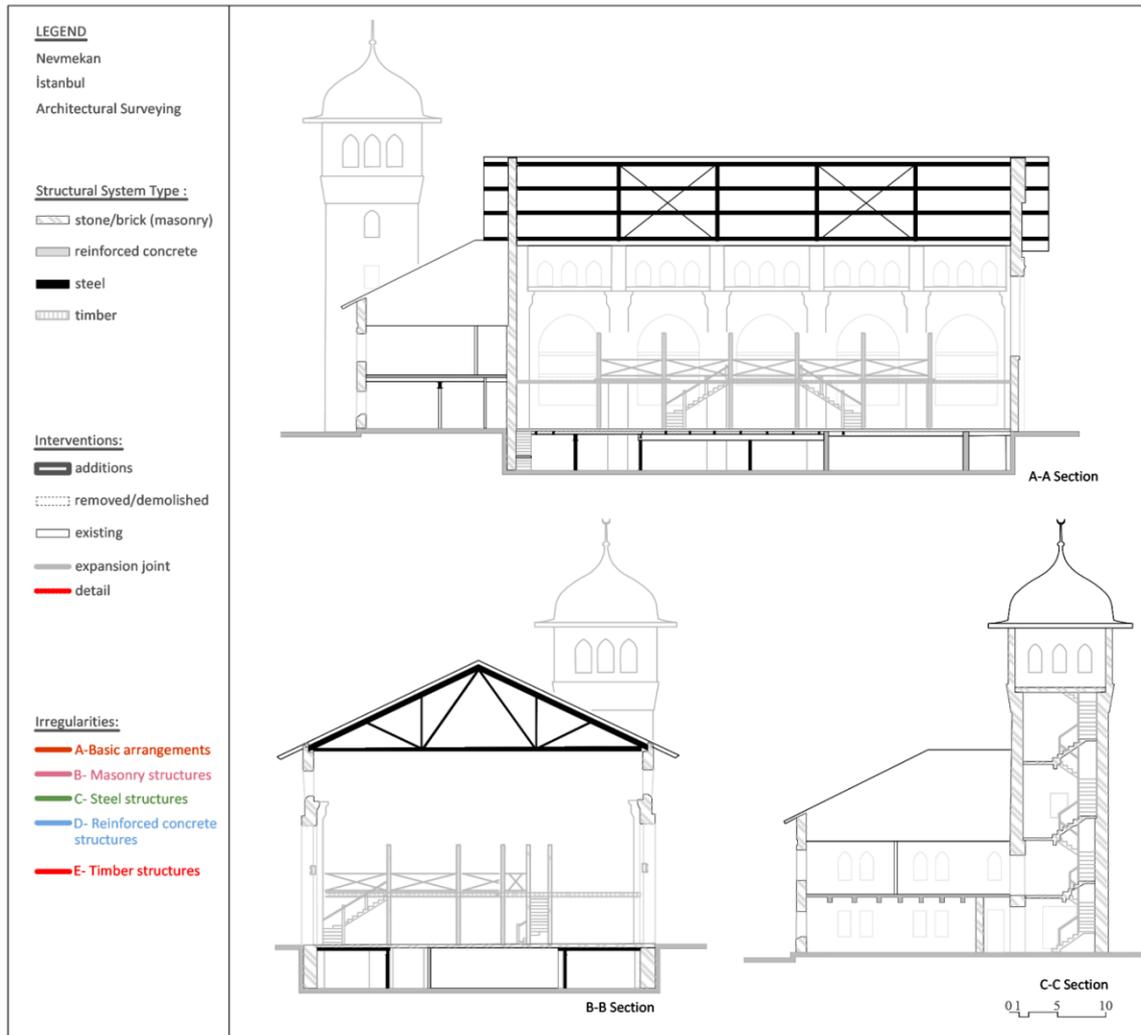
Figure 11. Nevmekean restoration project sections (Adapted from Köroğlu, 2019)

After the restoration, no arrangement could be identified to improve the horizontal loads on the masonry structural walls. The steel roof trusses were improved by the original by corrosion maintenance (Figure 11). On the other hand, the masonry and steel members were not changed in terms of material and design. Although architectural interventions for the new function were observed, structural concerns remained in the background.
