Title: 24 January 2020 Sivrice-Elazığ Earthquake: Assessment of Seismic Characteristics of Earthquake, Earthquake Territory and Structural Performance of Reinforced Concrete Structures

Authors: İbrahim Özgür DEDEOĞLU, Musa YETKİN, Yusuf CALAYIR

## 24 January 2020 Sivrice-Elazığ Earthquake: Assessment of Seismic Characteristics of Earthquake, Earthquake Territory and Structural Performance of Reinforced Concrete Structures

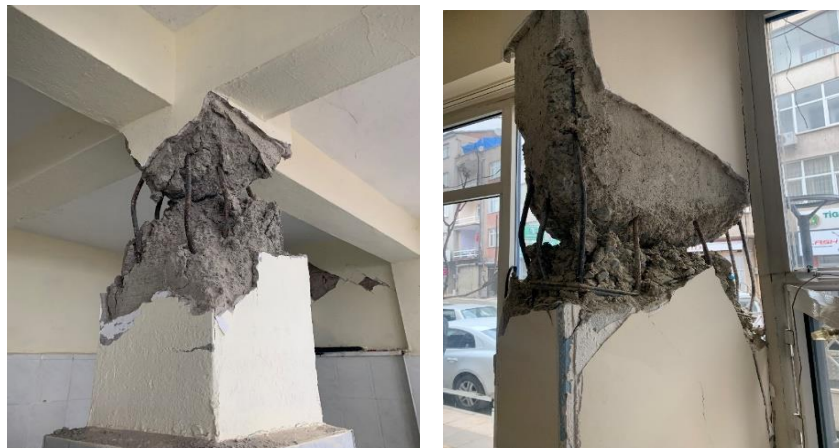
The transverse reinforcement is of primary importance to ensure the adequate ductility capacity of the system in earthquake resistant building design. During the earthquake, shear forces is increased significantly, especially at end of column and beam, and beam-column joints. For this reason, we, as engineers, should pay special attention to the transverse reinforcement details during the project and construction of the building. However, in the field observations made after the earthquake, it was observed that the columns were damaged due to insufficient transverse reinforcement in the plastic hinge regions. Besides, it was seen that longitudinal reinforcement bar were also buckled owing to inadequate transverse reinforcement. This important deficiency caused the columns to display low performance against the shear forces of earthquake. In Figure 7-8, some of columns damaged in the earthquake due to insufficient transverse reinforcement have presented.

Figure 7 Column damage due to insufficient transverse reinforcement

- Using plain bar, large spacing transverse reinforcement, absence of crossties has caused significant damage to structural elements. In addition, the ends of the stirrups, which is an important detail, had not bent 135 degrees. Because of all of these, the wrapping effect of the stirrups in the concrete block has considerably reduced and the section integrity has been sufficiently not ensured. To avoid damage of structural members, attention should be paid to detailing of transverse reinforcement, and close-spaced stirrups should be used.

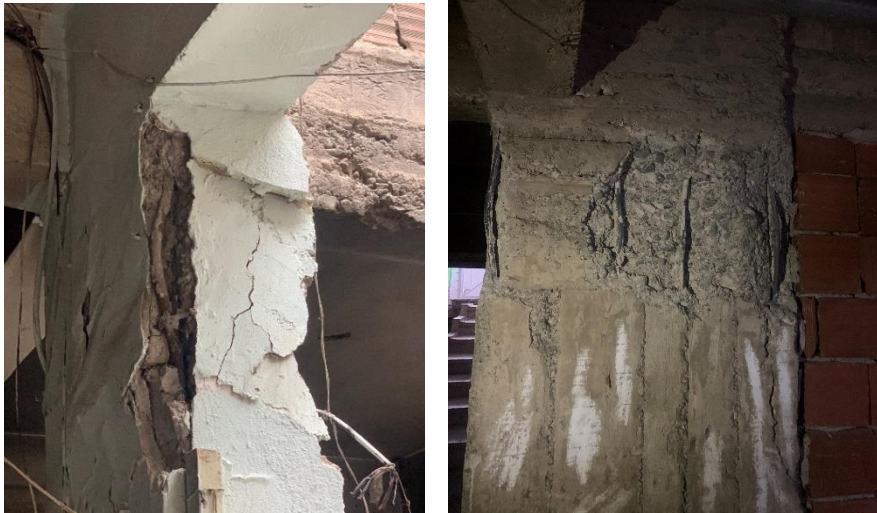
Figure 8 Buckling longitudinal reinforcement bars of damaged column due to insufficient transverse reinforcement

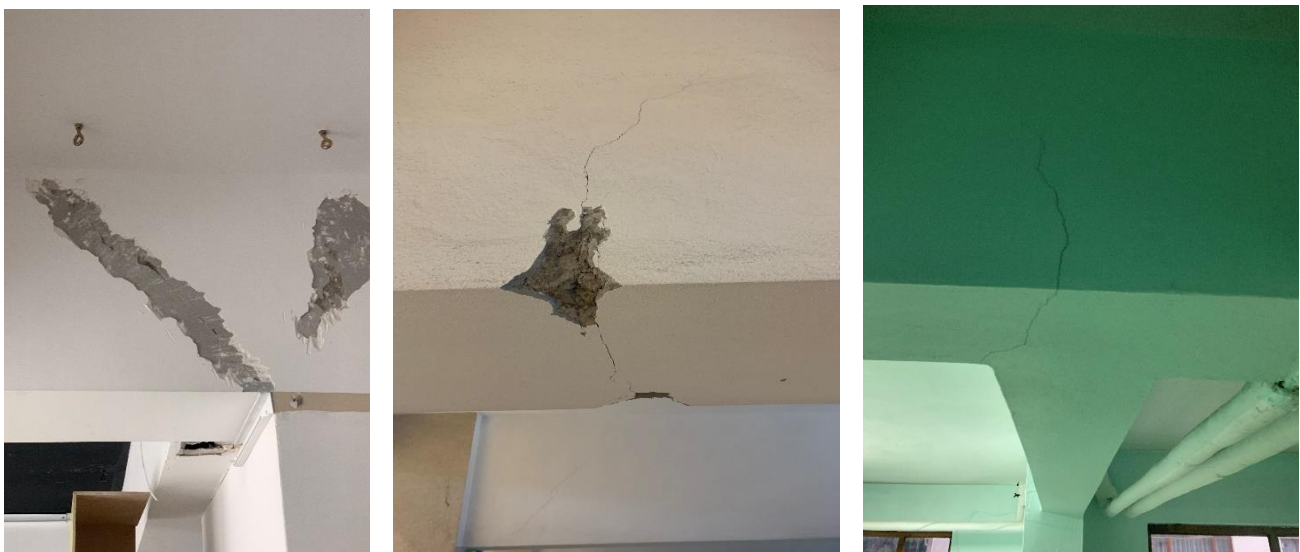
the Elazığ earthquake, shear and bending cracks were observed in the beams. In addition, damages were observed in the connected point the secondary beams to the supporting beams were as well. Some of the beams damaged in the earthquake have shown in Figure 9.

Figure 9 Beam damages

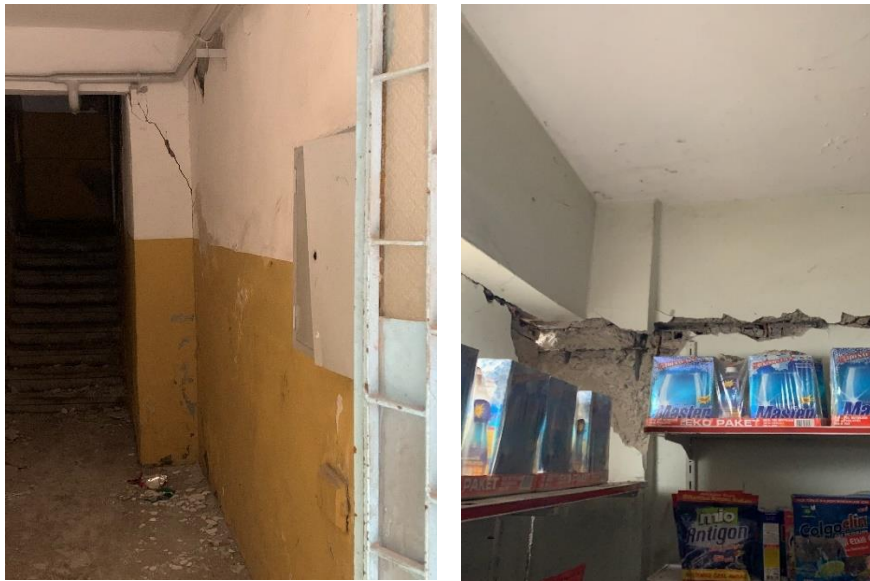
Therefore, damage of these RC building in the event of an earthquake start at the ends of the columns. The design of strong beam-weak column was the main reason of the partial and total collapse of some buildings during the Sivrice-Elazığ earthquake. In Figure 10, columns of structures damaged due to strong beam-weak column design are presented.

Figure 10 Strong beam–weak column

To prevent this kind of damages or collapses arising from the strong beam-weak column design, current and former seismic codes require that sum of ultimate moment of columns framing into a beam-column joint should be at least 20% more than the sum of ultimate moment of beams framing into the same joint [23, 24]. Thus, plastic hinges occur at the ends of the beam in case of the earthquake and brittle failure prevents.

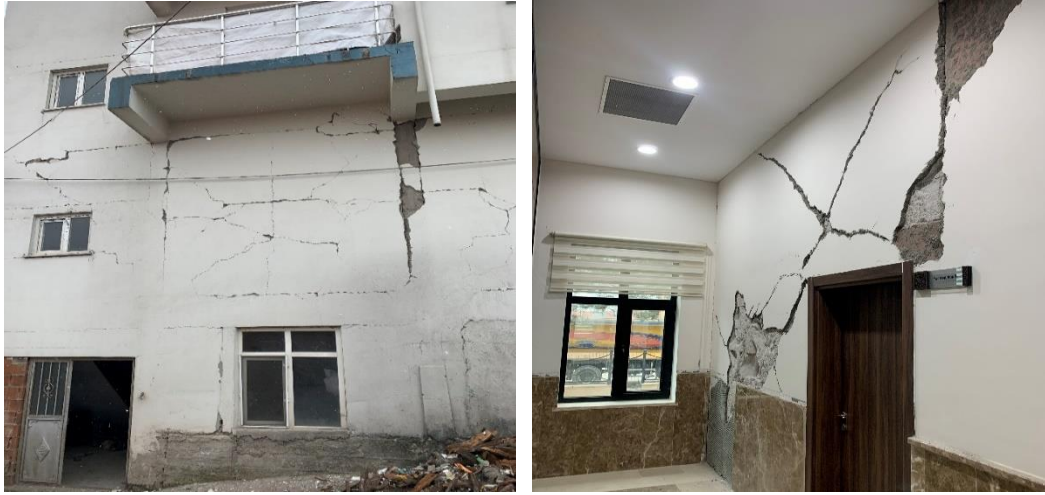
extremely complex and depends entirely on the interaction mechanism of the infill wall and RC frames. During the field observations, different type of infill damages were encountered as shown in Figure 11-14. During the earthquake, the diagonal cracks were observed in the infill walls due to the interaction with the RC frame. (Figure 11). Also partial or total out-of-plane mechanism was observed in the infill wall damages (Figure 12). The other type of observed damage in the infill wall is the separation of the infill wall from the frame (Figure 13). In addition, numerous overhang infill wall damages have been also observed in the earthquake-affected region with the aforementioned damages (Figure 14).

Figure 11 In-plane damage

Infill walls are especially very sensitive to the inter-story drift ratio demand of the structural system. Therefore, TBEC (2018) limits these ratios. In order to prevent such damages, rules of earthquake code must strictly comply both during the project and the construction stage.

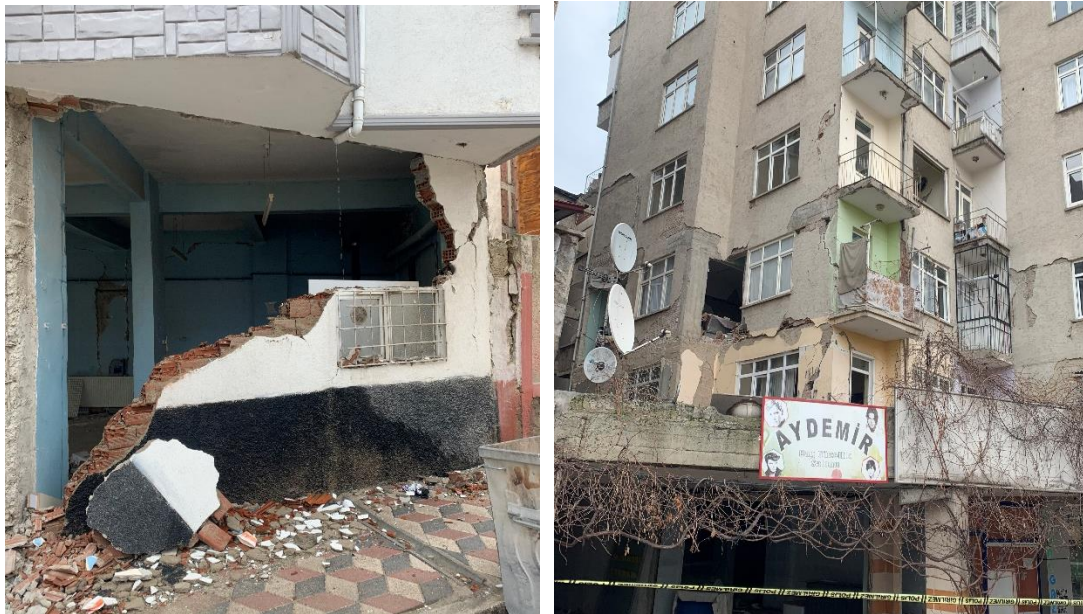
Figure 12 Partial out-of-plane damage

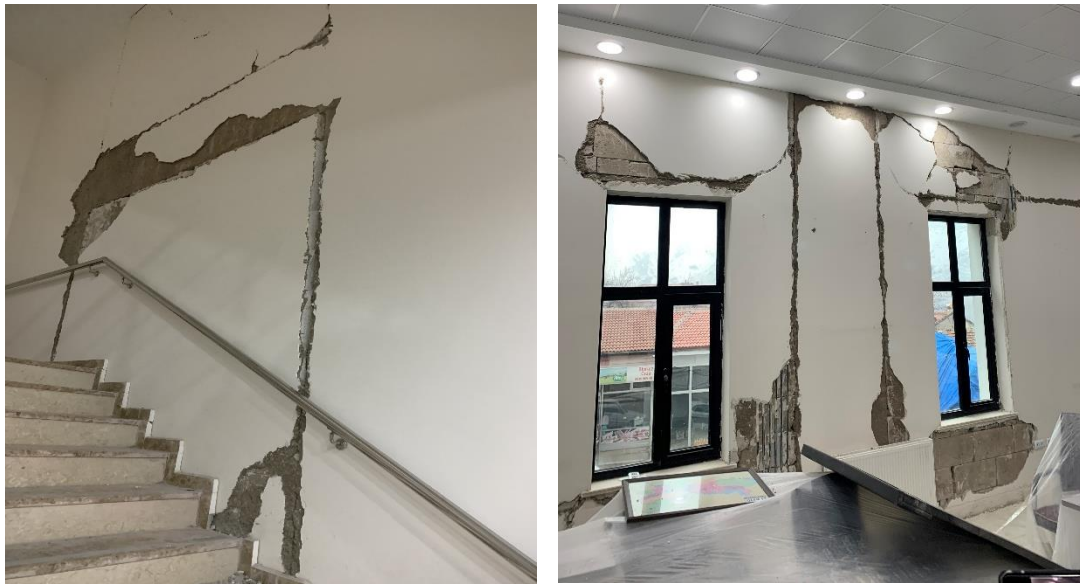
Figure 13 Disconnection of infill wall from the frame

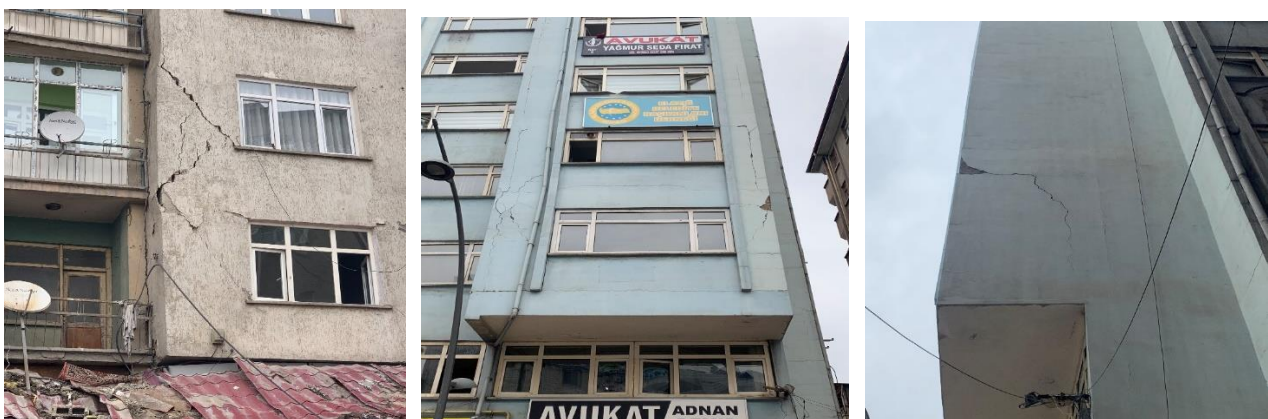
Figure 14 Damages of overhang infill walls

- During the earthquake, the diagonal cracks were observed in the infill walls due to the interaction with the RC frame. In addition, heavy overhangs in the building has increased the degree of damage. In order to prevent such damages, the infill wall should work independently from the frame. Also heavy overhangs should be avoided especially.

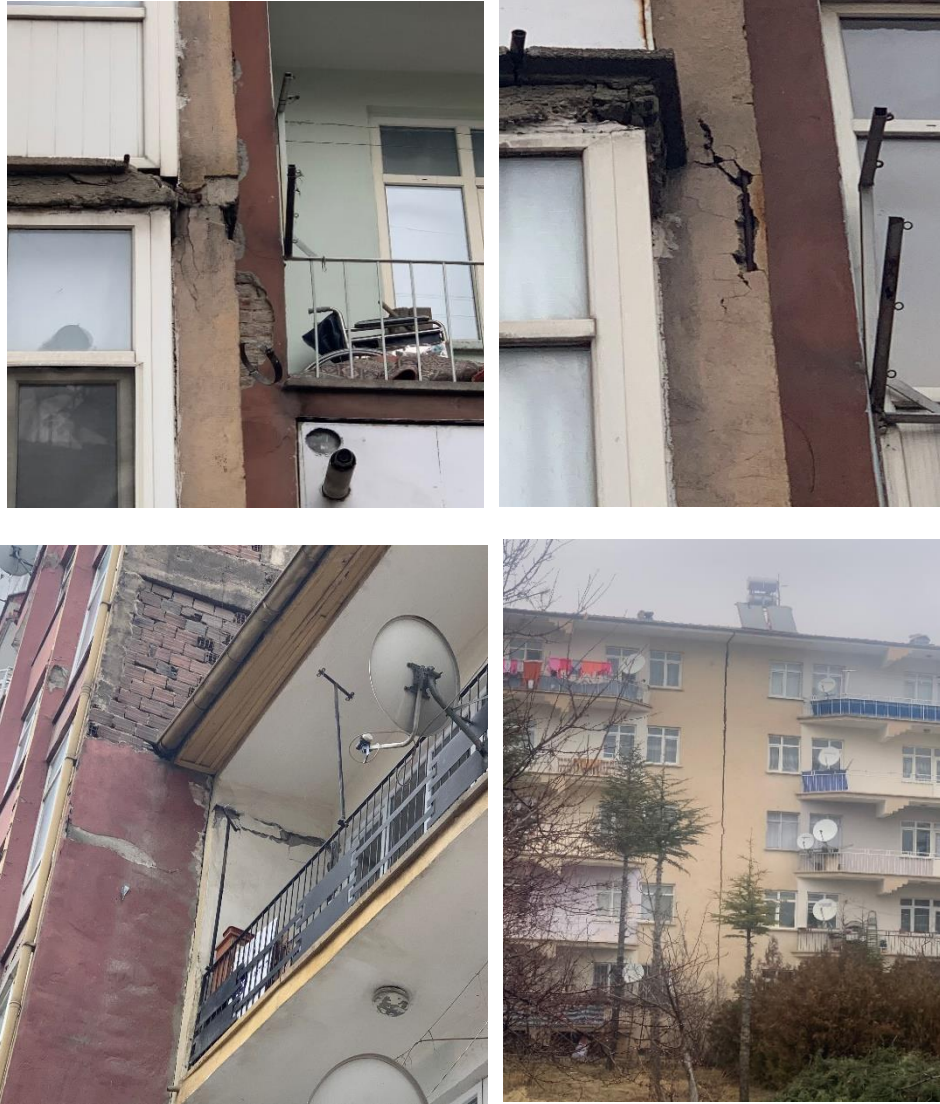
areas in city centers, adjacent buildings are often built. As a result of this, one or both facades of the buildings touch each other or there is little space between the buildings. Therefore, during an earthquake, these structures are collided because they do not have sufficient displacement space. A more dangerous situation is emerged when the story levels of adjacent structures are not same aligned. The slabs of the building can hit the columns of neighbor building, causing severely damage. Such damages were detected in the field observations made after the Elazığ earthquake (Figure 15).

Figure 15 Damages of adjacent buildings

To prevent such damages, there must be sufficient gaps between adjacent buildings. TBEC (2018) is required the construction of seismic joints that will maintain certain spacing between adjacent buildings. In this way, in the event of an earthquake, neighboring buildings can move independently without interfering with each other. According to the code, the minimum joint gap to be left will be at least 30 mm up to a height of 6 m and at least 10 mm will be added to this value for every 3 m of height after 6 m. Unless a more unfavorable value is obtained in accordance with requirement defined in previous statement, sizes of gaps should not be less than the sum of the absolute values of average story displacements multiplied by the coefficient  $\alpha$ . If adjacent floor levels of buildings at all stories are

same, then the amount of gap is  $\alpha = 0.25 (R/I)$ ,  $\alpha = 0.50 (R/I)$  if not. In these equations, R is the structural behavior factor and I building importance factor.

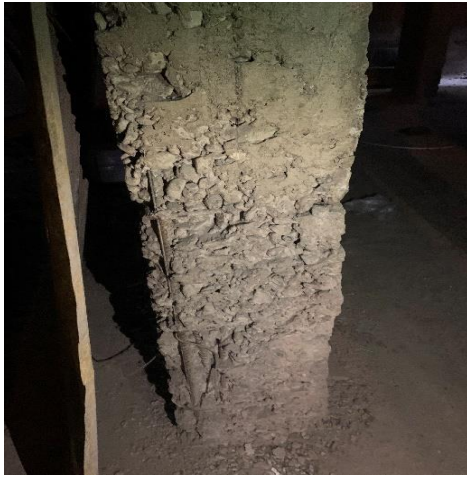
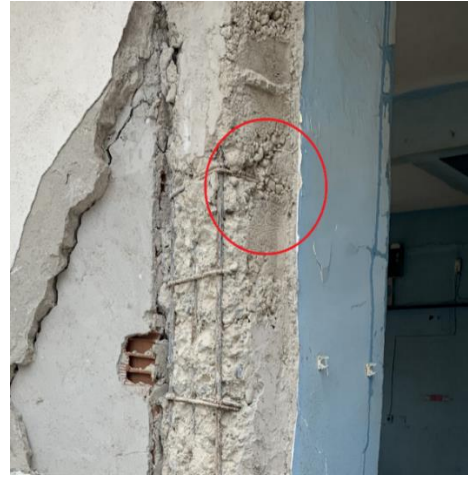
(a)

In Turkey, ready-mixed concrete has started to be used widely especially after 2000s. That's why, the majority of existing RC buildings were built with cast in-place concrete without any official control. As a result of this, many such buildings have low strength concrete due to high water-cement ratio, improper aggregate size and gradation, and reinforcement subjected to corrosion. In the field study, poor concrete

Figure 16 a) Poor concrete quality b) corrosion c) erroneous application

- Appropriate gradation concrete should be used.
- A vibrator should be used in order for the concrete to settle into the mold homogeneously.
- It should be ensured that the structural elements have sufficient concrete cover.
- Wrong applications that will weaken the RC system should be avoided.
