Bolu, Seben District, Dedeler Village Cuma Mosque Conservation Problems as a case of Rural Architecture

B. Isik AKSULU^{1,*}, Senem Ozbek ESEN²

ABSTRACT

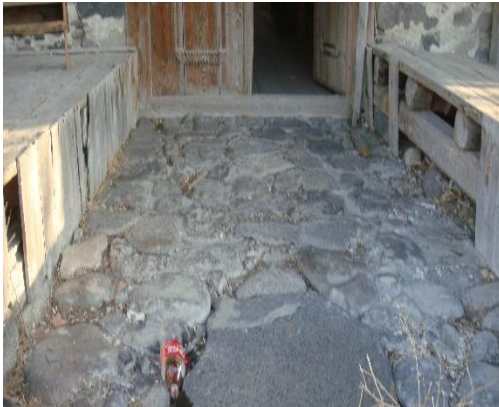
Figure 19. Latecomers' portico floor

22-23). Some parts of northeast façade wall and the entire interior walls are covered with cement plaster. There are deep slits and crashes in a part of floor covering of latecomer's portico. There are crashes on

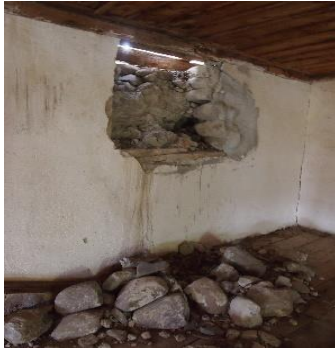
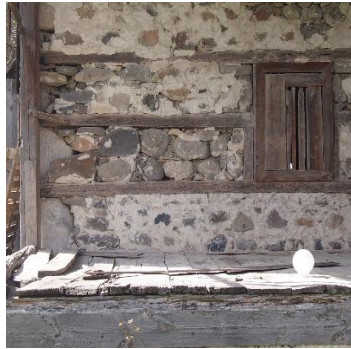
Figure 22-23. Deteriorations on stones

The southwest walls of the women's prayer space/balcony have been exposed to human made destructions, causing loss of stones on interior surfaces of southwest wall and on northeast outer walls. There are material losses on mortars and repointing of facade walls. In lower parts of stone walls the stone pattern was covered with inappropriate relief repointing (Figure

The material deteriorations determined in Dedeler Village Cuma Mosque should be preserved in line with appropriate restoration techniques. It is a structural need to make integration on material losses with original materials and techniques. It is required to clean the uncharacteristic relief repointing on stone walls. It is seen that the repointing on stone walls have been deteriorated and the repointing on the surfaces where uncharacteristic repointing are removed should made of mortar to be prepared in line with the result of analysis made on original structure. After removing the cement plaster at the interior walls of mosque, new plaster should be made by preparing the mortar in line with the results of analysis made on original plaster. Sustainability of traditional construction system is required to repair and restore the traditional structures [11]. The southeast wall of the building which was made of brick should be rebuilt by using the original stone material and construction technique. There are the gliding and climatic deterioration on roof tiles. After collecting the tiles, the ones in good condition should be selected. The ones in bed condition should be renewed by using the tiles which have original dimensions and characteristics. All the deficient parts should be completed after removing the roof cover. The timber parts which lost their chemical characteristic and function should be renewed. The humidity rate and physical characteristics of the new timber materials should be compatible with the current material [12]. The consolidation on the parts which have cracks, crashes, discolorations should be made and the materials should be protected. The timber parts should be purified from moisture. The parts of timber elements which have deep cracks and holes should be filled with resin or with appropriate oils. Surface protecting materials should be implemented on the surface where the climatic deterioration which causes color and pattern failure [13].

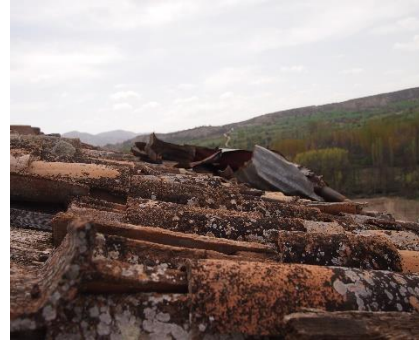
Figure 24. Deterioration on the roof

The building is subjected to direct negative impacts of weather conditions as there are the deficient parts on the covering board under the roof and as the roof tiles have been removed from their places (Figure 24). There is

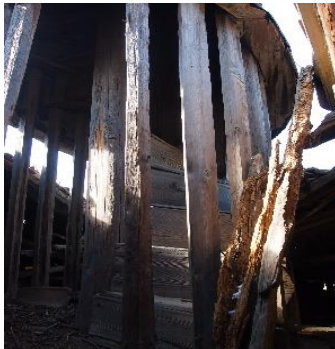
Figure 25-26-27. Deterioration on timber parts

the rottenness on the timber elements of roof as there is the minaret lacks the conical hat allowing the rain water and snow leaking into these elements (Figure 25).

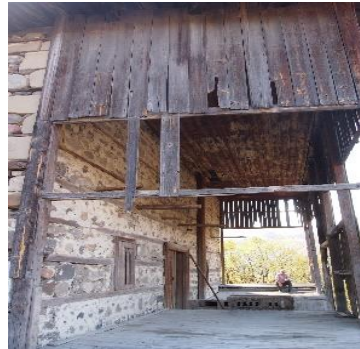
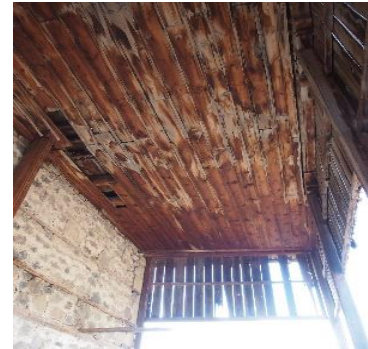
the ceilings of main prayer area and balcony and on the timber strips of the ceilings. Deep material detachments are also observable on the timber beams and cover of northeast and southwest facade walls (Figure 26-27).
