## Thermal image analysis for fault detection of PV systems in Ankara/Turkey

Hale Bakır<sup>1\*</sup>,

(1st International Conference on Engineering and Applied Natural Sciences ICAENS 2022, May 10-13, 2022)

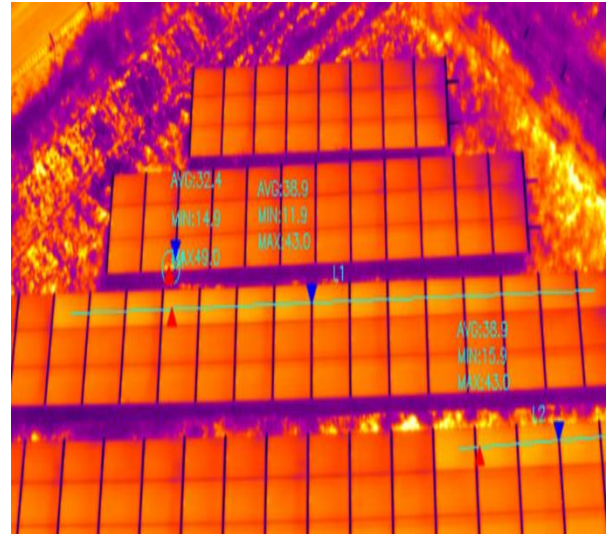
When the images taken with the drone were analyzed, a hotspot fault was detected on the panel shown in Figure 4. The panel temperature was determined to be a maximum of 43.0 degrees, a minimum of 11.9 degrees and an average of 38.9 degrees. In Figure 4, C1 is indicated by circle marks. One connection fault has been detected in the panel shown in Figure 4. The panel temperature was determined to be a maximum of 49.0 degrees, a minimum of 14.9 degrees and an average of 32.4 degrees.

Fig. 4. One Hotspot fault and one connection fault of 2.7 MW solar power plant captured by thermal drone

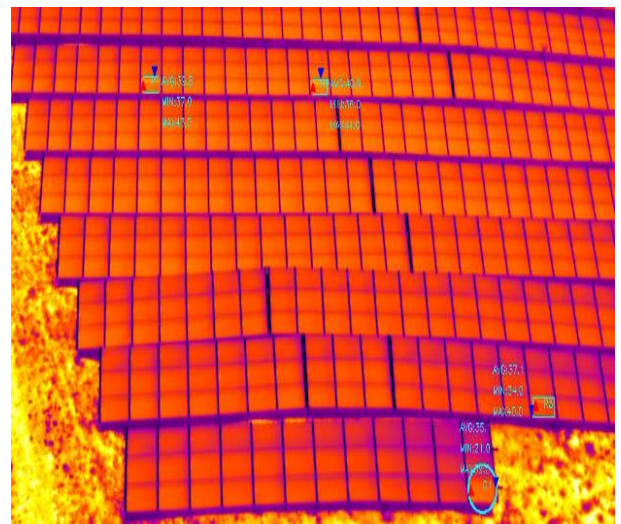
With the thermal drone in Figure 5, three Bypass diode faults were detected on the panel and the panel temperature was determined as maximum 43.0 degrees, min 37.0 degrees and average 39.8 degrees.

As another fault, one connection fault was detected on the panel with the thermal drone and the panel temperature was found to be maximum 38.95 degrees, min 20.95 degrees and average 35.13 degrees. The connection fault is indicated by the circle marks C1 in Figure 5. Five Bypass diode faults were detected on the panel with the thermal drone in Figure 6(a-b-c).

Fig. 5. Three Bypass diode fault and one connection fault of 2.7 MW solar power plant captured by thermal drone

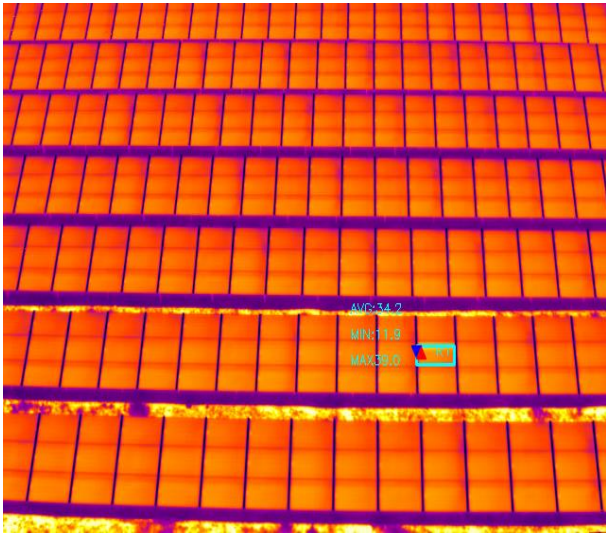
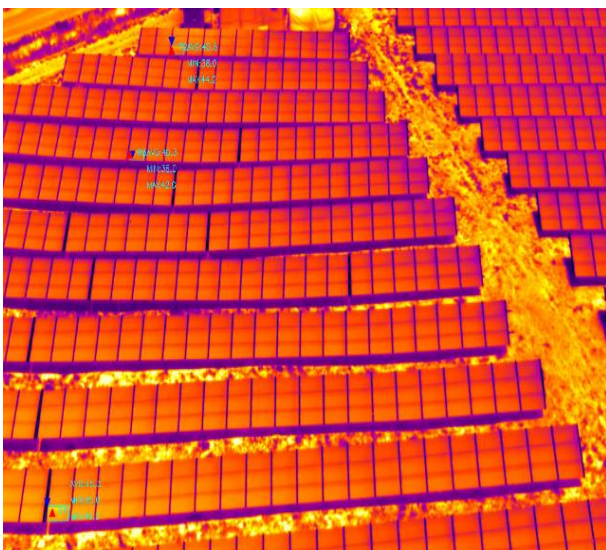
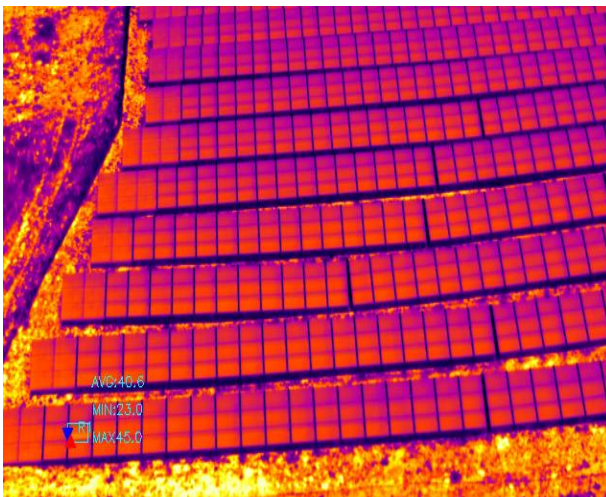
Fig. 6. (a-b-c) Bypass diode fault of 2.7 MW solar power plant captured by thermal drone

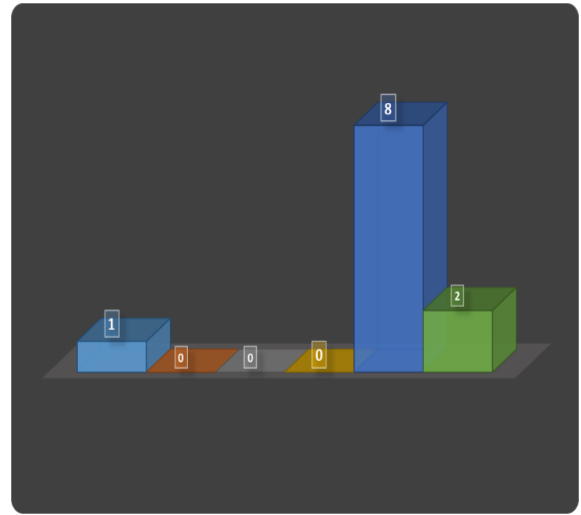
According to the tests, a total of 11 faults were detected, and the thermal shot fault distributions taken on the panels with the drone are given in Figure 7. 8 bypass diode faults are given

with dark blue colored busbar, two connection faults are given as green colored busbar, one hotspot fault is given as blue colored bus. No other type of fault has been detected. A total of 11 panel fault were detected and the number of panels affected by these faults was determined to be 28.

Fig. 7. Thermal shooting fault distributions for 2.7 MW solar power plant

As a result, an improvement of 0.68 % was achieved in energy production.
