**DETECTION AND CHARACTERIZATION OF SOME GLAZE FAULTS ENCOUNTERED  
IN SANITARYWARES**

**ABSTRACT**

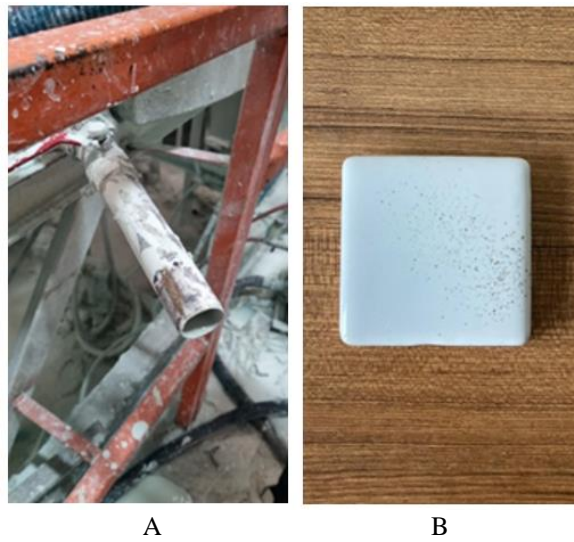
glazing cabinets. The inner parts of these pipes are caused by the friction of the glaze suspension, the upper parts are worn by the removal and installation of the clamps, and the abraded metallic particles mix into the glaze and cause staining on the glaze. The tank pipe end and its stain fault are given in Figure 3.

**Figure 3.** Tank pipe end (A) and faults due to tank pipe end (B).

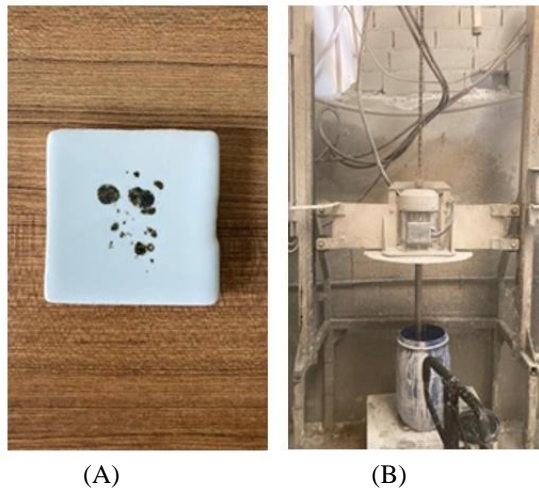
There are mixers used in glaze preparation and mixing glazes. These mixers are generally used in rheological adjustments of glaze suspension. Meanwhile, dried machine oil contaminations in the chain and bearing parts of these mixers, which have up and down moving parts, mix into the glaze. The glaze preparation mixer and its stain defects are given in Figure 4.

**Figure 4.** Faults caused by glaze mixers (A) and glaze preparation mixer (B).

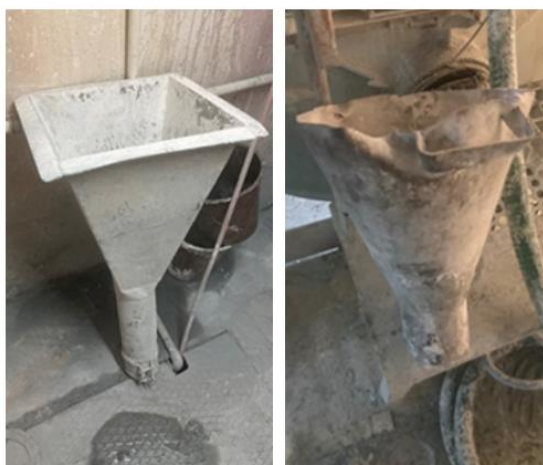
The raw materials that make up the glaze suspension are loaded into the mill from the weighing silo. Such faults can be prevented by using automatic systems while dosing to the mill. However, some glaze suspensions cannot be made with an automatic system in line with glaze consumption. The reason for this is that the glaze suspension cannot be passed through the system as tonnage or some raw materials that are not in the system are thrown manually. Some raw materials, which are proportionally less in glaze suspensions, are dosed manually. The raw material funnel, which is placed in the mouth of the mill when the workers do the dosing manually, is a metallic material made throughout the enterprise. Abrasions occur over time due to the contact of the metallic material with the raw materials, and these worn parts cause stain defects. The raw material chamber (funnel) and its stains faults are given in Figure 6.

**Figure 6.** Hopper for raw material addition.

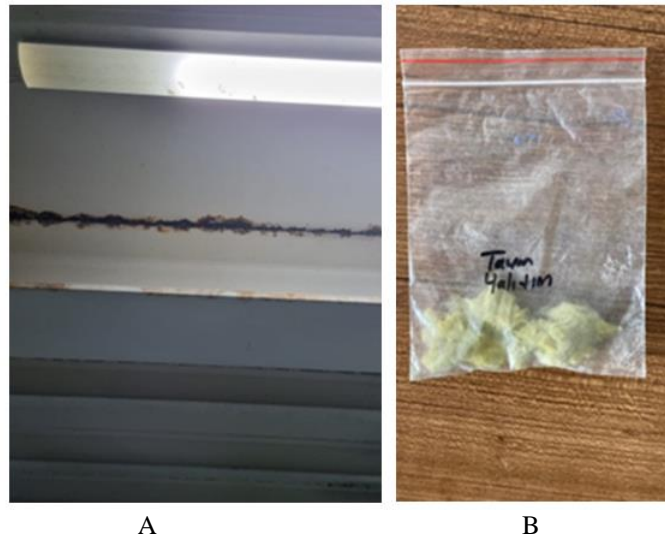
Insulations are made in some places so that the production units are less affected by the weather conditions in summer and winter months. The materials from which these insulations are made are porous materials such as rock wool. Ceramic powders in the process can also accumulate in such porous materials and cause stains such as spilling after a long time. In addition, when the ceilings are not properly insulated or when cleaning is done on an upper floor, the water leaking from the gaps between the metal plates or the concrete flooring causes the metal parts to rust and the paint on the metal to spill. The images of the rust defects caused by the ceiling coating material of the glaze preparation line and glazing and the moisture on the ceiling are given in Figure 7.

**Figure 7.** Ceiling of glaze preparation (A) and defects originated from glaze ceiling coating materials (B).

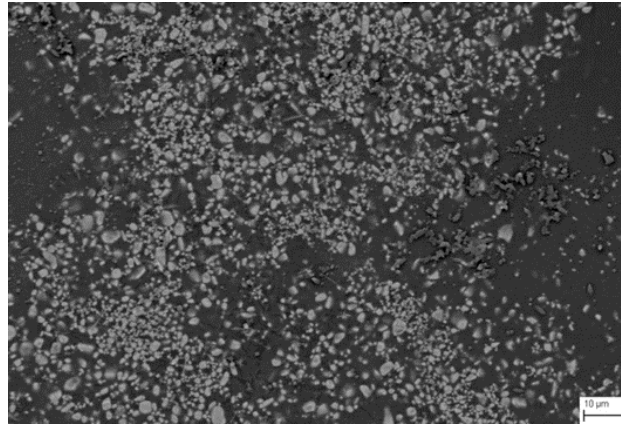
The pipes of the tanks are made of metallic materials. Since these materials are iron in their content, it is seen that there are iron stains when these materials are worn. When SEM analyses are examined, it is observed that a layered structure is formed in a hollow form in the region of iron stains. As seen in Figures 8 and 9,  $Fe^{+2}$  in the structure causes a regional deterioration by damaging the area around it as a result of melting with heat, as well as the place where it is poured. The iron region formed in the crystal phase disrupts the crystal formation in the structure. In the regional SEM analyses, it was determined that there are  $Fe_2O_3$  phases on the crystal structure.

**Figure 8.** SEM image of the faults caused by the end of the glaze tank pipe.

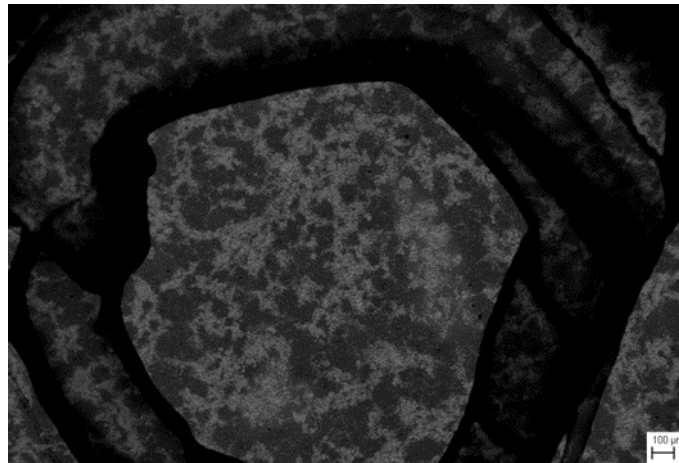
**Figure 9.** Sem image of iron phase fault caused by glaze tank pipe end defect.

According to the EDX analyses, the values in the  $\text{Fe}_2\text{O}_3$  are compatible the SEM analyses (Table 1). The zircon-based calcium alumina silicate structure, which forms the basic structure of the glaze, defines the formation of the glaze in all EDX studies. Apart from this, it is seen that the pieces that can break off from the pipe end are simulated in the experimental studies where the  $\text{Fe}_2\text{O}_3$  ratio is relatively high. These defects cause brown iron stains after firing [11,13].

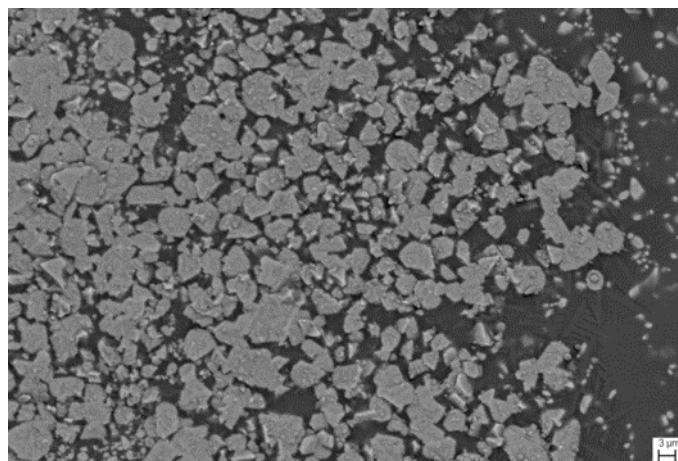
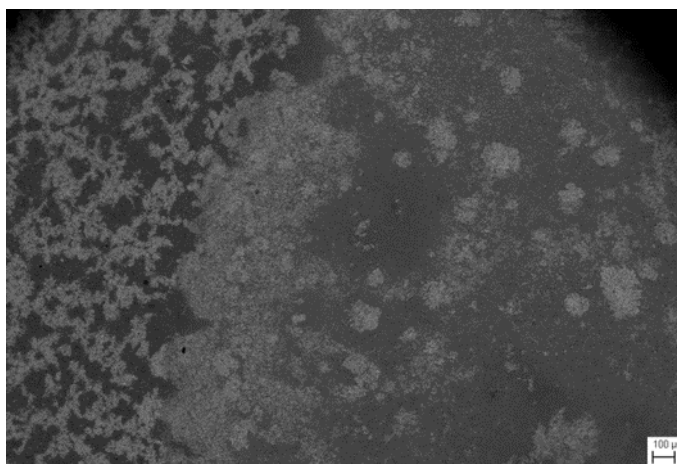
Since the need for production is continuous, glaze preparation tanks are changed frequently depending on the product manufactured. Glaze tanks, which are changed due to rheological changes, are mixed in production mixers after adding binders. In the meantime, impurities are mixed with the structure, and the staining that occurs as a result of this, as it is organic based, removes many components from the structure at  $\sim 450^{\circ}\text{C}$ , thus causing black or dark staining in the structure. Although the mixer ends are made of chrome-plated steel material, the hard particles in the glaze (such as quartz and alumina, etc.) break the coating on the mixer blades and cause such staining. As seen in Figures 10 and 11, the particles are disseminated in the whole sample [14].

**Figure 10.** SEM image of the faults caused by the glaze mixer.

**Figure 11.** SEM image of the faults caused by the glaze mixer.

As seen in the EDX analysis in Table 2, the stains transmitted from the bearing in the glaze preparation mixers are mainly chromium and iron content. Particularly iron-bearing particles were found. It is seen that the defect color is black and brown. As seen in Table 2, these rates increase due to the thinness of the chrome plating and the fact that the material at the bottom of the chromium plating consists of ferrous metallics.

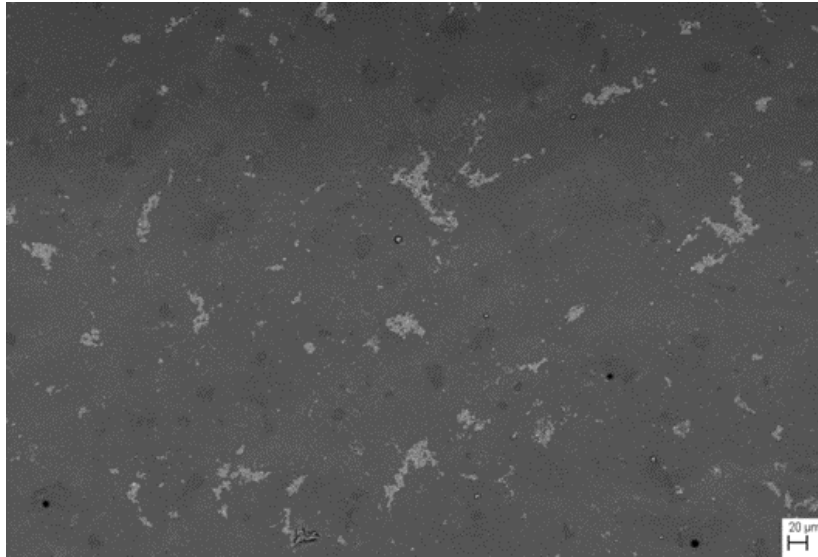
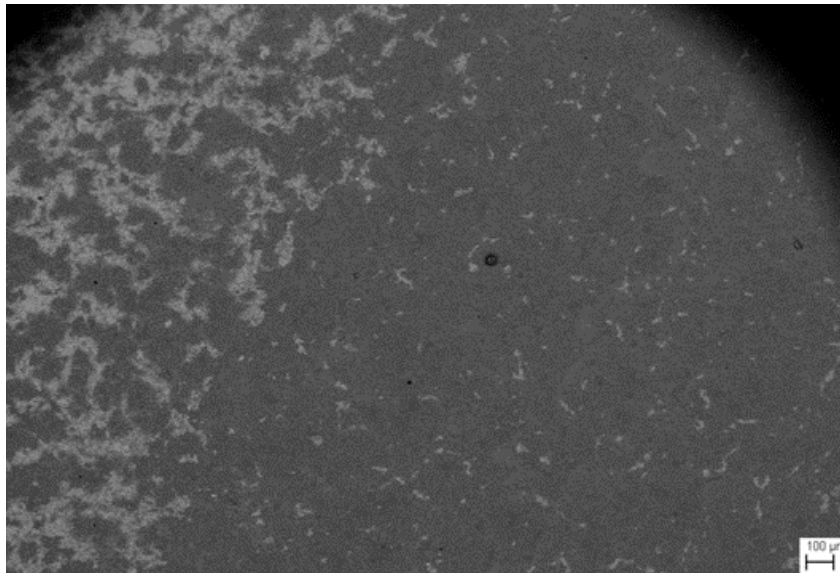
Glaze spatter formation is the faults that may occur due to not washing the pumps used in the transfer of glazes in the process to the airbrush (pistole). Although the glazing colors are separated according to the production planning, sometimes colored and white glazes can be glazed in the same cabinets. In these cases, pumps and cabinets are washed. However, the particles remaining on the edges of the pumps or cabinets may appear on the glaze surfaces as a stain defect with the effect of compressed air. When the SEM analysis in Figures 12 and 13 are examined, it is seen that the impurities are in light gray tones and with less density compared to the SEM's of iron-bearing structures. It is seen that some pigments melt in the body, reducing the color formation in the glaze layer and there are small regional densities.<sup>15</sup>

**Figure 12.** Sem image of the defects due to colored glaze splash.

**Figure 13.** Sem image of the defects due to colored glaze splash.

It has been observed that the dulled glazes come in the same color as in the stained areas. Due to the dull of glazes, Al ratios are high. It was observed that the structure of glossy glazes was targeted in the

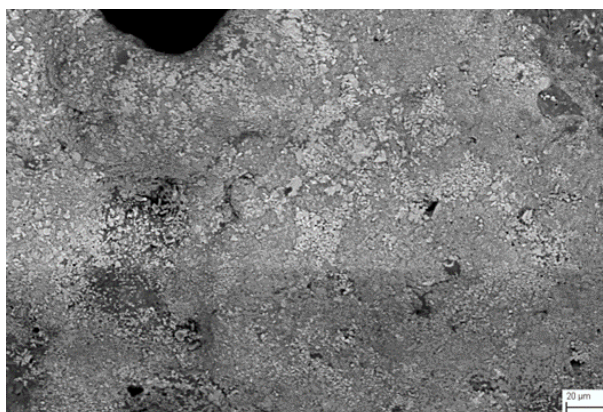
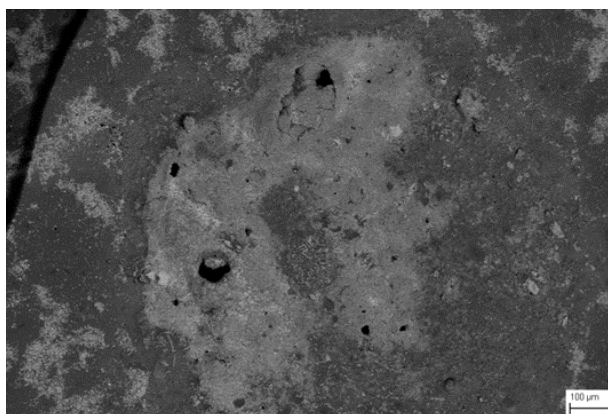
Since this tool is made of metallic materials in the operating workshops, iron stains have been observed. The fact that it is less than the other raw materials given in the study causes the glassy phase to be observed predominantly in the SEM images, while the impurities can be clearly examined in dark black in Figure 15. It has been observed that there are iron stains in the light gray areas, micro pinhole defects occur in the SEM images of these spots, the iron particles formed in these areas are separated from the environment by burning out and they leave stains in the structure together with the pinhole defect. In Figures 14 and 15, SEM images of the defect originating from the raw material chamber are given.

**Figure 14.** Sem image of the defect originated from the raw material hopper.

**Figure 15.** SEM image of the defect originated from the raw material hopper.

Since the iron rate is determined by the EDX analysis done for the black spots, the  $\text{Fe}_2\text{O}_3$ 's rate can increase up to ~62% and these results are given in Table 4. The results obtained from the spot EDX analysis done for the iron points support this determination. The deterioration of the glassy structure in these regions is associated with relatively low  $\text{SiO}_2$  ratios.

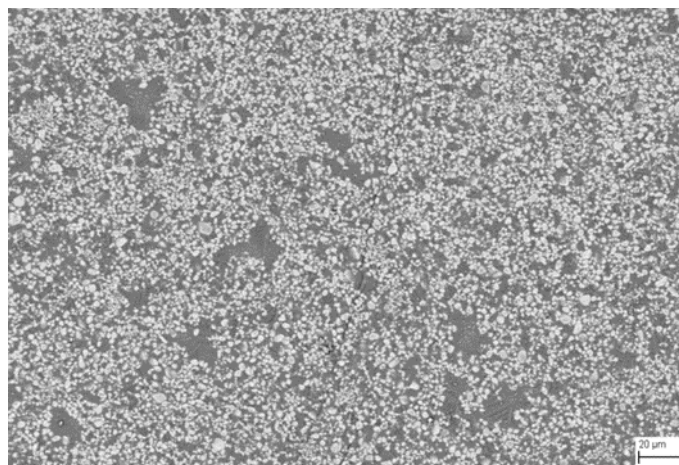
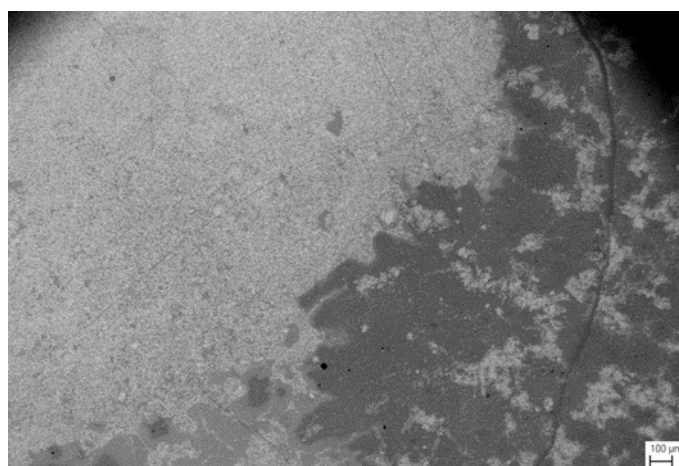
Ece Banyo factory operates as a two-story production facility. Glaze preparation and glazing sections are located at the bottom of the drying kilns. Since this platform is metal, stone wool materials are used in the interstices of the ceiling. These materials can deform over time with the effect of temperature and humidity, and they can break off from the structure and mix into the glaze tanks. It was determined that the materials used for insulation, other than iron, were poured in the particles poured from the ceiling due to the changes in ambient temperature, and Ca ions were high in these materials. In SEM analyses, this ratio is observed to be scattered regionally. Compared to the SEM analyses of the previous faults, it is observed that there is a more homogeneous structure and dark colored glaze structures are deteriorated, although it is not as effective as iron in the glassy phase. SEM images of the defects caused by glaze preparation ceiling and ceiling insulation materials are given in Figures 16 and 17.

**Figure 16.** Sem image of defects caused by glaze preparation ceiling insulation material.

**Figure 17.** Sem image of defects caused by glaze preparation ceiling insulation material.

The fact that CaO in the EDX analyses varies between ~22% and 3% in the structure shows that this is due to different spills. The SiO<sub>2</sub> ratio, which indicates the glassy phase, also varies due to the mixed material, and this change can be examined proportionally in both the impurities and the main building raw materials in Table 5.

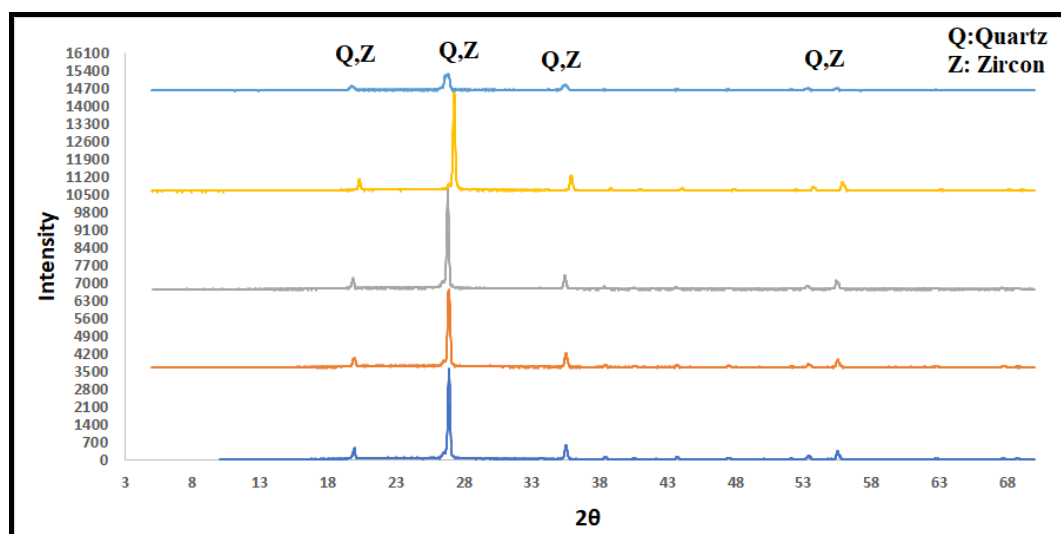
As seen from the XRD analyses below, the analyses of the samples listed as 3.1-3.5 from bottom to top show that the quartz peak is seen apart from the defects caused by the ceiling covering materials, but the structure is deteriorated due to the Zr content of the ceiling material. XRD analysis are given in Figure 18.

**Figure 18.** Xrd analysis results of the defects.
