Detection of micro-cracks in PV system using electroluminescence (EL) testing

Hale Bakır^{1,*}

¹ Department of Electronics and Automation, Sivas Cumhuriyet University, Sivas, Türkiye

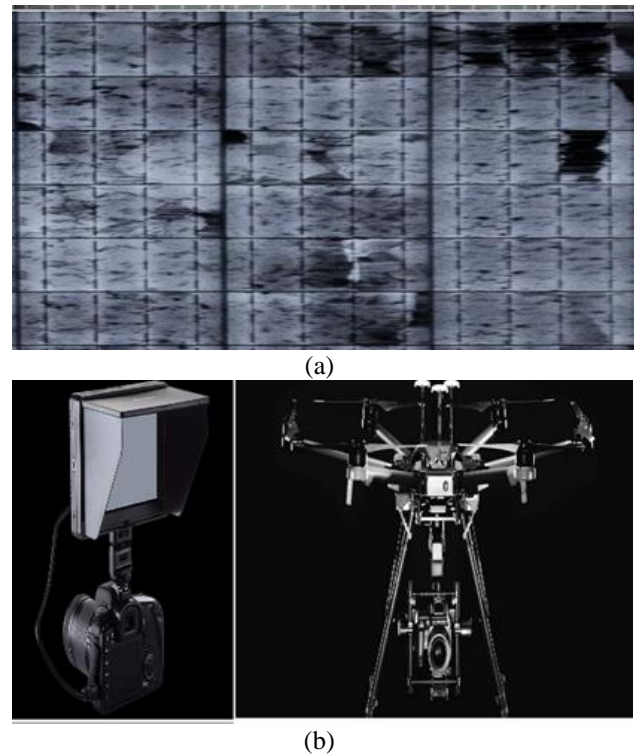
damaged or inactive cells appear dark-black as shown in Figure 2(a). The grey scale in the acquired images provides to determine the extent and cause of the damage in your SPP site. In this method, problematic solar panels can be detected for further laboratory testing. With this qualified imaging method, damages reasoned by mechanical stresses such as installation, transportation, hail, snow, and faulty bypass diodes can be detected quickly. However, deterioration in cells, broken cells, short circuits and malfunctioning panels can be easily detected. On-site Electroluminescence testing is currently the most cost-effective method on the market for the early and clear detection of potential or existing problems of PV panels. Figure 2 (b) shows a EL camera mounted on a drone.

Figure 2. (a) Damaged cells, (b) EL camera on a drone

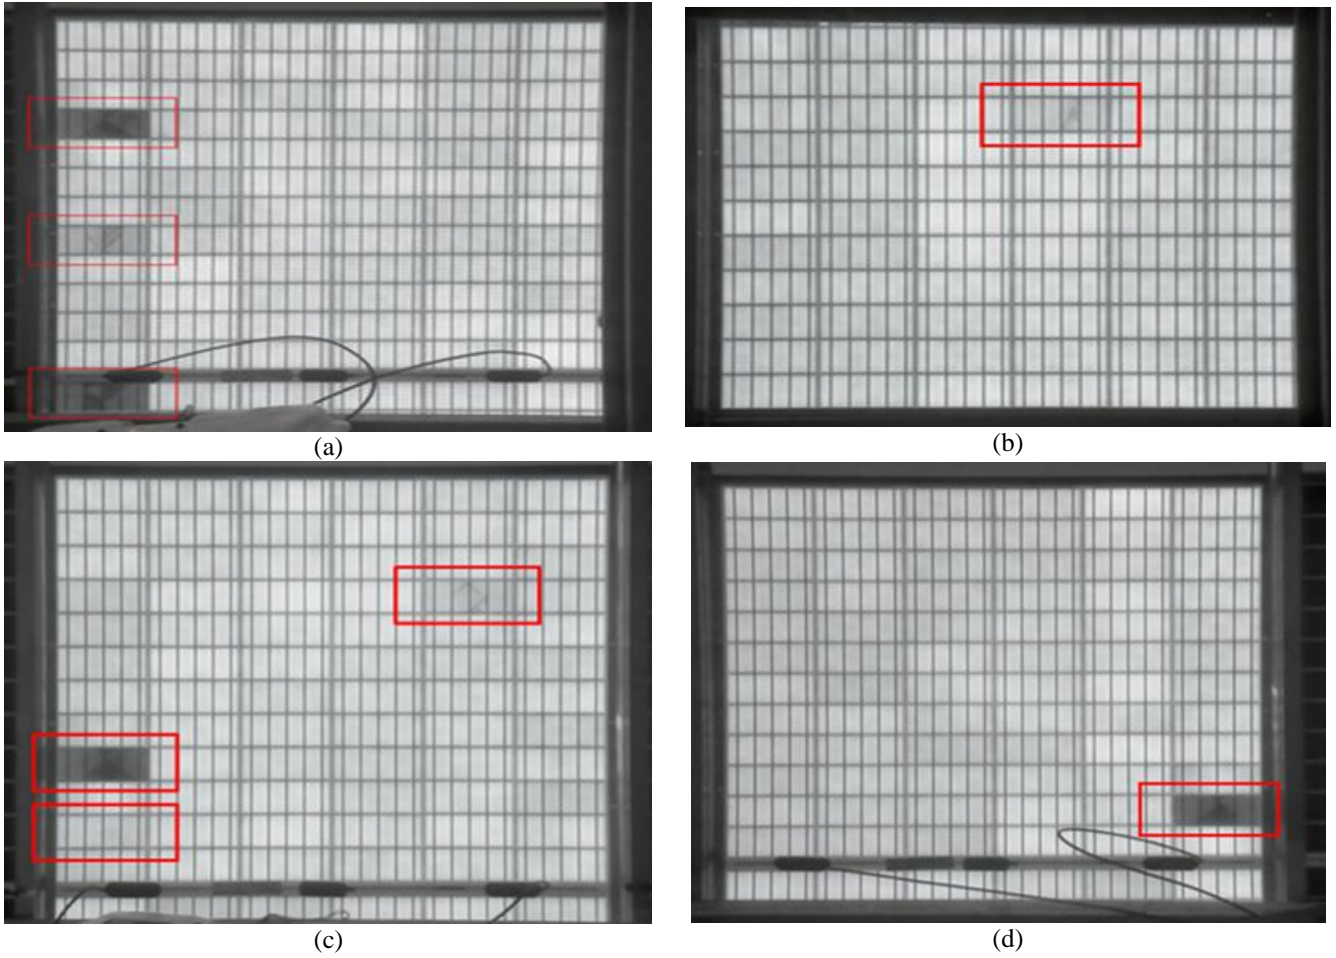
Panels tested by EL camera are shown in Figure 3. EL images taken with an electroluminescence test device are shown in Fig. 4-5. In Figure 4(a), the broken cells are seen in the darkest black areas with the EL test. In total, 8 broken cells were detected, as can be seen in Figure 4 (a-d). The problem cell is shown in Figure 5(a) with the EL test. In total, 3 problematic cells were identified, as can be seen in Figure 5 (a-c). With the EL test method, fast and precise resolution of failures is achieved. Cracks and breakages are visible. However, the type of failure occurring in the problematic cells is determined and energy losses are prevented by on-site intervention. Micro-cracks are cracks that occur on the panels and are difficult to see with the naked eye. Micro-cracks of the panel; may occur during production, transportation and installation phases. Although these cracks do not show their effect during the first installation and electricity generation, they may cause a decrease in the efficiency of the panel with the increase in the size of the cracks in the following periods. Any defects in solar cells, such as cracks, poorly soldered connections, and mismatches, cause higher resistance and become hot spots in the long run. A typical EL imaging setup is shown Figure 6. As a result, in this study, the number of samples displayed is 4, the number of cells displayed is 576, the number of damaged (broken / cracked / possible problem etc.) cell is 11. It is observed that the fractures/cracks detected in the panels have similar characteristics. This situation is not due to manufacturing defect, but rather transportation or assembly. It seems that the pressure applied to the panels during the process was created by impact. This should be compared and confirmed with their current condition by requesting the panel manufacturer's ex-factory electroluminescence images and IV measurements of the panels. Although it is thought that the detected "Possible Faulty" cells are not of the type that will affect the production at the moment, they are checked periodically. It is recommended to follow their development/progress.

Figure 4. (a-d): EL images of broken cracked cells taken with an EL test device [16]

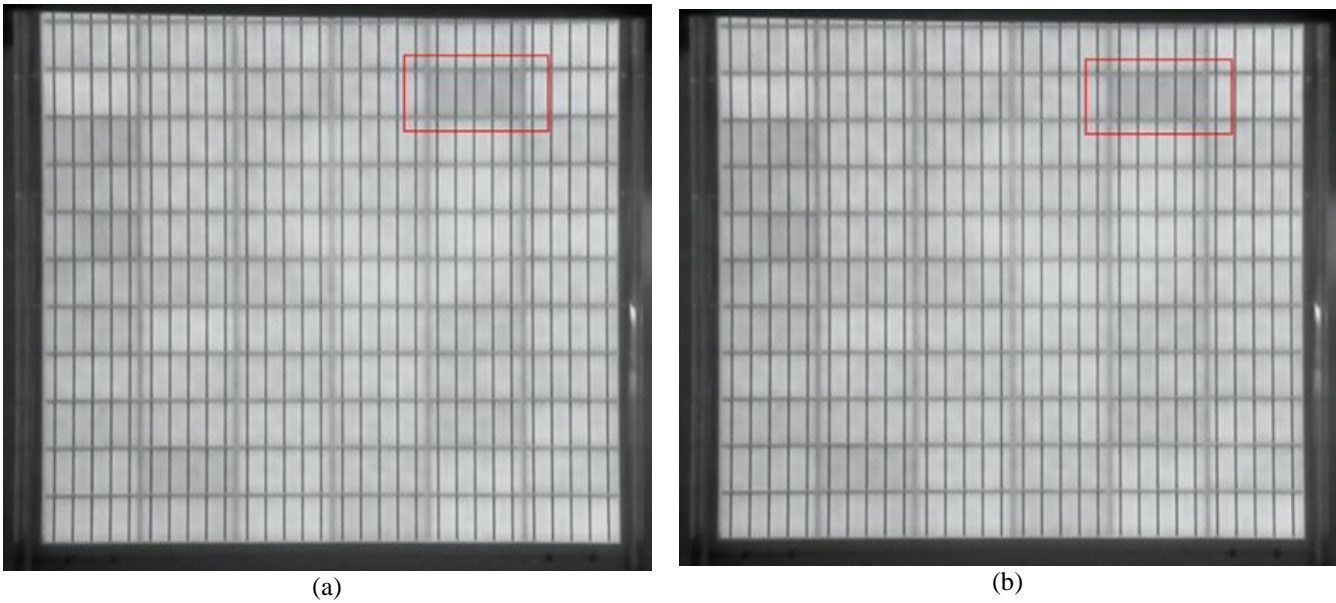
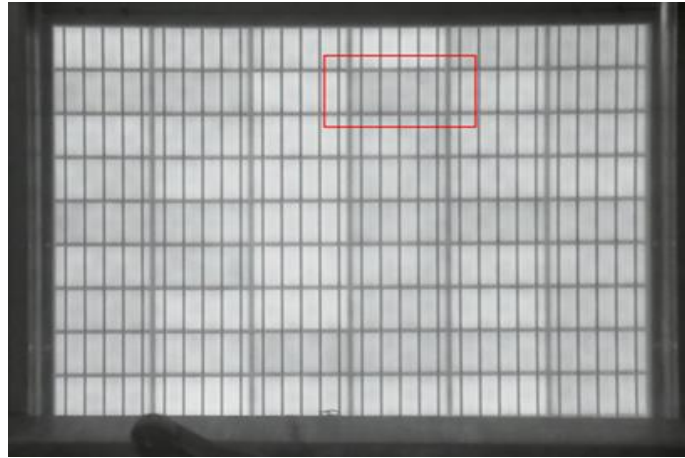
Figure 5. (a-c) EL images of problem cells taken with an EL test device

Figure 5 (continue). (a-c) EL images of problem cells taken with an EL test device

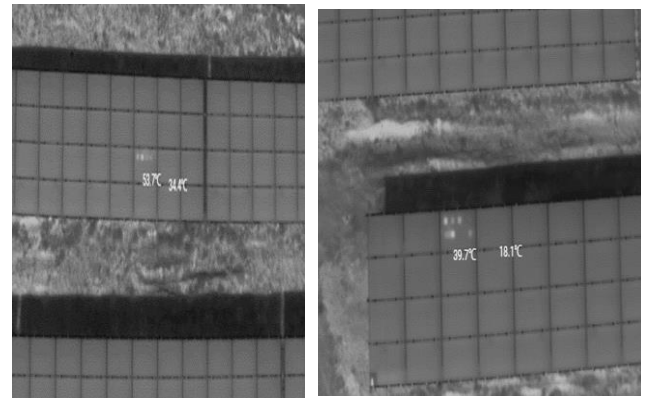
Although measurements with infrared thermal cameras in Figure 7 are very popular, they are insufficient in detecting micro-cracks. According to the tests performed, the images obtained with the thermal drone are given in the Figure 8 (a)-(b). The detected fault type is the hot spot, that is, the point heating fault, which occurs with the square geometry in a single cell [15]. The fault is detected as point brightness. What kind of fault type there is must be determined again by going to the field. However, according to these results, the EL test is more effective, reliable and superior to infrared thermal imaging in detecting micro-crack defects. And this is clearly seen from the images [15].

Figure 8. Thermal camera (Thermal drone)

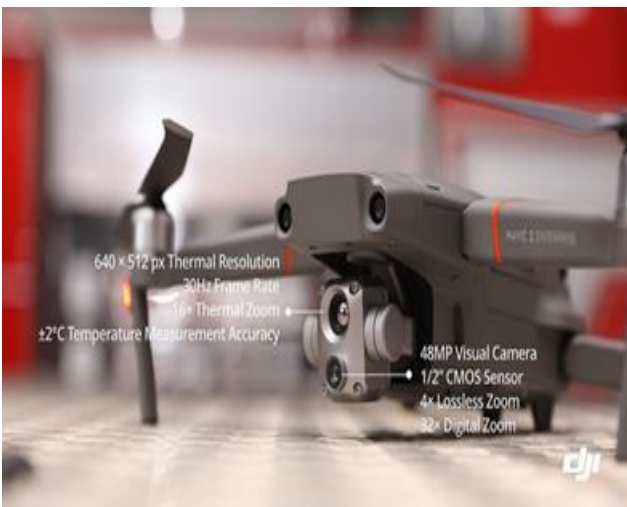
Figure 7. Thermal camera (Thermal drone)
