Lost Tangible Cultural Heritage: A Traditional Tokat House Restoration Project

Dilara Gökçen PAÇ^{1,*}

3. RESTORATION PROJECT OF A TRADITIONAL TOKAT HOUSE

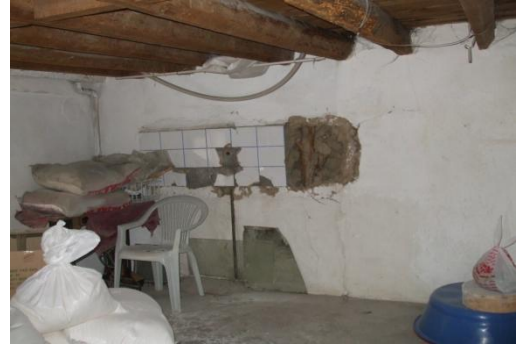
Figure 11. Mezzanine Floor Room A01 (Author's Archive)

There is a room on the mezzanine level (Figure 9). Access to the room on the mezzanine level, often used for storing provisions, is provided via a wooden staircase from the stone-paved area (Figure 10). The flooring is made of concrete, and the wooden construction of the house can be seen on the ceiling. The room covers an area of 11 square meters and has no door. It has two windows. The windowpanes are missing, and some areas are covered with linoleum. The windows are original and share similarities with the windows in many other rooms of the house. The walls of the room are damaged (Figure 11). Paint on the walls has partly disappeared, revealing wooden posts beneath.

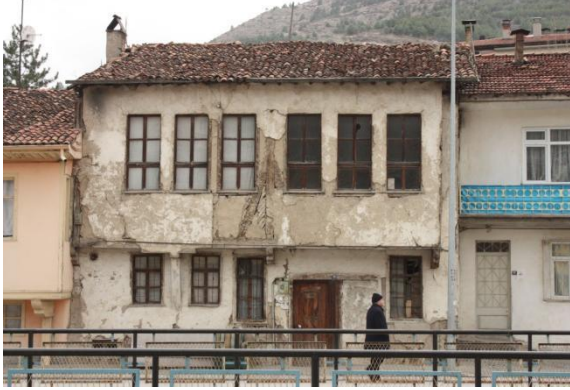
Figure 15. Front Facade Facing the Street
(Author's Archive)

On the Street Facade, the entrance door is situated 15 cm below the road level (Figure 15). The single-wing wooden door is undamaged and original. Two windows are visible on this facade from the mezzanine level. The window on the side of the bathroom is not visible from the mezzanine. There is a gap between the bathroom wall and the wall of this facade. The mezzanine room faces this facade. The facade features a projecting bay on the first floor. The bay is supported by wooden brackets. The windows of the living area (sofa) and the windows of room 103 face this facade. The windows on the first floor are in usable condition. Some cracks and signs of decay are visible on the facade, along with wooden brackets and beams exposed where the plaster has fallen off. The closed entrance door's one wing is still visible amidst the surrounding wooden elements.

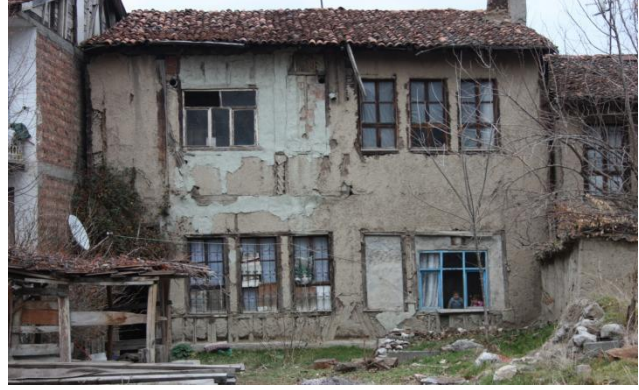
Figure 16. Rear Facade Facing the Street (Author's
Archive)

On the Rear Garden Facade, the plaster has fallen off in certain areas, revealing the underlying wooden construction (Figure 16). In some places, mud mortar can be seen beneath the plaster. The window of

room Z01 is not in its original state; it has been partially closed and modified. The rooms facing this facade are generally in a deteriorated state. Among them, room 102 on the first floor is the most deteriorated. The window of this room is not original. The garden is in a neglected state. The windows of room Z02 do not have glass; they are covered with cardboard.

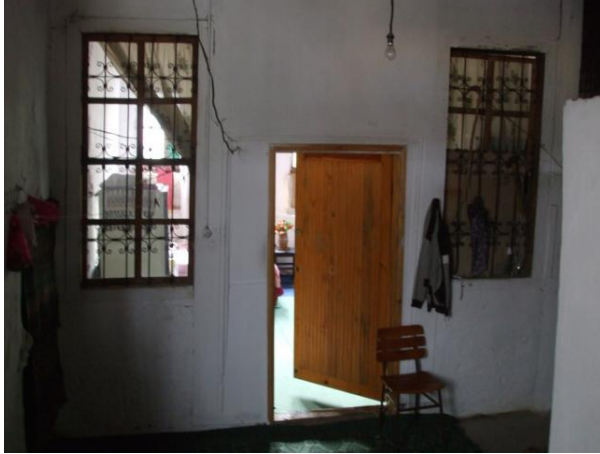
Figure 17. Windows in the Stone Base (Author's Archive)

The ground floor, first floor, and mezzanine level exhibit varying degrees of damage. The windows of the rooms on the ground floor lack glass and are covered with cardboard or vinyl (Figure 17). The wall of the hallway leading from the ground floor to the garden is in a damaged state (Figure 18). Steps of the wooden staircase are missing (Figure 19). One wall of the mezzanine-level room is damaged. The ceiling of room 102 on the first floor is in a deteriorated state (Figure 20). Room 101 has issues related to the chimney. The living area (sofa) and room 103 are in good condition.

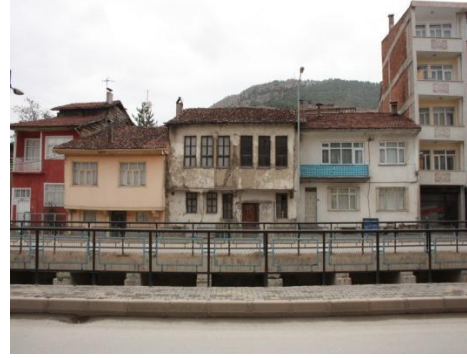
Figure 25. Front Facade Visual
(Author's Archive)

On the Street Facade, apart from the single leaf of the entrance door, the general facade features have been preserved in their original state. The structural system of the residence can also be inferred from the deteriorations in the existing plaster on the facade (Figure 25). The entrance door is positioned approximately 15 cm below the road level. Due to the road elevation above the facade, in the restitution, the door has been restored to its original state. The single leaf wooden entrance door is not damaged and is original; however, based on the wooden traces on the facade, it is evident that it was originally a double leaf door. The missing leaf has been added to the door according to its original design (Figure 24). The original wooden window, which was covered by a poorly constructed bathroom addition on the facade, has been reopened. The metal railings of the facade windows are original and have been renewed.

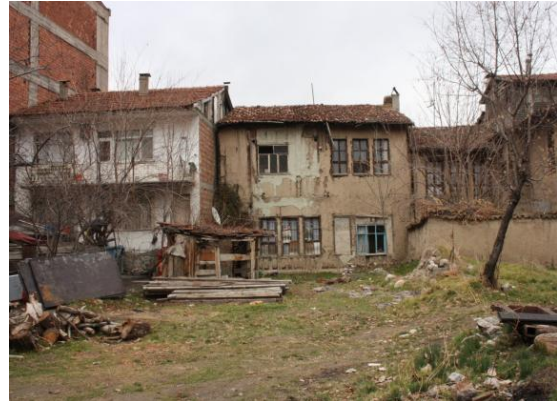
Figure 27. Rear Facade Visual (Author's Archive)

On the Rear Garden Facade, the plaster has partially fallen off in some areas, revealing the underlying wooden construction (Figure 27). In certain places, mud mortar can be seen beneath the removed plaster. The window of Room Z01 on the rear facade is not original; a portion of it has been closed and altered to an older state (as indicated by the wooden traces) and has been changed according to the original design (Figure 26). The window of Room 102 on the first floor is also not original and has been altered compared to the other original windows on the facade. The concrete mass rising from the ground level on the facade has been removed.
