INVESTIGATION OF DEFECTS OCCURRING IN THE CASTING SHOP PROCESS OF CERAMIC SANITARYWARE ON THE FINAL PRODUCT

Nihal Derin COSKUN^{1*}, Eray CASIN², Cumhur Eren ISIK³

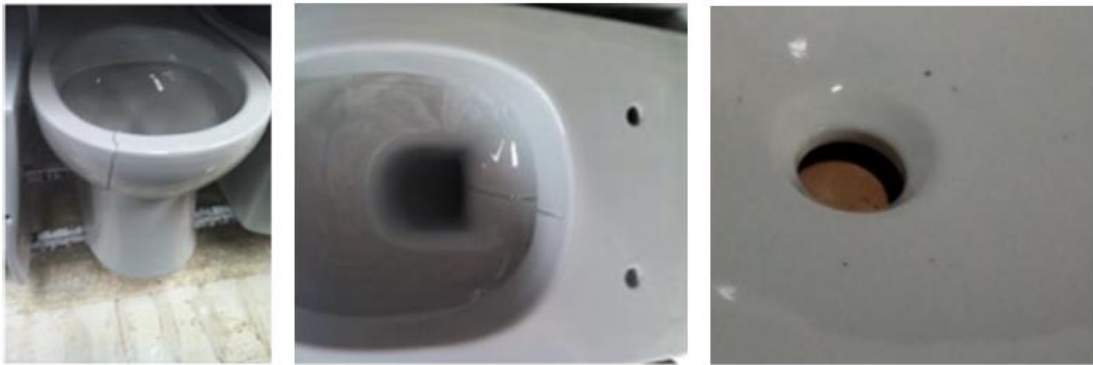
However, in vitrified products, which are an industrial production branch, these images visually distort the effect as seen in Figure 2. Since they are relatively large in size, these products go to waste which has a negative impact on production in terms of raw materials, labor, energy and time. These faults can also be seen in a porcelain plate or ceramic tile product, but the biggest loss is more visible in the sanitaryware industry due to its larger size (Fortuna and Fortuna, 2017; Fraser, 2005). Many studies have been done and are being carried out on ceramic defects in areas such as tableware and the tile sector, which require more patterns and designs. Efforts to eliminate these faults and possible causes of defects are determined, and some of the main faults in the literature are seen in Figure 3.

Figure 2. Manufacturing defects on some vitrified products.

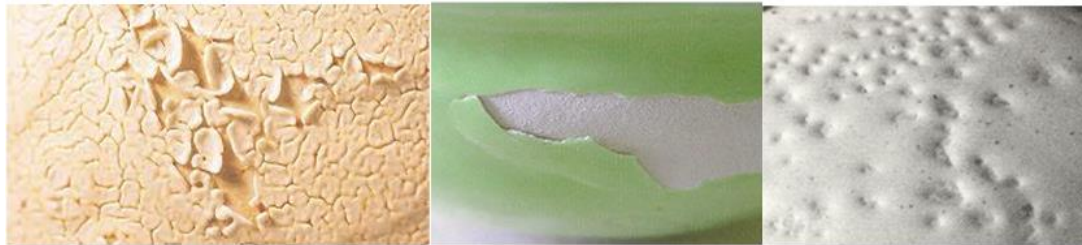
Figure 3. Some ceramic glaze defects (Hopper, 2023).

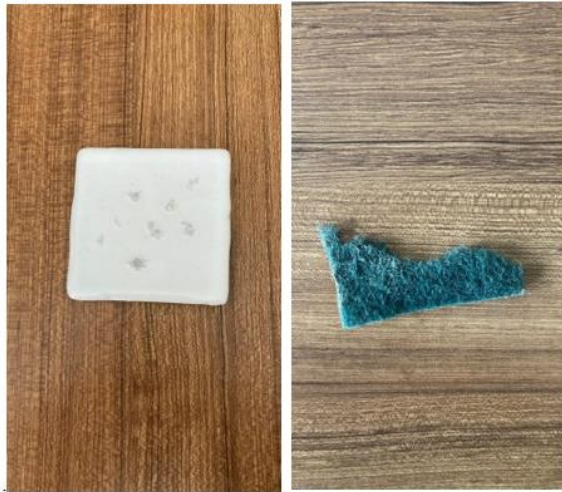
Green scotch is a material that is generally used for retouching the surfaces of semi-finished products containing 18% moisture from casting. It is especially used for rounding corners. It can also be used in semi-finished products after drying. Many apparatuses are used during the retouching in the casting shop, but since the green scotch comes into contact with the product with plenty of water, they can be buried in the product from time to time and cannot be noticed in the process (Figure 4).

Figure 4. Green scotch (Right) and defects due to green scotch (Left).

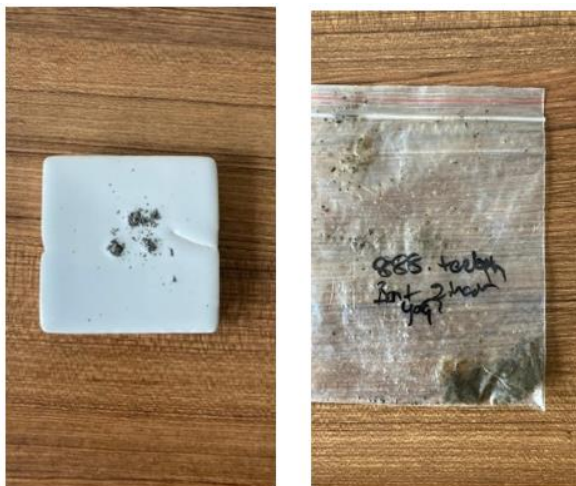
Pressure casting benches are different from conventional casting benches, they are more mechanical and have many moving and rotating parts. Machine elements such as belts or bearings are used in the rotational movements of these machine parts or the movements of the moving parts. Lubrication processes are also carried out to prevent the wear of these elements. The presence of water in the working environment causes these oils to clump and stick to the products in cases where cleaning processes are not carried out in a controlled manner. In addition, the abrasions that may occur due to the friction of some parts against each other and the resulting metal slags also cause the formation of metallic stains (Figure 5).

Figure 5. Die casting machine slag materials (Right) and defects caused by them (Left).

poured from the upper part of the counter due to friction cannot be detected because they are taken into the system by robots without human touch. These types of defects also appear as stain faults at the exit of the kiln.

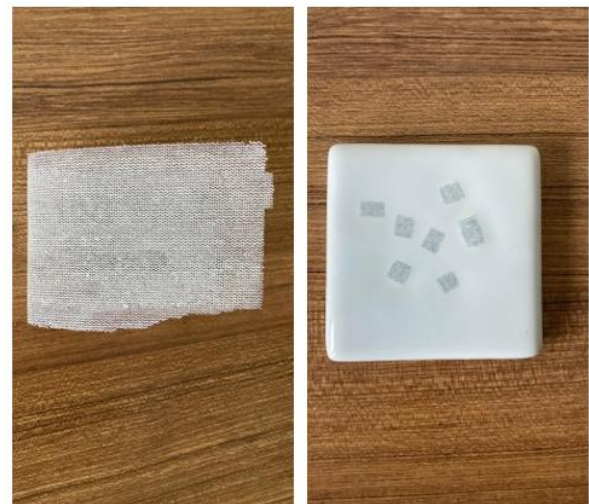
Strip tape abrasive is a hard, metallic abrasive type used in ceramic sanitaryware at the stage of semi-finished product control. This abrasive, which is generally preferred in the retouching processes carried out under the control of the products after drying, is used to ensure the rapid flow of semi-finished products. The reason for this is that it has a high ability to retouch, since it is a hard abrasive. After using this abrasive in the semi-finished product control process, the surface should be wiped with a damp cloth again and the touch-up marks on the surface should be closed. Since it is a metal-based material, it causes staining in case of any wear or breakage (Figure 7).

Figure 7. Strip tape abrasive (Left) and defects (Right) due to this abrasion.

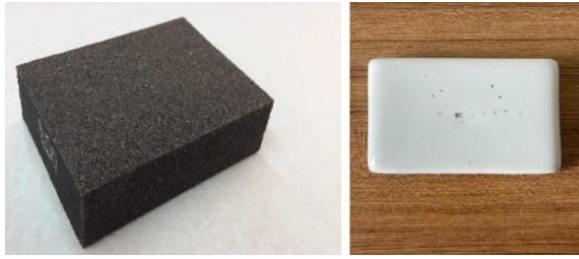
Box shaped abrasives are a different type of abrasive used in casting shop and used to perform surface treatments of products. It is a material that can be touched up without damaging the surfaces, since the eroding part is soft, box-shaped and has a sponge in the middle. In some cases, stains can be seen if this abrasive

(silicon carbide) wears off and the wearing parts adhere to the surfaces. In addition, abrasive particles that dissolve in the retouching waters in the casting shop and adhere to the surface with slip particles also cause staining (Figure 8).

Figure 8. Box Abrasive (Left) and Related Defects (Right).

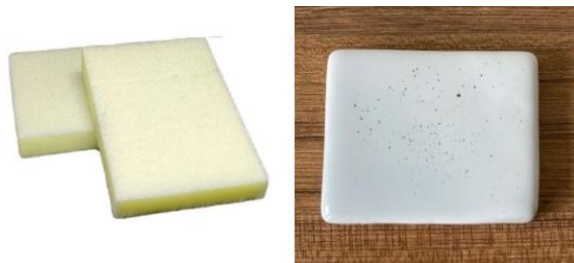
This type of abrasives is generally used in the semi-finished product control phase. White color is the chief reason for this abrasive to be utilized in the retouching process of the semi-finished product, because the upper area of the product is alumina-based. This type of abrasive is more preferred because black spots are observed in silicon alumina based abrasives. However, it is observed that this material also causes defects (Figure 9).

Figure 9. White Abrasive (Left) and its related defects (Right).

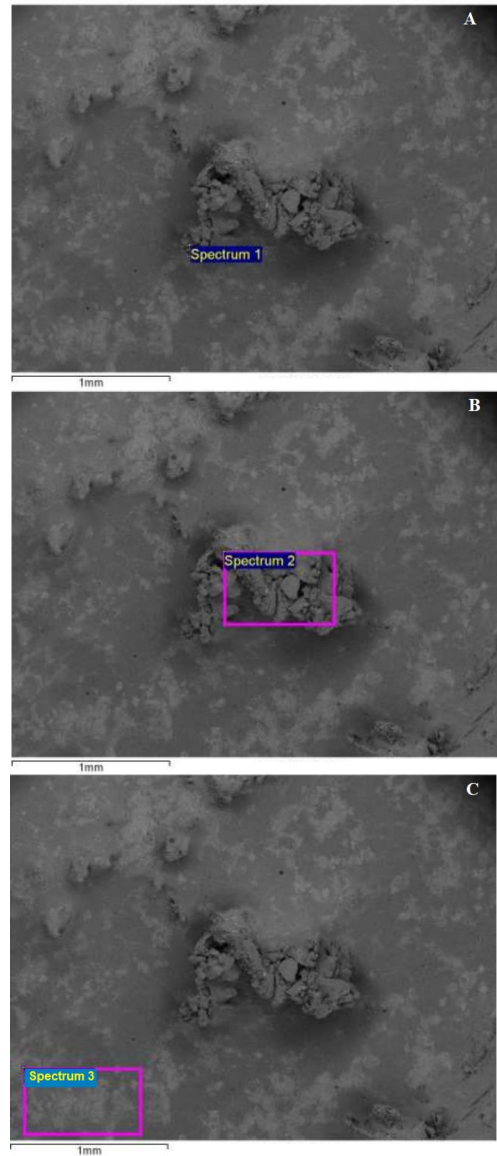
The green scotch-based defects seen in Figure 9 cause inclusions in the structure since the material is polymer-based. In the samples studied in a major scale, the material appears as a mound because it does not completely melt in the glaze. However, it is not completely combined in the glassy phase, and it shows itself as a separate formation from the structure, as seen the figures (Figure 10).

Since the green scotch is a polymeric material, it does not leave any residue after firing. The earlier melting temperature of the material, which is embedded in the glaze (i.e., if parts remain within the body), causes defect on the glaze surface.

Figure 10. Some SEM Analysis of Green Scotch Based Defects A, B, C (Table 1 displays EDX analysis of the defects).

As seen in Table 1, in the analysis of the points where the Al₂O₃ ratio higher, ZrO₂ ratio is not observed in the structure, indicating the green scotch is causing defects in the regions. The defect of the natural opaque glaze structure is evidenced by the zircon ratio.

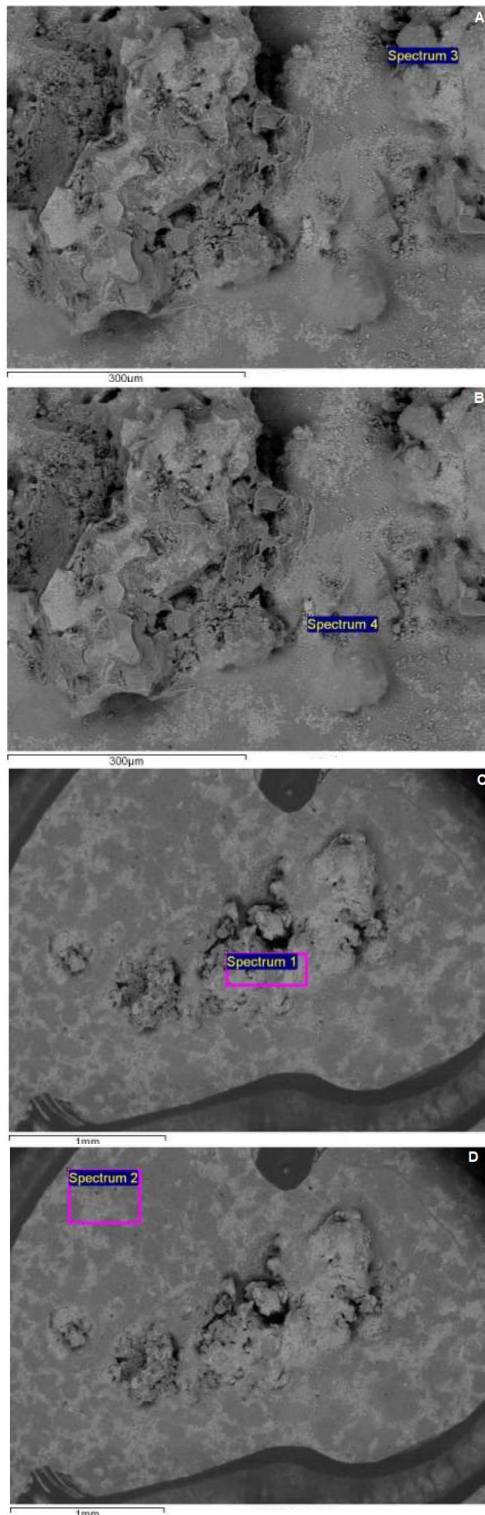
Since there are iron particles in the machine oil, and the viscosity of the oil increases and becomes semi-solid due to friction, iron defects are encountered on the product surface. Also, assuming that the oil lowers the surface tension, it is likely to cause glaze collection in cases where the body absorbs the oil (Figure 11).

Figure 11. Some SEM Analysis of Defects Due to Die Casting Machine Materials (A, B, C, D) (Table 2 displays EDX analysis of the defects).

The high Fe₂O₃ ratio in the point analyzes in Table 2 shows that the parts poured over the machine are iron-containing. However, although there is a structure that creates a depression in the iron structure, it is seen that the other impurities that come with the iron do not melt completely, allowing the structure to remain rigid.

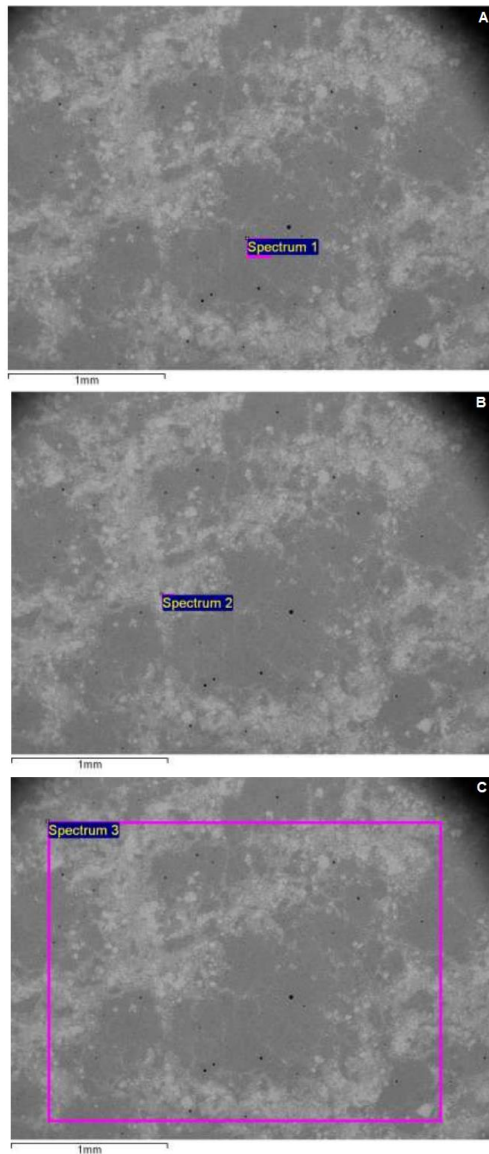
The tape abrasive is made of hard metallic materials. When seen under the glaze, it creates iron stains on the glaze surface. It has been observed that since it is placed as a whole piece in the figure, it does not spoil the glaze surface and behaves like a glaze in EDX analyses (Figure 12).

Due to the application of the defect as a major part in the experimental studies, the abrasive remained under the glaze surface without melting and it was observed that there were glaze surfaces in the SEM/EDX analyzes. It has been determined that the EDX analysis, which provides a homogeneous image of the structure, also supports this idea (Table 3).

Figure 12. Some SEM/EDX Analysis of Tape Abrasive Based Defects (A, B, C) (Table 3 displays EDX analysis of the defects).

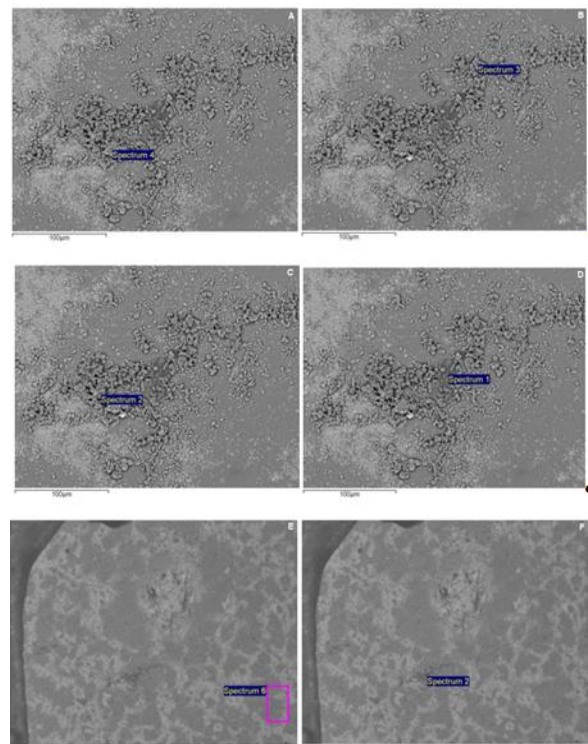
Box abrasives are applied on semi-wet products in the casting process. Especially the inner chambers of the toilet bowls and the fluffy parts on the outer surfaces are cleaned with these abrasives. For this reason, it is desired that this product should be hard. However, in the SEM images, it is seen that the SiC particles cause crystallization in the structure and are clustered locally (Figure 13).

As seen in Table 4, CO₂ formation was found that was not observed in other EDX analyzes. Another oxide seen here is SiO₂, proving that the material is SiC. In the results obtained from the faulty areas, it was determined that the glaze deteriorated on the surface and the ZrO₂ ratio was not found because the SiC material remained unmelted (Hasanuzzaman et al., 2022).

Figure 13. Some SEM/EDX Analysis of Box Abrasive Based Defects (A, B, C, D, E, F) (Table 4 displays EDX analysis of the defects).

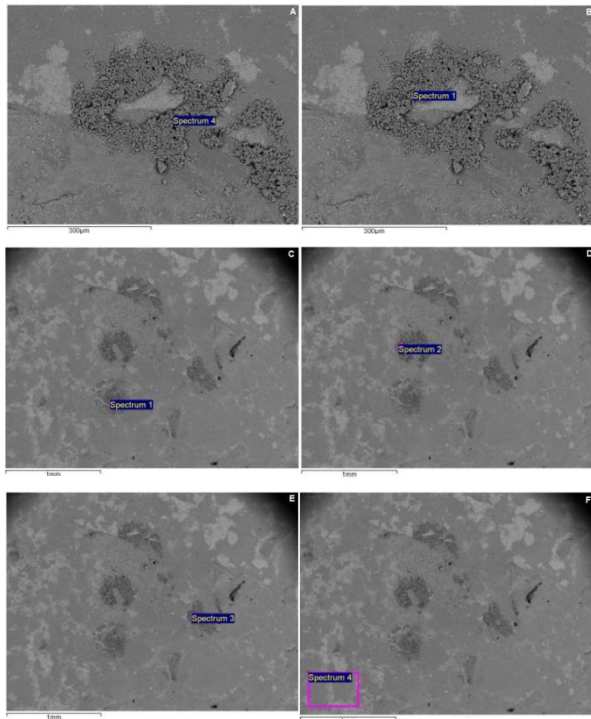
Since white abrasives are based on alumina silicate, it causes deterioration on the surface. The black spots seen on it are caused by the falling of the sponge pieces caused by friction and burning on the surface. The appearance of abrasive pieces on the glaze surface ensures that there are regions in the glaze structure as in the 2nd figure in Figure 14. As examined in the SEM images, it is seen that the alumina silicate layers deposited on the surface tend to mullite structures and begin to turn into a rod-like form. This causes refractory structures within the glaze, thereby distorting the appearance of the glaze (Figure 14).

Figure 14. Some SEM/EDX Analysis of White Abrasive Based Defects (A, B, C, D, E, F) (Table 5 displays EDX analysis of the defects).

It also shows itself in EDX analyzes with the decrease in zircon ratios in which the glaze structure is deteriorated. The increased alumina ratio coincides with the EDX values taken from the samples (Table 5).
