Typical cracks in deck of ship-shaped structures and ways to modify and improve the design

Özgür Özgüç*¹

ABSTRACT

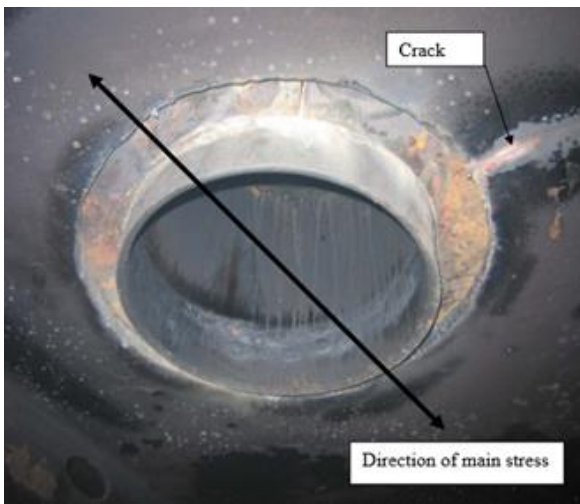
Figure 1. Crack in way of pipe penetration in main deck [1].

Figure 1 shows inert gas pipe with a doubler plate that is welded on the deck top only. The hole in

main deck has been cut with an oxy-acetylene torch leading to in a very rough edge. This could be very relevant case on how not to design it. The rough cut edge has created a crack to propagate and this likely occurred very quickly. The edge is supposed to cut correctly and the edge should be flush ground at all around. An insert plate would be a better way for a good solution [4]. The best design for a pipe that does not actually need to protrude through the deck, especially if access below deck is tough, is the “improved design” shown on Figure 2.

It should be stressed out that a doubler plate should always be welded through both sides and not like above where the underside is not welded.

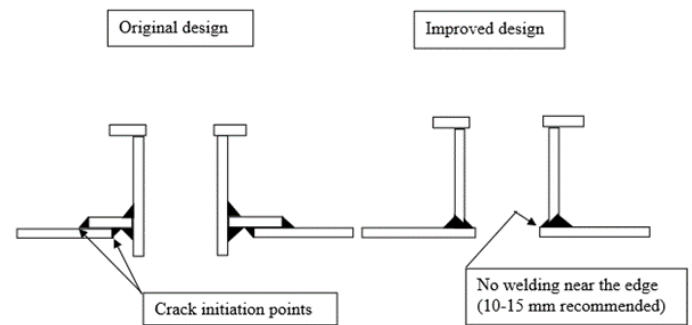
Figure 2. Sketches of damage and repair for pipe penetration.

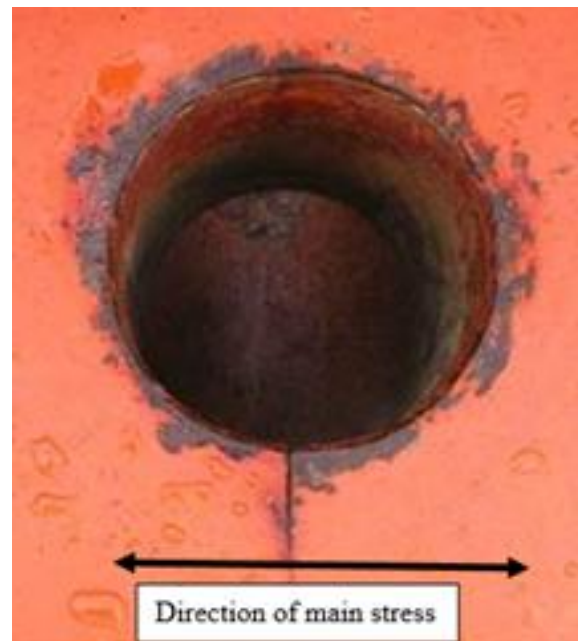
Figure 3. Crack in way of opening in deck [1].

Figure 3 shows a scupper pipe in main deck and although difficult to say how it was welded, it is probably that the welding has been close to the edge of opening. A rough cut opening is also a possible reason for the crack, although on the picture that it looks OK.

Once again the opening should be cut out correctly and smooth flush ground. Welding on or near the edge is not advised.

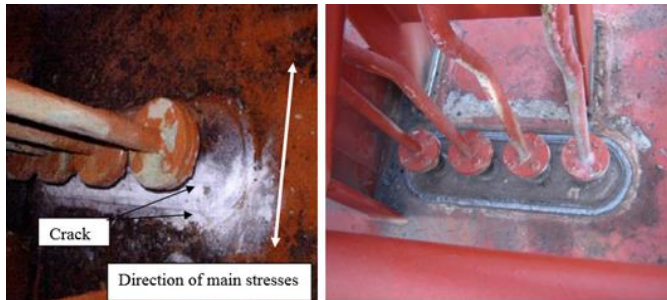
Figure 4. Crack in way of pipe penetration in main deck [2].

Figure 4 shows pipe penetration for heating coils. The picture on the left shows a doubler plate on the main deck top with the pipes going through the doubler. To add to the problems the cut out in deck is oriented in the transverse direction.

Photograph on the right shows repair using insert plate, which is much better than doubler welded on top. The latter should only be used in machinery space and aft and forward structure where longitudinal stresses induced by hull girder load are not a concern.

In this case, the risk of cracks would be reduced if the opening was cut out in the longitudinal direction, as the effective loss of deck area is less.

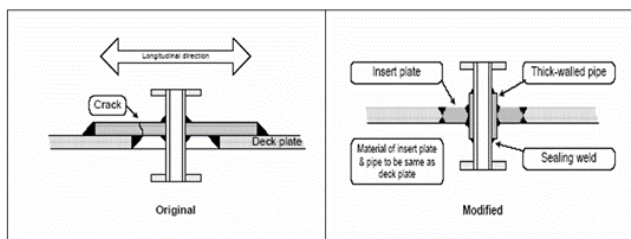
Figure 5. Recommended sketches of damage and repair / modifications for pipe penetrations.

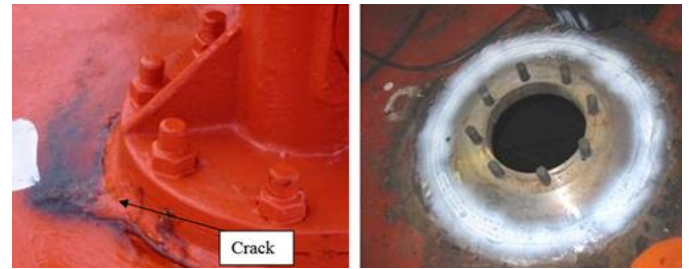
Figure 6. Crack in way of pipe penetration in main deck [3].

Figure 6 shows a COW (Crude Oil Washing) machine connection flange to deck. A crack can be seen extending from underneath a doubler ring/flange probably due to rough-cut and lack of grinding of the hole in deck.

The repair on the right hand side shows a new flange/insert plate with increased thickness. In addition, the hole is machine-cut nice and smooth.

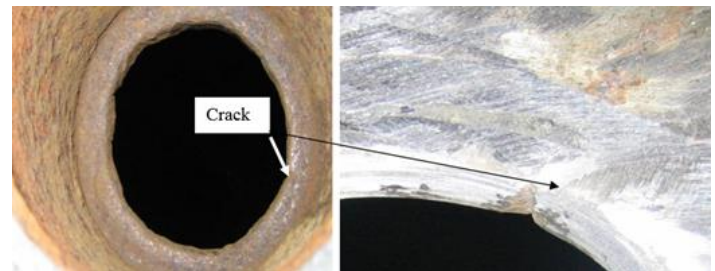
Figure 7. Crack in way of opening in deck.

Figure 7 shows a high-level alarm hole in deck. A pipe stub piece is welded to deck with hole in deck smaller than the pipe diameter. Photo on right hand side is taken after removal of pipe and grinding of the deck – crack is still visible. In this case a deck insert ring plate should be inserted to remove the crack before a new hole is cut, see sketch below. This will require back welding from below.

The method of welding a pipe stub or coaming to deck with a smaller cut hole in deck is the method we recommend, as all welding may be carried out from top side. It requires that the hole is cut properly (cut by oxy/acetylene torch is ok provided it is cut with a template or guide) and ground perfectly smooth. See also Figure 8 below.

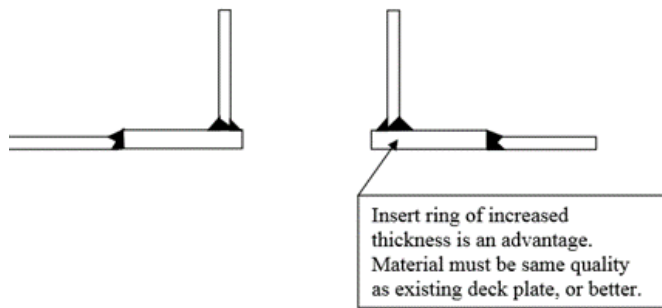
Figure 8. Recommended sketches for repair / modifications for insert ring.

If a crack occurs in a hole in deck, an insert needs to be fitted as shown Figure 8. This will require welding also from below.

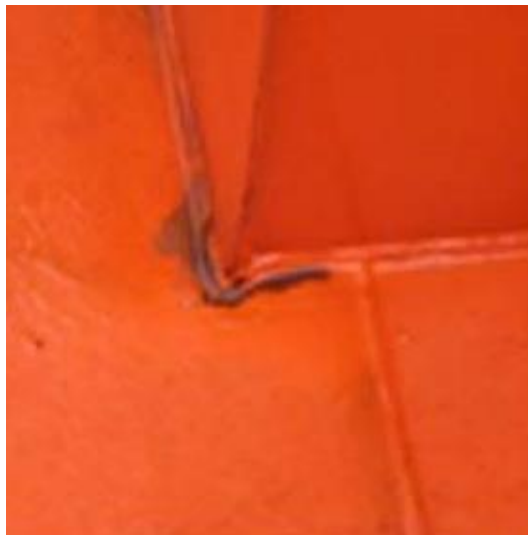
Figure 9. Crack in way of deckhouse corner [1].

Figure 9 shows a crack at the corner of a deckhouse in the midship area. Recommended modification is to fit a longitudinal soft bracket with increased thickness and welded full penetration to deck. Toe should preferably be ground flush with deck as shown on Figure 10.

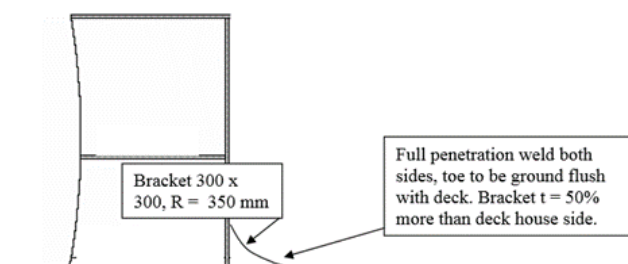
Figure 10. Recommended sketches for repair / modifications for deckhouse corner [5].

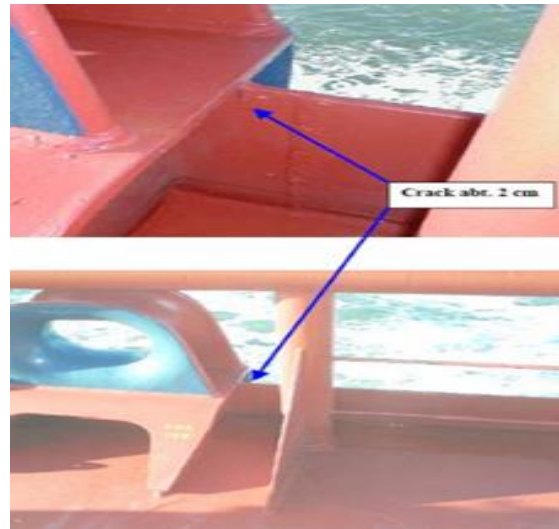
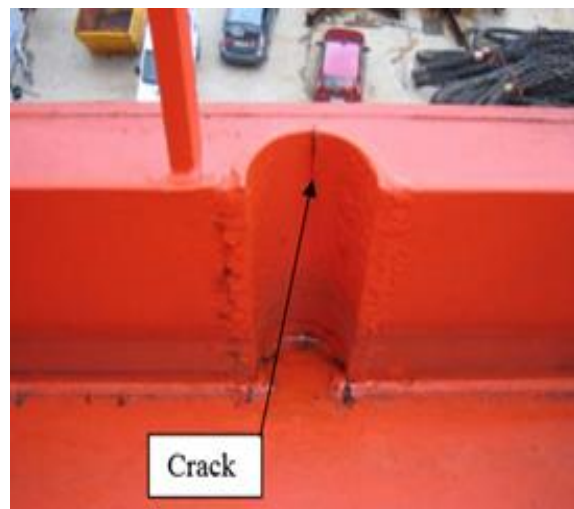
Figure 11. Cracks in gutter bar.

Figure 12. Cracks in gutter bar (in closed view).

The Panama Chock foundation top plate being attached to the gutter bar as shown by Figures 11 and 12 causes the crack. If at all possible, nothing should be welded to the gutter bar. If a Panama Chock foundation is welded to the gutter bar, nothing should be welded to the upper part of the gutter bar, i.e. in this case the foundation top plate should have been lifted to clear the top of the gutter bar. Hence, it would be better to have a continuous gutter bar.

Another possible solution is to use one of the designs shown on next page, see Figures 13 and 14. This may be used on both sides of Panama Chocks, bulwark etc. in the midship area.

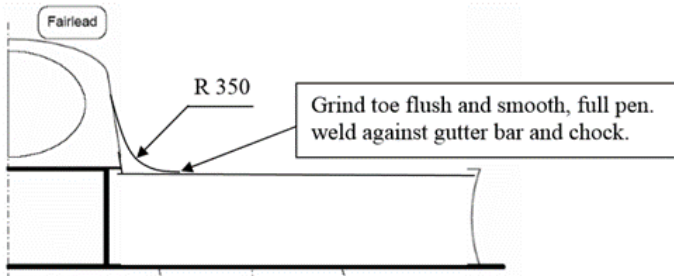
Figure 13. Design to improve the notch in the gutter bar. Bracket with minimum 15 mm thickness.

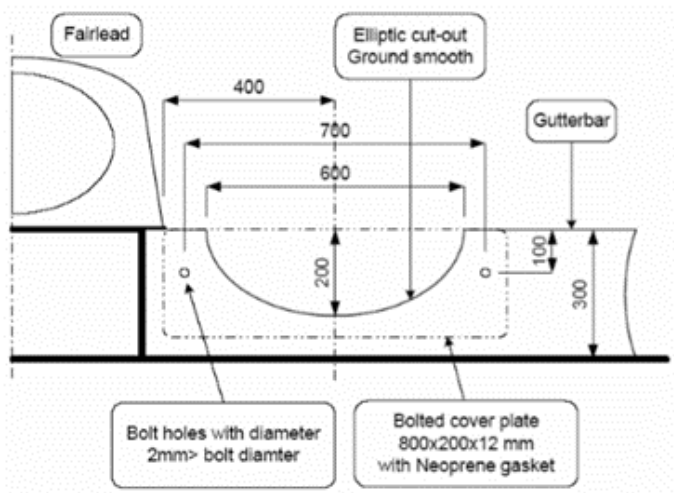
Figure 14. Design to reduce the stress in the gutter bar locally. The elliptical cut out should be ground perfectly smooth.

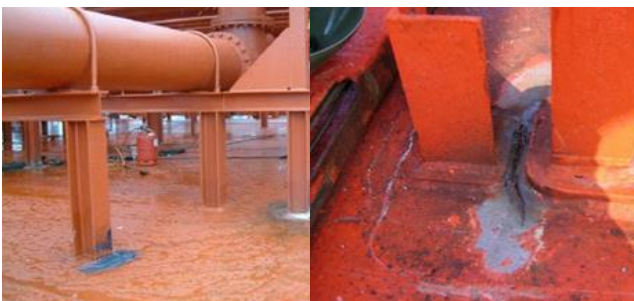
Pipe supports, manifold supports etc. frequently cause cracks in deck, also when positioned on doublers. Longitudinal stresses are combined with pillar bending in the fore and aft direction causing transverse cracks as shown on Figure 15.

Figure 15. Cracks on pipe supports on hull main deck [6].

To avoid longitudinal stresses causing the supports to bend and increase the stress around the support connection to deck, more flexible supports will improve the situation. The below

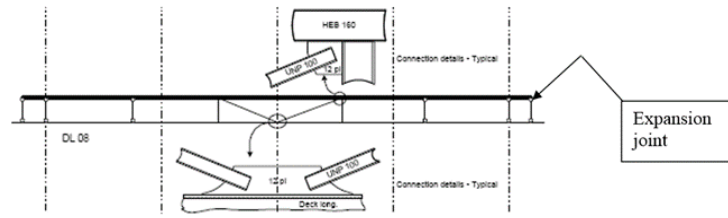
Figure 16. Recommended sketch for repair / modification on the pipe supports.

sketch shows an arrangement for anchoring a section of piping between expansion joints and leaving the other supports flexible. Figures 16 and 17 show for repairs and modification details.

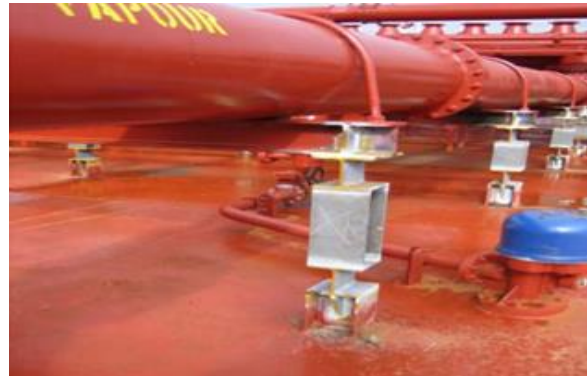
Figure 17. The flexible pipe supports.

Figure 17 shows the flexible supports while Figure 18 shows the longitudinal bracings to anchor the pipe in the longitudinal direction on the main deck.

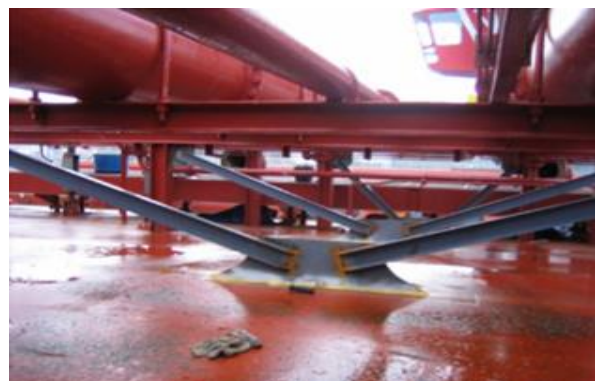
Figure 18. The longitudinal bracings to anchor the pipe.

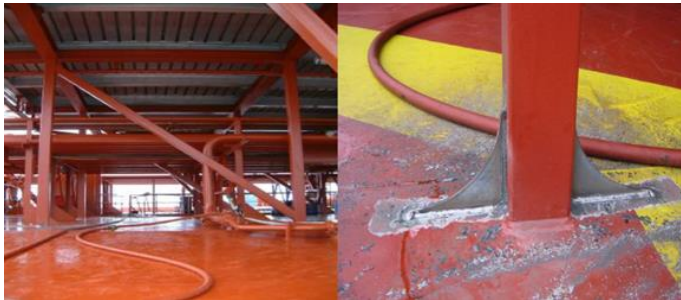
Figure 19. The applied repair / modification details on helicopter supporting structure [7].

Helicopter deck supports are in principle much the same as pipe supports and must be supplied with enough bracing to reduce the local bending of the supports. The remaining local bending can be

taken care of by fitting fore and aft brackets, as shown on Figure 19.

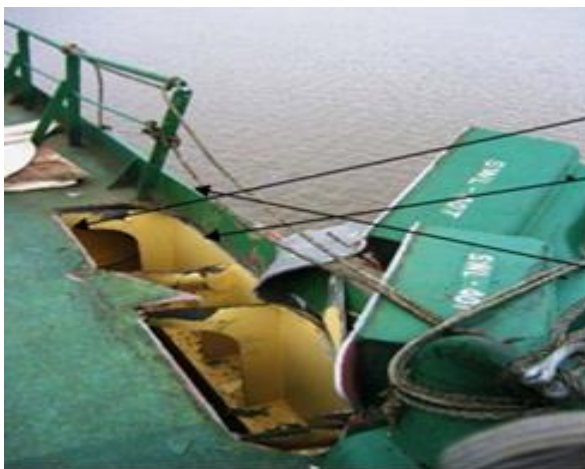
Under deck stiffener at front of chock foundation appears to be misaligned and aft edge not supported at all. The under deck support is completely inadequate for the loads applied. Normally all four sides of the foundation should be supported. In this case the aft edge of the chock foundation could have been welded to transom plate/gutter bar. In the cargo area, this should be avoided. Figure 20 shows panama chocks torn off poop deck by tug.

Figure 20. It shows 2 off 40 t SWL panama chocks torn off poop deck by tug.

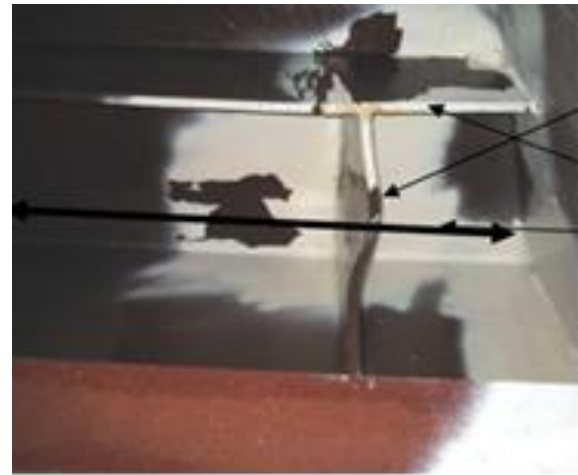
Figure 21. Recommended sketch for underdeck strengthening.

Figure 21 shows strengthening fitted under the sides of the roller. The best under deck support would be a short piece of pipe, with diameter equal to the base of the pedestal, which should be attached to surrounding stiffening [10].
