Evaluation of the Condition of Antakya (Antioch) Urban Site after the Kahramanmaraş Earthquake

Abstract

Keywords: Antakya (Antioch), Kahramanmaraş earthquakes, urban site, historical building, damage degree.

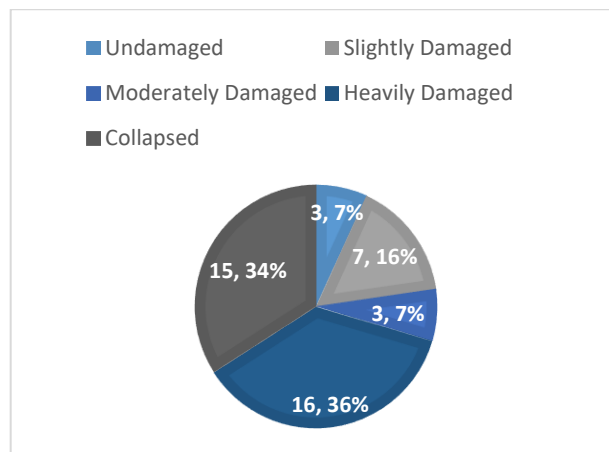
Figure 11. 1st Group damage level

Figure 11 and Figure 12 shown the damage level distribution due building types. From the 44 monumental buildings examined, 3 were undamaged, 7 were slightly damaged, 3 were moderately damaged, 16 were heavily damaged, and 15 were demolished (Table 3). Regarding the civil architecture works, 19 buildings were undamaged, 19 were slightly damaged, 13 were moderately damaged, 39 were heavily damaged, and 116 were demolished (Table 4). Out of 250 buildings, 131 buildings were completely demolished (Figure 13). Most of the remaining structures are heavily and moderately damaged.

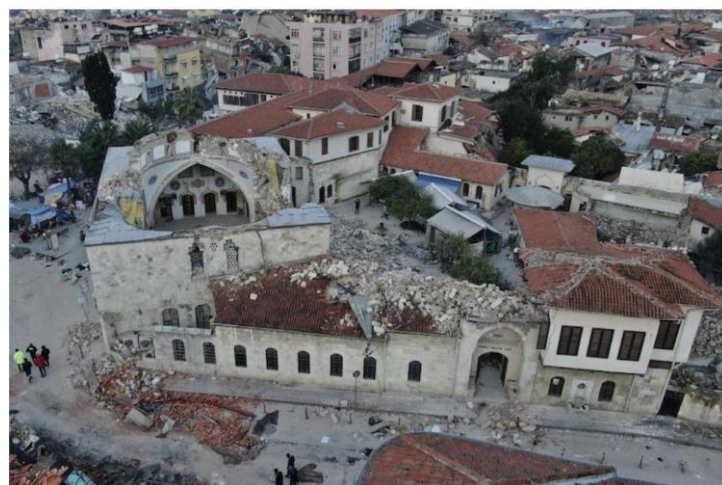
Figure 15. Habibi Neccar Mosque and its surrounding (Arkeofili, 2023)

The destruction of many monumental buildings (Figure 14) is thought to have serious implications for urban identity and people's perception of the city. Although the magnitude of the destruction may be attributed to the intensity of the earthquake, it is obvious that other factors should also be emphasized. The multilayered structure of the city, especially within the urban conservation area, the alluvial soil structure in the East of the Asi River, and even the fact that the river bed was wider in the past and that the water decreased in time and the construction of buildings near the river bed can be counted among the factors that increased the severity of the destruction. The Great Mosque of Hatay, one of the important gathering places of the city, was destroyed, while the Habibi Neccar Mosque was heavily damaged (Figure 15). Habibi Neccar Mosque is one of the symbolic structures of the city, with a group of buildings around it. The mosque has a very important place in the city's history as it is considered the first mosque built within the borders of today's Türkiye.

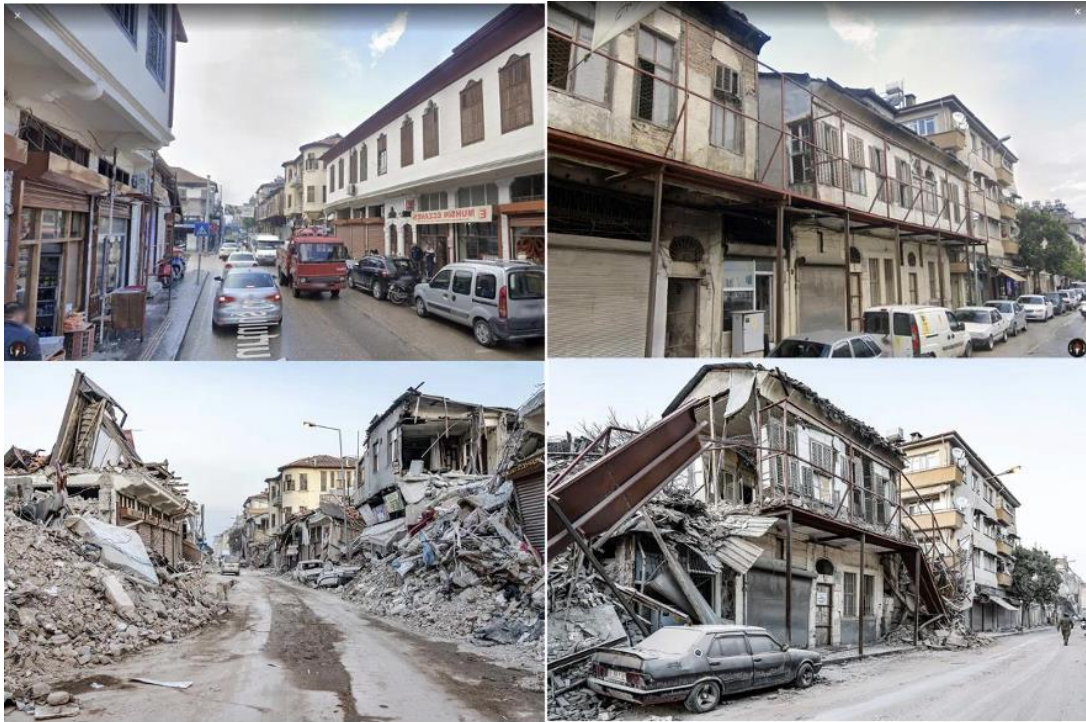
Figure 16. Kurtuluş Street before and after the earthquake (taken by the Authors, 2023)

Similarly, the Greek Orthodox Church (Church of St. Piyer and St. Paul) is a very important place for Christians and was heavily damaged after the earthquake. Buildings with residential-commercial functions located on Kurtuluş Street, one of the city's most important streets, were also significantly damaged (Figure 16). Antakya traditional houses with courtyard typology bounded by streets were also severely affected by the earthquake (Figure 17).
