Flooding and Its Effects on River Bridges in Western Black Sea Region

Müsteyde Baduna Koçyiğit¹, Hüseyin Akay² and A. Melih Yanmaz³

IV. SAFETY-INSPECTION STUDIES OF SEVERAL RIVER BRIDGES IN WESTERN BLACK SEA REGION

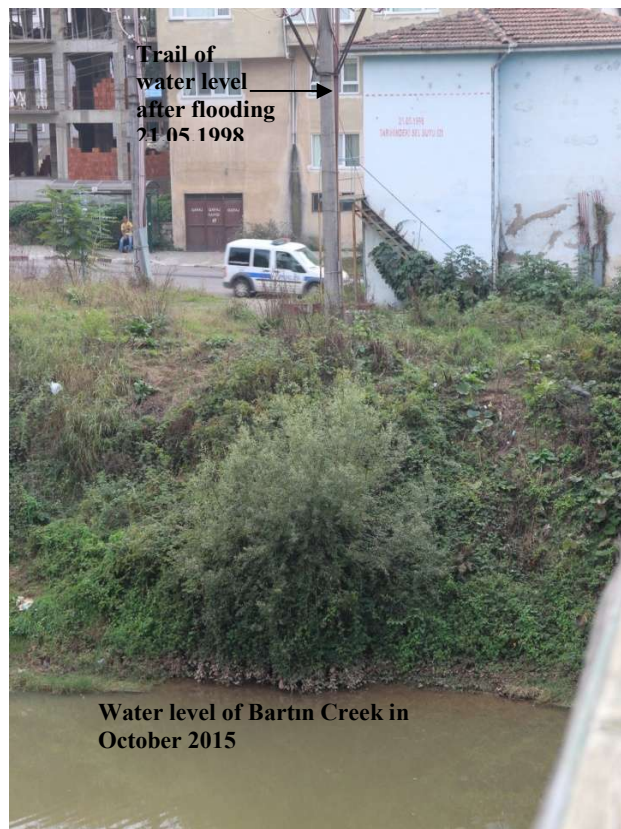
Photo 1. Bartın Creek and trail of increased water level on a nearby building at Orduyeri River Bridge, October, 2015

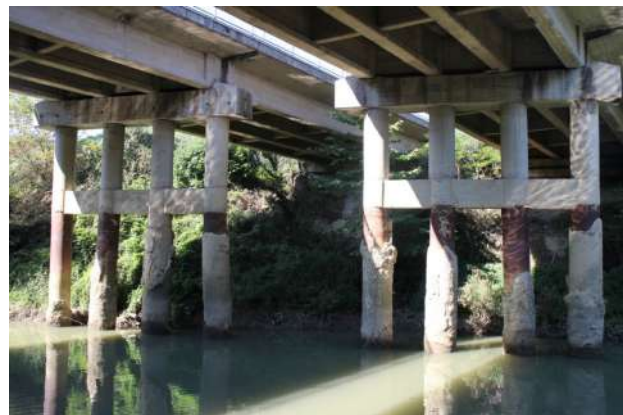
Bartın I Bridge comprises of two river bridges, each one a two lane, one-way bridge located in the 15th Region of KGM, on the Safranbolu-Çaycuma (Karabük-Devrek) road. Bartın I Bridge constructed as two separate RC bridges on Bartın Creek in 1979 as simply supported beam of $L=3 \times 20.0$ m length with three-spans and has got two piers and two abutments. In this area, Bartın Creek is rather meandering with very steep river banks on both sides of the river. The banks in the vicinity of the bridge are covered with trees of small trunks and dense bushes. Examination of old photos of the area and observations made during field trips show that new residential areas are built in recent years and thus the LC of the area has shown to decline rapidly. This condition is an important factor that directly affects the rainfall-runoff relationship in the area since vegetation cover delays the amount of precipitation that immediately turns into flow, thus reducing the severing and likelihood of probable flooding. The first thing that stands out in Bartın I Bridge during the inspection is the amount of scouring observed around piers of both bridges (Photo 2).

Photo 2. Piers of Bartın I Bridge

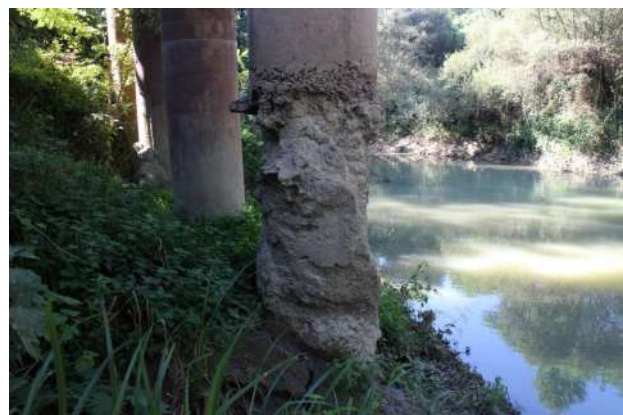
During inspections it is seen that piers that are exposed with sheathing sheet on are protected from the effect of abrasion of water while the pier without this protective shell has serious concrete abrasion and weakened sections (Photo 3).

Photo 3. Abrasion on pier of Bartın I Bridge

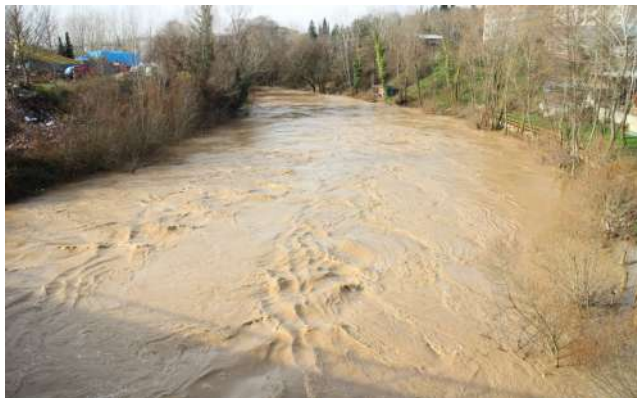
Stream is meandering and surrounded by residential areas and businesses which have been increasing rapidly. Both banks of the stream are covered by slim trees trunks and shrubs. During field visits the flow of the stream in the vicinity of bridge was found to be very calm, even in autumn and spring time. However, during an inspection it was witnessed that the discharge of the stream dramatically and quickly increased just after a day's rainfall. The flow under the bridge became quite severe and elated carrying

increased amount of fine sediment (Photo 4). This means that the drainage area of the basin is large and the precipitation quickly turns into runoff. Hence, it can be concluded that the risk of an intense rainfall causing flooding that would affect bridges in the area is quite high. Past flooding events experienced in the area is also evidence of this observation.

Photo 4. Downstream of Bartın III Bridge (December 2014)

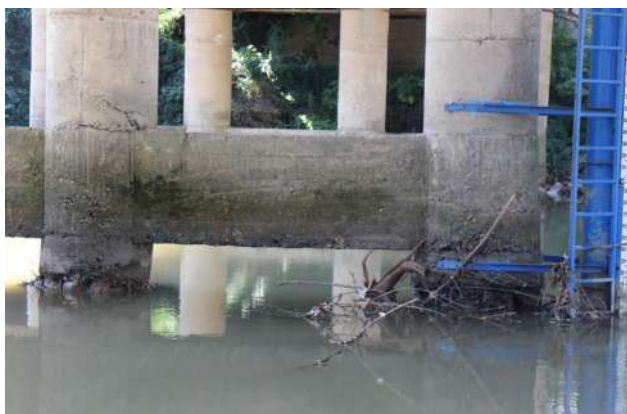
The first striking feature about Bartın III Bridge observed during the inspection as in Bartın I bridge, is also the excessive scouring around piers of the bridge (Photo 5). As seen in Photo 5, even the bond beams which should have been embedded in the river bed are exposed due to scouring and serious corrosion in the concrete of the beams and columns; cracks in places and formation of cavities, even reinforcements are seen.

Photo 5. Piers of Bartın III Bridge (October 2015)

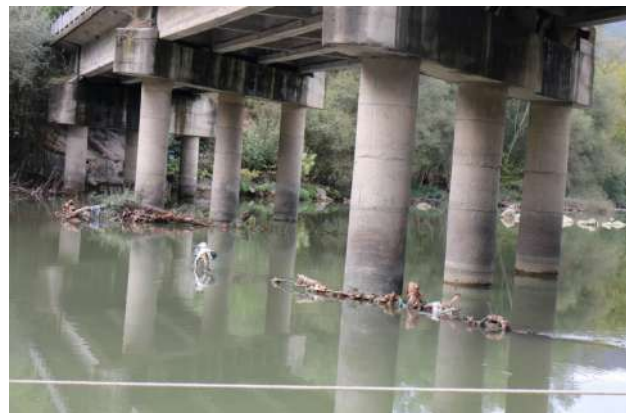
In May 1998, a settlement of magnitude 65 cm was observed at one of the piers. So in July 1998, the bridge deck has been reinstalled back to its original position (Photo 6).

Photo 6. Low water level under Filyos V Bridge (October 2015)

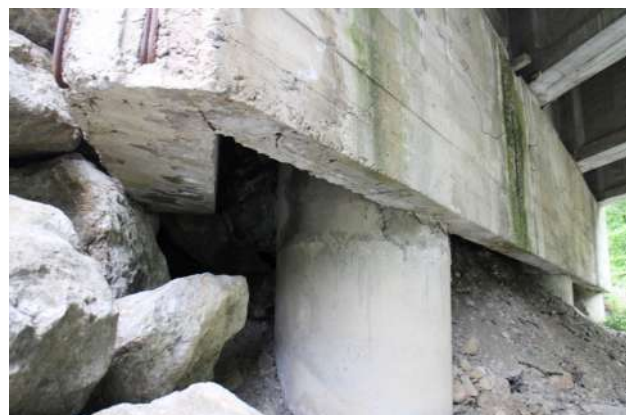
Although the exact date of the settlement of that pier is not recorded thus not known, the period, May 1998, it happened is remarkable. When the meteorological records of the area are investigated, it is found that the basin had severe rainfall during that period. This also coincides with flood event which struck and devastated Bartın. Available data and information about that flood event in May 1998 show that the region had heavy rain in a reasonable time span and this flooding may be likely the reason for that settlement at the pier of Filyos V Bridge. This also shows the important implications of flooding on river bridges. However, it should be noted here that, it is not possible to reach a definite conclusion due to the lack of any record or report about this problem or repair of the bridge pier. Once again, the importance of having an up-to-date inventory about bridges is clear. During the inspection of Filyos V Bridge, it was observed that there also was settlement at one of the bridge approach fill. The problem was aimed to be solved by rock fortification. However, even today it still seems there might be settlement in the approach fill in small amounts (Photo 7).

Photo 7. Abutment of Filyos V and settlement at bridge approach filling
