Utilization of unmanned aerial vehicles for the detection and localization of deteriorations in historical structures: a case study of Ishak Pasha Palace

Emirhan Özdemir*¹, Rüştü Çallı¹, Selim Kartal¹

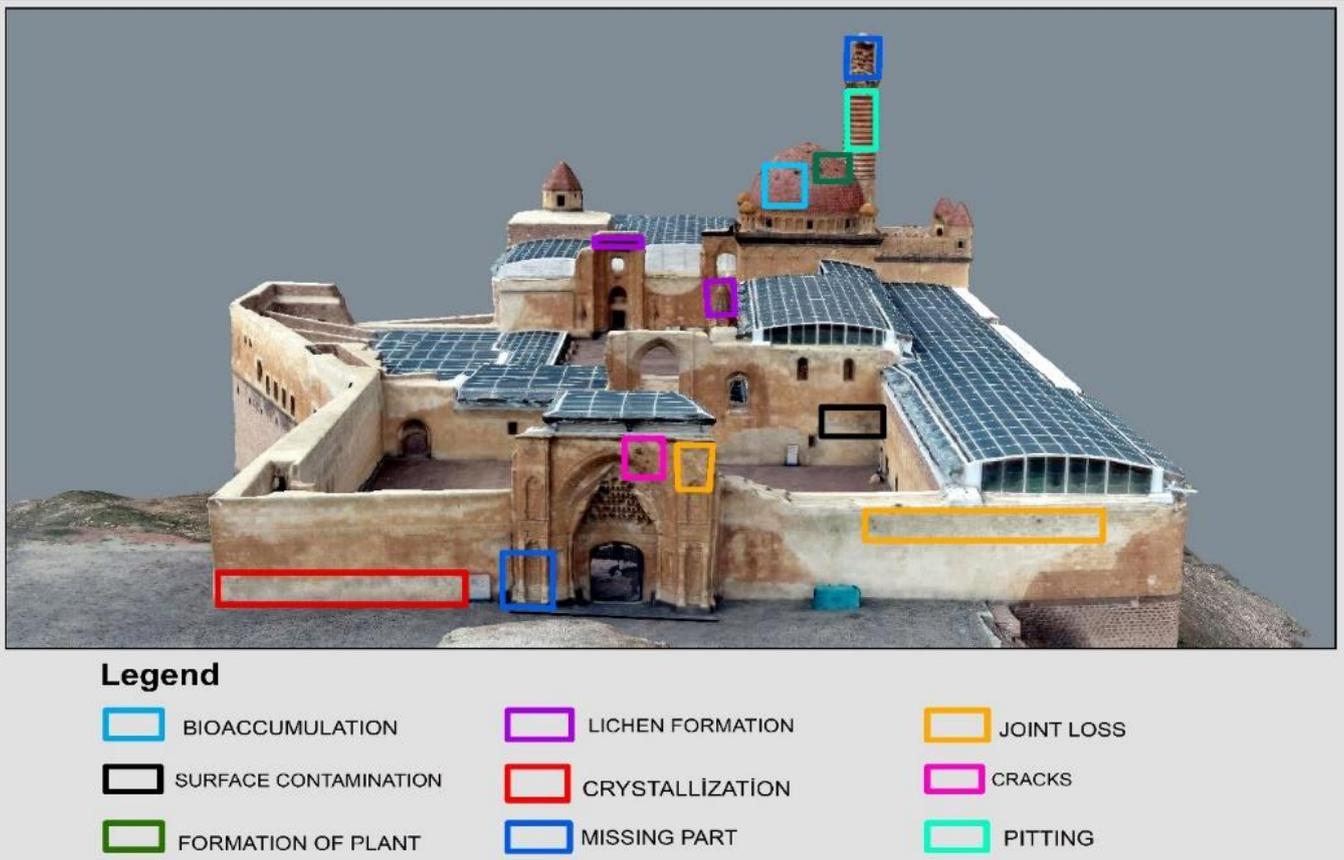
Figure 6. Detected distortions; East facade view

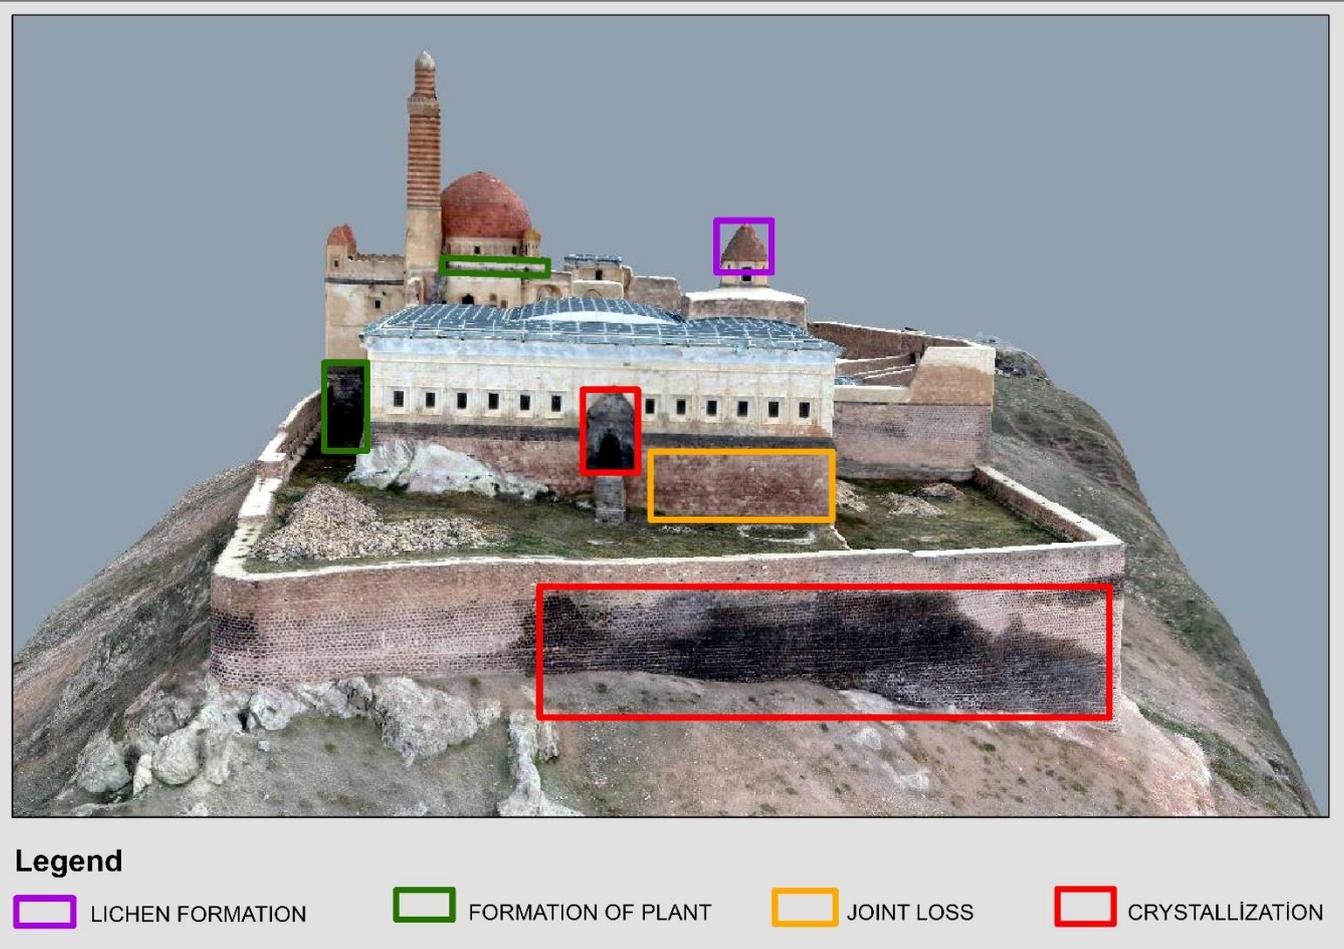
Figure 7. Detected distortions; West facade view

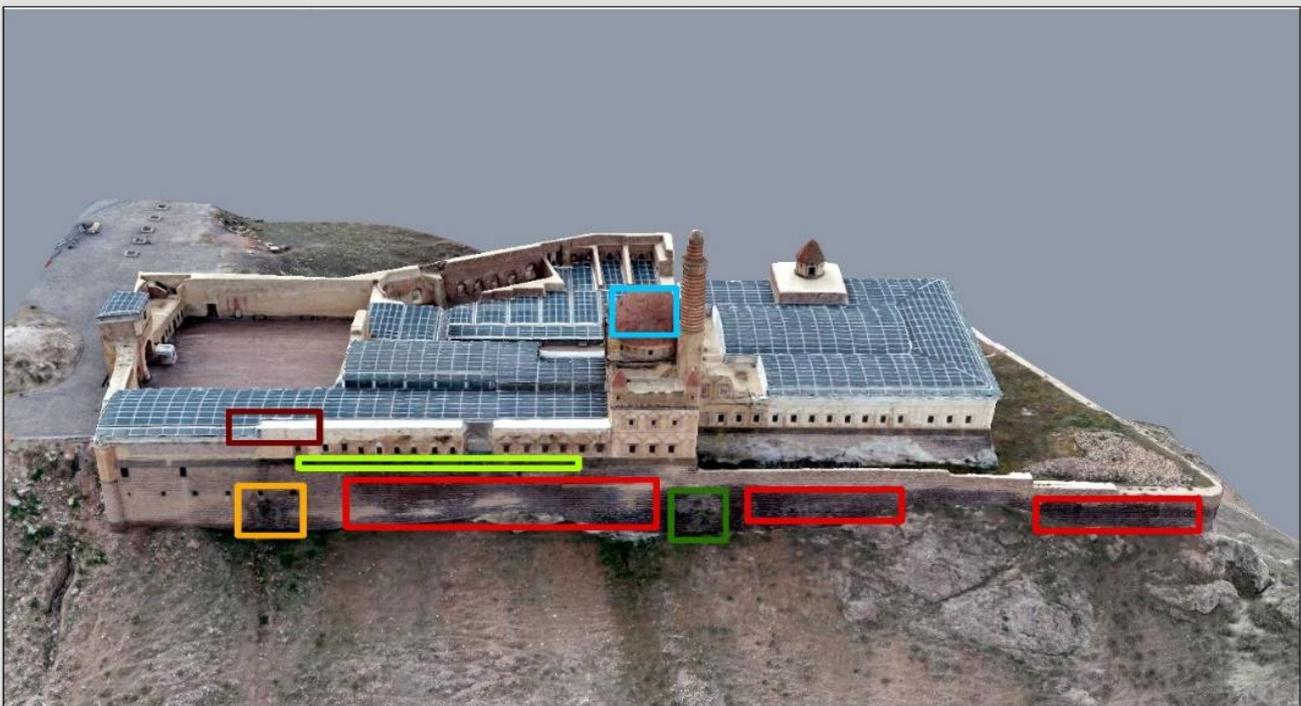
Figure 8. Detected distortions; North facade view

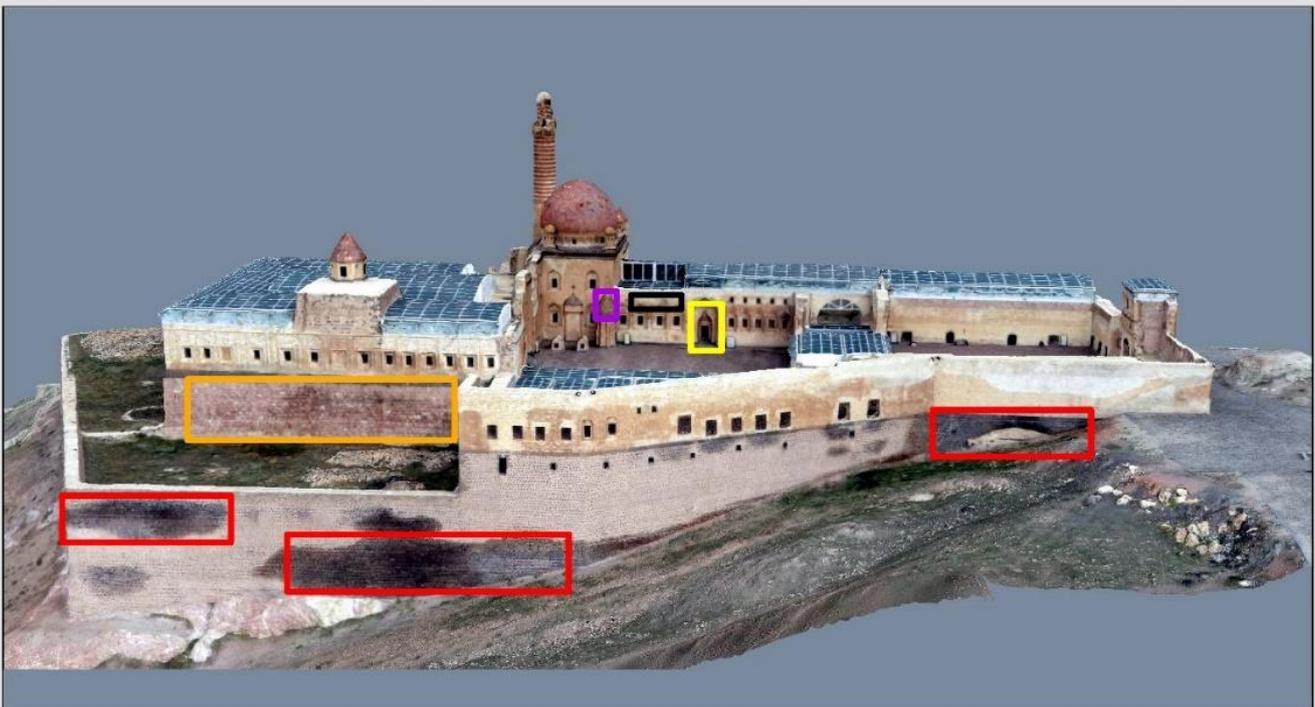
Figure 9. Detected distortions; South facade view

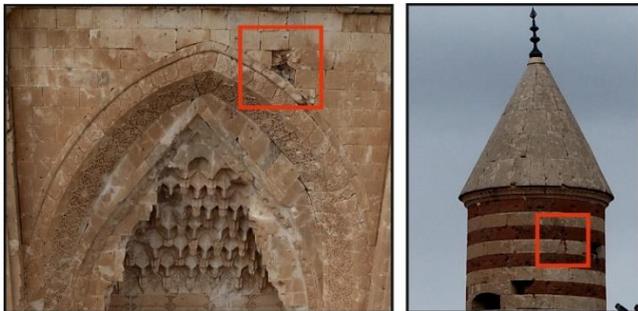
Mechanical deformations resulting in the cracking or fracturing of stone can occur due to factors beyond pressure exertion on the stone, such as ground movements or voids within the stone structure [11]. These deteriorations arise from climatic and physical events, including repetitive temperature fluctuations, freezing and thawing cycles, which affect the material's inherent structure. If left unaddressed, the sizes of cracks may enlarge over time, accelerating the deterioration process and leading to loss of parts [7]. Cracks have been identified in the walls of Ishak Pasha Palace, at the entrance crown gate, the second crown gate leading to the second courtyard, and in the minaret. Some of these cracks, particularly those in the crown gate and minaret, have resulted in the loss of parts (Figure 10).

Figure 10. Crack-fracture formations detected in Ishak Pasha Palace

Mechanical deformations resulting from the cracking or fracturing of stone cause loss of parts in the stone structure. Rainwater entering through cracks, holes, and joint gaps on the surfaces of the walls leads to moisture on the wall surfaces. Salting and grout loss occur on the stone surfaces, especially moss growth and plant formation in the sections exposed to north facade, due to this moisture. Stones with cracks and part loss should be replaced with new ones, and the voids observed in the grouts should be filled with mortar suitable for the original structure according to the analysis results. Moreover, rising waters from the ground cause salting on the basement walls and retaining walls. Additionally, rainwater accumulating in the soil area in the courtyard causes deterioration on both the walls of the harem and the retaining wall. Firstly, rainwater accumulated in the courtyard should be drained, and contact with water inside the structure should be cut off. Water flowing from a drain located in the northwest corner of the mosque comes into contact with the body wall and the base of the walls, causing moisture in these areas. Therefore, details that will divert rainwater from the structure body walls should be resolved. Especially, pitting in areas directly exposed to atmospheric effects and rainfall should be filled with suitable mortar as it accelerates the deterioration process of the stone. Plants

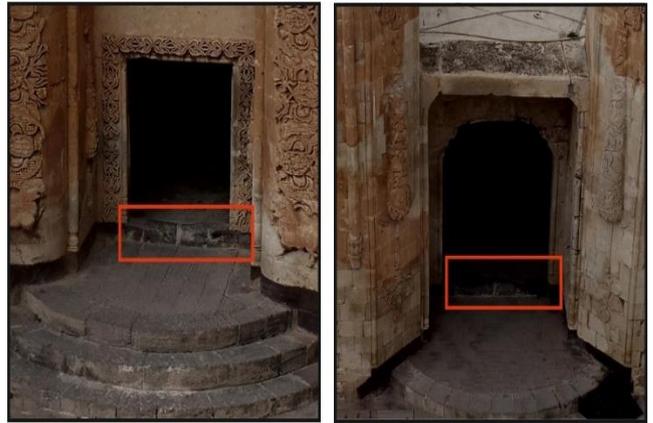
The surface abrasions predominantly observed on stone materials are primarily attributed to climatic factors such as rainfall, snow, and wind. Depending on the material's structure and the environmental influences it encounters, both superficial and deep abrasions may occur [7]. Furthermore, abrasions are commonly observed in thresholds or courtyard pavements of many historical stone structures due to the intense and continuous human movement they endure [4]. Such abrasions result from the stone's exposure to friction, causing gradual diminishment of its sections over time [38]. Abrasion has occurred on the stones constituting the steps of the salutation and harem entrance stairs of the palace, attributed to intense human circulation (Figure 11).

Figure 11. Erosion formation detected in Ishak Pasha Palace

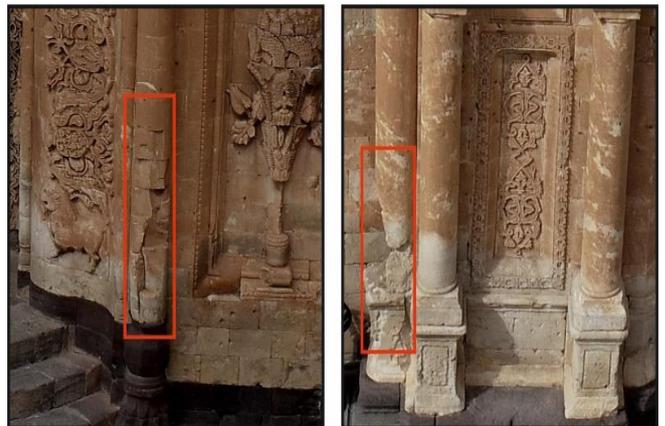
Material loss occurring throughout the entirety of the material due to factors such as physical impact and fracture. Losses in material integrity typically manifest as deteriorations such as fragmentation, abrasion, cracking, and fracturing [8]. Particularly, fragmentations are observed in decorative elements and details located in crown gates, mosque body walls, audience chamber walls, and harem exterior walls (Figure 12).

Figure 12. Fragment missing detected in Ishak Pasha Palace

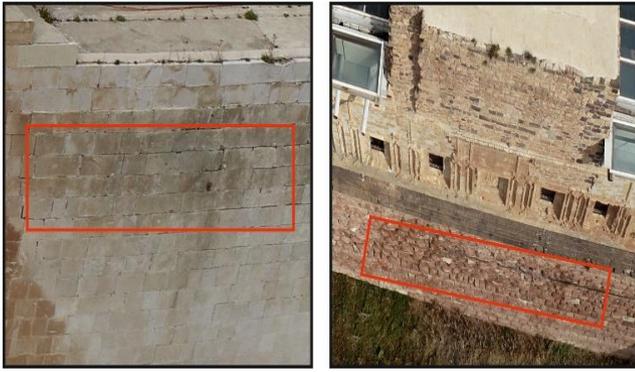
The partial or extensive loss of mortar in the stone masonry, starting from the outer surface and progressing inward, denotes the phenomenon of joint displacement. Mortars, being among the most vulnerable materials to outdoor conditions, undergo fragmentation and disintegration due to factors such as wetting-drying/freezing-thawing, leading to advanced joint displacements over time [8]. As a result of joint displacement, the surface between stones is left exposed, triggering the deterioration process in the stones [10]. Localized joint displacement is observed in the retaining walls, exterior and interior walls, crown gates, mosque body walls of the palace, where mortar fillings are depleted (Figure 13).

Figure 13. Joint drain detected in Ishak Pasha Palace

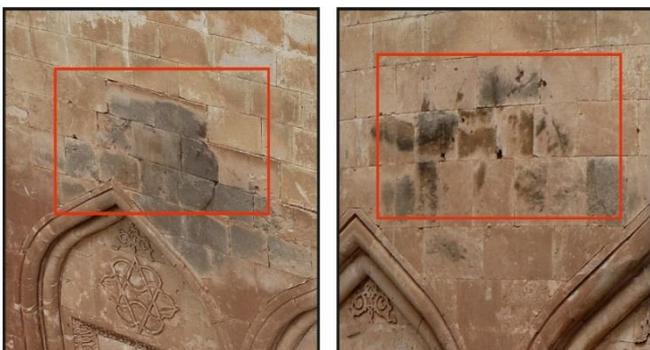
The accumulation of foreign materials on the stone surface, unrelated to the stone itself, typically observed as a thin layer of gray color and usually associated with air pollution, is referred to as soiling. The color, structure, and relationship with the surface of the dirt vary depending on the type of stone and the source of contamination. Especially in porous natural stones, the accumulation of dirt in pores constitutes a significant and challenging form of deterioration. The method of cleaning also varies depending on the condition of contamination and the type of stone [10]. Localized formation of a black layer is observed on the window and door tops of the reception wall facing the first courtyard of the palace. Additionally, partial formation of a black layer is detected on the upper and lower sections of windows on the north facade of the reception area and the harem (Figure 14).

Figure 14. Black layer formation detected in Ishak Pasha Palace

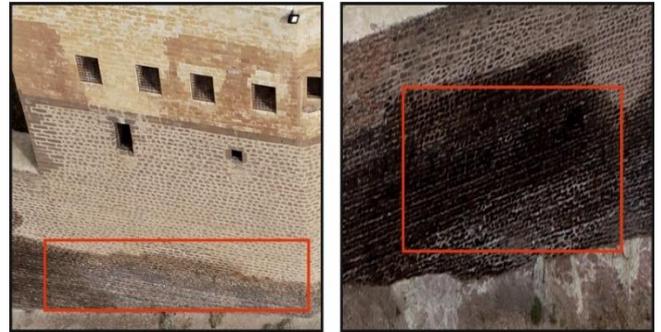
The absorption of water into the building elements, followed by its spreading on the surfaces and evaporation due to climatic effects, leads to the evaporation of water, while salts crystallize, causing the

formation of hard surfaces [39]. Over time, salt crystals formed on the surface contribute to the deterioration of stone surfaces and mortar joints. Particularly, salt efflorescence due to water and moisture is observed, especially on the retaining walls of the palace, with a higher occurrence rate on the northern facade. Additionally, the salt efflorescence rate is high on the northwest wall of the mosque and the northern and western body walls of the harem (Figure 15).

Figure 15. The salinization formation detected in the Ishak Pasha Palace

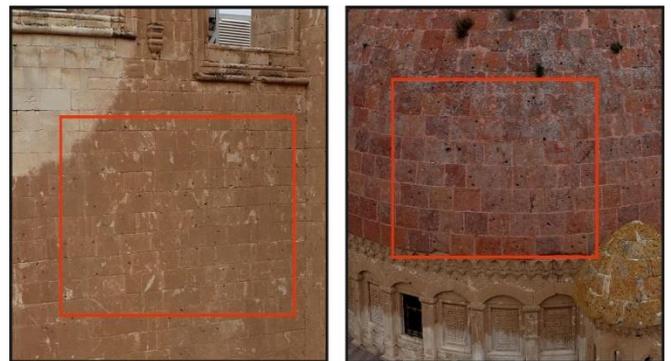
The formation of hollows and recesses observed in natural stones is the result of the weakening and detachment of coarse grains due to atmospheric effects. Consequently, random voids of various sizes occur on the stone surface. These voids accelerate other deterioration processes as they provide areas where water can easily accumulate or plants can grow [10]. Significant instances of hollowing deterioration have been encountered particularly at the main entrance portal of the palace, in the dome and body walls of the mosque, and in the body and honeycomb of the minaret (Figure 16).

Figure 16. Pitting formation detected in Ishak Pasha Palace

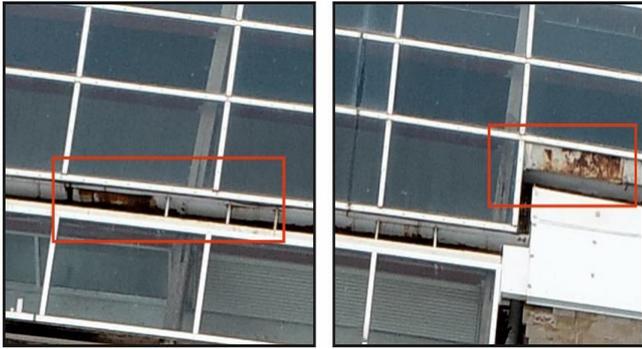
Corrosion is the phenomenon of metal materials undergoing chemical and electrochemical reactions from the surface towards the depths, resulting in alteration or erosion of the material. Metals undergoing corrosion contribute to visual pollution on building stones [40]. Generally, metal corrosion formation is observed on the roofs of the palace, which have laminate wood-beamed,

aluminum, and tempered glass upper protections (Figure 17).

Figure 17. Metal corrosion formation detected in Ishak Pasha Palace

growing in joints and cracks throughout the structure should be cleaned, and necessary parts should be filled with grout to prevent further formation. Corrosion formation is observed on metal parts in the roof cover of the building. The rust problem encountered in metal materials can be eliminated with various rust remover chemicals, and after that, protective materials against rusting can be applied to the surface for protection.

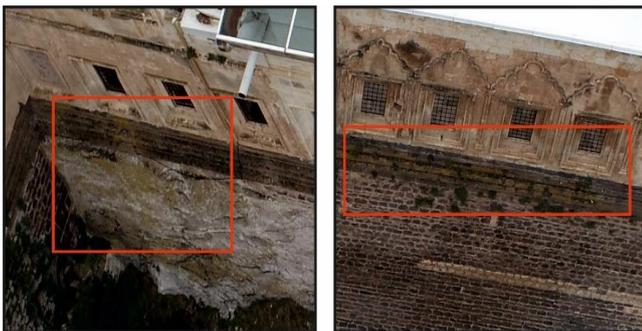
Algal growth is a form of biological deterioration that develops in continuously humid environments. It is typically observed in the lower regions of walls due to rising dampness or environmental conditions. Algae cover the surface, hindering the breathability of the wall structure [9]. Intensive algal growth is observed on the north facade of the palace and in the northwest corner of the mosque (Figure 18).

Figure 18. Moss formation detected in Ishak Pasha Palace

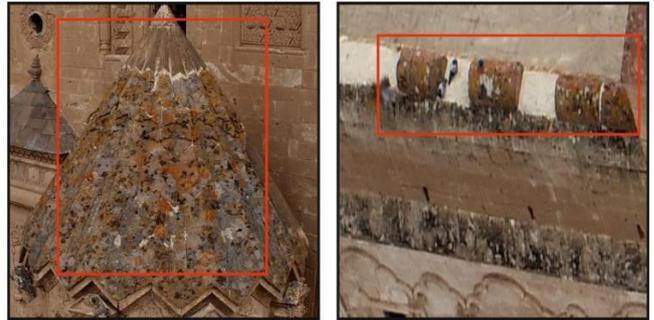
Lichens inhabiting the surfaces of calcareous and siliceous stones, being water-absorbent in nature, retain moisture on stone surfaces for extended periods, leading to deterioration. Lichens firmly adhere to the stone by releasing certain acids through fungal filaments in their structure, causing abrasion over time [41]. Lichen formation is observed in the upper section of the harem entrance portal, on the dome of the mausoleum, and on the north facade walls of the palace (Figure 19).

Figure 19. Lichen formation detected in Ishak Pasha Palace

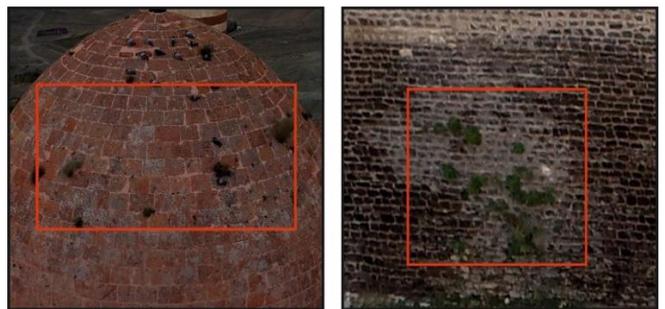
The growth of plants from seeds settling in small gaps on the wall surface, in joint crevices, or within voids in stones over time is referred to as plant formation [10]. Especially in the voids formed due to losses and disintegration in the masonry (such as in body walls and bottoms, cracks, and domes) and in the soil-filled gaps resulting from losses in the mortar joints, the vegetative formations accumulated exhibit mechanical pressures during their development, causing significant damage to the structure and contributing to the escalation of the deterioration process [8]. Plant formations have been intensively detected in the wall surface gaps and on the wall tops north of the main entrance portal of the palace, on the wall tops of the second courtyard entrance portal northward, on the stairs of the harem entrance portal, on the north and south walls of the harem entrance portal, on the mosque roof and dome, on the west wall of the mosque, on the north walls of the harem and the audience hall, and on the north retaining walls of the palace (Figure 20).

Figure 20. Plant formation detected in Ishak Pasha Palace

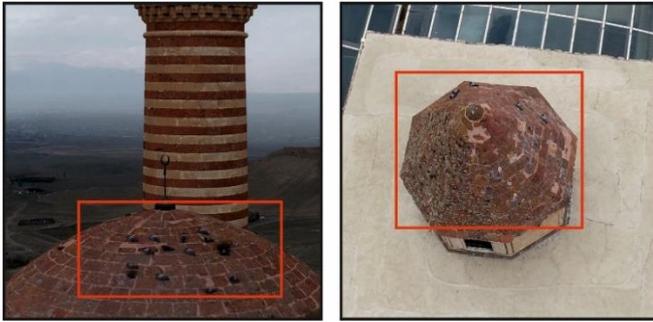
The deterioration type typically associated with bird droppings on stone surfaces, where accumulated excreta with its acidic nature affects stone surfaces and leads to deterioration over time, is known as avian fouling [11]. Intensive biological units have been identified on the window sills of the north facade of the palace, on the domes of the mausoleum, towers, and harem exit tower, on the roof parapets and corbels of the mosque, on the dome of the mosque, and on the minaret's balcony and pedestal (Figure 21).

Figure 21. The formation of biological accumulation detected in the Ishak Pasha Palace
