# Crack Analysis Of A Gasoline Engine Crankshaft

Ali KESKİN<sup>1</sup>, Kadir AYDIN<sup>2\*</sup>

## ABSTRACT

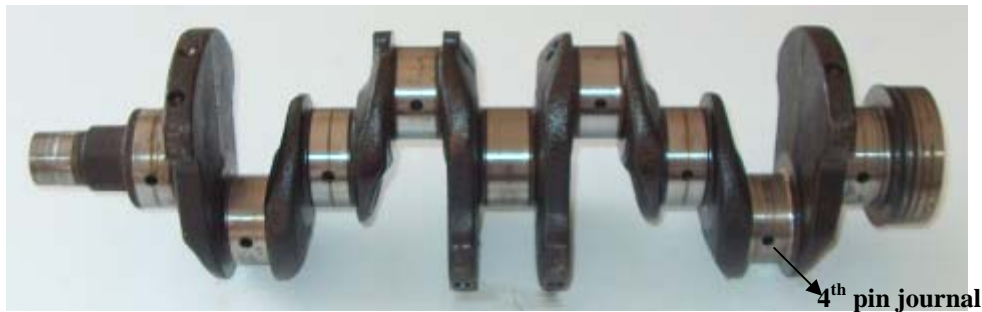
In this study, a failed crankshaft reported by automotive service technicians was examined in order to determine causes of the failure. The crankshaft made of nodular graphite cast iron is used in an automobile with four cylinder 75 HP gasoline engine. General appearance of the crankshaft is seen in Figure 1. A main crack and micro-cracks were determined on the surface of 4<sup>th</sup> crank pin journal. The cracks propagated along surface of the journal in axial direction.

Figure 1. General appearance of the failed crankshaft

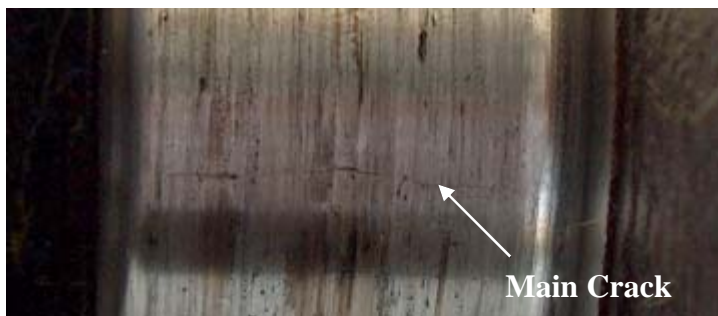
From the visual examination, a crack was determined on the surface of 4<sup>th</sup> pin journal which can be seen with naked eyes (Figure 2). The crack was called as main crack. The main crack propagated axially along the surface of the journal from one side to other. There were scratches on surface of the 4<sup>th</sup> pin and 5<sup>th</sup> main journals (Figure 3 and Figure 4). The scratches can be resulted from contact of bearings and journal surfaces. The observation of the journal surface with microscopy showed that there were micro-cracks at the near of the main crack which were parallel to the main crack (Figure 3 and Figure 4) and some of them connected with the main crack. As can be seen in Figure 5 and Figure 6, the micro-cracks dispersed and formed branches. Examination showed that the main crack and micro-cracks were superficial on surface of the journal. As can be seen in Figure 7, a good nodularity of graphite was observed in microstructure of the crankshaft material.

Figure 2. Magnified view of the main crack

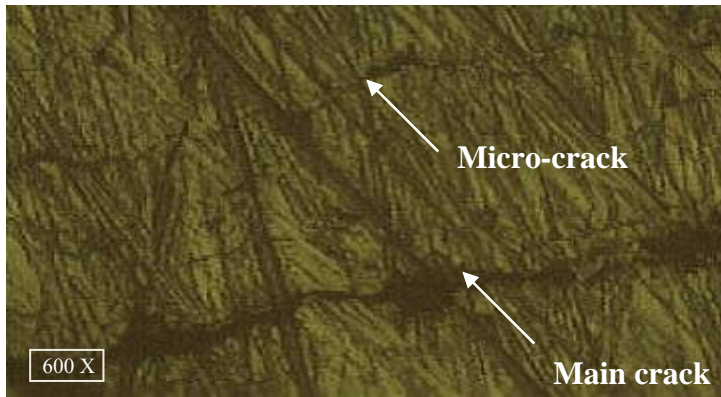
Figure 3. View of the main crack and a micro-crack

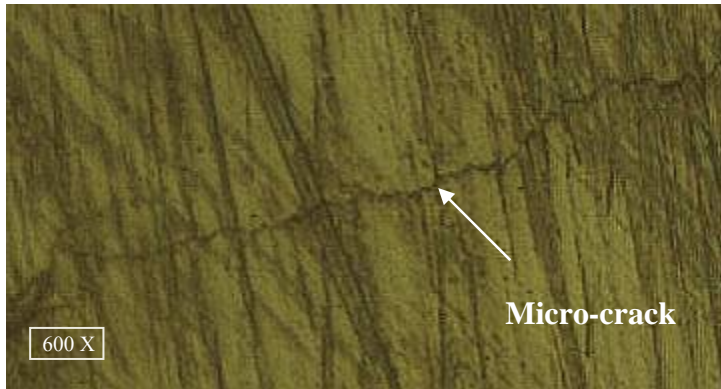
Figure 4. View of a micro-crack

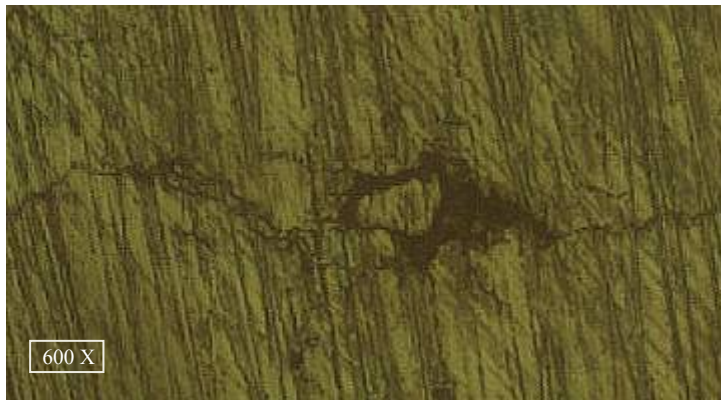
Figure 5. Dispersion of a micro-crack

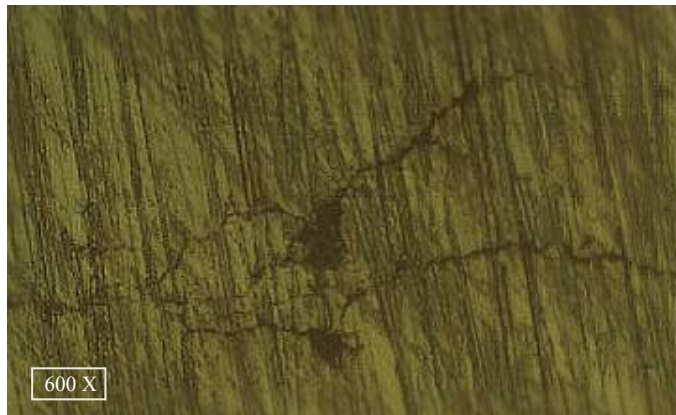
Figure 6. Formation of branch of a micro-crack

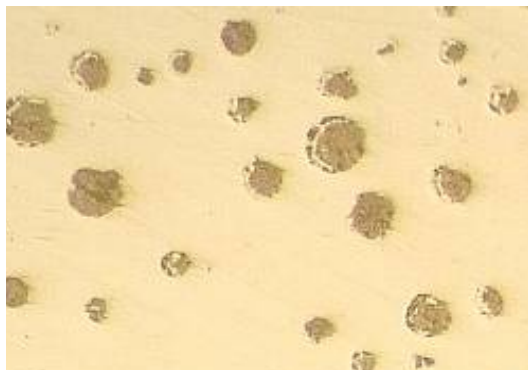
Figure 7. Microstructure of the failed crankshaft

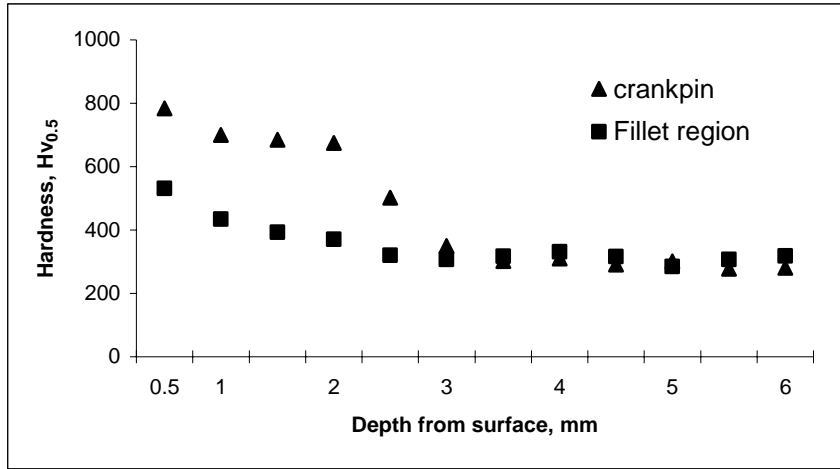
Variation of micro-hardness values of the crank pin and fillet region was shown in Figure 8. Micro-hardness was measured with a load of 500 g from surface to center with an interval of 0.5 mm. Depth of hardened surface was about 2.5 mm. As can be seen from Figure 8., lower hardness values were measured at fillet region compared with the crank pin. Micro-hardness of the crankshaft corresponds to the specified range.

Figure 8. Micro-hardness profiles of the crankpin and fillet region

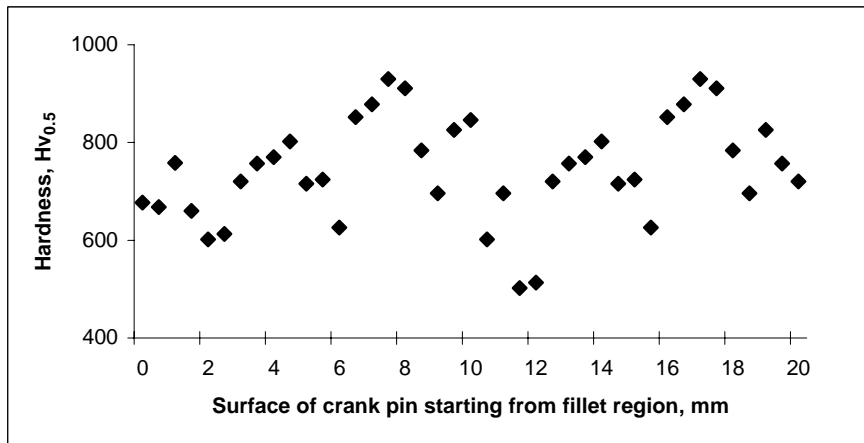
Variation of the micro-hardness values on the surface of the crank pin starting from fillet region are given in Figure 9. Micro-hardness values measured with an interval of 0.5 mm. Micro-hardness values changed between 502 to 930 H<sub>v</sub>.

Figure 9. Micro-hardness profiles of the crankpin surface
