THE DOCUMENTATION AND RESTORATION PROPOSAL FOR USAKIZADE RIFAT EFENDI MANSION IN KUTAHYA PROVINCE CENTRAL DISTRICT

Uşakizade Rifat Efendi mansion, located in the central district of Kütahya province, is one of the examples of civil architecture that preserves its unique features and embodies the plan, construction system and building elements of traditional Kütahya houses. Gözüm Seyh Sultan "tekke", located in the same courtyard with the mansion, is similar to traditional buildings in the region with its architectural features and construction techniques. The documentation of these buildings, which was studied for the master's thesis by the writers in 2020, carries utmost importance due to deterioration in the structures. Within the scope of this article, visual and vectoral documentation studies, analysis of deteriorations, corruptions and restitution are summarized, interventions for restoration and new function proposal are presented.

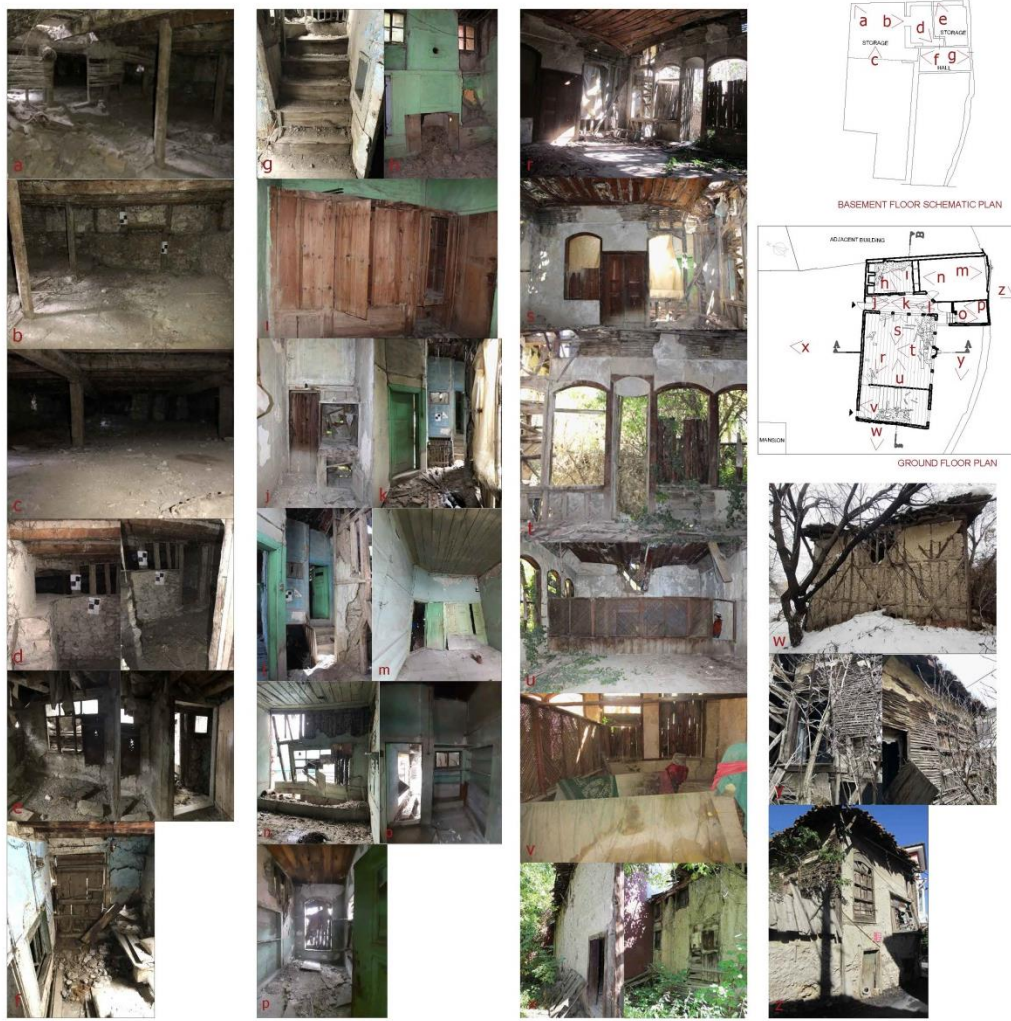
Figure 2. Photographs of Gözüm Seyh Sultan “tekke” (lodge)

When entering the tomb from the courtyard, it is seen that there are two wooden sarcophagi right across the entrance door (Figure 2-v). In the area surrounded by stones under the sarcophagi , it is thought that there are graves of a male and a female, named Gözüm Seyh and Valide Sultan [8]. The tomb was separated from the masjid with a wooden lattice divider (Figure 2-u). The masjid has a mihrab in the south direction (Figure 2-t). There are 6 window openings without casements on the both side of the mihrab. Structure of the space has serious problems such as decay, material loss, change in colour are observed.

The hall is accessed by a double-wing wooden door (Figure 2-s). In the hall, a wooden door and a window are opening to the courtyard (Figure 2-j). There are also three rooms that are connected to the hall and a stair go down to basement floor. In the kitchen, an original fireplace that has niches and windows on both sides of it, is located in the middle of the north wall facing the courtyard (Figure 2-h). A cabinet is located right across the fireplace (Figure 2-i). The corner room next to the kitchen is accessed through a painted door on bevelled wall. In this room, there is a built-in closet and sitting area “sedir”. The facade of the room is about to collapse (Figure 2-n). In the other room, which can be accessed by stairs, wooden shelves were placed in the closed window openings (Figure 2-o).

Windows: In the building, there are four types of windows. Arched wooden window openings that facing to the courtyard are in the masjid and tomb. Some window openings were closed such as between the kitchen and the hall. Also, shelves were created by closing windows in a wall between the rooms. Due to environmental conditions and neglect, losing in material and corruptions are occurred in windows.

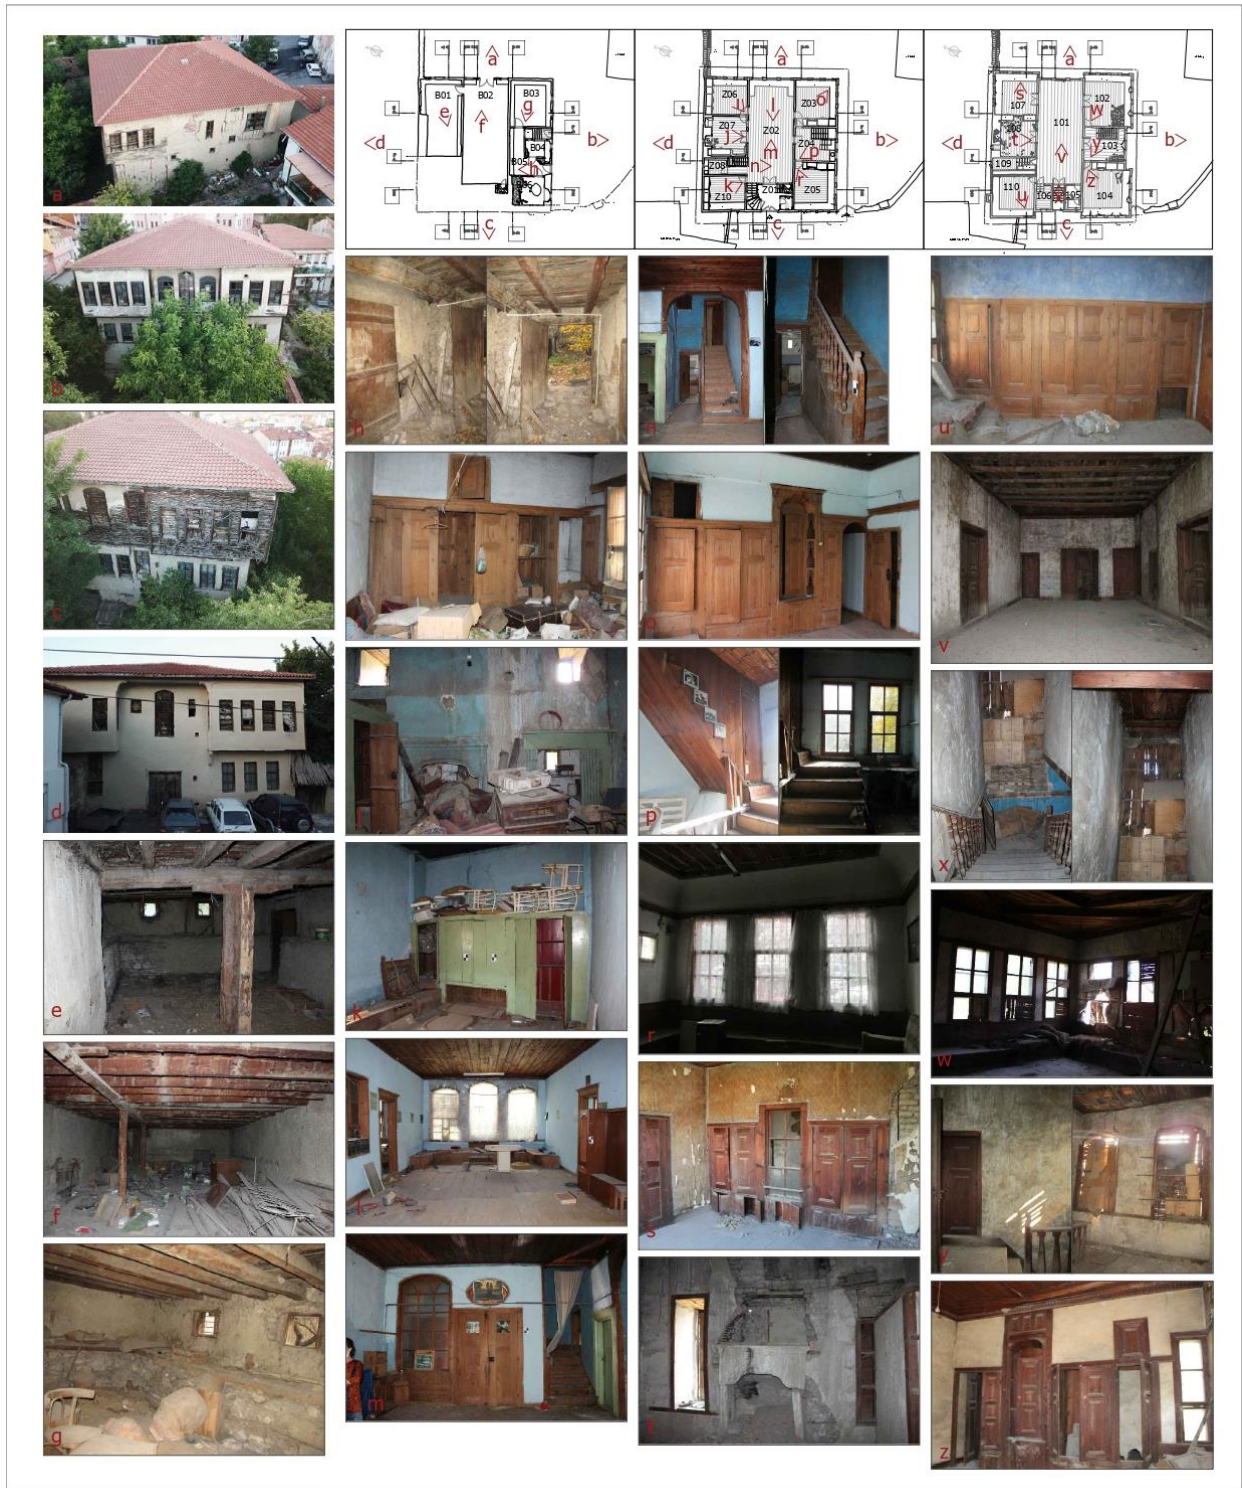
Figure 4. Photographs of Uşakizade Rıfat Edendi Mansion (2020)

Relation between the construction and topography has been solved with different number of floor in facades. The building covers an area of 15.34 x 15.22 m² and was consist of three floors which basement floor, ground floor and first floor (Figure 5). The building has 672.2 m² closed area which on basement floor is 180.2 m², on the ground floor is 235.4 m² and on the first floor is 256.6 m². There are three entrances; the main entrance to the residence with no 2 is through the west facade located near the garden entrance and the other entrances are from the south and east facades in the courtyard (Figure 4-d).

The mansion is connected with directly with the street. The entrance door on the west facade opens to the area named “taşlık”. There is a stair goes down to basement floor and toilet in the “taşlık” which has cement coated floor. From the “taşlık”, through a double wooden door reaches to the sofa (Figure 4-m). Sofa which constitutes the living areas of Uşakizade Rıfat Efendi mansion is rectangular shaped in east-west direction, and it was designed to be 5.10- 11.82 m in size (Figure 4-l). There are 6 rooms and 2 storerooms on the right and left of the sofa. The rooms are designed to allow passages both to the sofa and between each other. The place which has fireplace and open-closed shelves was used as kitchen (Figure 4-j). In this room and the other rooms that facing to the north facade have less windows compared to other facades. The rooms in the north have few windows since they face the courtyard on the side. On the corner rooms, there are sitting areas named “sedir” and built-in closets which contains lamp niches, bigger closets named as “yükçük” and ablution niches (Figure 4-o). There are two kitchen sinks in a room and a storeroom (Figure 4-p).

The basement floor consists of two parts; spaces which are used as barn and woodhouse, are accessed through the double winged wooden door on the east facade (Figure 4-f). The other part of the basement floor, consists of three storages and a hall is entered from the south facade (Figure 4-h). There is no transition between these two parts. In the middle of the basement spaces, there are 4 wooden columns that were placed to support the ceiling (Figure 4-e). The ceiling of the place was left uncovered and the floor is compacted soil. The walls were built as stone masonry and timber frame construction systems and plastered from the inside (Figure 4-g). The plaster of the walls is flaking away and there are some cracks on the surface.

The first floor plan scheme repeats the lower floor. Unlike the ground floor, corner rooms of it cantilevered in two directions except for the north facade (Figure 4-b). The sofa is based on size of 5.12- 11.82 m with a ceiling height 3.88 m. There is a toilet on the right of the sofa entrance door and the storeroom the other side of the door (Figure 4-v). The floors and ceilings of the spaces are wooden veneer. The ceiling ornamentations of this floor are more ostentatious compared to other rooms. It is thought that the room has most spectacular ceiling ornamentation and has not built-in cabinet is the main room for guests (Figure 4-w).

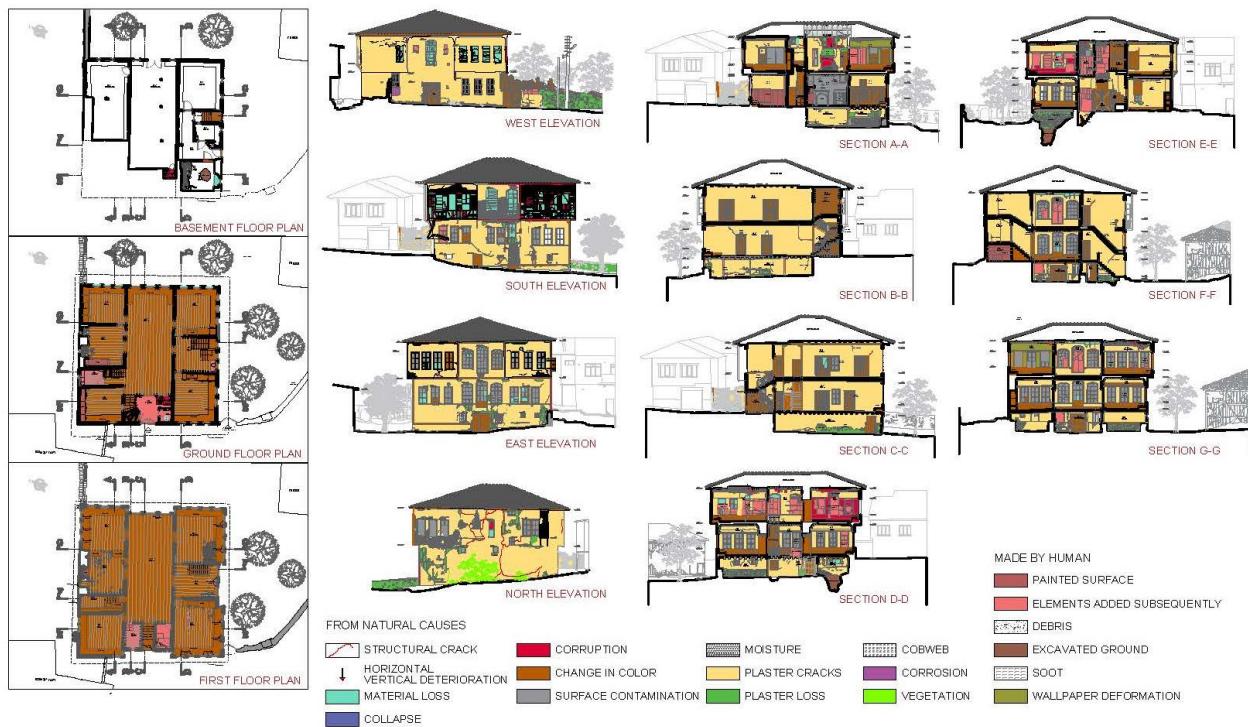
Figure 7. Deteriorations and corruptions

Deteriorations and corruptions in the mansion are examined under two title as deteriorations caused by nature and deteriorations made by human (Figure 7).

Among deteriorations caused by nature are structural and plaster cracks on the load bearing walls, plaster loss, collapse and material loss in timber, deflection on the ceilings and entrance door, vegetation, soot and change of colour.

Among deteriorations caused by human are cement based application, subsequently added or removed elements, debris, changing on the size of the elements.
