## Mechanical Properties of Wood Members in Santa Maria Church

Engin Derya GEZER\* Cenk DEMİRKİR Turgay ÖZDEMİR  
Karadeniz Technical University, Faculty of Forestry, Forest Industry Engineering, Trabzon, Turkey

The aim of this study was to determine the defects and damages in Santa Maria Church through non-destructive methods such as drilling resistance, screw holding, shear and elasticity modulus and to develop appropriate protection techniques that can contribute to the solution of the problems encountered.

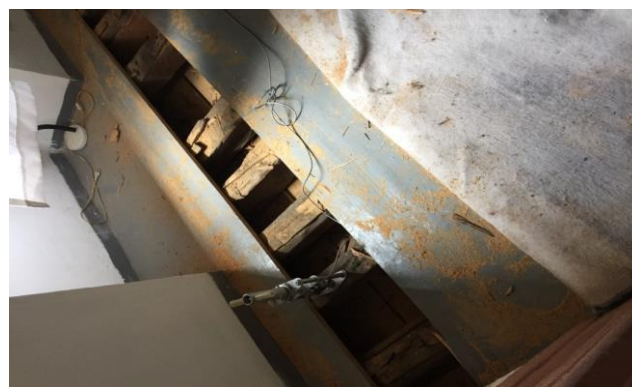
Figure 2. The beams in Santa Maria Church were tested using screw withdrawal resistance meter.

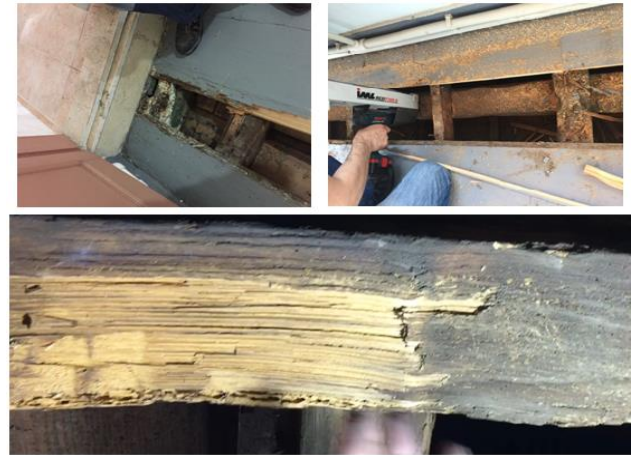
**Resistograph:** The wooden beams in 15 rooms of the Santa Maria Church were evaluated by Resistograph in order to determine the internal defects and deteriorations (Figure 3). Some of the Resistograph outputs obtained are given in Figure 4. As shown in the outputs, the higher peaks show the solid zone whereas the lower peaks indicate the decay, cracks, splits or deteriorated zones. The explanation of the Resistograph outputs was given on the outputs for each beam tested.

Figure 3. Evaluation of the beams by Resistograph.

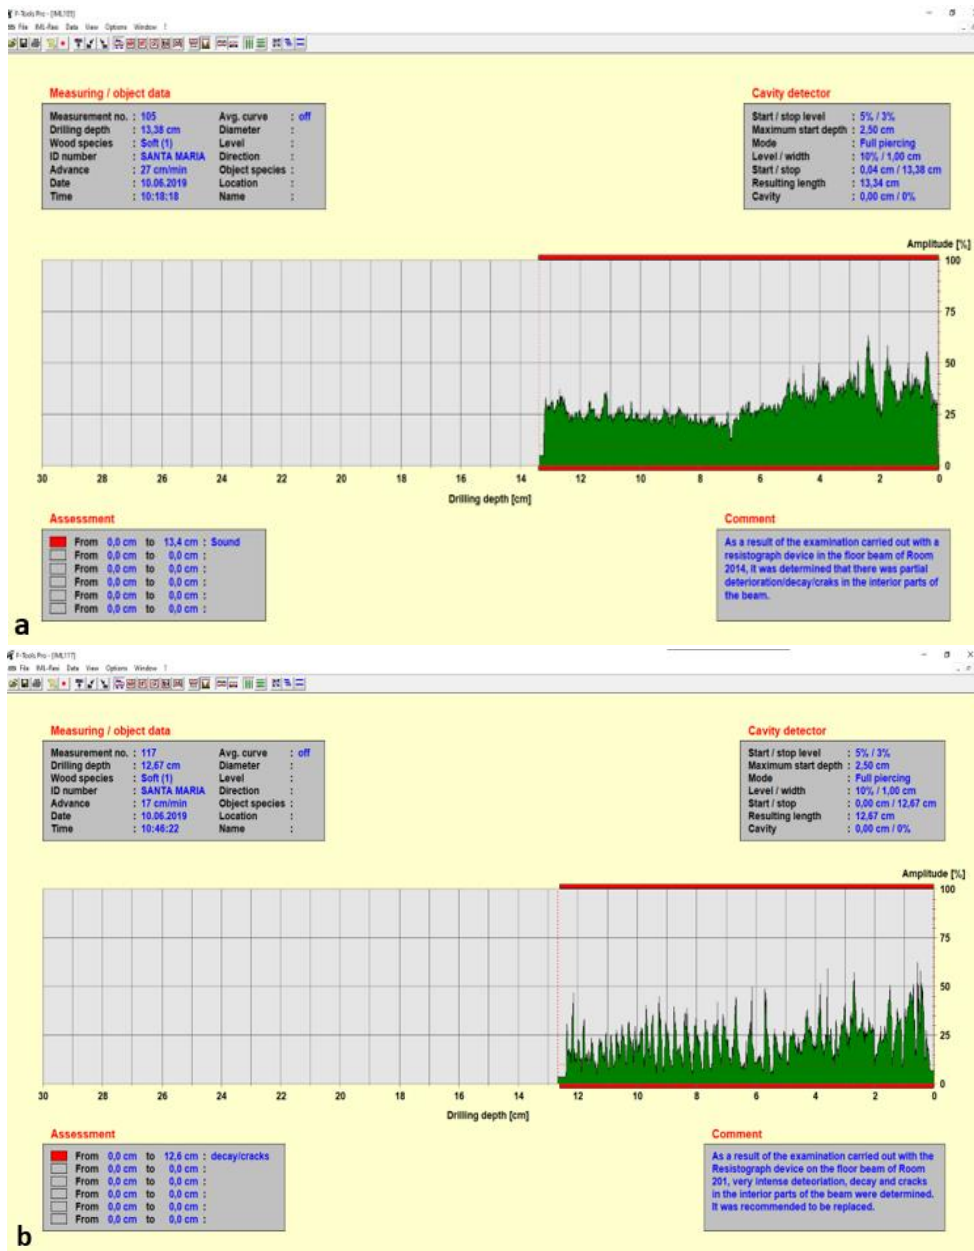
The results showed that beams in (Figure 4a) had partial damage, rot, cracks/voids in the interior. Rot/insect damage and the onset of rot were detected in the inner parts of the beam examined. As shown in the shaded area in (Figure 4b), intensive internal cracks with rot insect damage were detected in the inner parts of the beam. The obtained results from Resistograph testing verified the visual inspection observation. As a result of the

investigations carried out with the Resistograph device, it was determined that some of the beams had partial damage, while some of them had severe damage/cracks/decay. However, some of the beams recommended to be changed as a result of the findings obtained from both visual inspections and examinations made with non-destructive test devices.

Figure 4. Some Resistograph output of the beam.
