EVALUATION OF THE RESTORATION STUDIES DONE IN THE WOOD STRUCTURES OF HISTORICAL BUILDINGS: KEBAN YUSUF ZIYA PASHA MOSQUE

Mehmet Vefa HAN^{1*}, İmran DÖNGEL², Cevdet SÖĞÜTLÜ¹

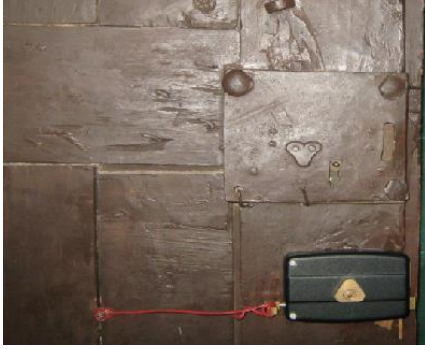
All headings should be even though there is an original door lock, it is no longer effective due to corrosion and the coating applied. Instead of repairing the damaged door lock, a new lock was fitted and cavities were made in the surface (Figure 5).

Figure 5. The original door lock and the lock that was fitted afterwards.

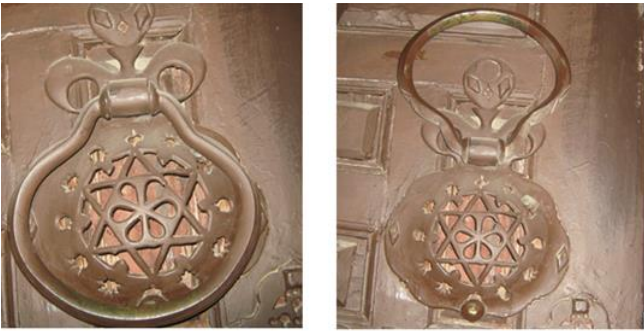
The coating that was applied to wooden parts for protection was also applied for metal painting without making any separation between materials. This case led especially to the deformation of metal elements' actual shape. It was clear to a poor workmanship since there was no coating to the exposed wooden parts, which were under metal connections and accessories (Figure 6).

Figure 6. The application of coating to wooden and metal parts of doors.

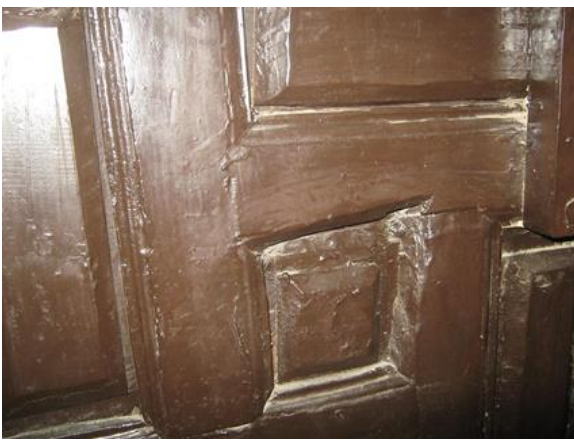
Doors were made with künde-kari and tablaruka techniques. In tablaruka and künde-kari technique, parts have to be positioned without being glued and merged to rails and panels. Tablaruka and künde-kari techniques lost effectiveness due to the fact that the protective coating applied was thick & gluey and filled the spaces in-between the parts (Figure 7). Namely, there is a high risk of deformation in doors in consequence of a possible work, which can occur with the change of the place's climatic conditions.

Figure 7. Details from the women's gathering room where coating was applied.

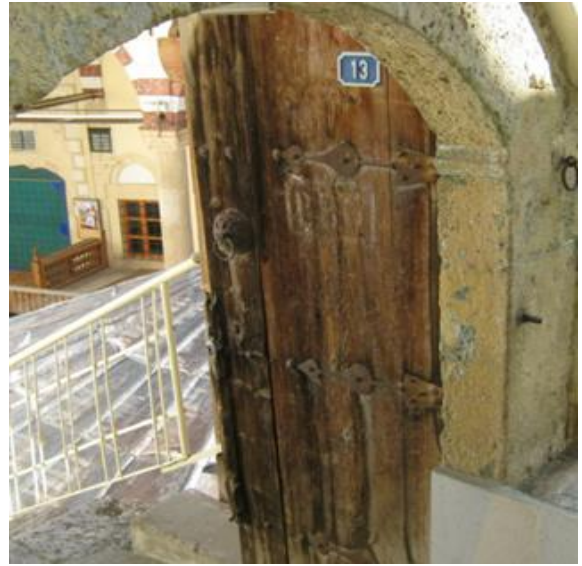
No measure was taken especially for door situated on the outer courtyard. Doors are completely under the influence of the outer atmosphere. This case paved the way for the corrosion of

courtyard door and loss of some parts within time (Figure 8). Nowadays, a metal door was placed instead of the wooden door in the courtyard of the lower entrance. Unless protective measures are taken for the top courtyard door, it is predicted that it will share a similar fate.

Figure 8. Corrosion seen in metal parts of the outer courtyard door and the rotting of wood.

It is important to protect and make interior elements usable, which are an important factor enabling the integrity of the construction. However, wooden elements such as the courtyard door whose huge parts are rotten and the preaching rostrum, which is no longer available to use, shall be taken under convenient protection conditions in museums. In addition, by imitating the general characteristics of the construction and replacing them, it would be possible to preserve the uniqueness by not destroying the integrity.

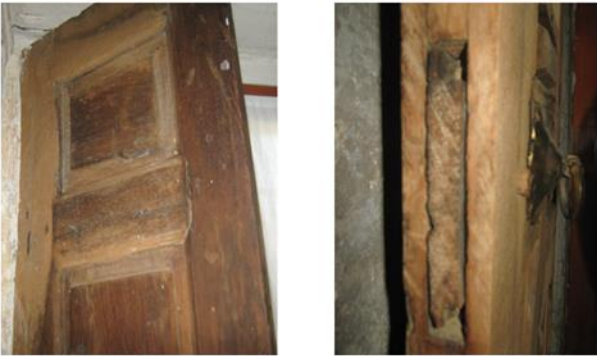
There are no decorations and tools on the upper service of wooden elements. This leads to the corrosion of some wooden elements (Figure 11). Even though they are protected from the outer atmosphere, they are negatively affected from the air and humidity. Rotting is especially seen on the parts close to the wall.

Figure 11. Corrosions seen in window shutters.

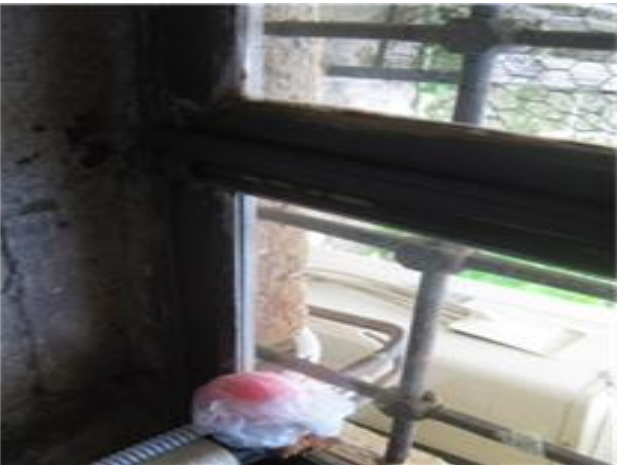
Fundamental elements were ignored when meeting technological needs of the construction, as it is the case for most historical constructions which are still open to use. The only window frame in which ac pipes were integrated was the original one among all the changed window frames (Figure 12).

Figure 12. Ac Pipes going through the window frame.

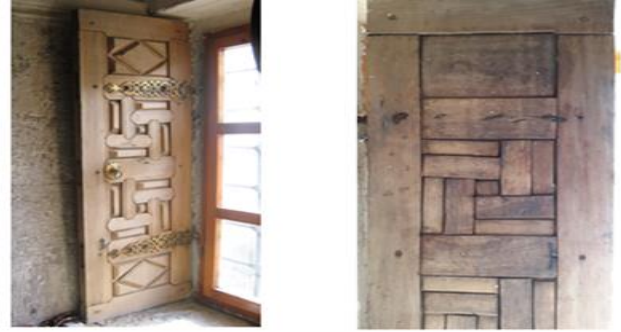
Windows are made with tablaruka technique, one of which is made with künde-kari technique. While those made with tablaruka technique were processed double-sided, those made with künde-kari technique were one-sided. However, when this window is closed, the non-decorated back surface is seen instead of the front surface. This leads to the idea that the window was changed. If it is the case, then there is no information about what happened to the original part. If it is not the case, it leads to the idea that its place and location was not taken into consideration.

Figure 13. Window shutter made with künde-kari technique positioned in the frontage.

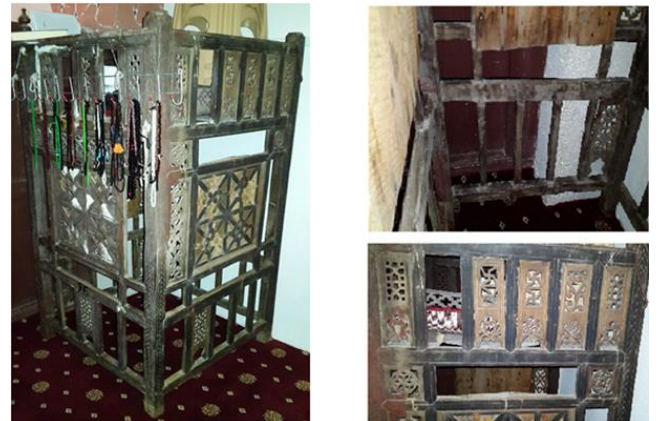
The rostrum that is no longer used nowadays is situated in the sultan gathering room that was used as a depot in the mosque. Alternatively, another marble rostrum that is not even the slightest compatible with the construction was placed there. During the restoration, there was no interference to the preaching rostrum that was taken to the depot. It was left to corrosion. It is possible to see that many parts of it decayed.

Furthermore, it was identified that some platforms dislocated or lost while some parts were tried to keep in place by nailing with nail. Geometric patterns were processed with a trellis künde-kari technique right in the middle front and two-side body of the rostrum, which was made in order to prevent a later collapse of boards that were nailed behind.

Figure 14. Preaching rostrum situated in the sultan gathering room.
