FAILURE ANALYSIS OF AN UPPER BENDING CYLINDER BUSHING IN A PLATE MILL

Premature failure of a bending cylinder bushing in a plate mill was investigated in this study. Visual, chemical and microscopic analyses were performed to detect the possible reasons of this failure and possible measures to be taken were mentioned not to be encountered for this type of failures in the future. No traces of welding were observed in the performed studies. Intensive elongated MnS inclusions, fatigue striations and splits from the grain boundaries were detected in the microstructural investigations. It was also proved that the base of the bushing was worked without chamfering. The importance of the removing hydrogen from the structure by annealing to decrease the hydrogen brittleness risk which would occur after the chromium coating process, and the chamfering of the bushing base to decrease the crack susceptibility was stressed.

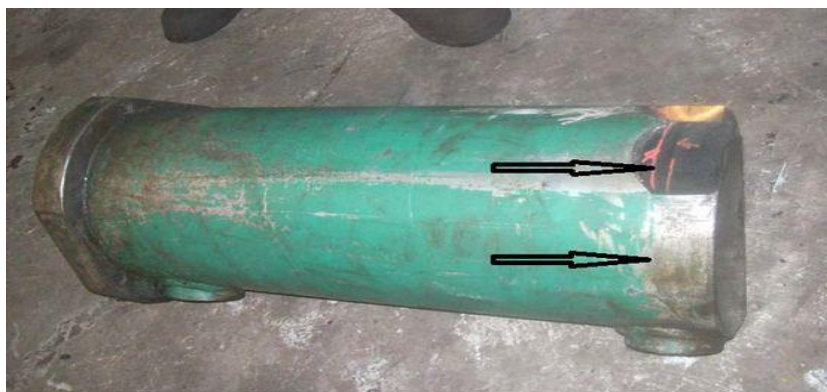
Cylinder stroke is 358.8 mm, working pressure is 275 bars, bushing material is S355J2, and working temperature is -20°C / +120°C for hydraulic cylinder system in this study. According to the contract in which the machine manufacturer describes the specifications and manufacturing conditions for the bending cylinder, chromium coating thickness over the bushing should be 25-30 µm. Outer diameter of the bushing is 203 mm and inner diameter (diameter of cylinder) is 165 mm. Although cylinder bushings' working lifetimes in this plate mill are about 10000 hours, the bushing under investigation failed after about 1000 hours of working.

General view of the broken cylinder bushing is given in Figure 1. Fracture occurred in the zone which is shown by the arrows in the Figure 1 and propagated along the periphery of the bushing.

Figure 1. General view of the broken cylinder bushing

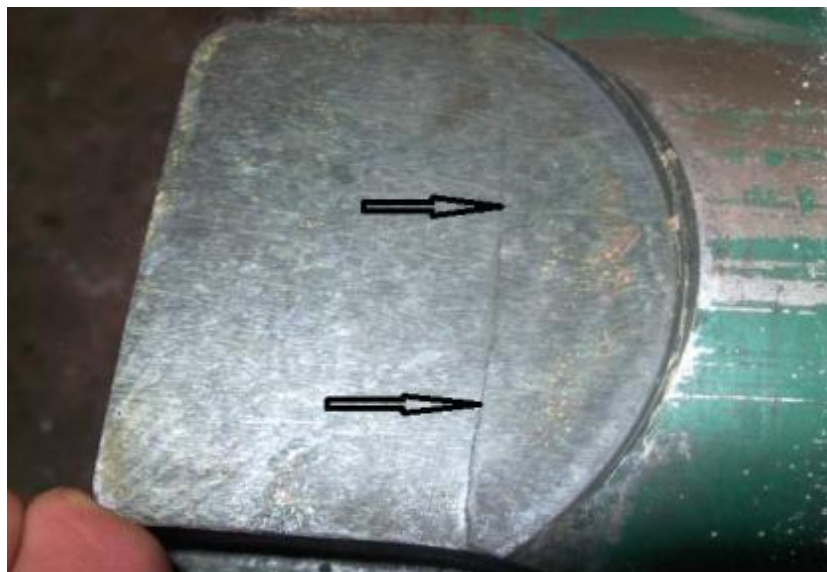
The chemical composition of the material which the cylinder bushing is made is within the prescribed limits for steel S355J2. Etched surface view is seen in Figure 3. There is a long crack on the surface and it is observed that the crack propagated along the periphery of the bushing.

Figure 3. Surface view of the part after etching

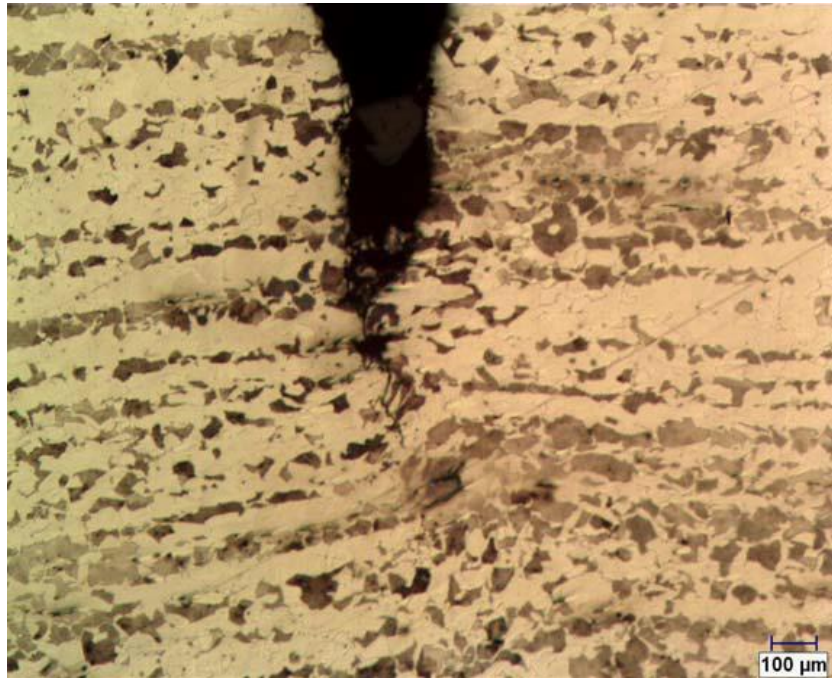
It is seen that the general microstructure of the bushing material consists of ferrite and banded pearlite phases (Figure 4). Elongated MnS inclusions in the microstructure (Figure 5) show that the part was possibly produced

Figure 4. Image of the fractured zone

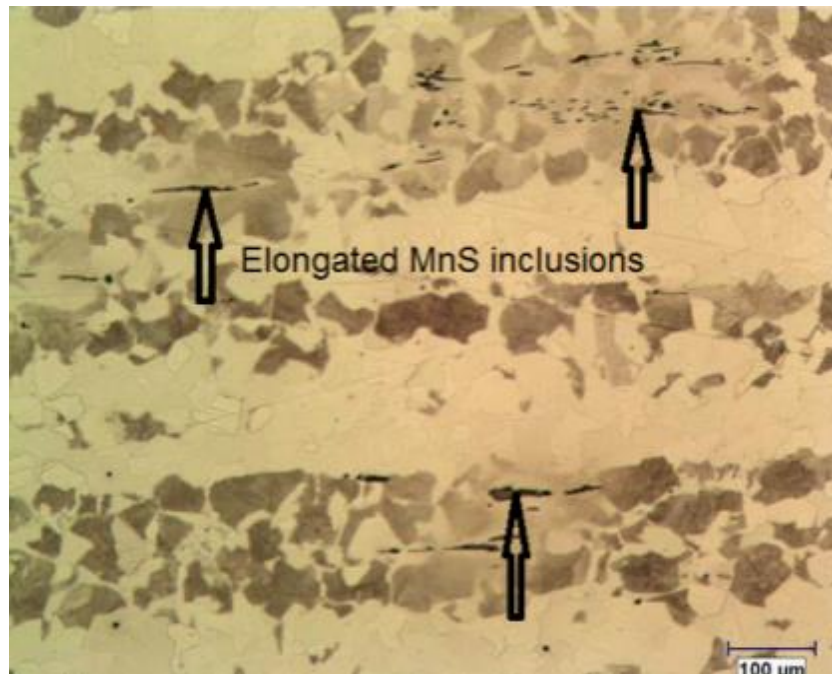
from a processed forged bloom. These sulfide inclusions act as stress raisers and fatigue cracks initiate at these points [9].

Figure 5. General microstructure of the part and elongated MnS inclusions

Welding or another manufacturing process which combine two or more pieces should not be used in the production of this type of parts. This condition was also pointed out in the contract as “bushing should be manufactured as a unique part”. No traces of welding process were seen in the performed studies. Intensive elongated MnS inclusions were detected in the microstructural investigations. The risk of creating sensitive zone for the crack initiation of these inclusions is very high.

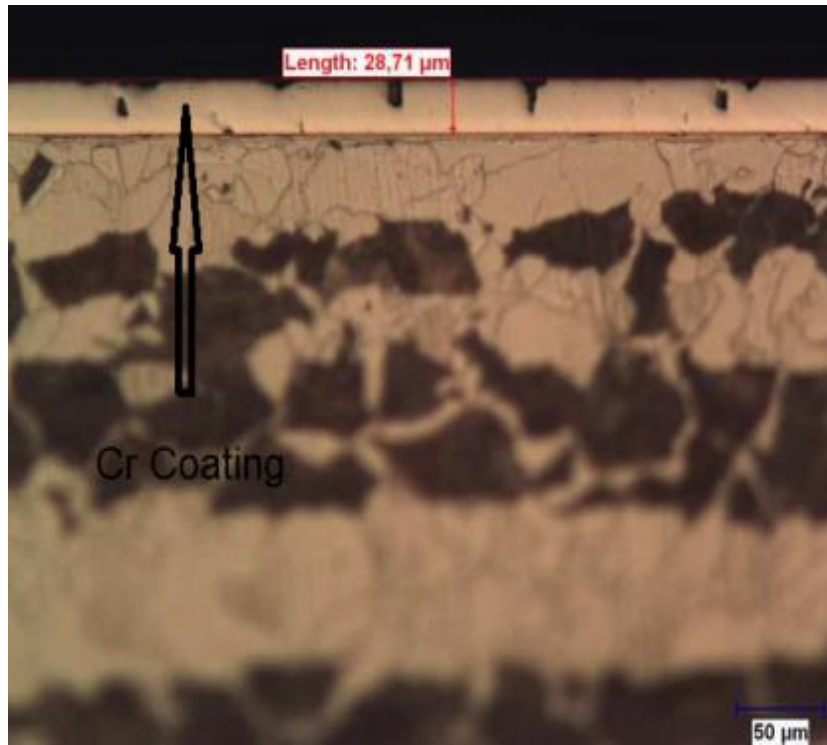
Chromium coating thickness measurements were also performed on the bushing whether the coating was between the limits written in the contract. It was detected from the coating thickness measurements that the measured thickness of chromium coating over the bushing confirmed the desired thickness value in the technical contract (Figure 6).

Figure 6. Chromium coating on the part

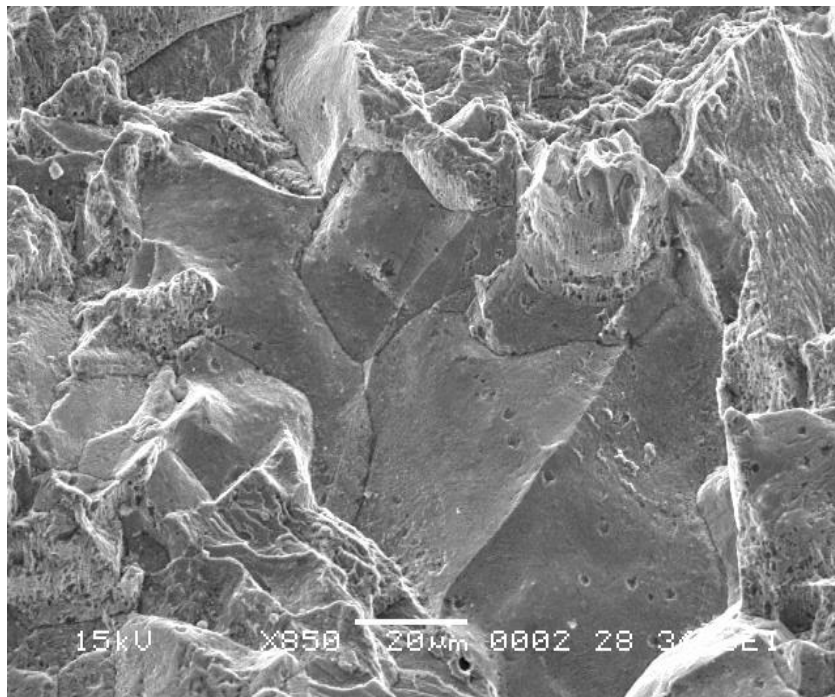
Figure 7. SEM image of the fracture surface

It was detected from the SEM investigations that fracture initiated from the grain boundaries. Furthermore fatigue striations were detected in the zone shown by the arrows in Figure 8.

Splits from the grain boundaries were detected on the broken surface investigations; these splits raise doubts that the part could pick up hydrogen during chromium coating process. Hydrogen may cause embrittlement of the material along selective paths, which can drastically reduce the resistance of a forged part to crack propagation resulting from impact loading, fatigue or stress corrosion [10]. Also, fatigue steps detected on the fractured surface show that fracture has occurred in a process by the time. This can be accepted ordinary as the part is thought to be exposed to the cyclic load. Removing the hydrogen from the structure by annealing the part at a proper temperature for a certain time can be useful to be able to decrease the hydrogen brittleness risk which would occur after the chromium coating process [11].

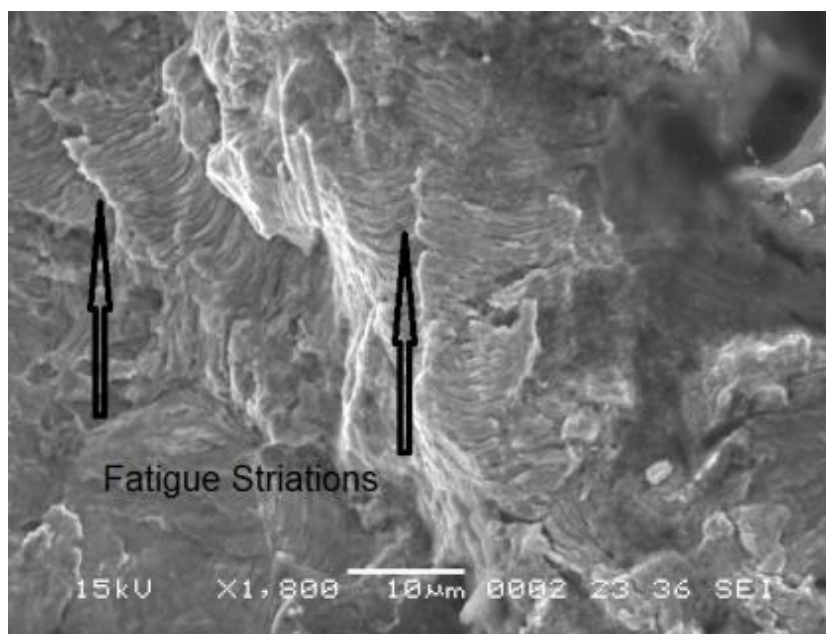
Figure 8. SEM image of the fracture surface
