Urfa Pazar (Hodja Ahmet) Mosque Repair and Conservation Practices

Emine EKİNCİ DAĞTEKİN ^{1*}

Citation: Ekinci Dağtekin, E. (2024). Urfa Pazar (Hodja Ahmet) Mosque repair and conservation practices. *Journal of Architectural Sciences and Applications*, 9 (1), 249-263.

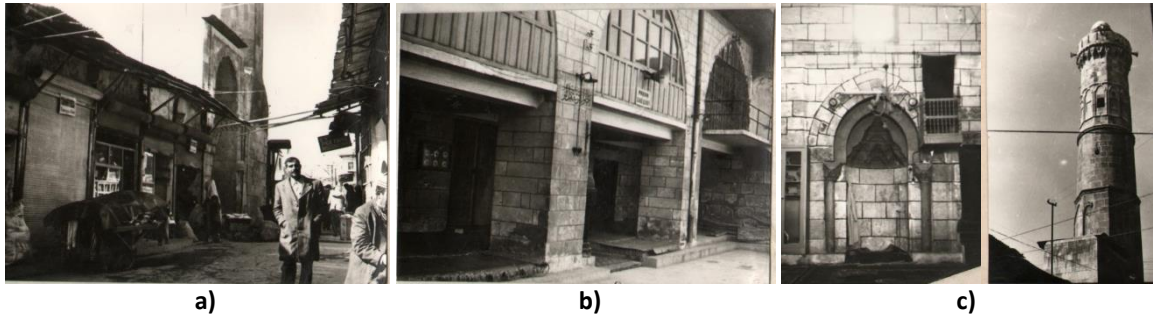
The year 1987: The first written document obtained in relation to the building is an inventory form of 1987. The original and first built section of Pazar Mosque is the area for the religious services located on the South side. According to the written and visual information in the inventory, a reinforced concrete mezzanine floor had been added to the three-part portico and the portico had been covered with wooden materials. The access to the mezzanine floor had been provided through a reinforced stairway positioned on the western façade. On the street where the entrance to the mosque is located, the shops and their eaves have not yet obstructed the view of the building (Figure 5).

Figure 5. a) Northern entry gate b) The mezzanine floor on the portico c) The altar (mihrab) d) The minaret (The inventory form (Şanlıurfa Regional Board for Conservation of Cultural Heritage Archive, 1984)

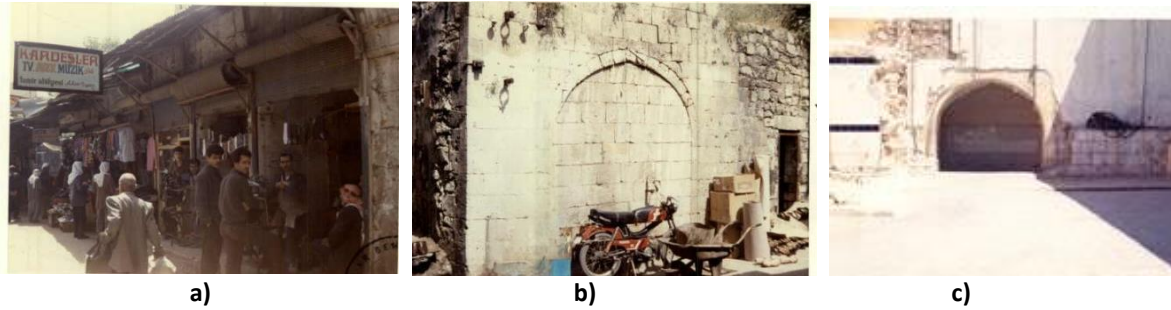
The years between 1987-1992: Some kind of congestion had come up in the Kovacılar Arcade, where the entrance to the mosque is, and the areas around the mosque were occupied. On the Western façade of the building, the arch where the second entrance gate is located had been closed and a passageway was provided by leaving a gap for a doorway. Washbasins had been added to the Northeast side, and the stone walls to the left and right of the ablution room on the east side had been plastered in places (Figure 6).

Figure 6. a) The shops on the North wall of the mosque b) The closed archway on the Western wall of the mosque c) The ablution room on the Eastern side of the courtyard (Şanlıurfa Regional Board for the Conservation of Cultural and Natural Heritage Archive, 1990)

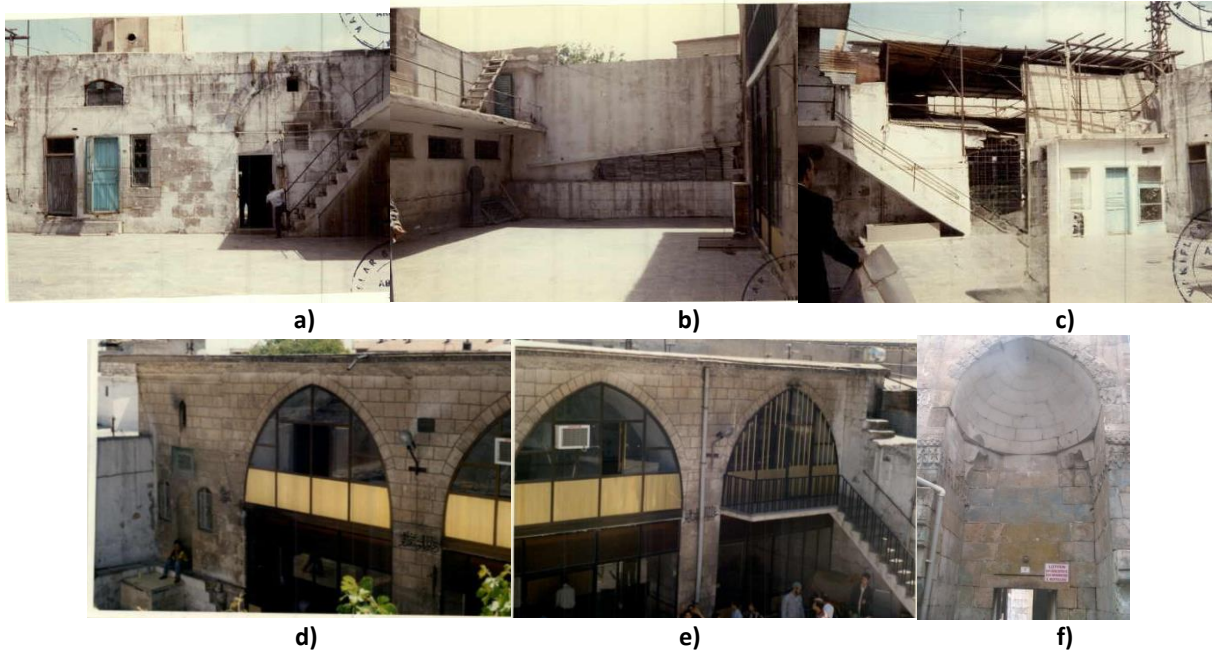
Figure 7. a) The closed archway on the North wall of the courtyard b) The closed ablution room on the East side of the courtyard c) The added new structures on the West entrance of the courtyard d, e) The shut down portico f) The entrance the mosque from Kovacılar Arcade (Şanlıurfa Regional Board for the Conservation of Cultural and Natural Heritage Archive 1984-1992)

It has been established that in the same period, the iwan of the Northern entrance gate of the courtyard was closed and access was provided through a small door gap, the entrance arch of the ablution room to the East was also closed, a new structure was added on the West, the portico was closed with metal materials, and that the portal of the northern entrance door was painted over (Figure 7).

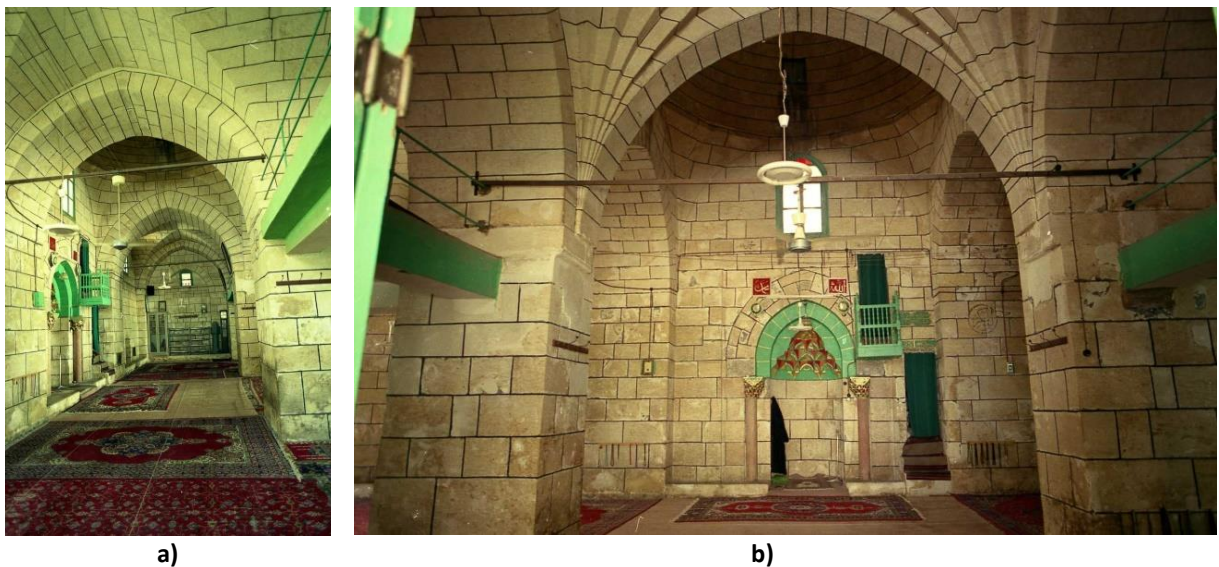
The year 1993: The interventions carried out during this period were identified using the photographs from the book Şanlıurfa Mosques by Cihat Kürkçüoğlu. In the photographs taken inside the religious services section, it was observed that women's gathering section has been built using reinforced concrete mezzanine floors, the stone surface and the altar (mihrab) have been painted over and thus the original form has been damaged (Figure 8).

Figure 8. a) Sanctum sanctorum (harim) and the reinforced concrete mezzanine floor (Kürkçüoğlu, 1993b, p.49)
b) The painted altar (mihrab) and the pulpit (mimbar) (Kürkçüoğlu, 1993b, p.49)

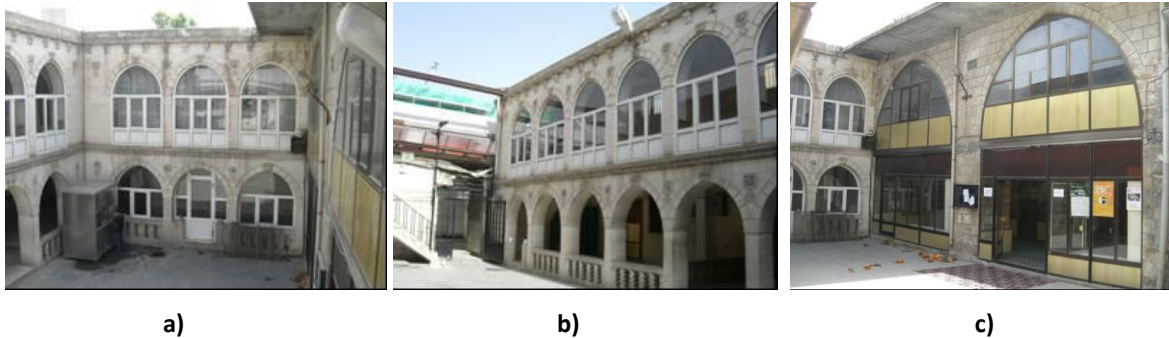
The year 1996: This is the period when the structure had been subjected the highest number of interventions within the courtyard. A restoration project was submitted to Şanlıurfa Regional Board for the Conservation of Cultural and Natural Heritage for the construction of an Imam room, an ablution room and a toilet in the North and East of the courtyard with the excuse that the congregation of the mosque had increased, and this project was approved within the framework of the board's proposals, however, the certified restoration project was not implemented. Instead, two-storey buildings were constructed to the North and East of the courtyard. The wing added to the North of the courtyard had seven arch openings each with a façade to the courtyard and had toilets on the ground floor and was used as Qur'an Course classes on the second floor behind the arches on the top floor. The Eastern wing also had two floors, the ground floor being used as an ablution room and the second floor as an Imam's room. This new arrangement shrank the dimensions of the courtyard of the mosque, and thereby avoiding the recognition of the original religious site (Figure 9).

Figure 9. a) The section added to the East side of the courtyard b) The section added to the North side of the courtyard c) The portico (Dağtekin Archive, 2023)

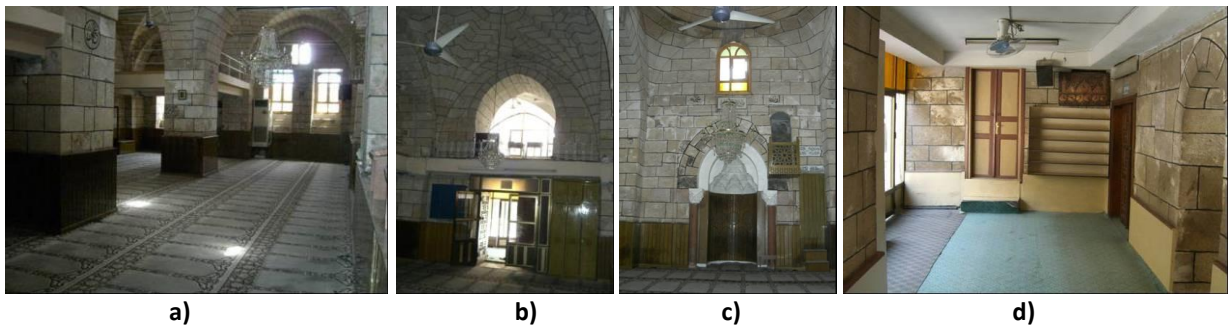
The year 2009: The detailed documentation work in respect of the building had been undertaken during this period. Survey, restitution and restoration projects were drawn up and analysed. The outer circumference of the mosque had been completely occupied within this period, the open-plan shops had been transformed into enclosed spaces and additional shops had been built. The perception of the mosque from the street had been completely lost. New structures were added to the East and West sides of the courtyard, and the walls and the flooring were renewed using materials such as tiles, etc. Along with the portico that had been shut down, the mosque had been subjected to aesthetic and physical deterioration. During this period, the stalactite work (muqarnas) of the altar (mihrab) niche in the sanctum sanctorum (harim) section and its joints were painted over, metal profiles were added to the reinforced concrete gathering places, wooden wainscots were applied to the walls, and a broken wind was constructed (Figure 10).

Figure 10. a) The wooden wainscots added to the sanctum sanctorum (harim) b) The breakwind section that was added to the entryway c) The painted over altar (mihrab) d) The added reinforced concrete flooring (Dağtekin Archive, 2023)

The stones on the surface of the building and the minaret, the muqarnas and the ornaments on the entrance door of the mosque were found to be contaminated by physical and natural weather conditions, and the ornaments were found to be flaking and broken.

Plaster spillage had occurred in the interior spaces due to humidity. The use of metal and the polyvinyl chloride (PVC) materials that are not compatible with the historical building has caused visual pollution.

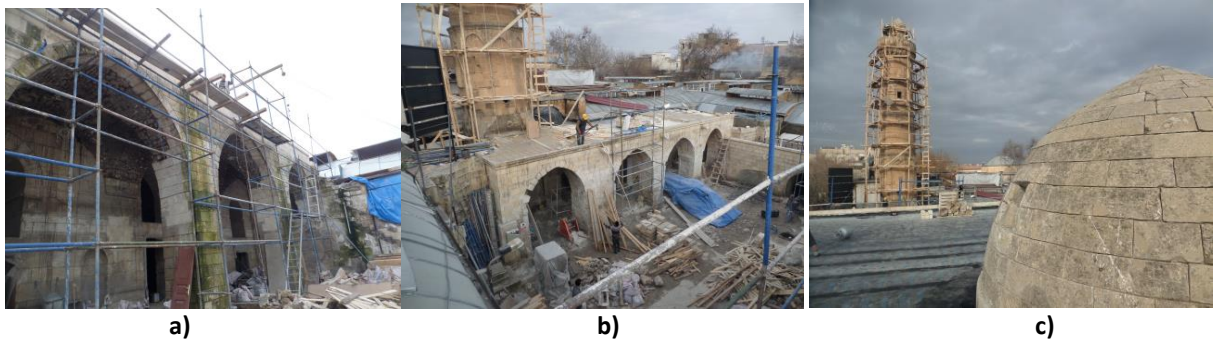
Figure 12. a) The removal of the additions to the portal b) The removal of the added stories onto the North side c) Cleaning in the minaret (Şanlıurfa Regional Board for the Conservation of Cultural and Natural Heritage and Şanlıurfa Regional Directorate for Foundations Archive, 2017).

The overflowing joint grouts and paint remains on the stalactite and covering stones over the mosque entrance door on the North façade have been cleaned, the stones with a surface loss more than five centimetres have been rotten and the fractures on the stones have been consolidated.

The surfaces of the stones have been cleaned by preserving the patina layers against tarnishes due to weathering on the surfaces of the mosque and the minaret, the joint grouts filled with cement have also been cleaned and the joints have been remade using lime-based joints. The painted stone surface on the altar (mihrab) have been cleaned (Figure 12- 13).

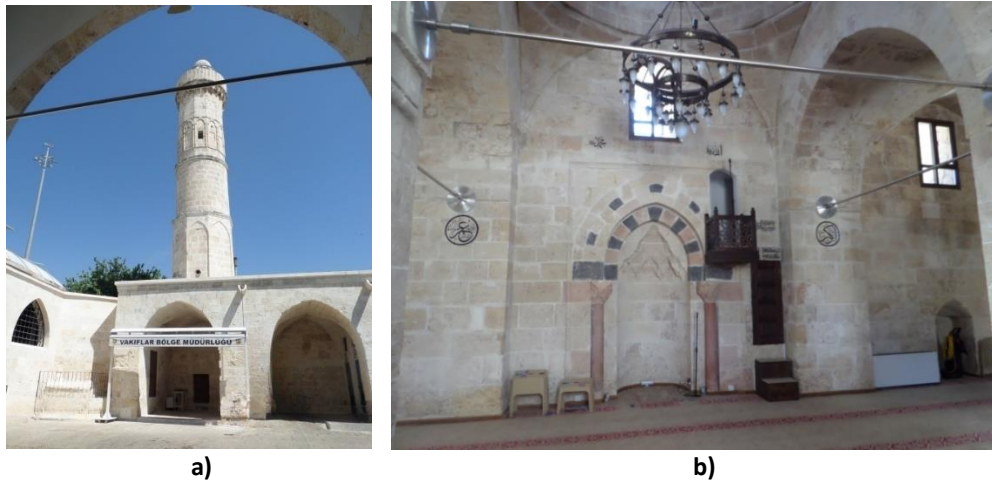
Figure 13. a) The North wing arrangement after the restoration b) The mezzanine floors and the tension bars that have been removed (Dağtekin Archive, 2023)

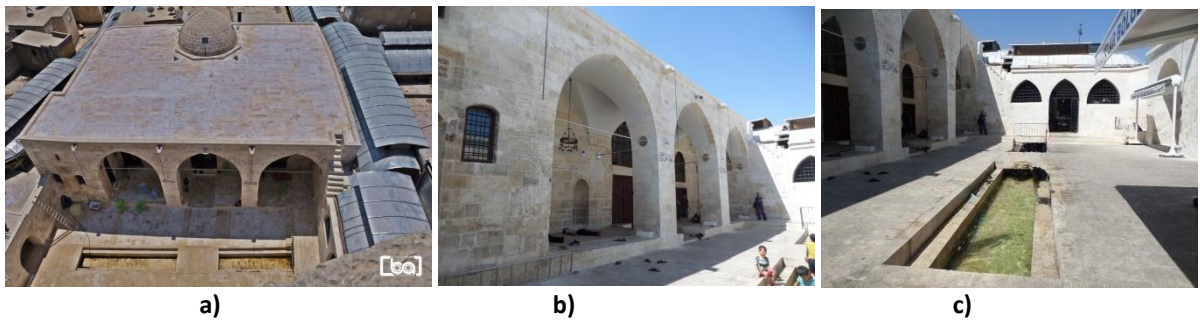
Figure 14. a) The roof and the courtyard after the repair works (Ölmez Archive, 2023, Şanlıurfa Regional Directorate for Foundations Archive, 2023) b) Portico (Topalan Archive, 2023). c) The Eastern façade of the courtyard and the water groove of the Pool Abraham (Dağtekin Archive, 2023)

The two-storey additional structure on the North and East wings of the mosque has been removed, and the courtyard of the structure has been provided to be recognised in its original form (Figure 14).

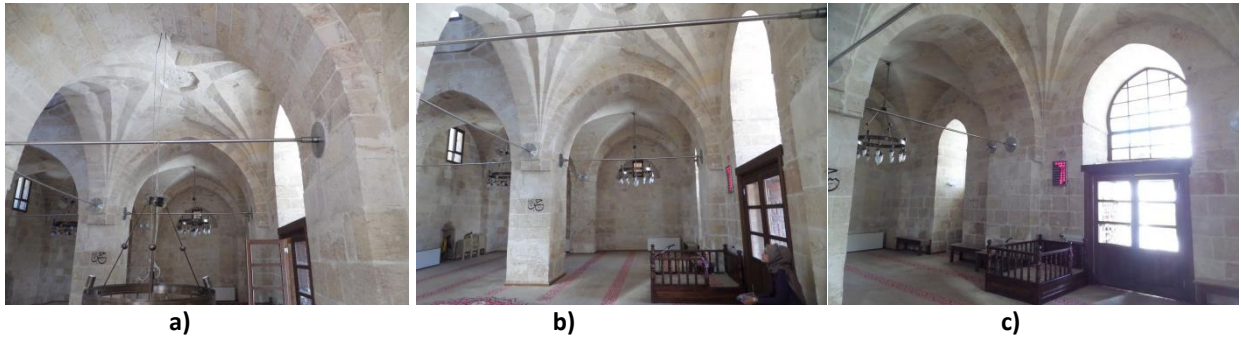
Figure 15. a) The added reinforced concrete flooring which was removed after the repairs b) The wainscots removed within the sanctum sanctorum (harim) c) Arrangements at the entrance gate (Dağtekin Archive, 2023)

The reinforced concrete mezzanine of the sanctum sanctorum (harim) and the portal and the window walls have been removed. In order to avoid possible situations such as fractures and demolishes, etc... through the effects of the removed reinforced concrete flooring on the religious services area and the portico of the mosque, the top cover has been opened up and then re-reinforcement works have been undertaken by wrapping with the seam method and glass mesh application. The arches have been tied

to each other using steel tension rods in the religious services area and portico of the-building (Figure 15).

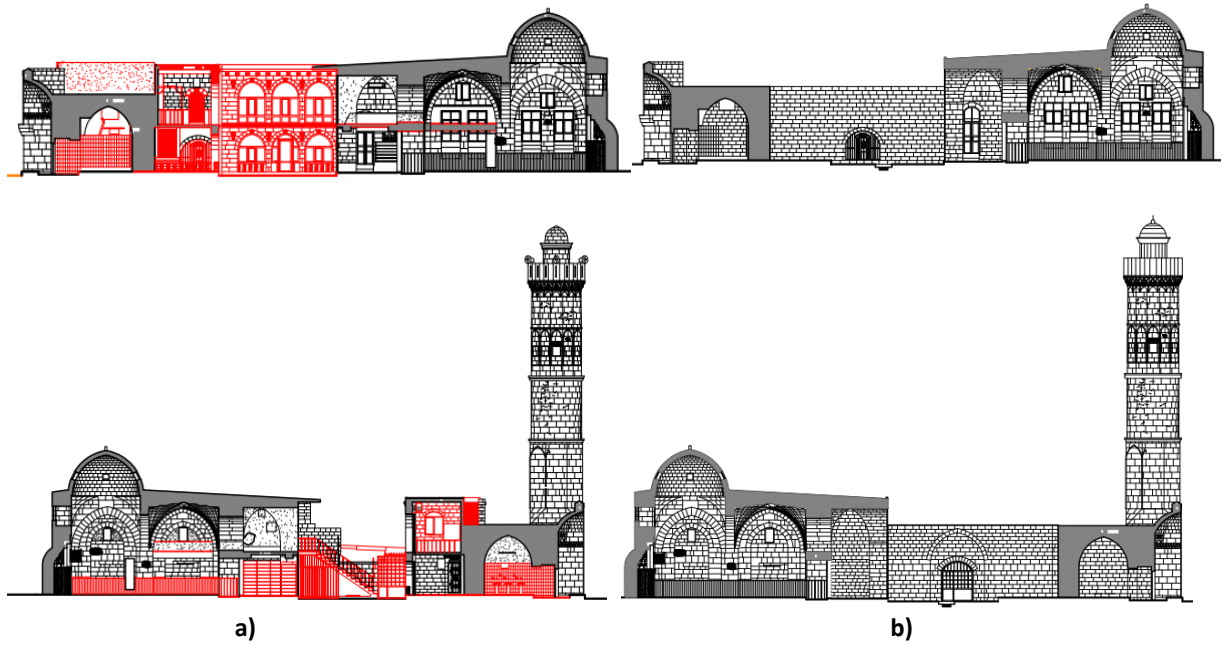
Pazar Mosque is located within Urfa Urban Archeological Site. The mosque and its surroundings have an impressive value together with many cultural assets such as religious, defence, bathing, accommodation and shopping structures belonging to various civilisations. It bears an architectural and technologic value with its inscriptions and solutions in its construction techniques. Factors such as the mosque's location in the city's most popular bazaar area, and the fact that the mosque's community was becoming more crowded for rituals such as Friday prayers and Salaat Al Eid, led to the addition of new spaces to the mosque, as well as some changes. Although the repairs carried up to the 20th century did not alter its original identity, the mosque had been changed has undergone significant changes especially since 1987. An analysis of the documents obtained between 1963 and 2017 and the current state of the mosque revealed that the additions and alterations that had been made had resulted in differences to the original form of the mosque, the original ablution rooms in the courtyard, and the architectural and spatial traces, such as the water groove, had been closed or erased. After 1990, the gathering floor created with a reinforced concrete being added to the worship area of the mosque, the shutdown portico, painting over the altar (mihrab) and stone walls, and the two storey building added to the courtyard have all brought forth the deterioration of the integrity and originality of the mosque. The shops added in a manner that would spoil the silhouette of the building and a manner that would block the entrance gate into the bazaar space adjacent to the mosque walls (Figure 16).

Figure 16. a) Additions made inside and outside the mosque b) The original state of the mosque (Dağtekin Archive, 2023)
