A Historical Building Functioned As A Museum; Bursa Umurbey Bath

The Umurbey Turkish Bath, located in the present Sericulture district, one of the most important Silk production centers of Bursa in the past, was built in 1430. It is important because the bath reflects its architectural characteristics. The Turkish Baths are divided into two groups: "Single Baths" where men and women benefit separately, or "Double Baths", where separate hammams adjacent to each other for men and women are constructed together. The Umurbey Hammam is the "Single" Hammam. The change seen in the societies changes the needs of the people as well as changing the structures because of the places that are shaped by the time they belong. Structures that can't carry their function from past to today are provided with a secondary function to continue their lives. The Umurbey Bath was given a function as a museum. In this study, the daily change of the Umurbey Baths from the past, survey drawings, survey reports, restoration projects, restoration reports and photographs before and after the restoration were included.

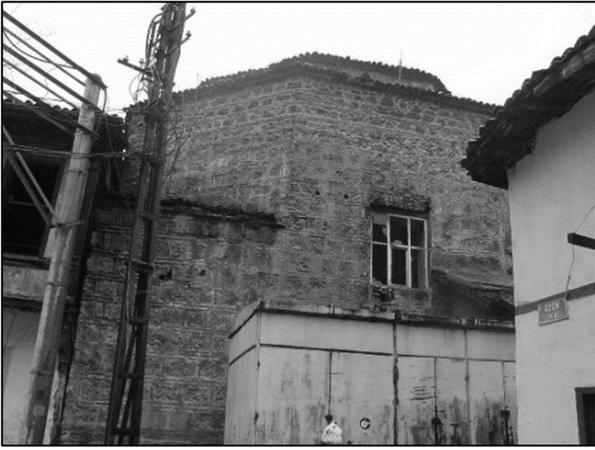
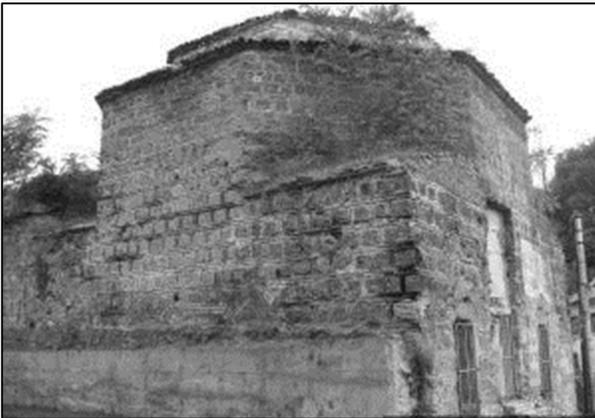
Fig. 2 West and south façades

The first construction technique is two or three rows of bricks, sometimes one or two rows of cut stones, and a vertical brick between them. The exterior walls of the hall of halvet are rubble stone walls. After that, most of these walls were renovated with cement mortar. Most of the exterior walls of the hammam were ruined because of the fire and earthquakes that occurred. In addition, a part of the rear wall was demolished and rebuilt in a recent period of the hammam. Lighting on the top of the dome there is no residue from the glass mounted on the metal parts. In addition, the boiler chimney was destroyed.

The window gaps in the front of the hammam were enlarged horizontally and vertically, and they were also changed. A water reservoir was added to the back of the hammam. The tops of the halvet rooms were covered with a roof with an octagonal plan but after that these shapes were deformed by renovation work. The parts where the lighting lanterns are located have been renovated with cement mortar. Most of the roof tiles are broken and lost. In addition, many plants are growing, with great wear on the roof. The bottom elevation levels of the windows on the northern side were lowered, the 90-degree angle of the side walls of the window is degraded. The original iron railings of the windows were rusted.

The exterior of the hammam; the worn out pieces of cut stone, rubble stone and blend bricks were replaced with new ones and a joint mortar was made between them. In addition, the interior walls of the hammam were scraped to reveal the masonry system and a joint mortar was made between them.

The main entrance door of the hammam was repaired. The damaged arched windows have been restored. The arch above the entrance door of the bath was unearthed. Additional steps that were added to the coldness part have been removed. The windows that were closed with bricks were opened. In order to establish a connection between the foyer and the hammam, the window in the coldness part was converted into the door. The difference in elevation between the foyer and the hammam was solved by the ramp.
