# The Documentation and Restoration Proposal for Zaimzade Kamil Efendi Mansion Located in Eskişehir Province Sivrihisar District

Özlem YILMAZ<sup>1, \*</sup>, Özlem SAĞIROĞLU<sup>2</sup>

Zaimzade Kamil Efendi mansion located in Eskişehir province, Sivrihisar district is one of the examples of civil architecture which considerably preserves its unique features within historical environment and embodies authentic construction technique, original space formation and architectural elements of traditional Sivrihisar houses. The mansion, settled in by the groups prone to vandalism, has entered into a fast deterioration process as it is open to atmospheric effects. Within the scope of this article, the formation of the mansion, authentic architectural elements and construction system is defined; the current situation is documented with the problems, dated, recommendations given in connection with restitution and restoration recommendations have been presented in both graphic and vectorial with their stages

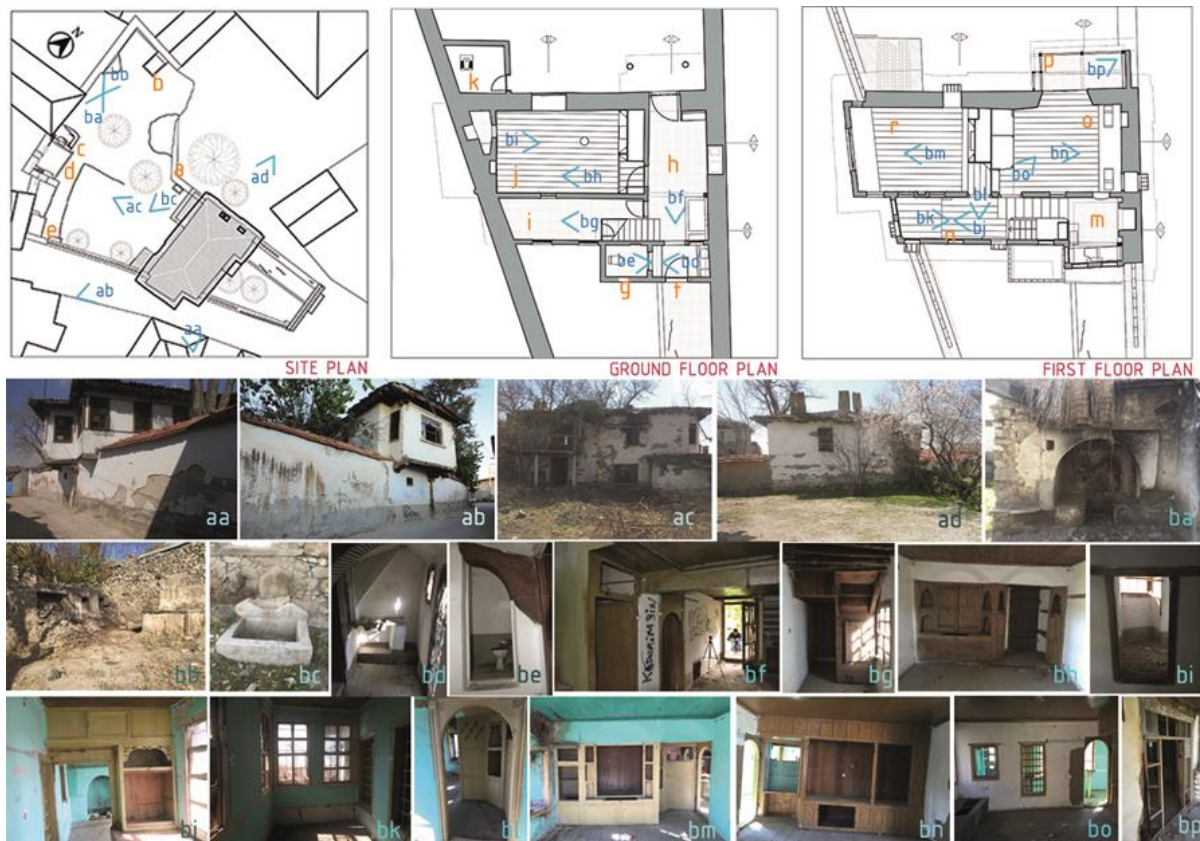
There are poultry house(Fig.2e), "tandırevi"(tandoor)(Fig.2d), oven (Fig.2c), "harçevi" (cellar) and warehouse (Fig.2b), concrete fountain (Fig.2a) constructed next-door to the neighbour mansion in the garden, there is also a toilet built later next to the building. Poultry house is ruined. "Tandırevi", is an authentic structure used in Sivrihisar mansions and built in a suitable part in courtyard-garden or inside the building usually in every mansion. There are oven, warehouse and cupboards in these building used generally for baking bread[7]. "Tandırevi" in the mansion is in a bad condition. 2 furnaces-one big one small-, an oven added later on next to the tandoor survived until today(Fig.2ba). "Harçevi" just next to the "Tandırevi" is ruined and we have information related to the area it covers and its size from the traces on the garden and ground. Warehouse inside the "Harçevi" is existent today, deteriorated physically and chemically as a result of atmospheric conditions. Three cupboards on the garden wall that forms the three walls of the "Harçevi" survived until today, shutters of the two of these cupboards were removed(Fig.2.bb). There are concrete toilet and sink joined to the building later in the garden located in the east of the mansion.

After passing the garden gate; the entrance of Zaimzade Kamil Efendi mansion is from the entrance hall (Fig.2f), which was added after covering the bottom of upstairs balcony. There is a concrete toilet which was added later to the south of this place (Fig.2g). The entrance hall opens onto the "taşlık" (stonyground). On the southwest wall of "taşlık" (Fig.2h); there is a place called "izbe"(Dark space located in the basement or ground floors of the mansions-warehouse) used as an indoor cellar. Also on the same wall, there are stairs and door of the winter room; there is a "şarapana" with the furnace on northeast wall, which is covered with sheet metal, and there is a wooden cupboard on northwest wall, which was added later, with the door giving access to the garden. The surface of "şarapana" is covered with concrete based cement today and its originality has been distorted. The height of the ceiling of "taşlık", which covers 11.2 m<sup>2</sup> area is 2.30 meters. The ground of "taşlık" is covered with concrete based cement and the ceiling is covered with plywood today. The ceiling of "izbe", which covers 7.9 m<sup>2</sup> area from the southwest entrance of "taşlık", is 2.54 m height ( Fig.2i). Today; its ground is covered with cement while its ceiling is not covered. The wicker (hasır) upholstery, the rough-hewn timber girders and the timber covering boards of the first floor on this upholstery can be seen below the ceiling. The place under the stairs in the "izbe" has been closed by using wooden panels and it was used as a cupboard. The winter room, which is designed next to the "izbe", ( Fig.2j) covers 20 m<sup>2</sup> area and it has 2.39 m height. The wall on the northeast of this room is covered with a "yüklük"(closet)

which has a large part for beds and small lamp stands (lambalık-şiralık). "Güsulhane" (ablution niche) (Fig.2bi) was designed in a trapezoid structure on the southwest wall against the wall and its originality was distorted with the concrete based cement which is added to a part of ground and walls. The ground of the room is covered with timber covering boards and the ceiling is a lath-nailed wooden ceiling which is used on the rough hewn girders.

Figure 2. Photographs of Zaimzade Kamil Efendi Mansion.

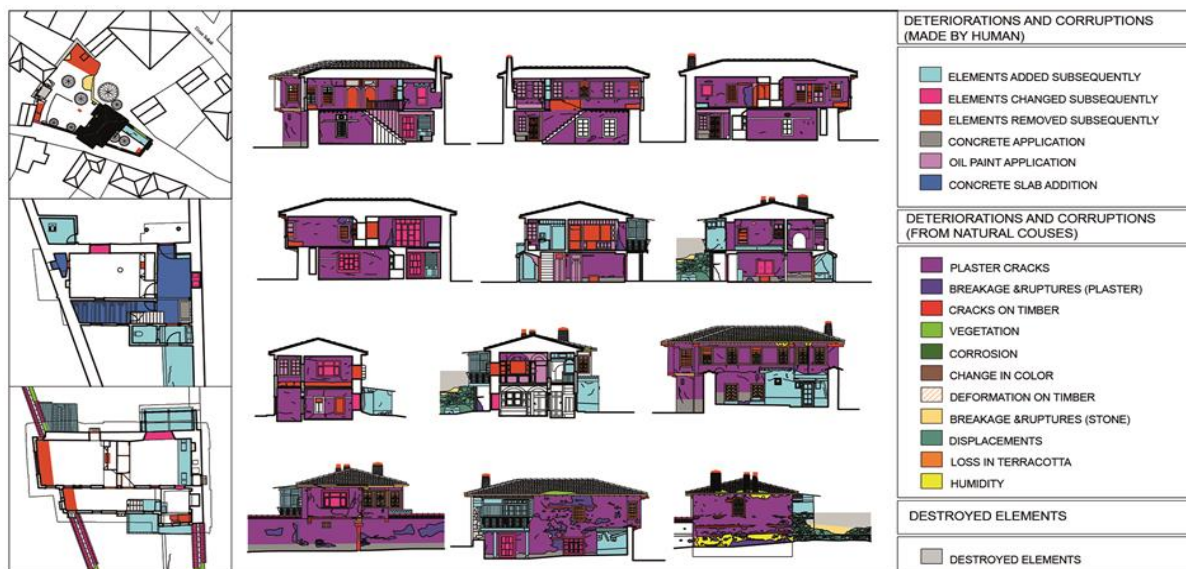
The structural condition of the mansion requires urgent intervention. Deteriorations and corruptions in the mansion were divided into those caused by nature and those made by people (Fig. 5).

Among the deformations from natural causes are; cracks in the wooden elements and plaster, corrosion in metal elements, deflection in wooden parts, loss and sliding in structural elements, vegetation, fracture and humidity in structural elements and color change caused by ageing (Fig.5).

Among the deformations caused by humans are; spaces and elements changed or added later, cement based material applications and oil paint application(Fig.5).

Figure 5. Deteriorations and corruptions of the mansion

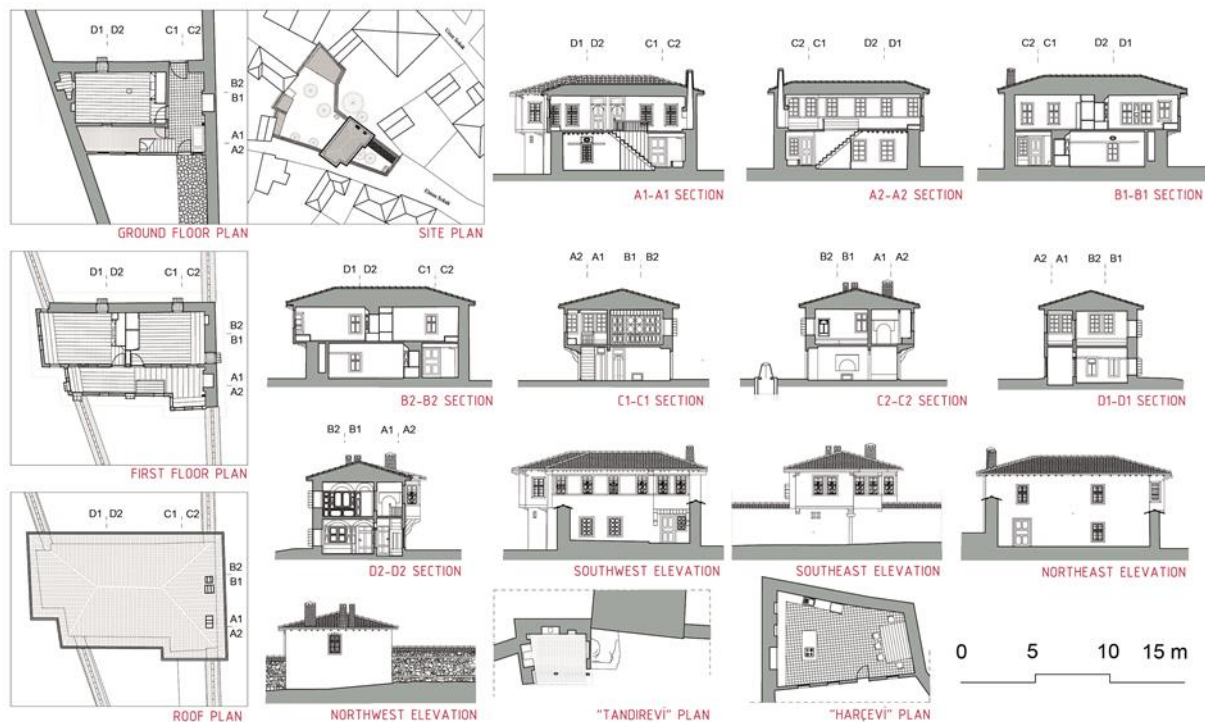
**Figure 8.** Restoration approach

**1st Stage:** Removing all the unqualified spatial built-ons in the yard and garden and unqualified elements that built in the mansion later,

**2nd Stage:** Performing the drilling work in the ground against increasing humidity, solving the problem with a drainage system (by taking necessary precautions for the

walls) and insulating the walls that are in contact with the soil against water.

**3rd Stage:** Removing the original tiles from the roof without any damage to determine the deformations resulting from the rain water, reinforcing the roof by changing the decayed and deteriorated elements of roof structure, furring strips and eaves fascia, determining and replacing the original tiles that have not been deteriorated physically and chemically, replacing the deteriorated tiles and connecting the gutters and downpipes that were destroyed to the drainage system according to their originals,

**4th Stage:** Cleaning of the scaffold to be built and elements on the front of the mansion, repairing the elements that are needed to be repaired and removing the elements that cannot be used and rebuilding them, renovating and completing the deformations occurred in structure materials and structure elements where necessary by determining the suitable physical and chemical treatments,

**5th Stage:** Performing the necessary repairs and renovations on the floor and ceiling tilings of the building,

**6th Stage:** Renovating the toilet in the yard, poultry house, “tandirevi” and “harçevi” in the garden with authentic details after repairs of the garden and yard walls and rebuilding the garden wall,
