# Measuring of Core Split Line Defect on Pillar Type Vented Brake Disc and Investigation of Crack Occurrence Potential on the Disc Caused by Its Geometric Deviation

<sup>1</sup> TOFAŞ Turk Automobile Company, R&D Center.  
\*recep.akyuz@tofas.com.tr

## Abstract

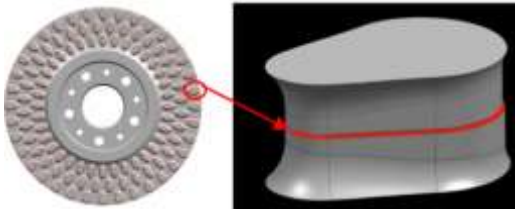
**Figure 1.** Core split line irregularity illustration on the brake disc pillar.

The defect illustration is shown Figure 1. This type of geometric defect can cause micro or macro cracking on the disc pillars during braking under high temperature and pressure [10, 11]. Goo et.al. investigated the thermal fatigue characteristics of cast iron brake disc under high load pressure. The mechanical and thermal properties of the samples were measured. Thermal fatigue tests were then carried out using equipment developed by the author. It is claimed that the fatigue lifetime of cast iron could be increased by regulating its composition and metallurgical structures [12, 13]. In another study, Gigan et.al. investigated thermo mechanical fatigue of grey cast iron brake discs for heavy vehicles via finite elements method. They claimed that the analysis of stress-strain hysteresis loops showed that the mechanical properties drop substantially at high temperature (above 500 °C) [14, 15]. Maraveas et. al. studied mechanical properties of structural cast iron at elevated temperatures up to 900 °C and after cooling down by

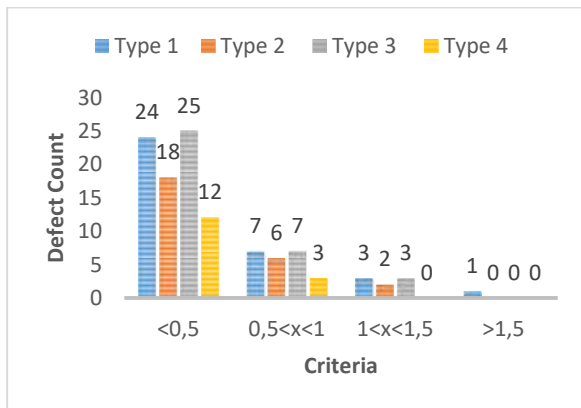
Before testing, 4 different types of vented brake disc were examined with above specified method in terms of 10 samples which were selected from each type of those brake discs were measured by contour measuring [20] and reported in Figure 4. According to analysis results, the defect characterizations were similar in Type 1 and Type 3. But standard deviation of the defects was bigger in Type 1 (See Figure 5). Also, it is seen that the depth of defects in Type 1 were distributed in a larger range compared to other types. (see Figure 6). After evaluation of the outputs, it was decided to carry out the tests with Type 1.

**Figure 4.** Detected defect amount in inspected 4 type vented brake discs.

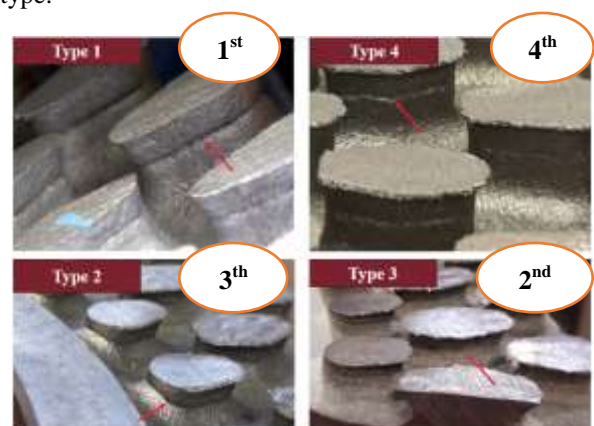
defect profile. Each type of brake discs was produced by different foundry. Some defect examples are shown in Figure 7 and comparison table is presented on Table 1.

**Figure 7.** Defect sample on the pillars in 4 types vented discs.

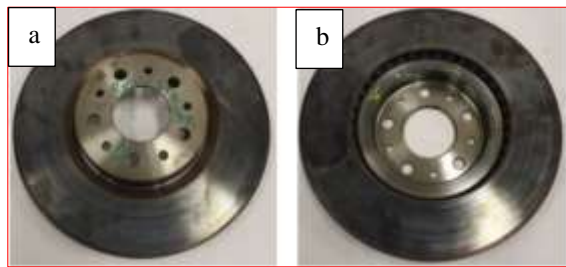
Four rotors that have visually higher defect depth out of 30 rotors which have core split line defect were tested to analyze their crack occurrence. Maximum defect depth and occurrence of cracks on defects' base upon rotors, which cut with fret saw, were analyzed via defined methodology after crack test (Figures 11, 12a, 12b, 13a and 10b) and the results are shown on Table 2.

**Figure 12.** Rotors after crack tests. **a.** left, **b.** right.

- Approximately 20% of defects was measured with more than 1 mm depth within all depth distribution. The maximum defect depth was 1,6 mm.
- No cracks on surface of rotors and pillars were observed after crack test (1st test) on bench test. There was any micro crack via checking under microscope. The maximum defect depth was 1,6 mm.

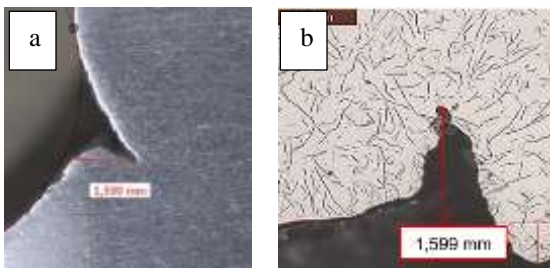
**Figure 13.** Defect analysis under microscope after crack test. **a.** measurement, **b.** crack analysis.

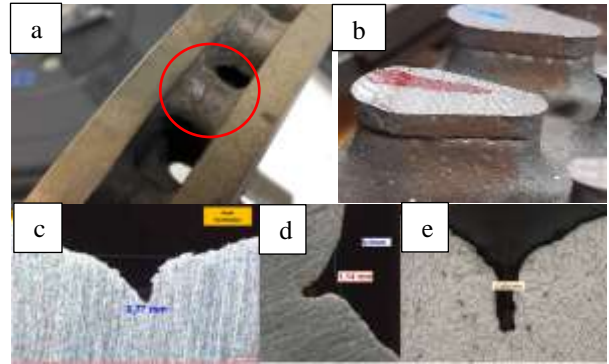
Defect areas on 4 rotors were analyzed after test (Figure 14, 15a, b, c, d, e). Depth of defects are shown on Table 3. Crack occurrence of 4 pillars that has highest depth was investigated.

**Figure 15.** Defects after crack test with thermal shock. **a.** and **b.** defect view, **c.** **d.** and **e.** defect analysis.

- No cracks – even micro cracks – were observed after thermal shocked crack test (2nd test) on laboratory. The maximum defect depth was 1,16 mm.
- No crack or breakage on pillars were observed after thermal shocked crack test (3rd test) on vehicle. The maximum defect depth was 1,24 mm. Besides, there was no micro-crack on the base of defect.

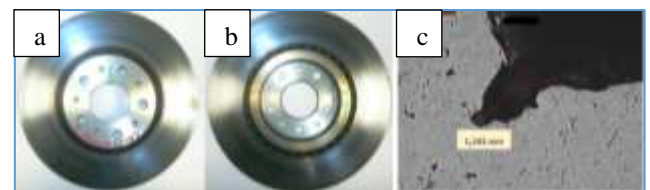
In this test, 2 rotors which were specified as worst according to defined measuring method, were mounted and tested on vehicle. After test, the core split line defects were measured and analyzed crack occurrence under microscope (Figure 16a, b, c). The results are shown in Table 4.

**Figure 16.** The tested rotors, **a.** left wheel, **b.** right wheel and **c.** analyzing under microscope.
