Temporal Change of Drainage Structures in Forest Roads (Study of Bentler Forest Enterprise 2009-2019)

Tolga Ozturk

Istanbul University-Cerrahpasa, Faculty of Forestry, 34473, Bahcekoy/Istanbul, Turkey

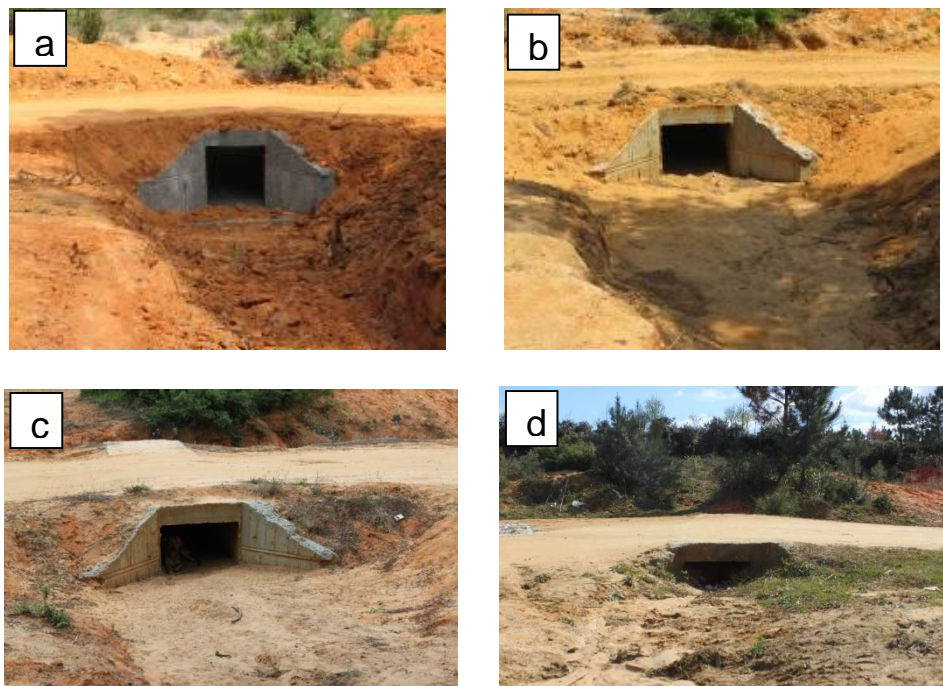
The exit and entrance grades of the culvert number 5 were below the road grade and were very close to each other. In addition, the exit point of the culvert was the endpoint of a fire road, and all sediment and rainfall waters coming from the slope of the fire road were filled to the part of the culvert where the exit was constructed. Since the entrance section of this culvert was filled with water from road dip drains, it could not be even named for entrance or exit. At both points, even at the end of the first year after the construction date, sediment accumulation started and at the end of the tenth year, the culvert was filled with 90% sediment and lost its function (Figure 2). The culvert number 6 was constructed perpendicularly to the road so that the flow could not be

Figure 2. Fifth culvert photos 2009 (a), 2012 (b), 2016 (c) and 2019 (d)

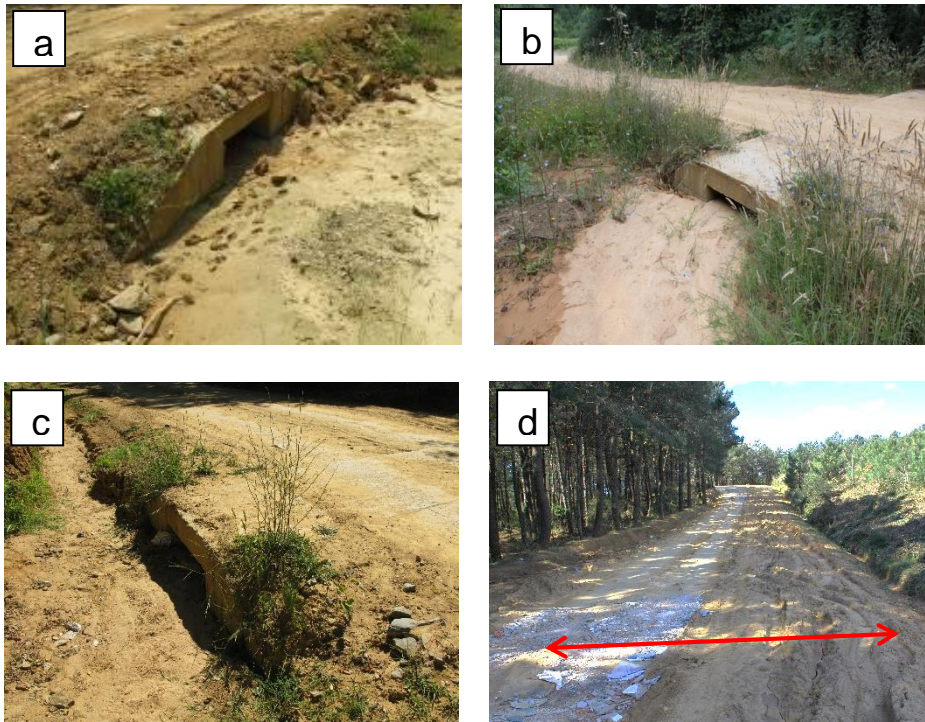
provided easily. Therefore, it was observed that all sediment and precipitation waters coming from the dip drain accumulate at the entrance and exit of the culverts and fill the culverts. If these culverts were constructed at 30°-45° angle by road, sediment flow would occur through the culverts and thus the culvert entrance would not be filled with sediment (Figure 3).

Figure 3. Sixth culvert photos 2009 (a), 2012 (b), 2016 (c) and 2019 (d)

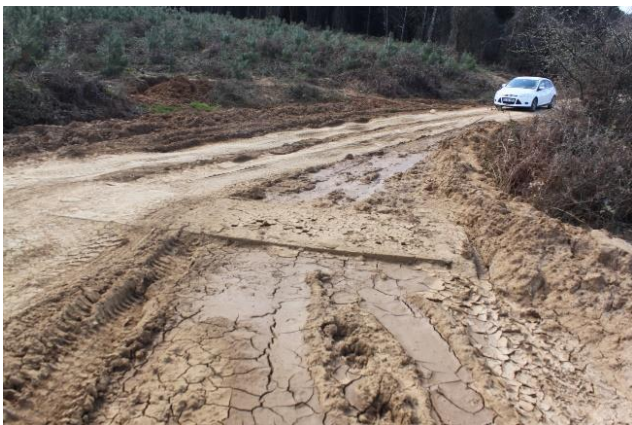
Since the culvert number 2 was completely trapped under sediment, both sides of the culvert were closed and could not be functional (Figure 4). However, the culvert number 7 fulfils its function without any problems since it was in front of a stream that constantly carried water and was constructed in necessary sizes (Figure 5).

Figure 4. Culvert completely covered with sediment

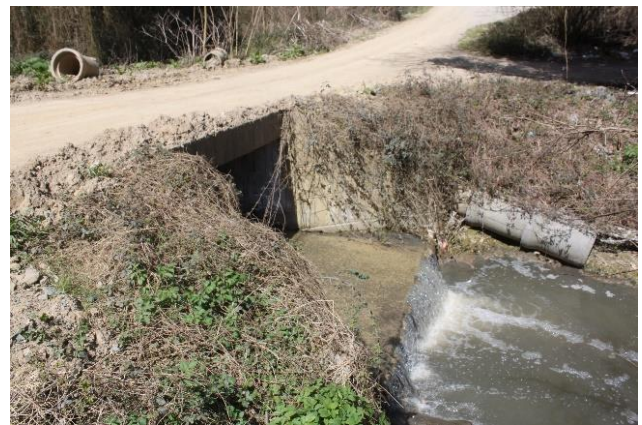
Figure 5. Completely open seventh culvert
