WALL PAINTINGS AND PLASTERS OF SİDE HARBOUR BATHS: TECHNIQUES, PROBLEMS, AND CONSERVATION METHODOLOGY

Bekir Eskici

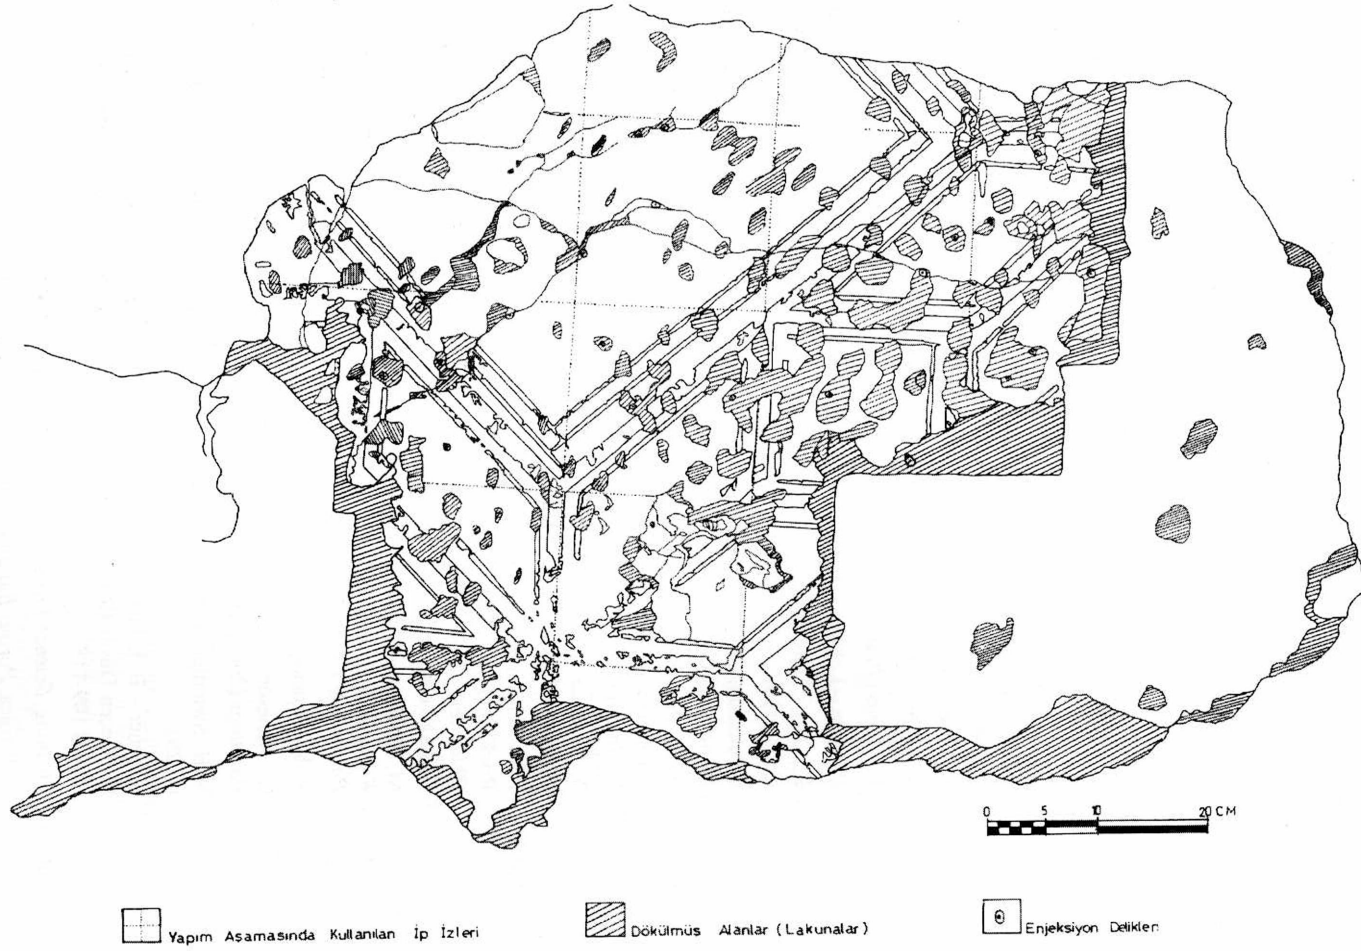
Figure 1

Traces of a rope (or a thread) that reveal information on the application technique were uncovered on the first layer of wall paintings, which have been brought into light through the cleaning process (Fig. 5). From these traces, it is understood that the surface is first divided into equal squares (18x17 cm) with thin bands in vertical and horizontal directions and in this way, the sketch drawing (design) is transferred on the wall without causing an error⁶ (Fig. 1).

- Figure 1** Side Harbour Baths, original wall painting remnant revealed after the conservation.
- Figure 2** Side Harbour Baths, restitution of the original wall painting decoration.

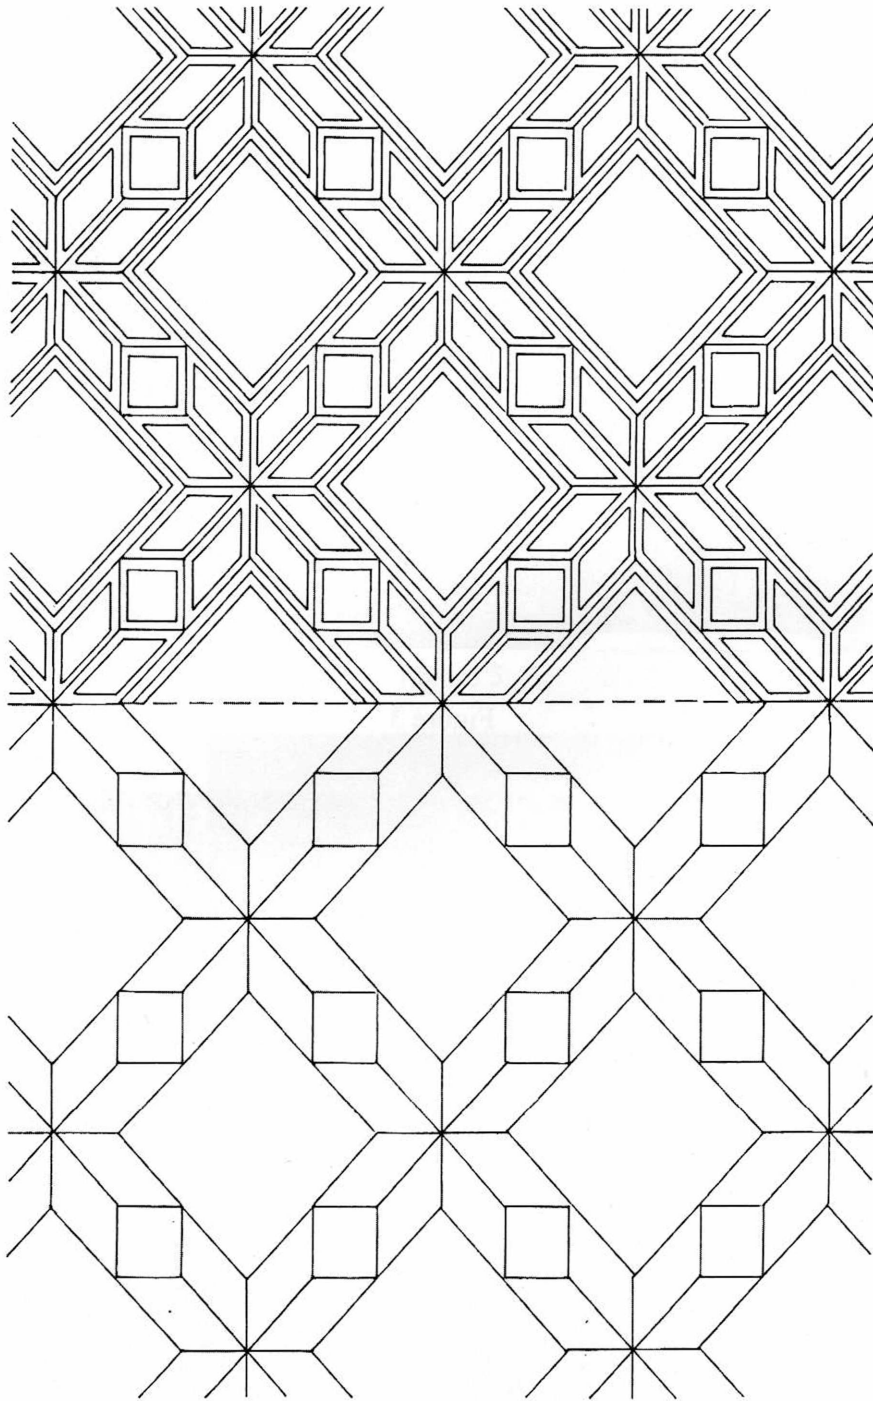
Figure 2

Thus, the remains of painted decoration on the southern wall of the area from the first and from the later periods of the building were revealed (Fig. 12). Unfortunately, only an approximately 1 m² part of this painted decoration has survived (Fig. 1). The first layer of this consists of a geometrical composition²⁰ (Fig. 2). The design is formed

with black and red bands on a light (white) background. The plaster remains of the second layer survived at some spots on very small areas. Contrary to the first layer, remains of the motif which resembles a curved twig and painted on light background with black gives evidence for the presence of a floral decoration.

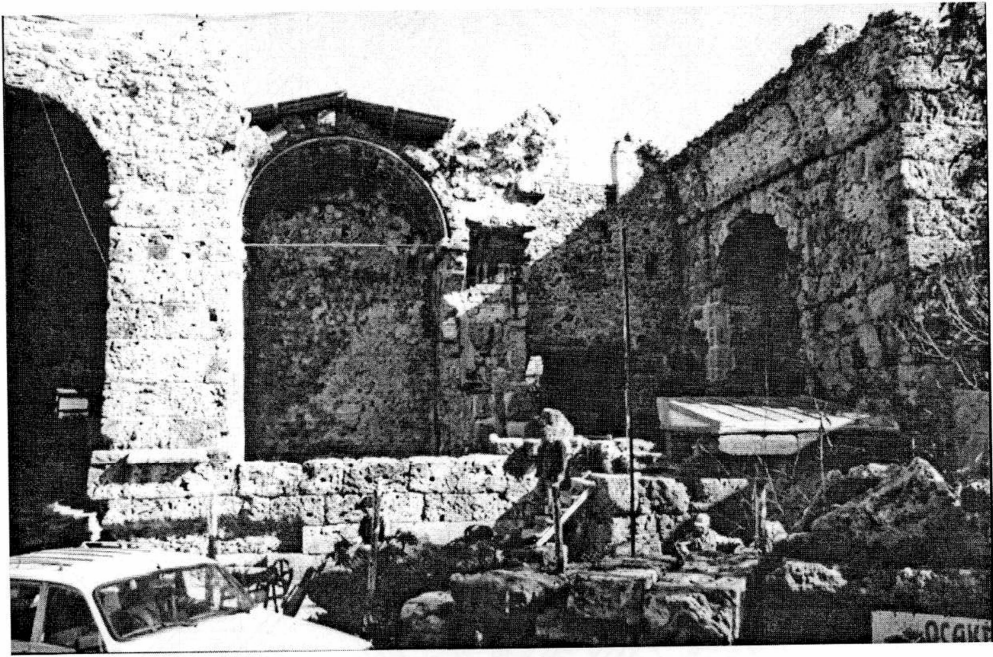
Figure 3

- Figure 3** Side Harbour Baths, a view from the southern facade.
- Figure 4** Side Harbour Baths, plaster remnant (pre-conservation condition)
- Figure 5** Side Harbour Baths, original wire (thread) traces on the plaster.

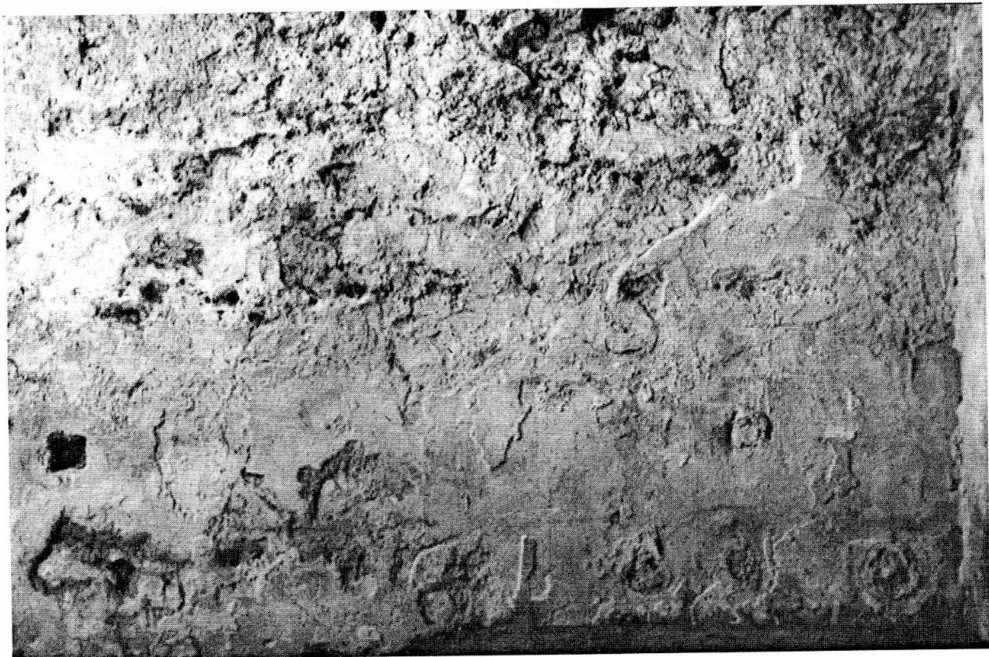
Figure 4

an application of the second painting layer from later periods is visible (Fig. 4). The thickness of mortar varies between 2-5 cm, that of the plaster is 4-6 mm and that of the finishing plaster is 1-2 mm thick according to the evenness of the wall surface⁵. On the plasters, paint remnants in different colours (white, red, black, green) were discovered after the cleaning process.

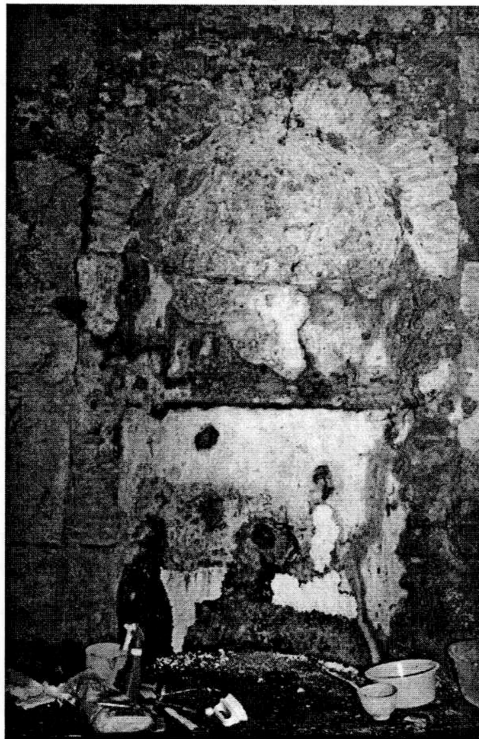
Figure 6

- Figure 6** Side Harbour Baths, cleaning studies with the wrapping method.
- Figure 7** Side Harbour Baths, cleaning and consolidation studies.
- Figure 8** Side Harbour Baths, cleaning and consolidation studies.

1- Cleaning: The light dirt such as dust, earth, and mud were removed first with soft hair brushes and then with damp sponges. Chemical methods were used in cleaning of hard calcareous layers formed on the surfaces by deposition of salts insoluble in

water. A solution of EDTA¹¹ (ethylene diamino tetra acetic acid) that was prepared in water in various proportions (5-10 %) was mixed with paper pulp to form a paste and then was applied over these surfaces¹² (Fig. 6). The cleaning was then done with bistouries and damp sponge; the solution remnants over the surface were removed thoroughly with water.

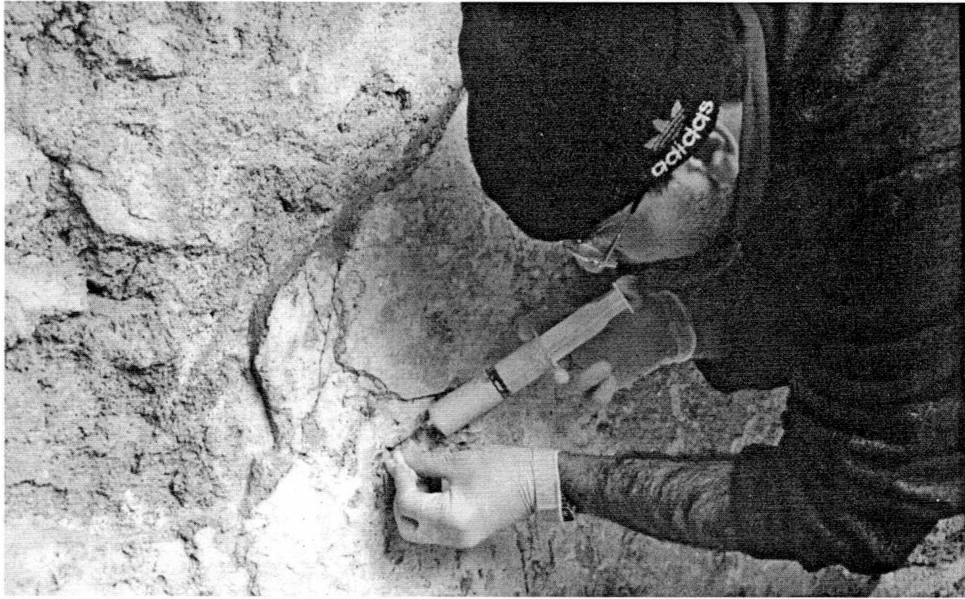
Figure 9

- Figure 9** Side Harbour Baths, consolidation studies with liquid mortar injection.
- Figure 10** Side Harbour Baths, recent time plaster layer covering the original wall painting.

2- Consolidation: One of the important conservation problems of the building is that the remains of the wall paintings of which very few survived face the risk of powdering. Acrylic resin (Primal AC33¹⁵ in water 20 %) was injected to consolidate the flaked plaster-mortar layers (Fig. 9). The wide and large lacunae between mortar-wall were filled with hydraulic lime-based liquid mortar (Malta 2002)¹⁶. Thus, the plaster that

was about to fall down were fixed to the wall. Methacrilate resin (Paraloid B72¹⁷ in acetone 3-5 %) was used to consolidate the weakened painted surfaces.

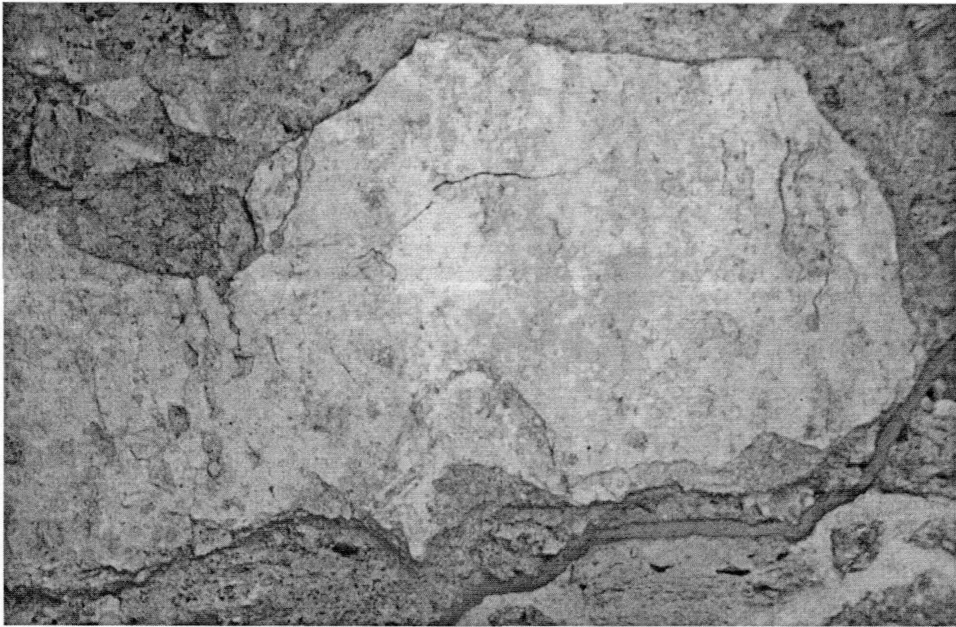
Figure 10

In some places, multi layered plaster application from different periods were discovered. In Room VII (at the north of the caldarium)¹⁸, it is understood that the upper unpainted plaster layer which covers the original decoration was made in recent times (Fig. 10). This covering plaster which does not have an archaeological and aesthetic value was carefully removed with bistouries, small chisels and perforating tools¹⁹ (Fig. 11).

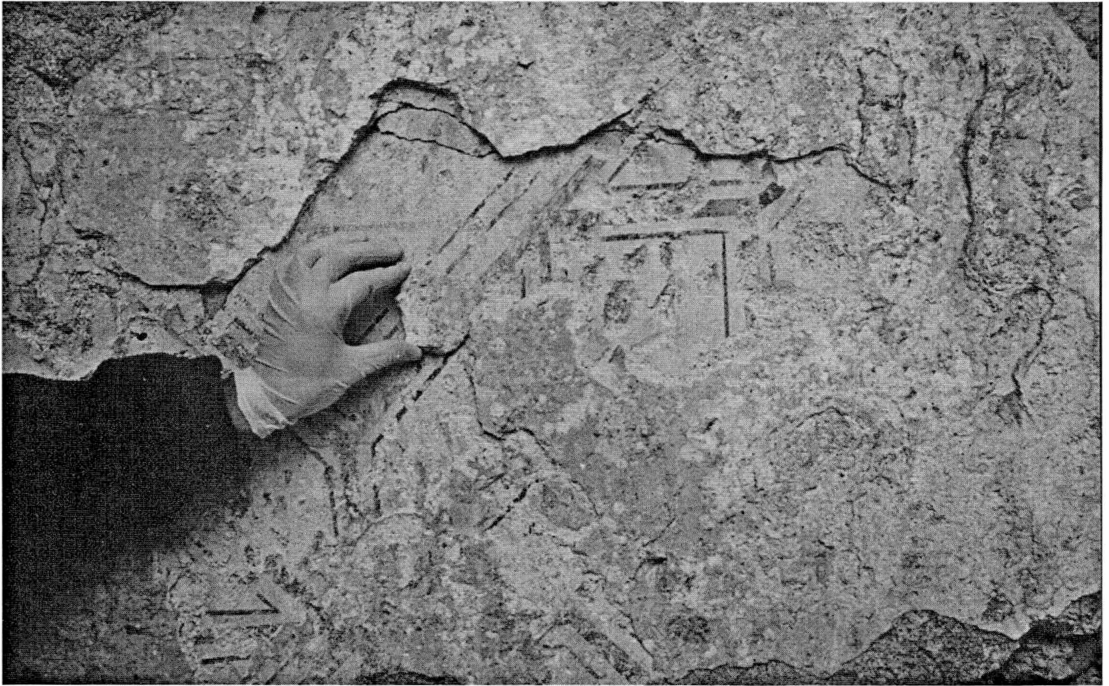
Figure 11

- Figure 11** Side Harbour Baths, removal of the upper recent time plaster layer.
- Figure 12** Side Harbour Baths, original wall painting under the recent time plaster layer.

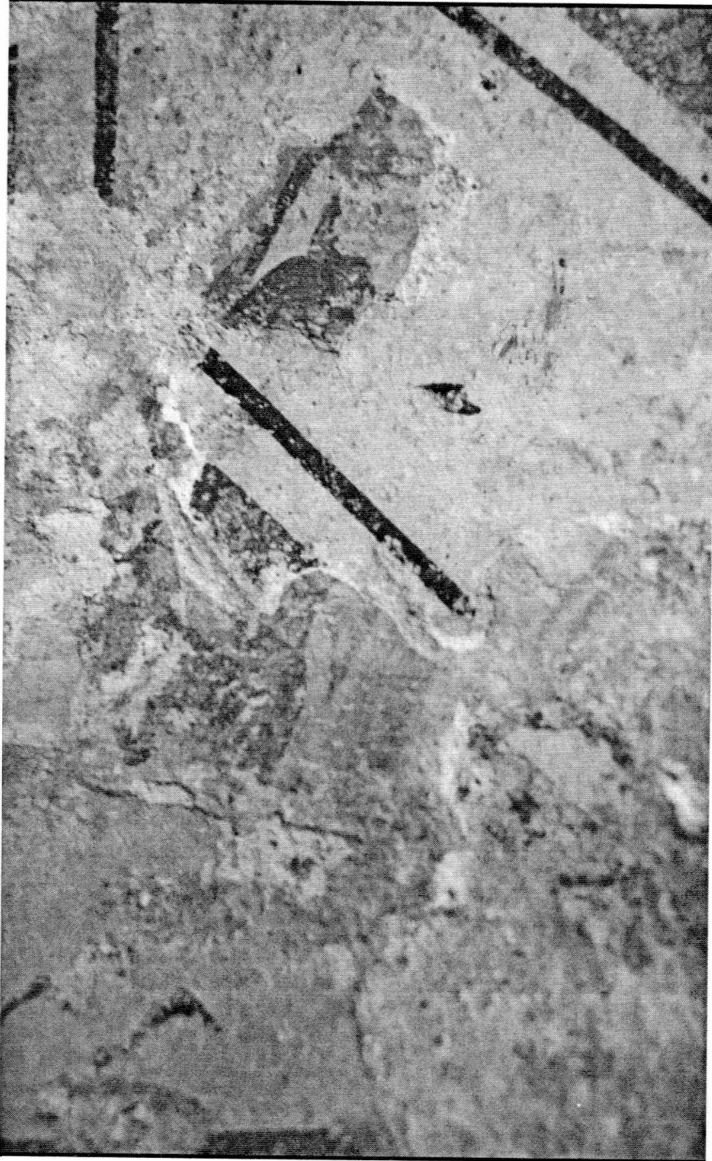
Figure 13

- Figure 13** Side Harbour Baths, remains of the second layer of painted plaster on the original wall painting, detail.
