Failure Analysis of Distributor Gear

Abstract

Keywords: Failure Analysis, Distributor Gear, Finite Element Method, Fatigue

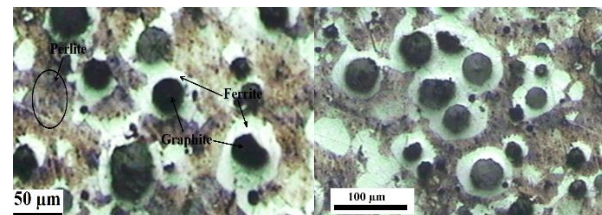
Fig. 2. Optical microscopy images of the distributor gear

Figure 2 seen that the ferrite structures in the pearlitic matrix microstructure are surrounded by graphite nodules. The matrix is ductile cast iron. The specific shape of graphite in the ferritic microstructure acts as a crack stopper and lowers the stress density in front of the crack, making it a suitable material for such cyclically loaded structures.

The roundness of graphites in ferritic microstructure reduces crack propagation and stress end. This microstructure feature adds impact resistance to ductile iron cast iron. [11-15]. Pearlite is a product of ferrite with a carbide structure called cementite. There are two phases in thin layers in the pearlite structure. So actually, the pearlite is not a single phase, it is more accurate as a combined joint of the two phases (cementite and ferrite). This structure creates a higher strength and hardness of ferrite, as the thin carbide layers of pearlite support the thin ferrite layers arranged together [16]. It is required that the resistance to this demand is high, the pearlite ratio in the casting should be increased. As a natural result of this increase in strength, it is observed that the ductility of cast iron with pearlitic structure has decreased a little.

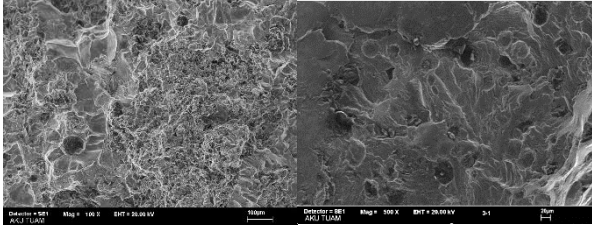
Fig. 3. SEM Images of the distributor gear

Figure 3 shows the SEM images of the fractured surfaces of the distributor gear. SEM images is shown the progressive flat fatigue fracture region. This surface is the fatigue appearance of cast iron under torsional stress. Fatigue striations and elongation of the nodule cavity could be seen in the crack propagation zone. Mixture of striations and fractured pearlite zone on fracture surfaces are a typical characteristic of fatigue failure of ductile cast irons [17,18].

Fatigue damage in mechanical structures generally starts at notches. Threaded areas, dimensional transitions, rivet holes, weld and keyways, lubrication holes are natural and generally unavoidable notches [19]. This is because the maximum stress is at the notches zone. also, when the distributor gear is in force, the spherical graphite's in the hole area increase the stress concentration. In addition, it is well known that if there are free graphite and non-spheroidal graphite in the microstructure, not only can this lead to

a high stress concentration, but can also cause fatigue crack start during a short working time [20].

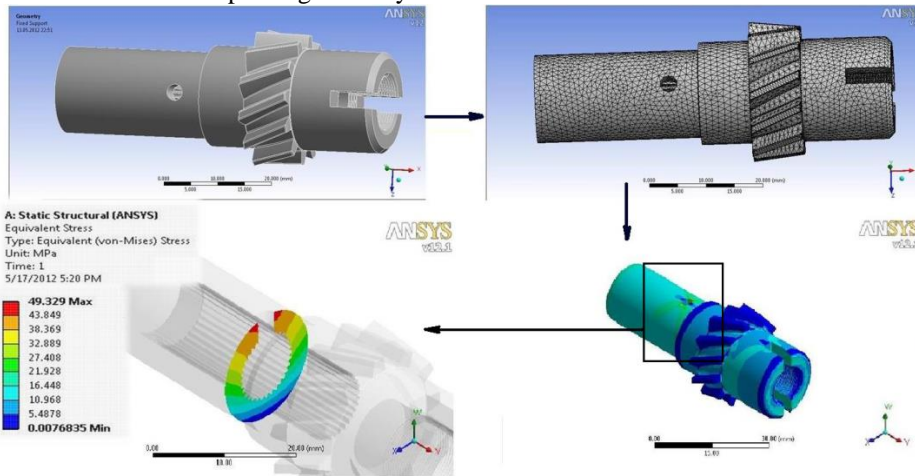
Fig. 4. Finite element analysis of distributor gear

The results of the analysis show that the maximum stress occurred in the whole region. The region where stress concentration occurred was sectioned in order to see the stresses that occurred in the critical region of the part (Fig. 5).

Distributor gear was drawn in the Solid Works program and the Ansys finite element program was used for the analysis. 0.75 mm mesh was implemented in the static analysis model (Fig.4). Distributor gear was mounted on the upper and lower sections and force was applied from the gear surfaces. Figure 4 presents the voltage distribution graph values on 52 points on a line of the sectioned form of the critical region.

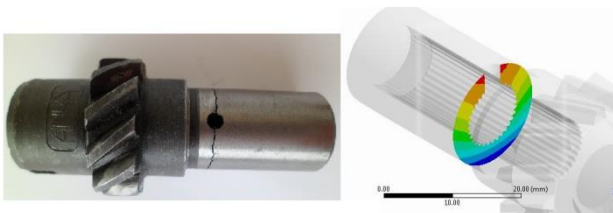
Fig. 5. Images of the distributor gear analysis result and of the damaged part

The results of the analysis showed that the maximum stress occurred on each side of the hole and that similar damage occurred in the part. The stress occurred in a straight line with the axis of the hole and the fractured part indicated that the fractured axis occurred similar to the analysis.

As shown in Figure 5, the lubrication hole was perpendicular to the axis of the gear material; therefore, it increased the stress concentration. When the local stress exceeds the material yield strength, it is possible to form a fatigue crack. The gear working thus is thought to cause the occurrence of a two-way crack in this area as a result of fatigue over time. Also, the graphite nodules near the hole zone acted as stress raisers, when the distributor gear is under torsion stress in service. It is thought that the crack propagation occurred in a bidirectional manner and the gear was not able to carry the load after a certain time, and after incurring fractures. As can also be seen in the finite element analysis, maximum stress occurred in both regions of the lubrication hole of the gear material and it was determined that the damage was caused by the design.
