Formation and Failure of Natural Dams in Uttarakhand Himalaya: An Observation from Lwarkha, Chamba Tahsil of Tehri Garhwal District, India

5. Case Study of Lwarkha, Chamba Tahsil of Tehri Garhwal district

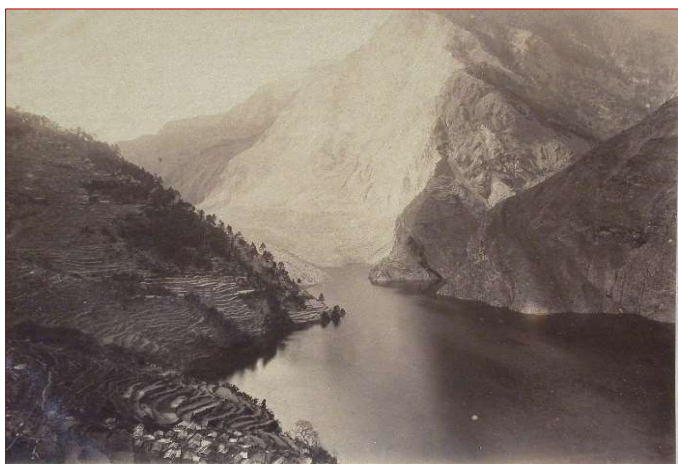
Fig. 2. Gohna Lake formation on Birahi Ganga due to rock fall/slide (courtesy: Internet)

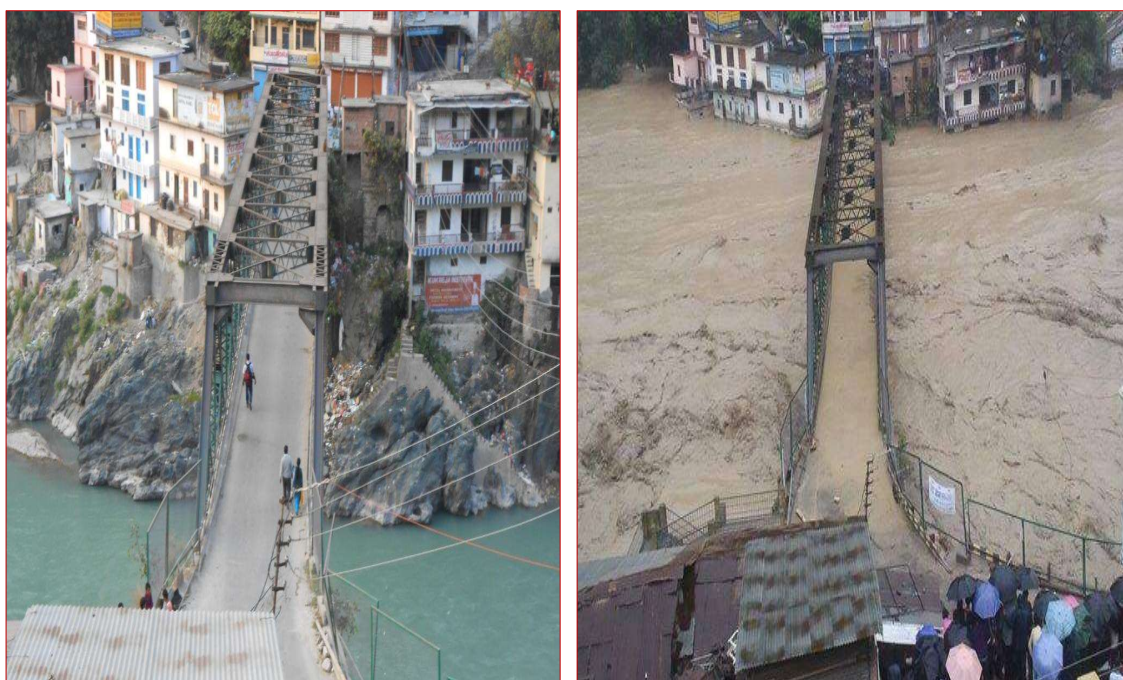
Fig. 3. Water level of Alaknanda River at Rudraprayag just upstream of its confluence with Mandakini River before (left) and after June 2013 floods (right)

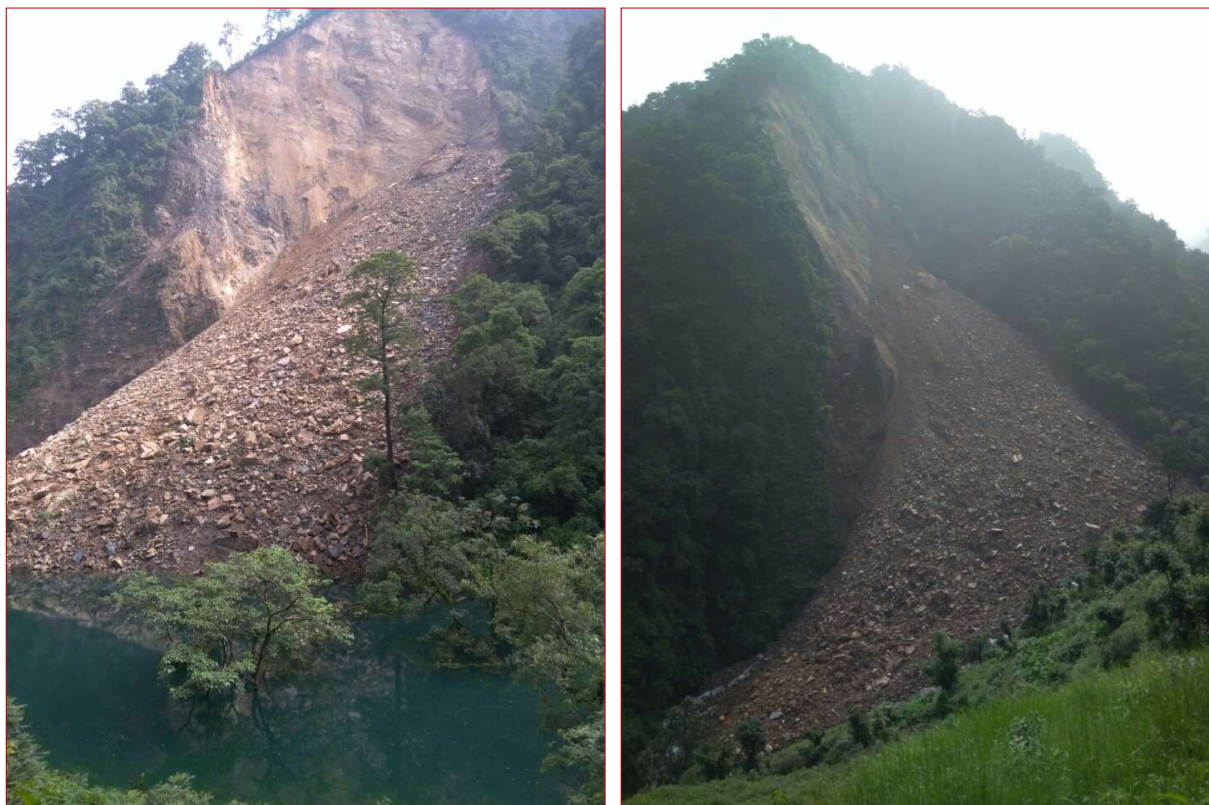
According to local people Mon Khala ridge landslide initiated in the morning hours of 13 August, 2018 around 10:00 AM. The same took place on the right bank of local stream that is tributary of Song River. Large volume of dislodged rock mass consequently got accumulated over the course of the stream and blocked the flow of water creating a lake about 150 meters long, 40 meters wide and 3 to 5 meters deep. The stream flow was reported to be completely stopped within about 6 to 7 hours. A number of cultivated fields together with a water mill were damaged by the same. The landslide dam posed threat to the downstream settlements that are located in the close proximity of the stream.

The slide was observed to have occurred on the southwestern slope of NW-SE trending Mon Khala ridge. The slide was observed to be located in the forest land and some of trees were observed to have been uprooted by the same. Fractured and jointed quartzites and shales were observed around the slide zone. The inclination of failed slope was observed to be 65° to 70° whereas in the crown portion it was observed to be almost sub-vertical to vertical. The width of the failure slope was about 110 meters along the stream and height of the slide from the stream bed to the crown was about 150 meters. The course of the stream was observed to have shifted around 10 to 15 meters towards the left bank due to landsliding. Downstream side flank of the slide at crown portion was also observed to be active and could also trigger in future.

The rock exposures of Lesser Himalayan quartzites/slates were observed along the footpath section on the left bank of the stream around 50 meters upstream to tok. The rocks were generally observed to trend NW– SE with gentle dips towards NE. The rocks were observed to be traversed by numerous joints. Important joint sets are observed to dip towards SE and SW (50° / 120° and 45° / 250°). Factors contributing to landslide in the area were deduced to include high relief, very steep slope and heavy precipitation together with highly jointed and medium to thinly bedded nature of quartzites and shales observed in the area. A number of seepages on mid slope of the slide and on the upstream side flank area highlight the role of precipitation in the landsliding.

Fig. 6. The lake formation by landslide dam (left) and downstream view of landslide (right) at Lwarkha in Chamba tehsil of Tehri district

Timli Sain tok of Lwarkha village is located amid cultivated lands and around 50 meters upslope from the stream bed on the left bank. The landslide therefore does not pose any threat to the tok/village. A number of cultivated fields located just downstream of the lake were however observed to be in a highly vulnerable state. It is therefore recommended that human presence in these fields be avoided, particularly
