The 2009 L'Aquila earthquake (Italy): Its characteristics and implications for earthquake science and earthquake engineering

¹Ömer AYDAN, ²Halil KUMSAR, ³Selçuk TOPRAK

ABSTRACT

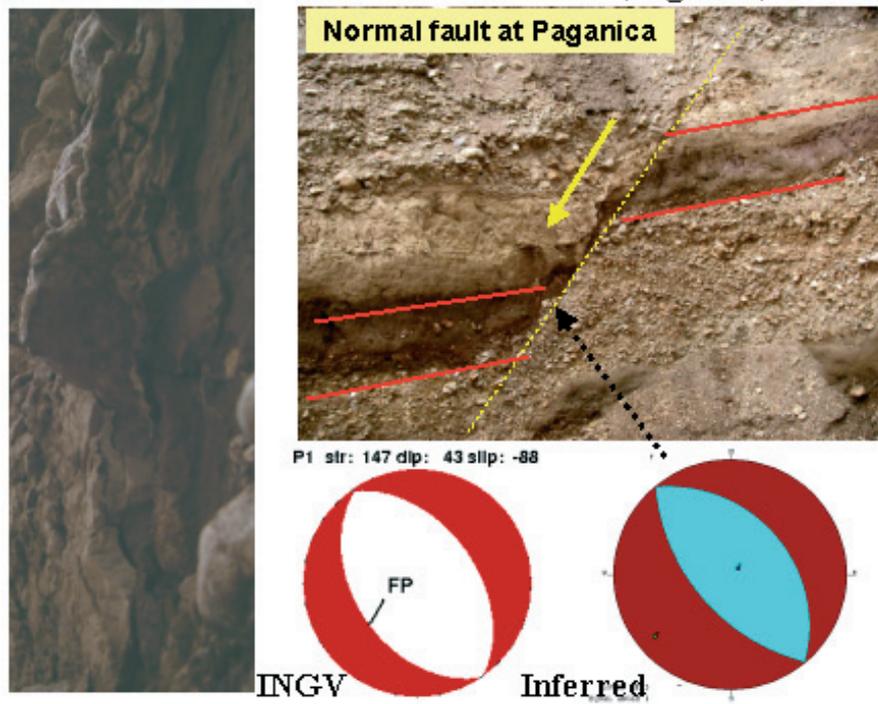
method. It was particularly interesting to note that the parameters of the active fault observed at Paganica were almost the same as those of the focal plane solutions estimated by several seismological institutes.

Figure 4. A very young fault in Paganica and comparison of inferred focal mechanism.
Şekil 4. Paganica'daki çok genç bir fay ve odak mekanizmasının karşılaştırılması.

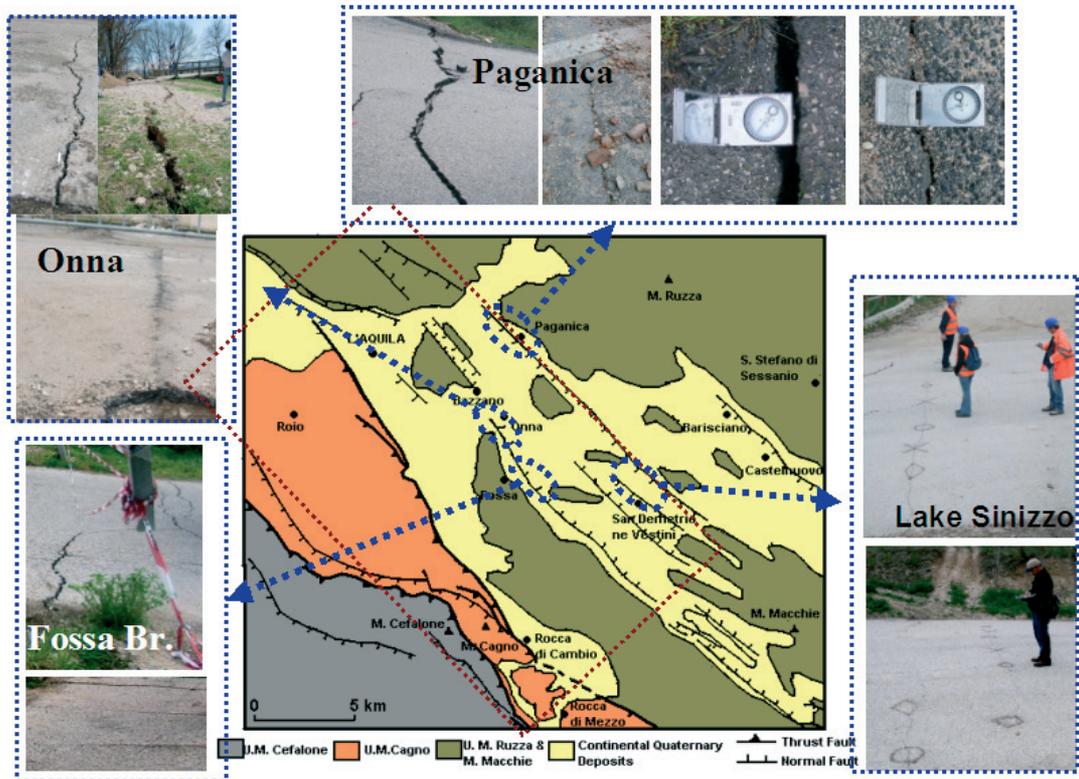
Surface ruptures were observed during the reconnaissance at the localities of Paganica, Lake Sinizzo, Onna and Fossa Bridge (Figure 5). Surface ruptures were also observed at three locations in Paganica town. Most fractures in Paganica indicated the opening of surface cracks with a normal displacement.

The authors observed cracks on the road to Lake Sinizzo, which is thought to be the southeastern end of the earthquake fault. There were also surface cracks in the vicinity of damaged or collapsed bridges on the Aterno River near Onna and Fossa.villages Some of the cracks were of a compressive type while most of them were of an extension type. As the permanent ground displacement inferred from the InSAR technique (INGV, 2009) concentrates along the Aterno River, the surface ruptures seen in these localities may also imply the extension of the L'Aquila basin in a NE-SW direction, (this is a graben structure) and that the Aterno River flows along a course at the lowest elevation of the basin. The INGV (2009) geological group also reported that surface fractures occurring at Paganica extended to the north of the A24 Motorway, which may imply that some surface ruptures might pass beneath the via-

Figure 5. Locations and pictures of surface ruptures.
Şekil 5. Yüzey kırıklarının yerleri ve görüntüleri.

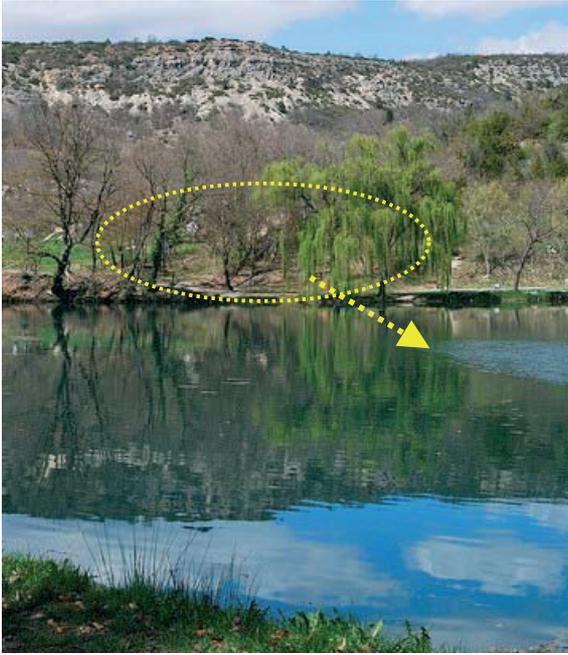
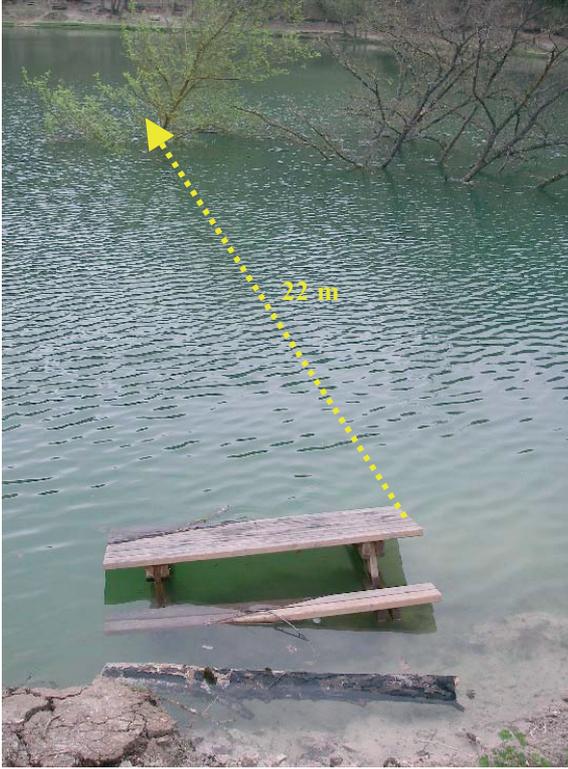
The Abruzzi region is karstic and many sinkholes and dolines exist in the epicentral area. Lake Sinizzo is a doline lake with embankment reinforcement on its northwest side. The lake is 9.8 m deep and it has an average diameter of 122.7 m (Bertini et al., 1989). Extensive ground failures took place around the shore of Lake Sinizzo (Figure 12). Although the surrounding ground is mainly calcareous conglomerate, the lakebed is composed of Holocene deposits.

Figure 12. Views of the ground failure before and after the earthquake.

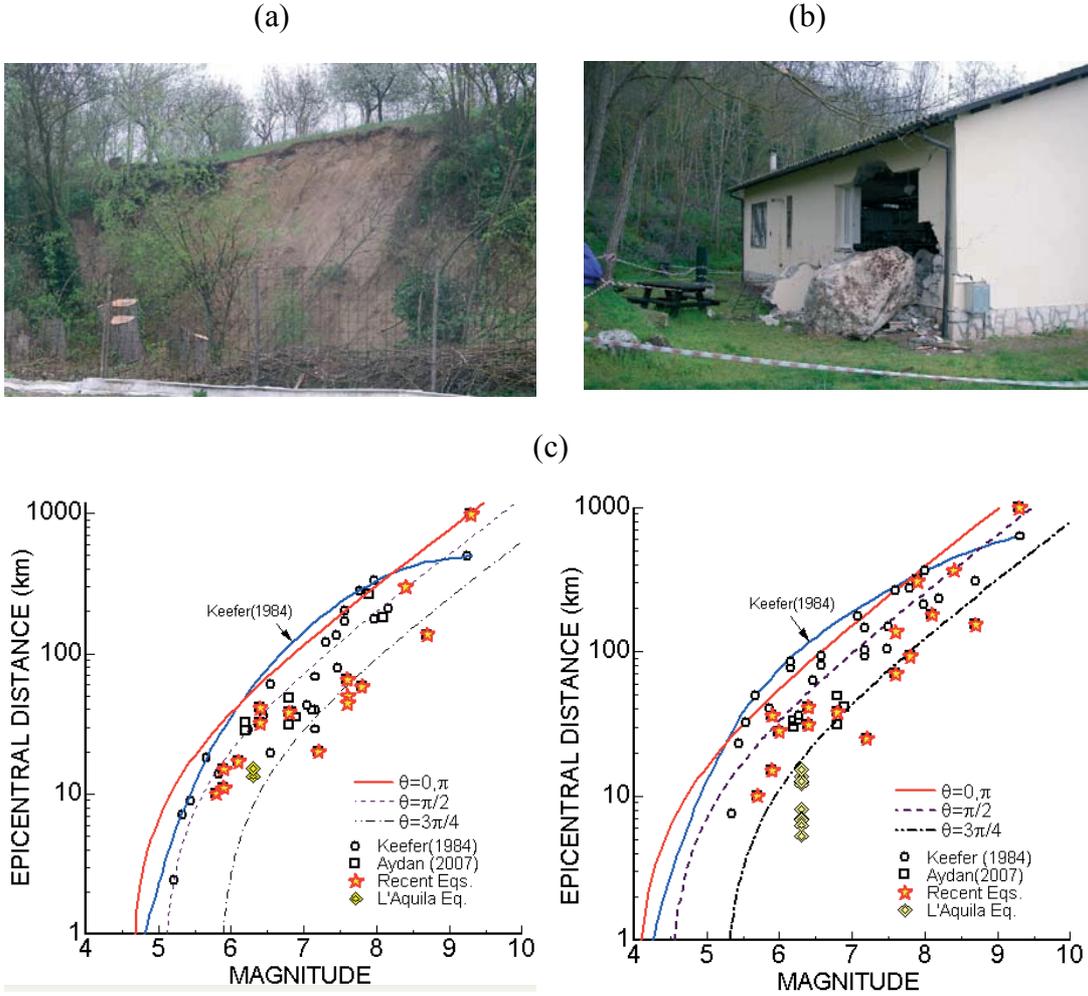
ved along the Aterno River's shores in mountainous areas such as in the vicinity of Campotosto. Figure 13a shows a soil slope failure along the Aterno River in the Martini District.

Rockfalls were observed in the areas where steep rock slopes and cliffs outcrop. Large scale rock falls were observed in the vicinity of Stiffe, San Demetrio and Lake Sinizzo, and Paganica (Figure 13b). Some of these rockfalls induced damage to structures. Nevertheless, the rock-

Figure 13. (a) Soil slope failure at Martini district, (b) rockfall at Stiffe, and (c) comparison of data of L'Aquila earthquake with empirical bounds (coherent slopes and disturbed slopes).

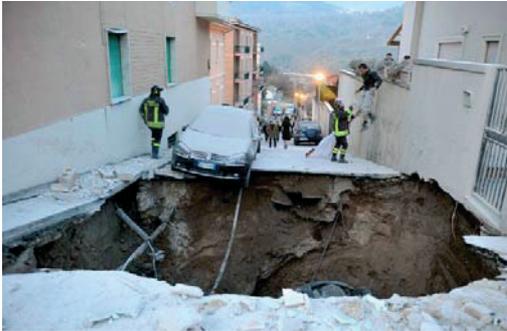
Figure 15. (a) A sinkhole in L'Aquila, and (b) liquefaction in Martini district.

Settlements and the sliding of ground and geotechnical structures occurred at numerous locations in the lowland areas along the Aterno River, and a number of slope failures and rock-falls occurred in the mountainous regions. Two sinkholes were formed in the old city of L'Aquila.

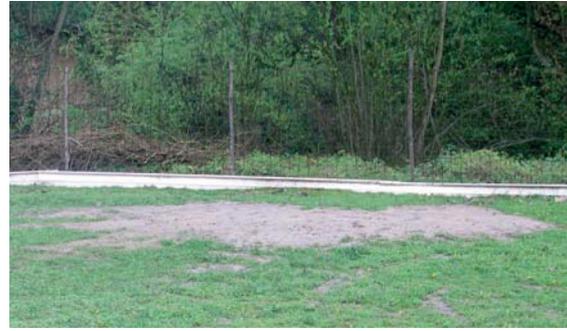
(b)

kely to have resulted in the locations of the meanders. In the Martini district, liquefaction created many NE-SW trending fractures parallel to the river embankment, as shown in Figure 15b. Sand boiling as thick as 150 mm was observed in various locations. The movement of ground was towards a SE direction. Boiled sand is almost homogenous and its grain size distribution falls within the easily-liquefiable bounds ac-

The ground liquefaction also induced lateral spreading. The sum of crack openings from the adjacent field towards the river embankment ranged between 250-350 mm. There were several depot-like structures and bridges for railways and roadways in the area where soil liquefaction was observed. However, there was

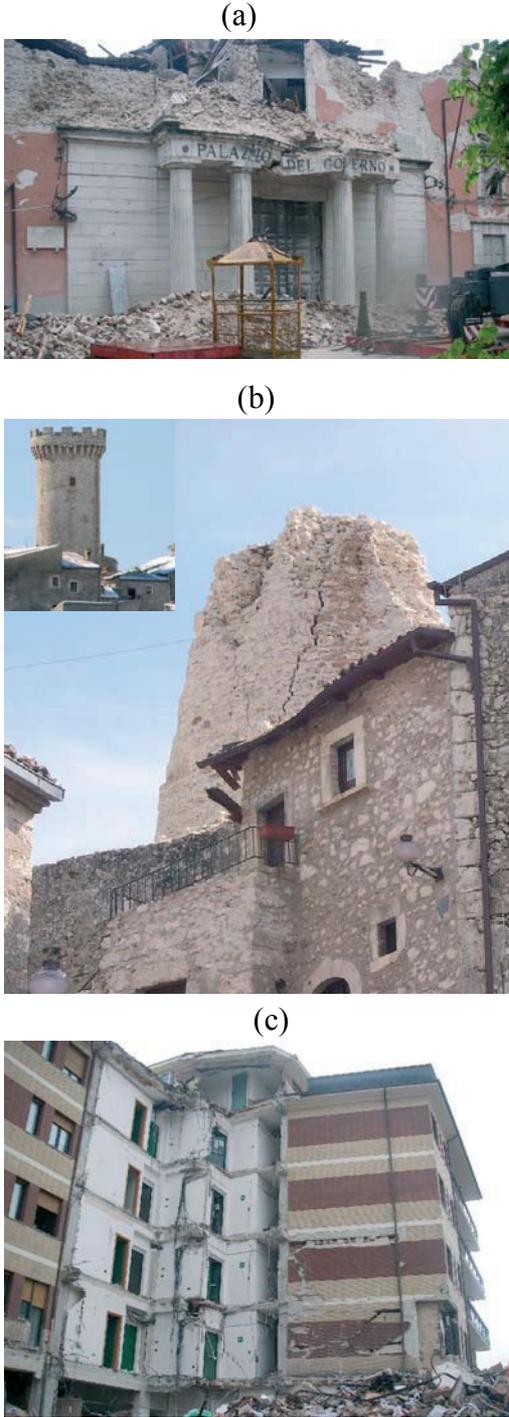
Masonry buildings can be grouped into two; specifically, residential buildings and cultural and historical masonry buildings (Figure 17a). Residential masonry buildings are generally two story buildings and in this area they were made of stone or brick, or a mixture of stone and brick. The mortar is mud or lime. Heavily damaged or collapsed buildings had almost no tie beams. Furthermore, the mortar of these buildings was mud. The main cause of the collapse or heavy damage to masonry buildings was out-of plane failure.

Cultural and historical buildings are of a larger scale and involve domes, towers and facades. The failure mechanism of these buildings is fundamentally quite similar to that of ordinary masonry buildings. The non-existence of tie beams make these buildings quite vulnerable to heavy damage or collapse. The dome of Santa Maria del Suffragio collapsed although wooden tie beams had been used. As the wooden tie beams were not continuous over the perimetry of the dome, the effect of the earthquake was disastrous. The masonry cylindrical tower at Stefano di Sessanio, which is about 20 km from the epicenter, had completely collapsed (Figure 17b). It was important to notice that another tower of almost same height and located at the foot of the same hill survived the earthquake. This may be related to a difference in the amplification characteristics of the top and the foot of the hill, as well as to the shape and shaking characteristics of the towers.

Figure 17. (a) An example of masonry building damage, (b) views of the tower of Stefano di Sessanio before and after the earthquake, and (c) an example of heavily damaged or collapsed reinforced concrete building.

Many reinforced concrete (RC) buildings had either collapsed or were heavily damaged by the earthquake (Figure 17c). The reasons for the heavy damage or collapse are similar to those found in Turkey (Aydan et al., 2000a, 2000b) and elsewhere. The possible reasons are poor workmanship, design and construction mistakes, resonance, lack of professional ethics, the soft floor effect and collision. It was interesting to note, in some of heavily damaged buildings, that unwashed sea sand had been used for concrete mixture even though this place is 90 km away from the sea.

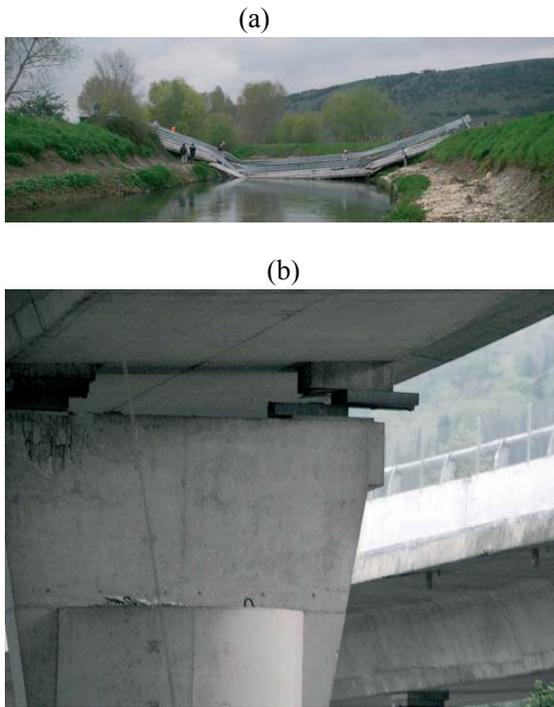
A 35 m long and 5 m wide, three-span, continuous reinforced concrete bridge had collapsed, as seen in Figure 18a. It was located at the crossing of SR261 to Fossa on the Aterno River. Four reinforced concrete columns with hexagonal sections had been broken at their column-slab connections, and had slid sideways and penetrated the deck slab. The columns had six 17 mm diameter smooth bars at each corner of the hexagonal section. 9 mm diameter smooth bars had also been used to fix the top of the columns to the reinforced concrete girders. The stir-ups were 6 mm in diameter at a spacing of 300 mm. The vertical downward motion might have played an important role in the failure of this bridge.

Figure 18. (a) A collapsed bridge, and (b) damage to A24 expressway.

anywhere (Figure 18b). The viaducts are simply supported PC box-girder bridges supported by reinforced concrete piers. They were supported by steel sliders and roller bearings or elastomeric bearings. The viaduct was displaced and there were gaps as large as 200 mm at numerous locations. A number of decks had drifted in the longitudinal and transverse directions. Some of these gaps were repaired by asphalt filling.

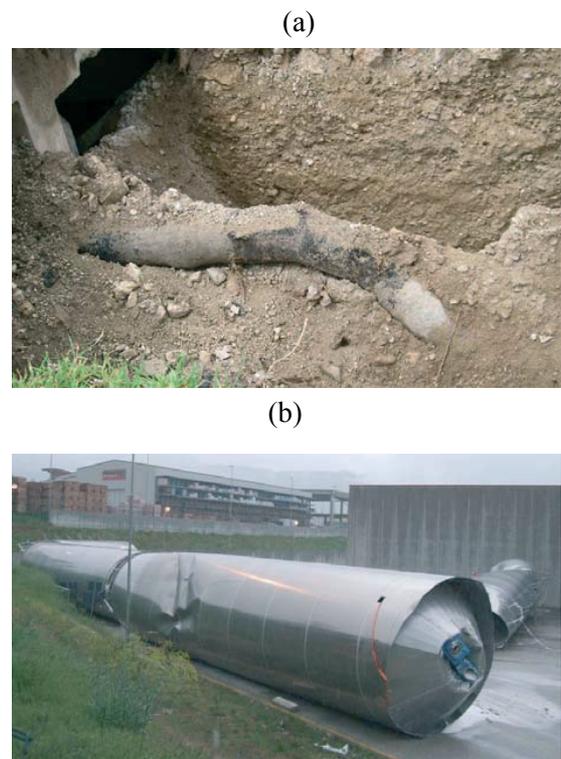
Figure 19. (a) A pipe damaged by permanent ground movement near Onna, and (b) view of a buckled silo.

induced lateral spreading. The authors observed damage to water pipes in Paganica and near Onna. (Figure 19a). The damage to water pipes in Paganica was caused by the combined effects of faulting and slope failure. Pipes were damaged due to the extensional movement of the surrounding medium. The damage to a pipe near Onna was caused by the movement of its surrounding ground towards the center of the bridge over the Aterno. The pipe was damaged on both sides of the river. Nevertheless, the movement was much larger on the eastern side of the bridge where the pipe was buckled.

There were two types of silos built at different times. The first one was a group of 8 silos founded on a common pile foundation and supported by a steel frame structure. The other group was 12 silos set in two rows on a cylindrical skirt resting on 1.2 m thick concrete slabs on pile foundations. The cylindrical skirt is fixed to the pile cap through anchor bolts. The silos were made of 6 mm thick aluminum plate. The silos that buckled were totally full during the earthquake, while those full to only 65% of their capacities did not collapse. During the earthquake, the buckled silos pounded into the adjacent warehouse. The damaged bottom skirts of the silos exhibited diamond-buckling modes.
