An analysis on the corrosion of a cultural heritage

Ömer Bozdoğan¹, Aydan Yaman^{*2}, Hacı Murat Yılmaz²

²Aksaray University, Engineering Faculty, Department of Geomatics Engineering, Aksaray, Turkey

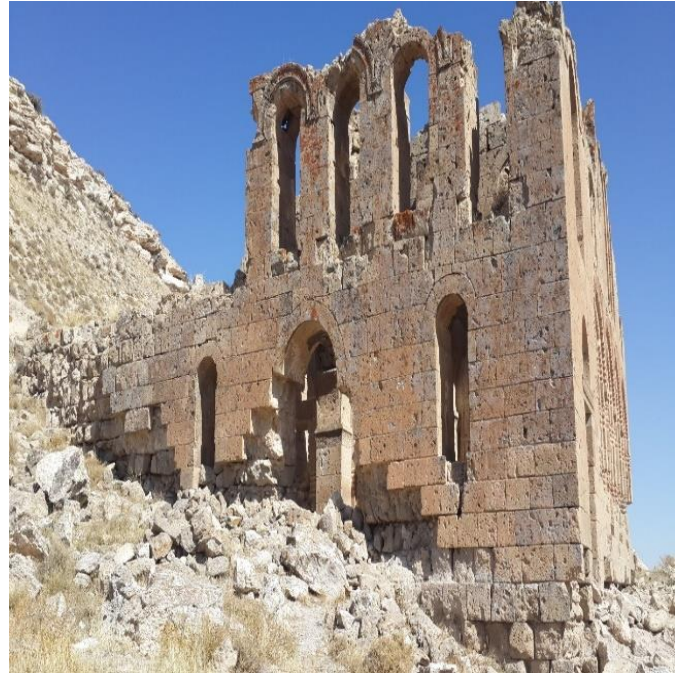
Figure 6. The situation of Çanlı Church in 2019

While Çanlı Church is famous for the mummies pulled from its ground, its environment is also known as a significant religious center. Çanlı Church is one of the perfect examples of Byzantine art. It is one of the places that remained intact in the region and reflect the Byzantine art in a best way. Çanlı Church and its environment are one of the most important areas that should be introduced into the tourism. However, it is still like a ruin. The area with various sized houses dating back to 10th-14th centuries and carved into the rocks in the church and its environment, look like a Byzantine town. However, since it has not been put under protection yet and it is far away from the centers and the church still gets the attention of the treasure hunters and thus the destruction is growing. The biggest lack in protection plan may be ignoring the buildings that are located at a far distance. Figure 2 represents a photograph of North-west facade of the church from a study conducted in 1981 (Yılmaz et al. 2007). According to this study, the state of the North-west facade for 2006 can be seen in Figure 3, for 2010 in Figure 4, for 2016 in Figure 5 and for 2019 in Figure 6. The east facade of the church was completely destroyed.

The bell, that the church was named after, could not be seen in the photograph, since it was stolen in ancient times. As seen in the picture, this historical building is

about to be destroyed due to the neglect. In addition to the local people looking for treasure, it is also thought that weather conditions have destroyed the structure.

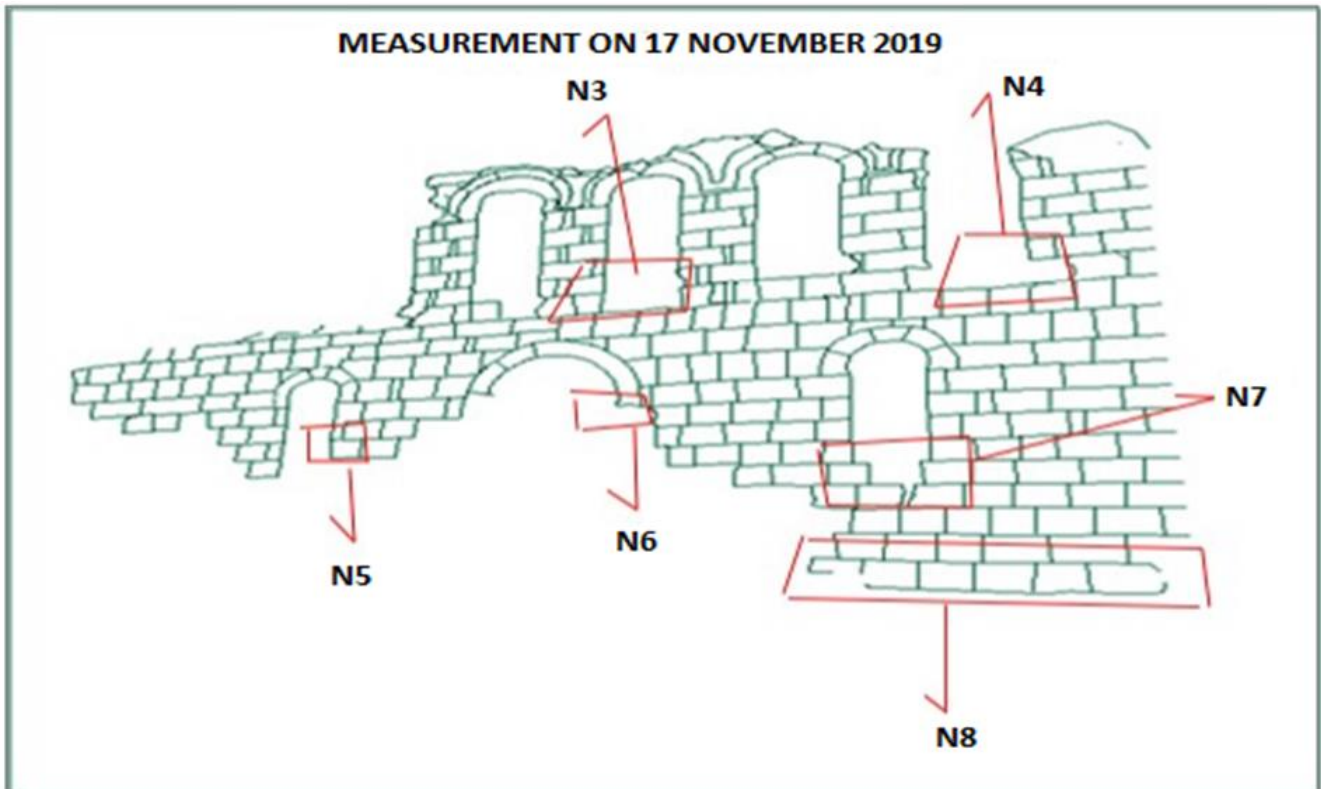
Figure 10. Measurement of Çanlı Church's north facade for 2019

On the north facade some corrosions indicated by N3, N4, N5, N6, N7 and N8 were found (Figure 10). On West facade the stones in the areas indicated by arrow marks W1, W2, W3, W4, W5 and W6 fell (Figure 12).

the corrosion in the church was associated with the data of meteorological events occurred between the dates. On the North facade of the church 6 serious corrosion have been found. It has been seen that the stones fell in three areas on the west facade. On the south facade one serious corrosion has been seen and stone aggregates fell in one place. The corrosion values are seen on Table 1.

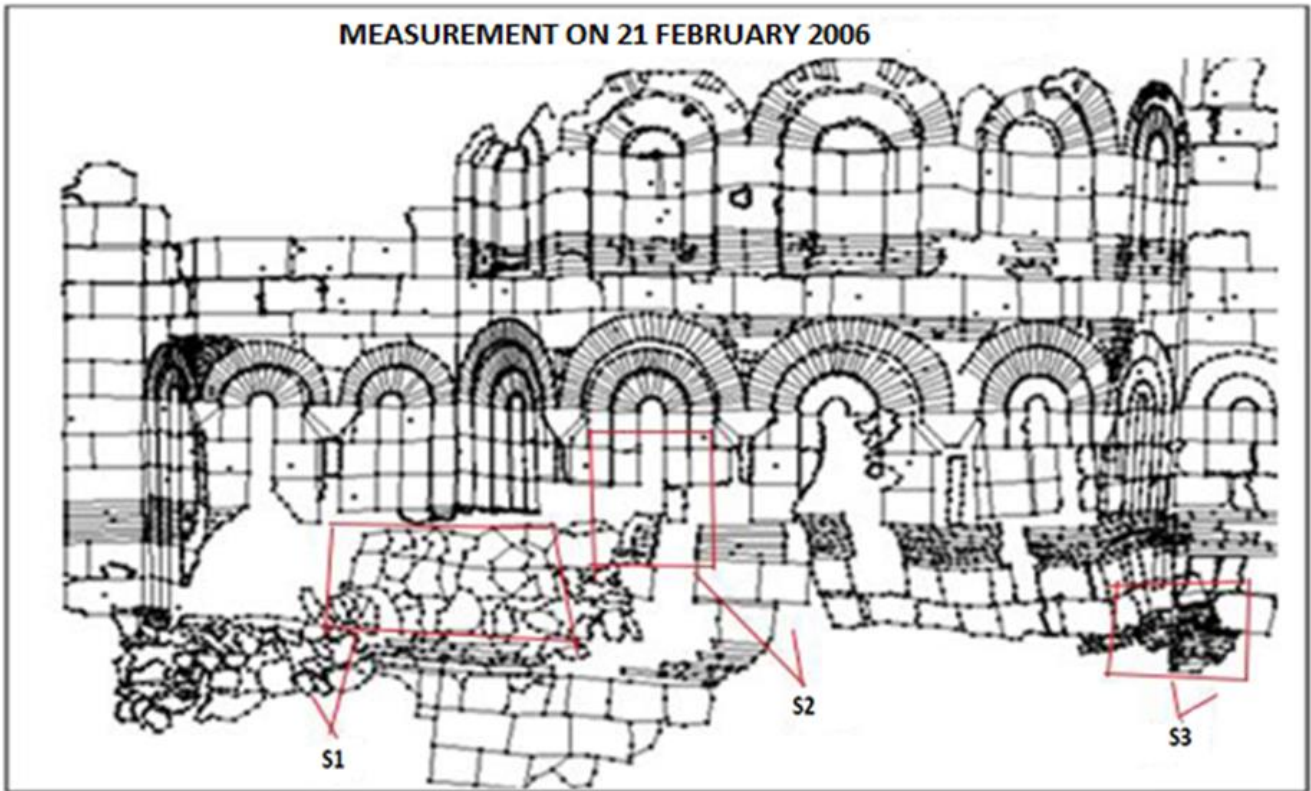
Figure 15. Measurement of Çanlı Church's south facade for 2006 (Bozdoğan & Yılmaz 2019)

A serious deformation is seen in the parts indicated by S4 on the south facade and stone aggregates fell in the part numbered S5. In comparison with the 2006 measurement indicated by S1, S2 and S3, it was found that the stones fell (Figure 15).

When Table 1 was examined, the north facade area was calculated as 4.251.891,00 m², the west facade area was 3.860.913,00 m² and the south facade area was 7.629.097,00 m², in the studies conducted in 2006 and in comparison, with the areas in 2019, it is seen that the highest corrosion is on the South facade with 13%.

When the meteorological data is examined, it is seen that the year 2009 is the stormiest time in the last ten years. It is thought that the corrosion occurred in the church was mostly caused by storm. The storm generally occurred in the north-south direction. That is the why the most eroded facade in the church is the south facade. The falling parts have been toppled towards the inside.

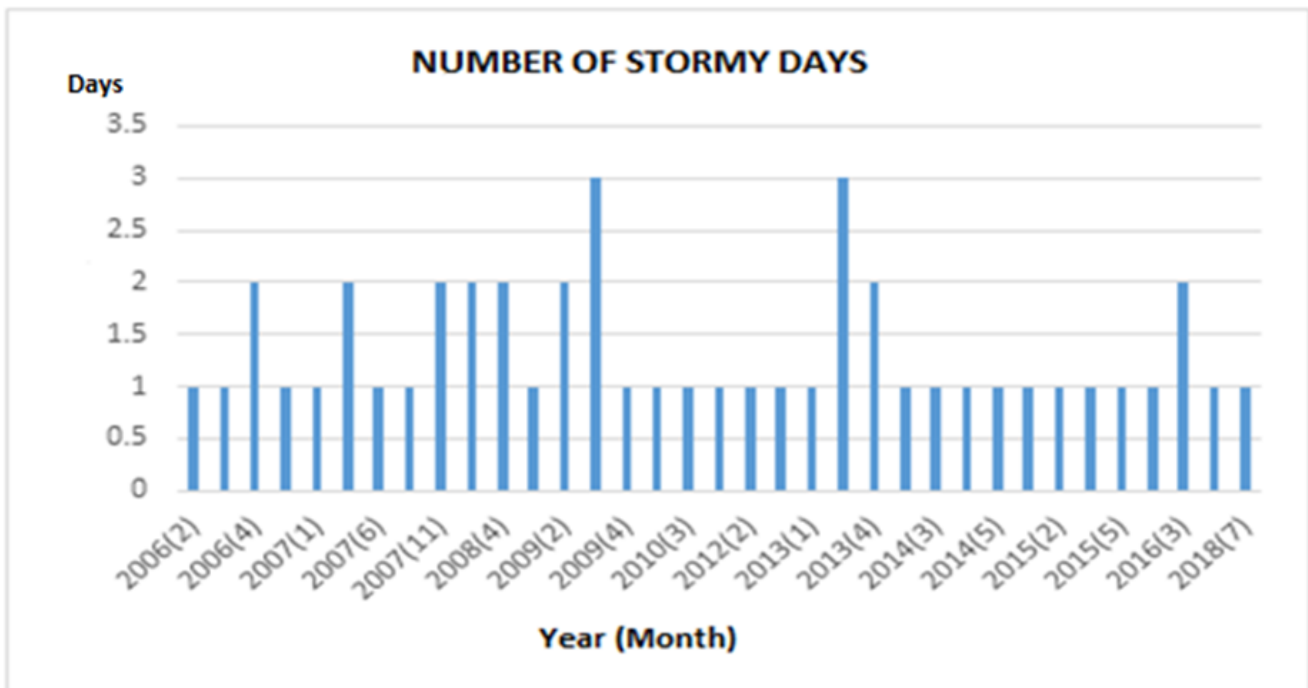
Figure 22. Monthly number of stormy days

When the monthly number of stormy days examined, it was seen that the storm was at highest

level in March 2009 and in March 2013 and that it lasted 3 days. After the 7th month of 2018 no storm has been seen (Figure 22).
