İSTANBUL ÜNİVERSİTESİ
ORMAN FAKÜLTESİ
D E R G İ S İ

Analysis of Pavement Construction on a Sample Forest Road Section in Sarıyer Region

Tolga Öztürk^{1*}, Necmettin Şentürk¹

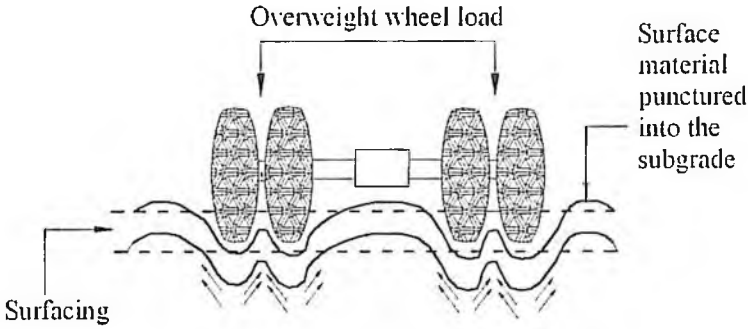
Figure 1. Shear failure of a road surface because of overweight wheel load
Şekil 1. Tekerlek yükü altında yol yüzeyinin biçim değişiklikleri
(Keller and Sherar, 2003)

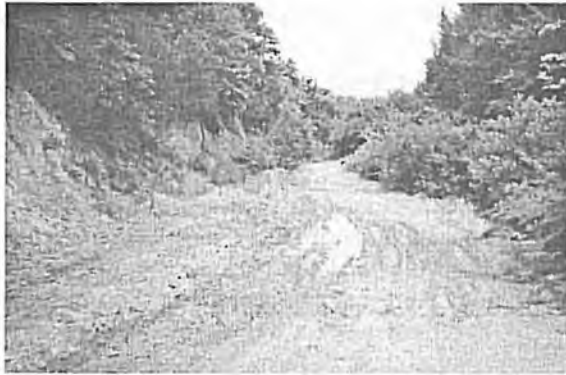
The observations of the sample road prior to the pavement activity indicated that ditches were filled and some parts of the road surface were deformed. Based on the field investigation, no passage could be provided, due to excessive deformation on some parts of the road. The further investigation indicated that damages have occurred on head wall parts of drainage structures and on culvert aprons (Figure 3).

Figure 3. The conditions of 02 code forest road, ditch, and roadbed prior to pavement activities (Photo: T.Ozturk)

First, the deformation on Type B forest road and the general condition was examined and photographed. It was observed that almost all road pavements were in poor condition, filled with eroded soil, siltation, trees, trunks, and branch residues. It was also inspected that some of them were broken and eroded partially. On the other hand, it was seen that beneath the head and sideways of some culverts have been eroded.

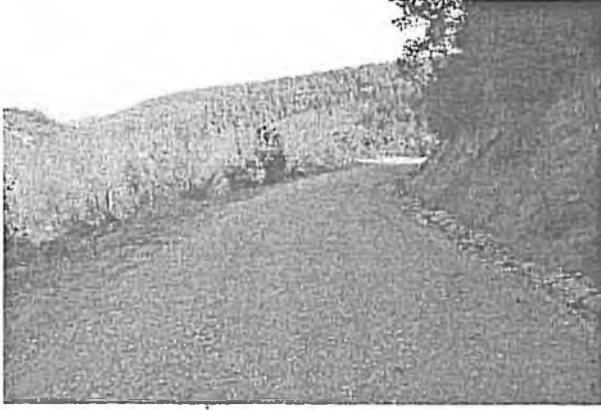
Figure 5. A view from the forest road after pavement activity (Photo: T.Ozturk)
Şekil 5. Üstyapı çalışmasından sonra orman yolundan bir görünüş

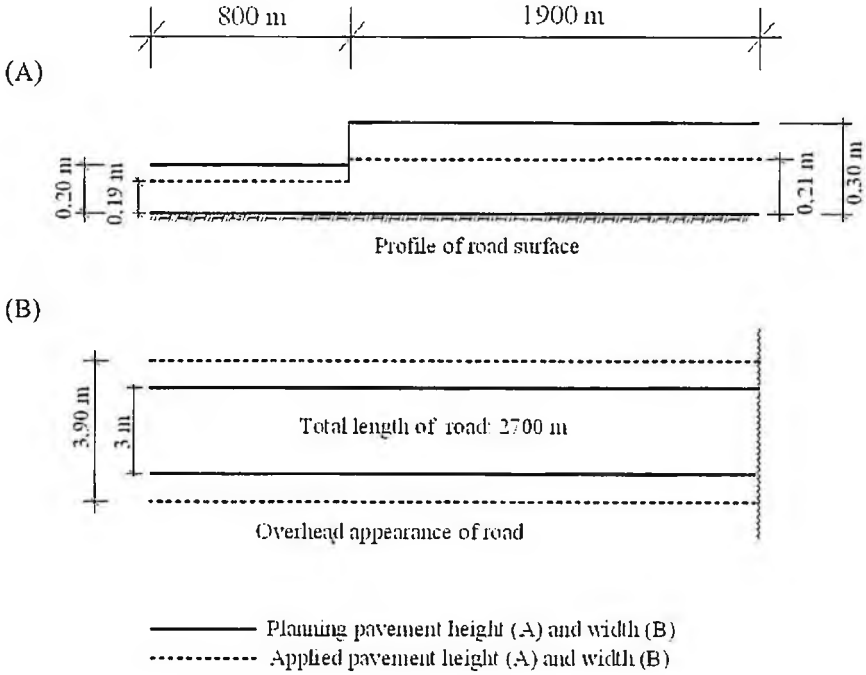
After completing pavement activity, the width of scattered materials was measured as 3.90 meters as an average for the first 1000 meters of the road, while it was measured 3.80 meters as an average for the rest of the road (Figure 6). The reason for such a difference is because of using loader when scattering the materials, instead of grader. Simply, loader cannot scatter the materials evenly and homogenously, therefore, the material thickness became different in different parts of the road. In contrast, grader may take the overflowed materials back to the middle of the road and scatters the materials more homogenous than that of loader.

The quantity of the materials used for pavement, including crossfields, was calculated as 2310 m³. The planned material thickness was similar to the thickness of the pavement material used in the application. The reason for that the material scattering width was wider than 3 meters (3.80 m and 3.90 m).

Figure 6. Thickness and width of planned and applied pavement materials
 Şekil 6. Planlanan ve uygulanan üstyapı kalınlığı ve genişliği

During pavement work, the recommended spreading width of the material should be complied. The material that spread wider than it was necessary flows to ditches or downwards from the fill slope and lost. As a result, the material thickness will be lower and more material will be wasted. The materials should be spread on the road by a bulldozer. Bulldozer can distribute the material on the road homogeneously and can better adjust the thickness of the spread material.

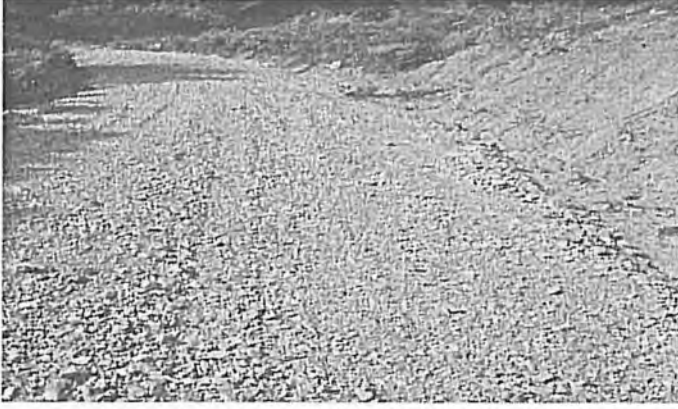
In the last part of the pavement, scattered material was tightened by a road roller. Due to insufficiently tightening and unevenly distributing the materials, the materials have been scattered throughout the road after passing a winter season (Figure 7). On the other hand, since the side ditches could not be opened enough when locating pavement, the ditches could not function well and the materials have caused damage to the surface of the road, following winter and spring rainfalls. Suitable materials have been used for pavement, which means that, in the swamps, large materials were used, whereas, in the regular road structure, small materials were preferred. In Table 3, the results from the sieve analyses of pavement materials were listed, considering thick, normal, and thin materials.

Figure 7. The condition of a part of paved road – one year later (Photo: T.Ozturk)
Şekil 7. Bir yıl sonra üstyapı yapılmış yolun bir bölümünün durumu

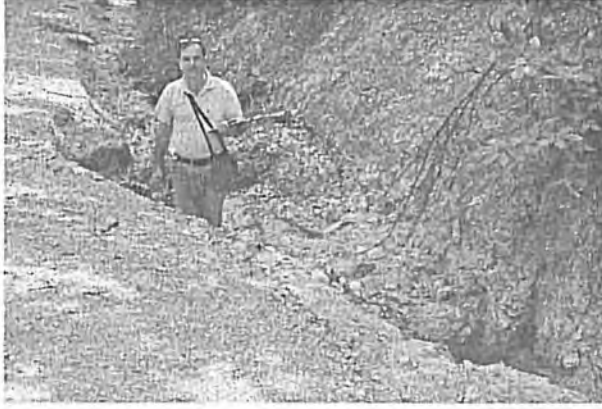
During the road construction work, culverts and concert pipes were needed within nine different points of the forest road with 02 code. Then, it was contemplated that this problem was solved by constructing culverts and concert pipes in a particular size. Due to constructing insufficient number of culverts and concert pipes in necessary places, water from rainfall and cut slopes have been accumulated in side ditches and could not be transferred across the road, and thus, the road and its coat were always left humid and damped.

As a result, when heavy vehicles and trucks were driven, the road has been seriously deformed and damaged. On the other hand, the scattered materials were sunk into the ground and could not function well.

The trees, trunks, soil, and other materials were filled in the entrance and exit of the culverts and concert pipes, and blocking overflow were cleared by a small excavator. Therefore, the constructions have been functioned again. Then, throughout the road, it was investigated that parts of the some culverts and concert pipes were broken and dropped into the creeks. As a solution, it was recommended that the structures should be repaired and their maintenance work should be carried out regularly. Deformation at ditches and lost of pavement materials are showed in Figure 8.

Figure 8. Deformation at ditches and lost of pavement materials (Photo: T.Ozturk)
Şekil 8. Üstyapı materyalinin kaybı ve hendeklerdeki deformasyon

One of the most important matters that should be noted is that the pavement material that flows to ditches or road sides should not be taken from the area that exists and should not be re-used as mixed with soil. Pavement material mixed with forest soil can reduce the resistance of road surface. The other important task in a pavement activity of a forest road is opening the ditches and performing the maintenance of the ditches. Lacking or closing of the ditches along the road sides enables the rain water frequently moves on the road that damages the road and the pavement material. Besides, bevel should be banked on both sides of road axis on flat places, and the material should be spread in pavement activity by considering these bevels.
