Investigation of structural problems on the ground and walls of Diyarbakir Historical Behram Pasha Mosque by the georadar (GPR) method

Diyarbakir, Behram Pasha Mosque,
Georadar(GPR), structural problem

ABSTRACT

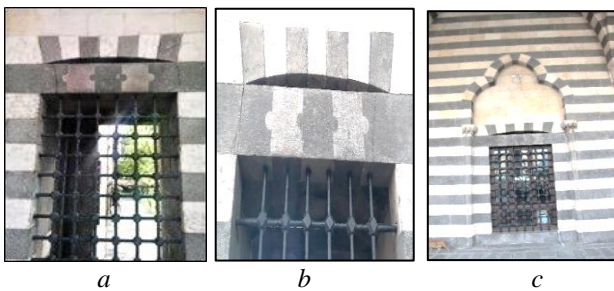
Behram Pasha Mosque occupies an important place in Diyarbakır thanks to its plan layout, construction technique, and original stonework and decorations. The mosque has undergone many repairs in the past. However, no extensive restoration has been carried out in the mosque recently. For this reason, some structural problems have occurred in the building over time. An observational field study was conducted to determine the existing structural problems in the mosque. During the fieldwork, partial cracks were detected on the northern façade of the mosque and the lintels of the minaret entrance door and window on the southern façade, as shown in Figure 13 a, b, c. Vertical cracks and partial level irregularities in the mosque cause to think possible settlements due to the ground.

Figure 13. Cracks in the lintels of the Behram Pasha Mosque (2021)

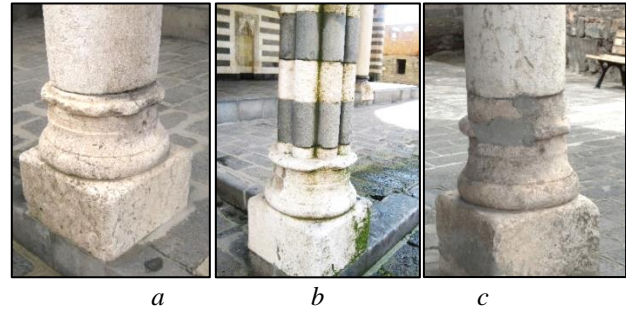
In the harim, partial material losses occurred on the windowsills and outer surfaces of the niches defined as the iwan. There are also mortar losses on the southern and western façades of the mosque. There is a loss of material in the lower and upper column headings of the portico. Due to the absence of tension rings on the columns, partial slidings occurred between the column base and the sub-headings. Temporary solutions were made by filling the

Figure 14. Material loss in columns and partial axle slip damage (2021)

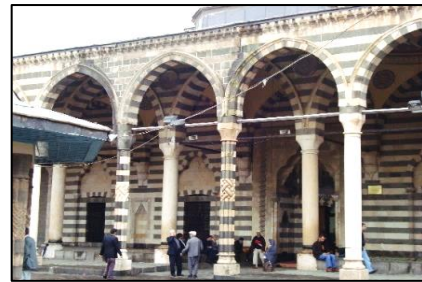
Mortar losses and contaminations have occurred on the façade due to external conditions. Especially, on the southern and western façades that were exposed to the sun, discharges depending on mortar losses and separations on the wall have occurred. There are darkening and partial stone deterioration and moss on the façade surfaces where pollution is intense, as demonstrated in Figure 15.

Figure 15. Weathering damages and contamination on façades (2021)

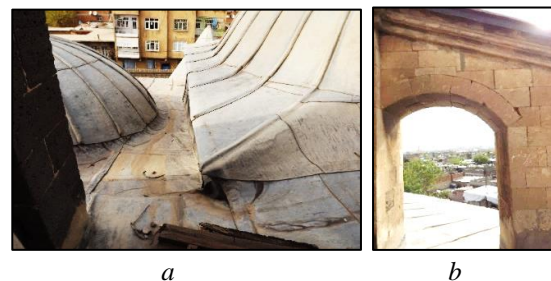
Some of the lead plates in the domes have been corroded over time due to the effects of external conditions, and openings have occurred between some of the lead plates, as can be seen in Figure 16. There are mortar losses between the stones on the flying buttresses made of limestone in the dome. In addition, there are material losses and deterioration due to pollution in the balcony section of the minaret, as shown in Figure 16 a and b.

Figure 16. Openings between lead plates and segregation damages in buttresses (2021)

- Mosque domes should be replaced with new ones due to corrosion of the existing tension rods in order to prevent the opening of the arches.

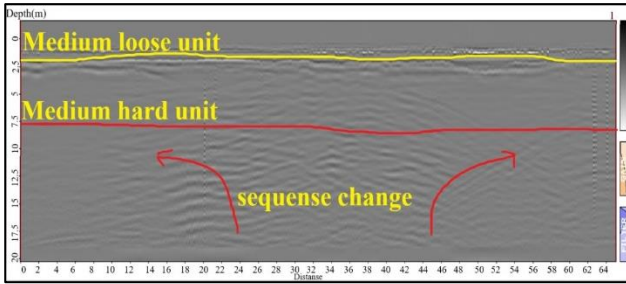
Figure 19. Radargram section of the ground of location 1

70 m profile length and 20 m depth of research were selected in the ground survey carried out in the southeast part of Behram Pasha Mosque, GPR 1 (1). According to the obtained radargram sections, two different levels of the medium, one is loose unit lying from the ground to 2.5 m depth and the other one is hard unit starting from 2.5 m and ending at the 10.00 m depth, were detected in the scanned area. No deformation was detected in this section (Figure 19).

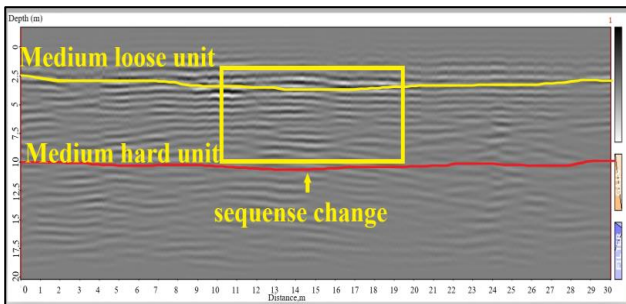
Figure 20. Radargram section of the ground of location 2

A profile length of 30 m and a surveying depth of 20 m was designated at the southwest of the mosque, location number 2. According to the obtained radargram sections, two different levels of the medium, one is loose unit lying from the ground to 2.5 m depth and the other one is hard unit starting from 2.5 m and ending at the 10.00 m depth, were detected in the scanned area. In this region, subsidence deformations between 2.5 m and 6.00 m were detected. It was determined that there are stack changes between 6.00 m and 9.00 m (Figure 20).

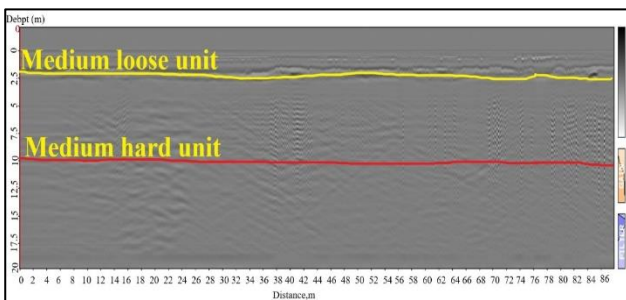
Figure 21. Radargram section of the ground of location 3

In the harim of the mosque, namely location number 3, no deformation was detected except for the changes in the stack (Figure 21).

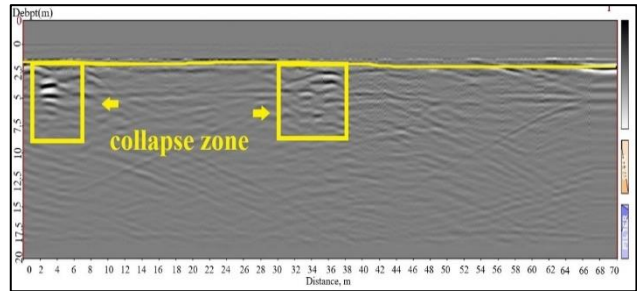
Figure 22. Radargram section of the ground of location 4

In the scans made in the direction of the entrance door of the harim and mihrab, in other words at location number 4, two collapsed deformations were observed. It was

determined that the first collapse is between 1.00 m and 4.00 m, and the second collapse is between 1.00 m and 6.00 m (Figure 22).

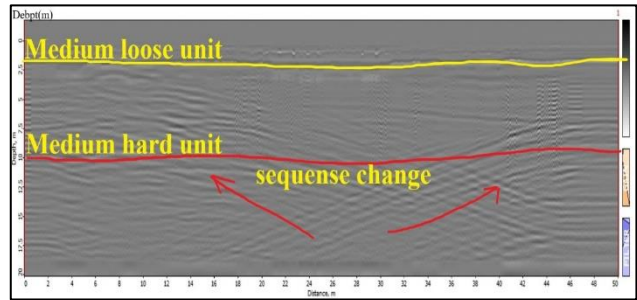
Figure 23. Radargram section of the ground of location 5

According to the obtained radargram sections, two different levels of the medium, medium-loose unit between 0 and 2.5 m depth and medium-hard unit between 2.5 m and 10.00 m depth, were detected in the scanned area. In this part of the mosque, no deformation was observed except for the changes in the stack (Figure 23).

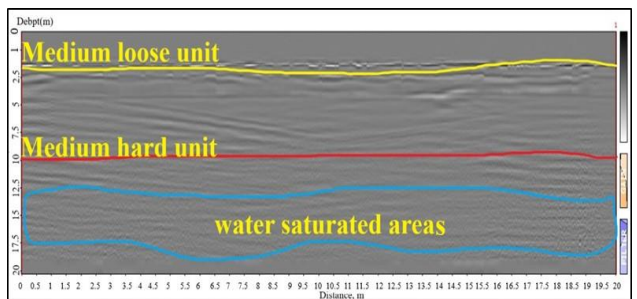
Figure 24. Radargram section of the ground of location 6

In the scans made under the mahfil on the northern façade of the mosque’s harim, a medium-loose unit up to 2.50 m and a medium-hard unit between 2.50-10.00 m were identified.

According to the radargram sections and velocity analyzes obtained, it was determined that there was a dense water structure after 12.50 m. Partial collapse deformations are thought to occur in areas where water is concentrated (Figure 24).

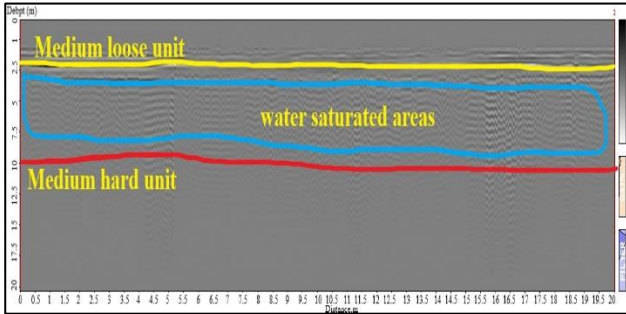
Figure 25. Radargram section of the ground of location 7

In the GPR surveys made in the northeast direction of the first portico, it was determined that the ground was medium-loose unit up to 2.5 m and medium-hard unit differentiation between 2.50 m and 10.00 m. Intense water-saturated areas were detected in the 1.00-5.00 m range of the scanned area. There are partial collapses in these areas (Figure 25).

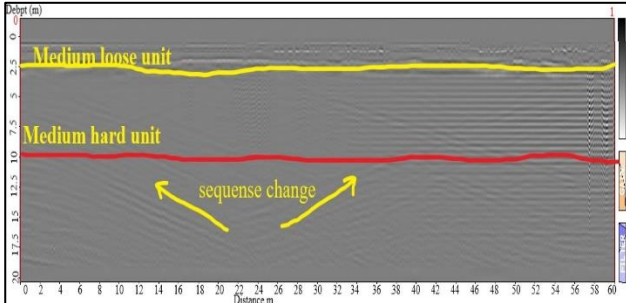
Figure 26. Radargram section of the ground of location 8

In the scans made in the northwest of the first portico of the mosque, it was observed that there is a medium-loose unit up to 2.5 m and a medium-hard unit in the range of 2.50-10.00 m. In this part of the portico, it has been determined by radargram sections that there is no deformation except for the stack changes (Figure 26).

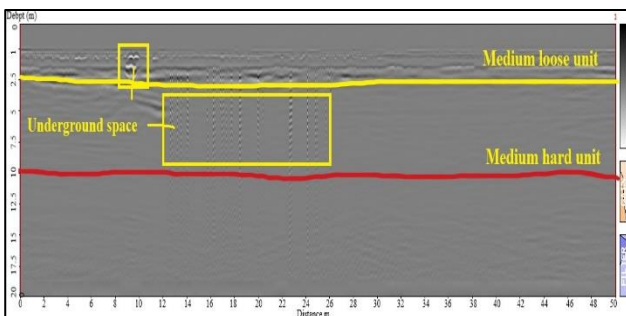
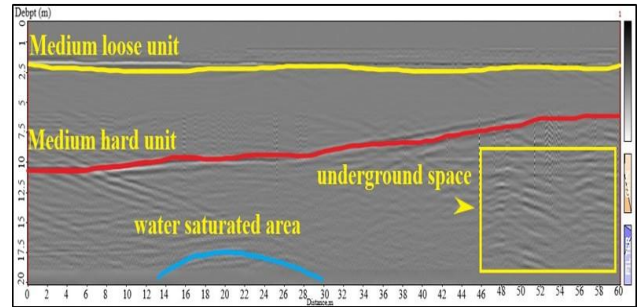
Figure 27. Radargram section of the ground of location 9

GPR scans made in the second portico of the mosque revealed a gap of 2 m in diameter at a depth of 1 m between the depth of 1 m and 8.00-10.00 m (Figure 27).

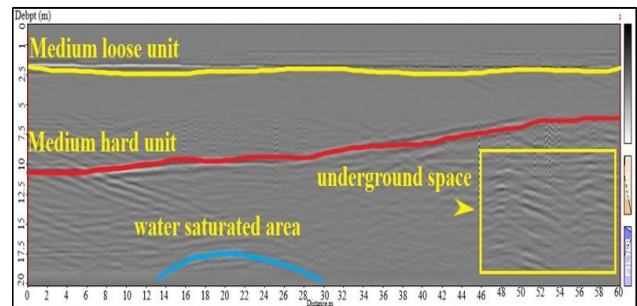
Figure 28. Radargram section of the ground of location 10

In the georadar scans made in the courtyard of the Behram Pasha Mosque, a 90-m profile length and a research depth of 20.00 m were selected. It has been determined that there are a medium-loose unit up to 2.50 m, a medium-hard unit between 2.50-11.00 m, and three different levels where firmness increases. It has been determined in the radargram sections that there are two void structures and flooded areas on the courtyard floor after 18.00 m. It is thought that the parts that receive water originate from the fountain in the courtyard (Figure 28).

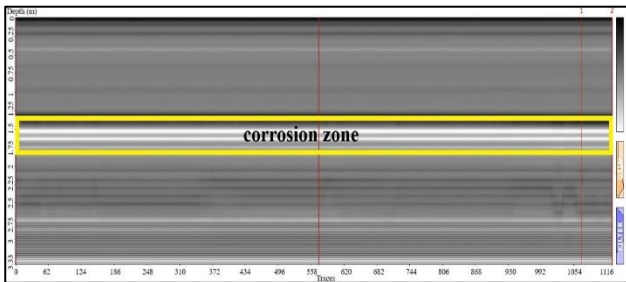
Figure 30. Radargram section of the wall of location 1

In the radargram sections obtained as a result of the scans made on the southeast walls of the harim and mihrab, no deformation was observed at the inner wall till a depth of 1.25 m. However, after a depth of 1.25 m, a corrosion structure caused by water leaks was determined (Figure 30).

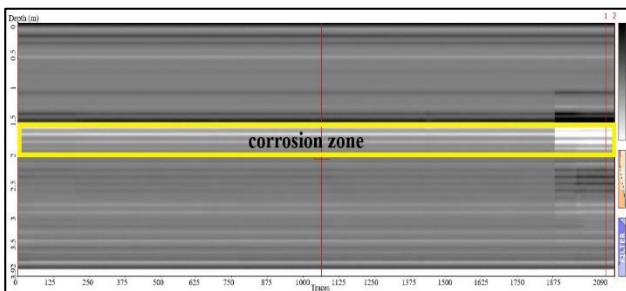
Figure 31. Radargram section of the wall of location 2

According to the radargram sections obtained as a result of the scans made on the southwest wall of the harim, it was determined that there were deformations due to corrosion after 1.50 m from the inner wall to the outside (Figure 31).

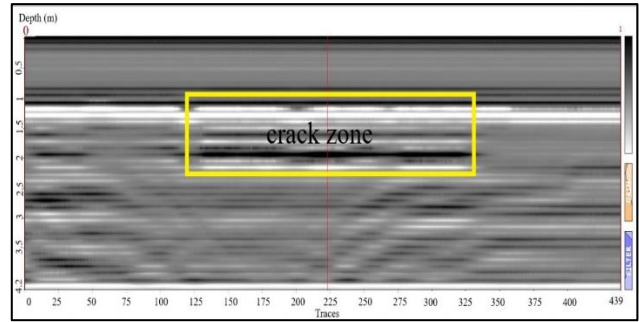
Figure 32. Radargram section of the wall of location 3

In the radargram sections obtained after scanning on the wall in the northwest direction of the harim, it was determined that there were cracks and fracture deformations after 1.00 m of the wall. There are also cracks in the lintels on the outer parts of these walls (Figure 32).

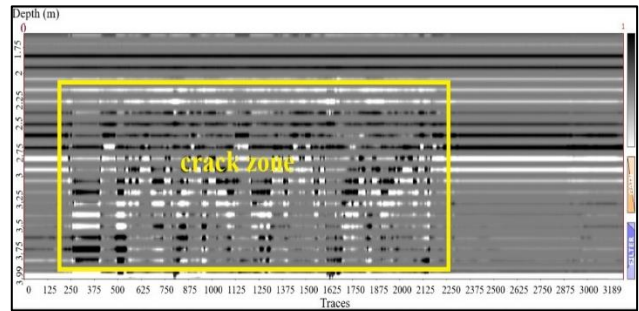
Figure 33. Radargram section of the wall of location 4

Numerous cracks and fracture deformations were detected after 2.50 m in the radargram section obtained as a result of the scans made on the entrance door of the harim and the northeastern wall. It is thought that these deformations will increase the structural problems in the mosque over time (Figure 33).

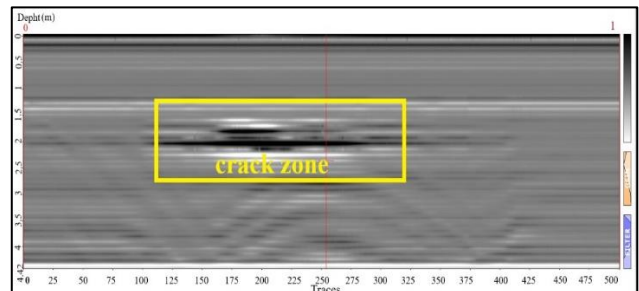
Figure 34. Radargram section of the wall of location 5

It has been determined that there is 1 crack deformation at a depth of 2.00 m in the radargram sections obtained as a result of the scans made on the eastern wall of the harim (Figure 34).

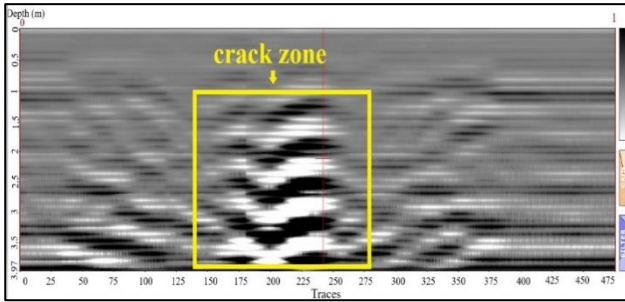
Figure 35. Radargram section of the wall of location 6

GPR scans were made on the northern wall including the entrance to the harim. In the radargram sections, broken deformations were detected on the walls in both directions of the entrance door with a size of 7 cm at 2-m depth (Figure 35).
