Solution Proposals for Fires Occuring in the Laminatoin Units of Inline Lamination Machines

Hasan Uğur ÖNCEL¹

, Emre RESULOĞLU²

¹TC İstanbul Gedik Üniversitesi, Sağlık Bilimleri Fakültesi, 34906, İstanbul, Türkiye
²TC İstanbul Gedik Üniversitesi, Lisansüstü Eğitim Enstitüsü, 34906, İstanbul, Türkiye

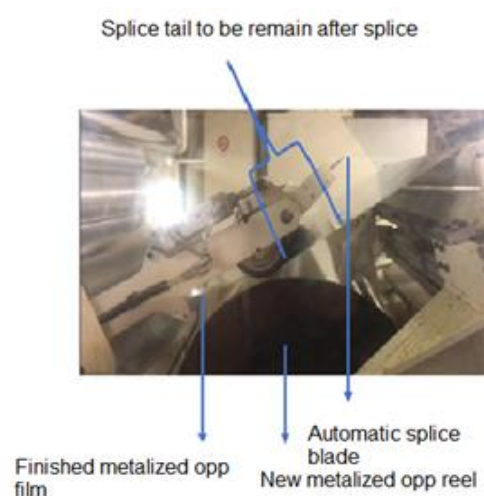
Figure 1. Automatic splicing unit

At a machine speed of 250 metres/minute, the splice tail reaches the lamination unit approximately 5 seconds after the automatic splice takes place. For reasons of food safety, the metallized surface of the metallized OPP should not come into contact with the food product, therefore the metallized surface is the one making with contact the adhesive cylinder to be coated with solvent-based adhesive before entering the drying tunnel. Fires were observed to occur synchronously with the entrance of the splice tail into the tunnel.

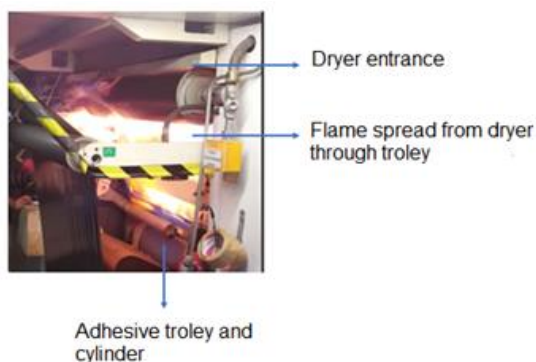
Following the fire, the film breaks; the machine then detects the loss of tension in the film via a load cell and automatically stops. With the machine stopped, the fire in the tunnel itself ends but continues to propagate onto the adhesive trolley.

Figure 2. Fire incident experienced

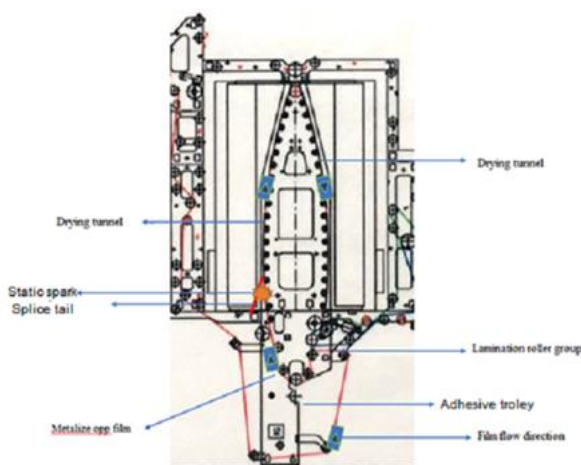
After drying, the metallized OPP film (with dried but still tacky adhesive) and the printed OPP film are brought into contact in the lamination roller group located in the second drying tunnel of the 11th unit. No flames were observed at any time in the second drying tunnel.

Figure 3. Lamination unit with fire

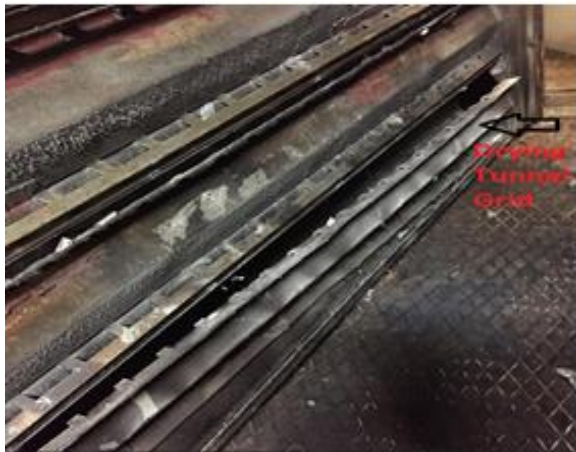
An ethyl acetate-air mixture at this concentration and temperature has an ignition energy of 0.46 mJ. If it encounters an energy source above this level it can easily be ignited. During the investigation of fire cases, the damage detected in the grate where the blowing nozzles at the entrance of the tunnel and the carbonization on its surface are proof that the flames started at the bottom of the tunnel [3] [4] [5] [6].

Figure 4. Damage and darkening of the dryer tunnel sub-grids after fire.

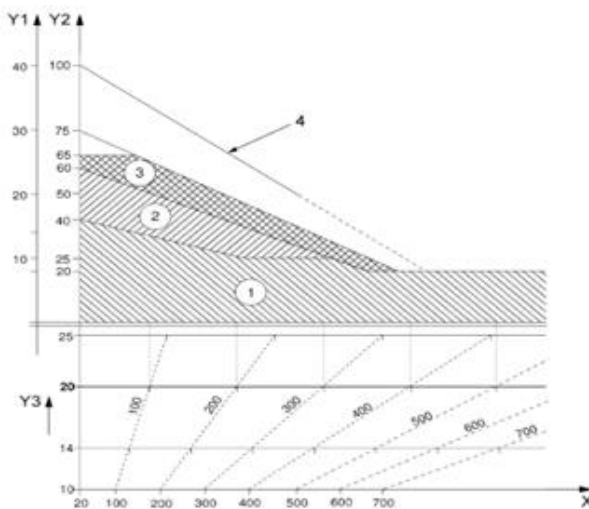
It must not be forgotten that, as the temperature in the dryer tunnel increases, the LEL% value at which ignition occurs decreases (Figure 5).

Figure 5. Maximum acceptable concentration and temperature values for inflammable substances

The chart above (Fig. 5) is taken from the BS EN 1539:2015 standard for the design of dryers and ovens operating with substances that produce highly flammable/flammable gases. As can be understood from the graph, as the temperature increases in the environment with solvent vapor, the LEL% value required for explosion/flammability decreases. Since the starting point of the graph is 20 °C and at this temperature a solvent at 100% LEL level can reach the ignition level, when there is a temperature increase to 100 °C, ignitions can occur at 80% measured LEL [7].

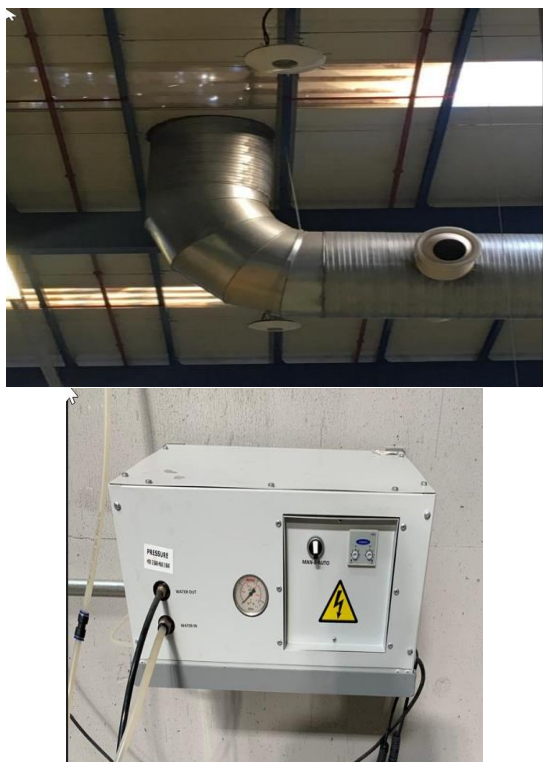
Figure 6. (7x0.17mm) Pulverized spraying equipment and pump assembly

In addition to the conditioning system installed in the production environment, an atomized water spray system was installed in the 11th unit at the entrance of the first drying tunnel. This helped prevent the remaining 10 cm tail part from fluctuating while at the same time the conductivity of the film surface was increased. In addition, the ethyl acetate concentration at the tunnel entrance was further reduced.

For the system, the pump has a water spraying capacity of 1 liter per minute, feeding water to 5x0.15mm spray nozzles at the point where the film comes out of the nip between the impression roller and the application cylinder. The water spray from these nozzles helps to ensure surface conductivity. A further 2x0.15mm nozzles spray water to act as a barrier between the tail and the main film at the time of entering the tunnel, with an additional set of 5x0.15mm nozzles, intended to reduce the ethyl acetate concentration, installed at the tunnel entrance.

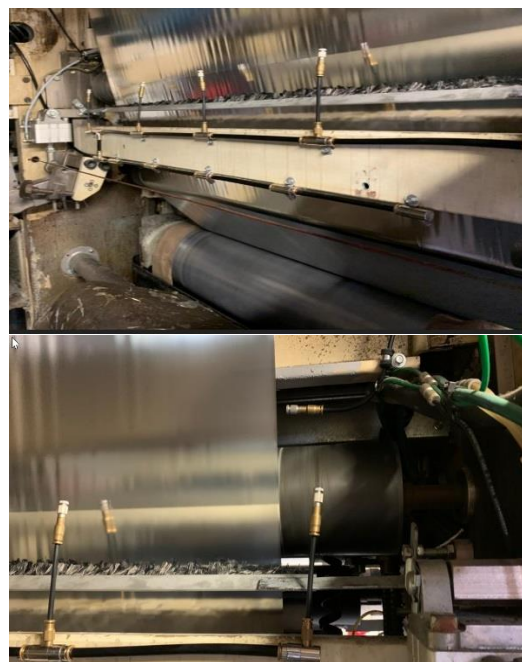
Figure 7. Dryer tunnel inlet pulverized water spray system.
