Rain-Induced Slope Instability: Case Study of Monsoon 2020 Affected Villages in Pithoragarh District of Uttarakhand, India

Sushil Khanduri^{1*}

¹Uttarakhand State Disaster Management Authority, Department of Disaster Management, Uttarakhand Secretariat, 4 Subhash Road, Dehradun-248001, Uttarakhand, India

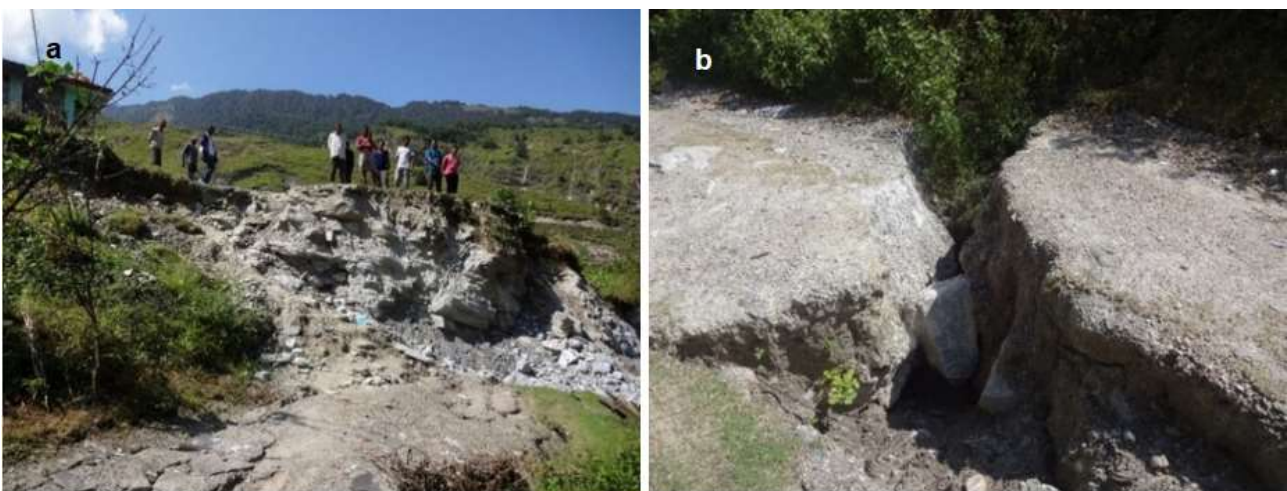
Subsidence and ground fissures that were observed to facilitate movement of huge slope mass around the Ropad Tok. This caused a number of houses completely damaged and destroyed. Overall, the angle of failure slope is observed to be around 25° and even more. The direction of the slope is observed to be towards Northwest. The ground fissures in the newly under construction road area are observed to be 1.5 to 3.5 meters long (Fig. 6a). The subsided material lying on gentle to moderate slopes has developed tension cracks which were trending from WNW-ENE and N-S on the same area and these are observed to be up to 50 cm wide and 0.5 - 1.5 meters deep indicating active soil movement (Fig. 6b).

Fig. 6. Slope instability in the area around Josha Village; (a) ground fissures at Ropad Tok and (b) cracks trending N-S across newly under construction road between the Ropad Tok and Sirwakhan Tok area

Recommendations: Subsidence and ground fissures that were observed to facilitate movement of huge slope mass around the Ropad Tok caused 8 houses destroyed. It is therefore highly recommended that immediately rehabilitation of this tok is need to be required and the residents are therefore advised to stay away from the active subsidence zone, especially during heavy or prolonged rainfall. Benching and erection of appropriately designed retaining structures with firm foundation are required to be erected around the affected area of Lorkhet Tok for protecting the habitations and agricultural fields as well as bank of Dhanpaniyari Gad from stream erosion on its right bank. Channelizing the entire course of the Dhol Gadhera in steps together with banks protection. This would help in reducing the pace of the flow and thus arrest erosion in the agricultural fields as well as Sirwakhan Tok area.

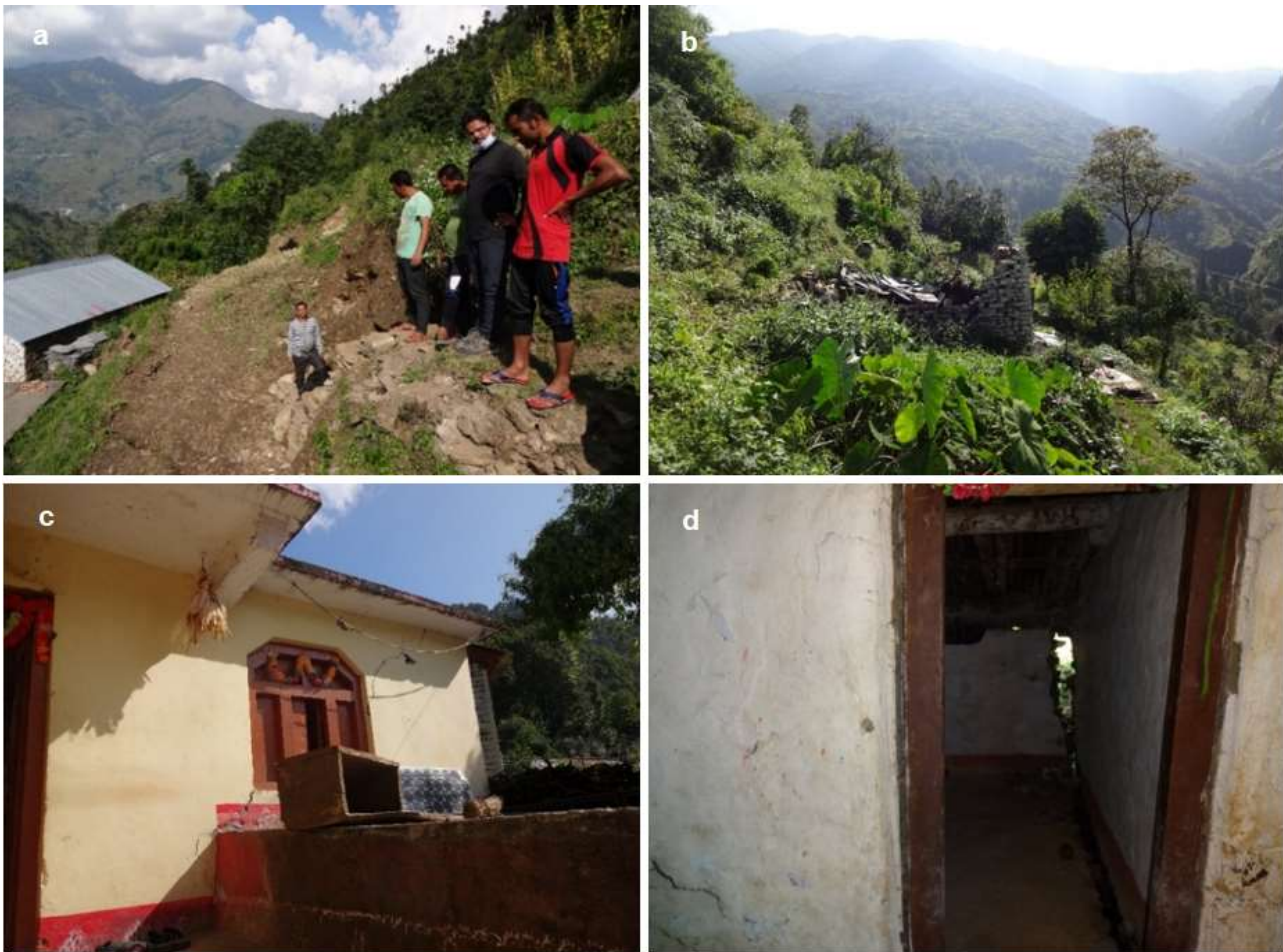
The ground fissures in the agricultural fields are observed to be up to 4.0 meters long (Fig. 7a). The subsided material lying on gentle to moderate slopes has developed tension cracks which was trending from NE-SW on the same area. Total of 2 houses were ruined in the same incidence (Fig. 7b). As also, cracks were observed to be in a number of houses (Figs. 7c and 7d).

Fig. 7. Ground subsidence related damages in the Malupati Village; (a) ground fissure in agricultural fields, (b) collapsed a house, (c) crack in a house and (d) detached back side wall of a house

Downhill slope of the village is observed to be affected by landslide. The same was occurred due to the toe erosion by the Bharadi Nadi on its right bank. The width of the failure slope is around 100 to 300 meters along the Northeast flowing Bharadi Nadi while the height of the slide from river bed to the crown is about 50-70 meters. The inclination of failure slope is observed to be around 35° . The Southeastern proximity to fresh ground fissure zone, a small seasonal stream is to be observed in the area. The same is flowing through the old landslide which was observed below the village area. Apart from, seepage was also observed in the agricultural fields between fresh landslide and old landslide in the area. Whole habitation of the Malupati Village is under high risk due to landslide and subsidence.

Recommendation: Presently, the Malupati Village is facing serious slope stability problem where whole habitated area is affected by active subsidence whereas downslope is affected by toe erosion of the Bharadi Nadi. These factors have critically affected the stability of the area. During investigations, wide cracks were observed in the walls and floors of many houses that indicating active slope movement in the area. It is therefore advisable to rehabilitate the Malupati Village to an alternate safe location.

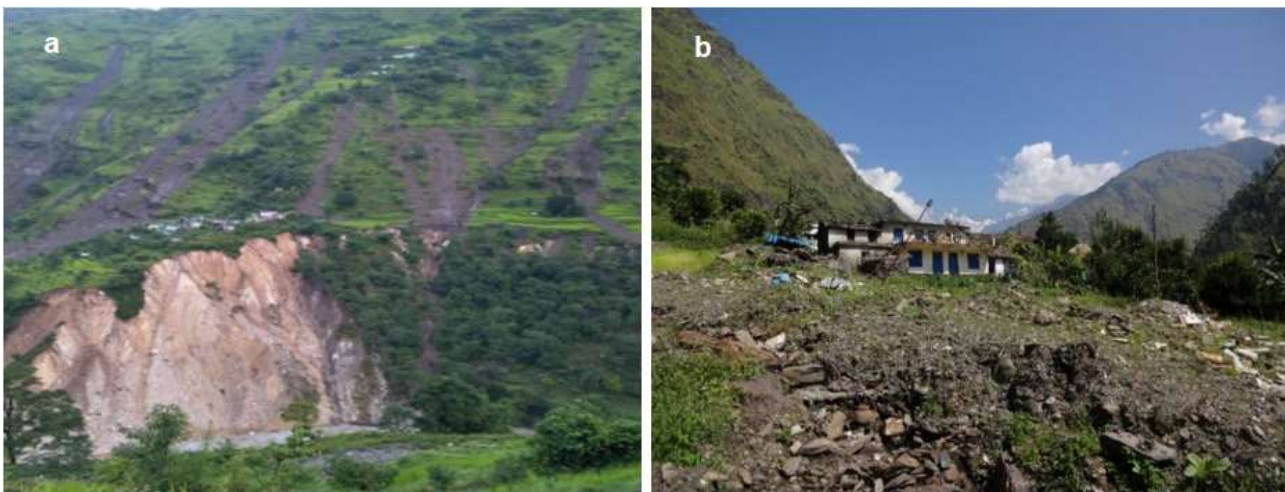
The Southwestern proximity to the village area, West flowing seasonal stream is observed to have overrun the agricultural fields and had create deep gullies in the area. This directly hit habitations of which some proximity to its course. As many as 11 persons lost their lives, of which one person was injured and body of one person could not be recovered together with 12 animals were lost in these incidences. A number of agricultural fields were also damaged and total of 4 houses were destroyed in these incidences (Fig. 9b).

The upslope of the Tanga area was triggered by many superficial landslides and downhill of the same was eroded by bank erosion of the Pena Gad during excessive rainfall events. This was observed to have contributed to the stability of the slopes in this area. An eroded terrace with sub-vertical

cut around of 40-60 meters was observed on the right bank of Pena Gad just below the entire stretch of the village area indicating active movement in the area.

Fig. 9. Heavy rains triggered landslides and associated damages; (a) numbers of superficial landslides whereas downslope affected by Pena Gad and (b) the place where houses were destroyed along with casualties

Recommendation: The upslope of the Tanga Village was triggered by many superficial landslides whereas the downhill movement of the upper crest all along the village due to toe erosion by Pena Gad indicates that active slope movements in the area. Therefore, no remedial measures will be sufficient considering the location and risk involved, hence permanent rehabilitation of the Tanga Village to safer location is recommended.

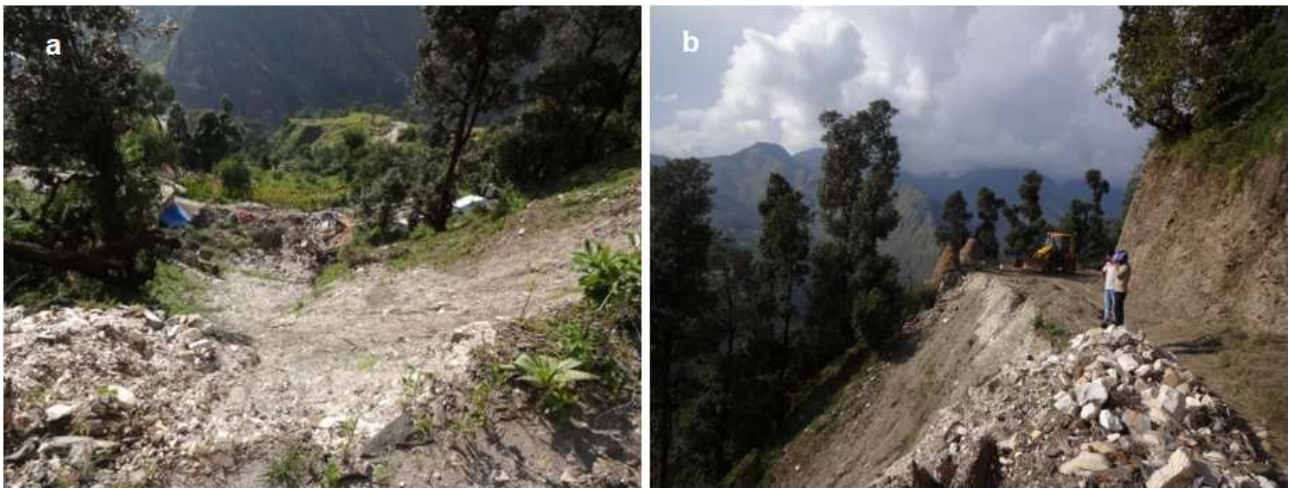
Newly under construction road valley side slope triggered after heavy rainfall of 20th July, 2020 at Gaila Malla Tok in Pattharkot Village of Bangapani Tahsil. Debris slide is observed to have occurred on the West slope of tok. The inclination of failure slope is observed to be 60° - 70° . The width of the failure slope (damaged road section) is about 40-50 meters at the crown portion and height between toe and the crown is about 55-65 meters (Figs.12a and 12b). Thick pile of loose debris along with wire crates retaining structures

that descended down from the area upslope of the tok is observed to have badly hit both agricultural fields and a house. As many as 3 persons of a family lost their lives in the same incidence. As also, the South proximity to the failure slope just below road area, there is a wire creates retaining structure which was observed to be partially bulged and tilted. The same is posing risk to a house which is located downhill of its.

Fig. 12. Slope failure at Gaila Malla Tok in Pattharkot Village; (a) failure slope above destroyed house (b) damaged portion of under construction road

Recommendations: The road should be shifted towards hillside along the affected slide zone. After this suitably designed breast wall of appropriate height with weep holes should be constructed at road level. In case of South proximity to slope failure zone, tilted and bulged wire creates retaining structures should be reconstructed properly with due attention to actual ground conditions. It is also strongly recommended that construction of any sort should not be allowed around the affected zone. The households located below the same zone are required to be shifted to alternate safer locations.

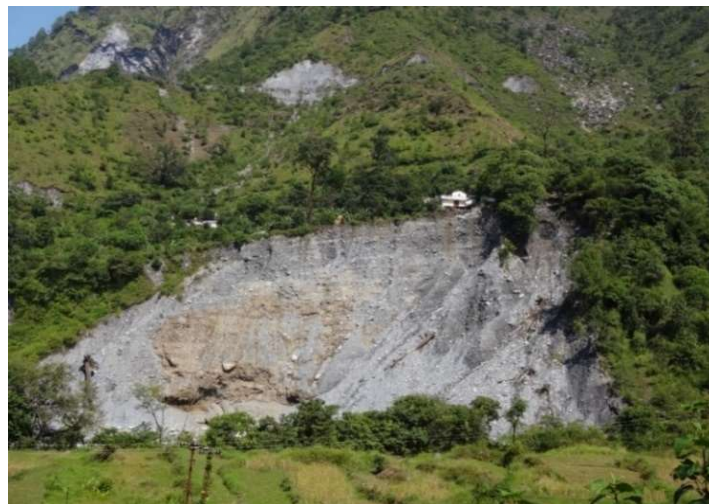
Fig. 13. Severally damaged a house in Khetali Village located in close proximity to eroded terrace cut that was eroded by Barar Gad

severally damaged. The failure slope in right portion of the house is observed to have occurred on the Southwestern slope having almost sub-vertical to vertical due to heavy rainfall associated with gully erosion, underground seepage

and toe erosion by Barar Gad on its right bank. The width of the eroded slope is about 120 meters along the stream and height of the slope is about 60-70 meters (Fig. 13). Right portion of this house and a track were damaged in these incidences.

Recommendations: The house near the slide area should be demolished and people must be made aware not to construct any habitat in and around the slide area. At least 5 meters buffer zone to be kept from eroded terrace cut and construction of houses in the proximity to the affected site should not be allowed. Road side drain should be lined with suitable gradient and connected it with nearest depression/streams. This would protect the houses from down thrust of the monsoonal discharge. The affected slope to be retained must be protected by wire mesh along with hydroseeding. As also, a toe wall along the Barar Gad in the whole length of the affected village should be provided in order to check the toe erosion and the scouring action in this area.

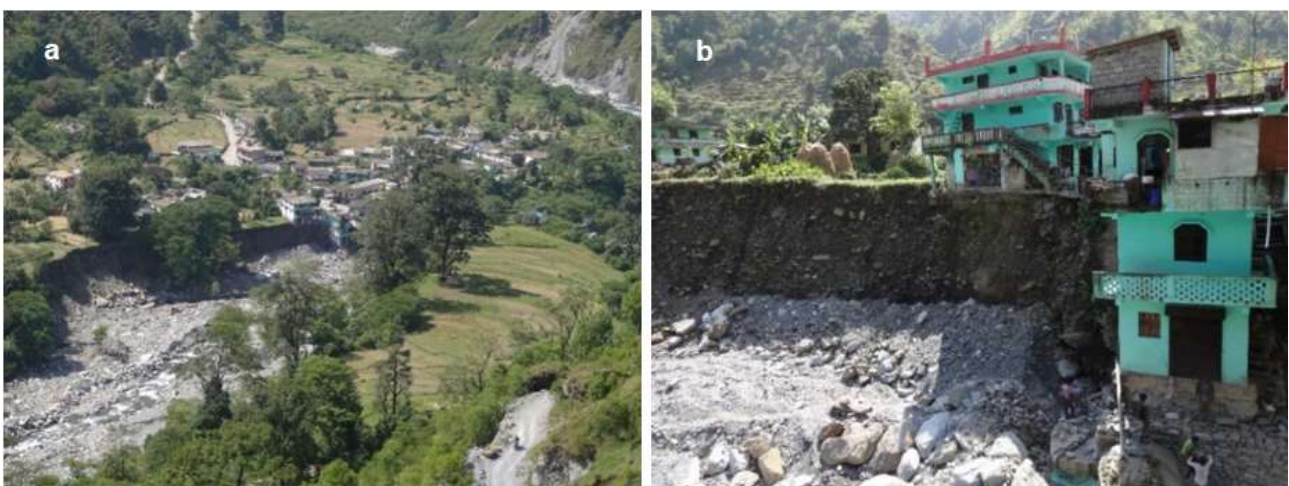
Fig. 14. View of eroded terrace with houses in vulnerable state on the left bank of Barar Gad; (a) panoramic view and (b) close view

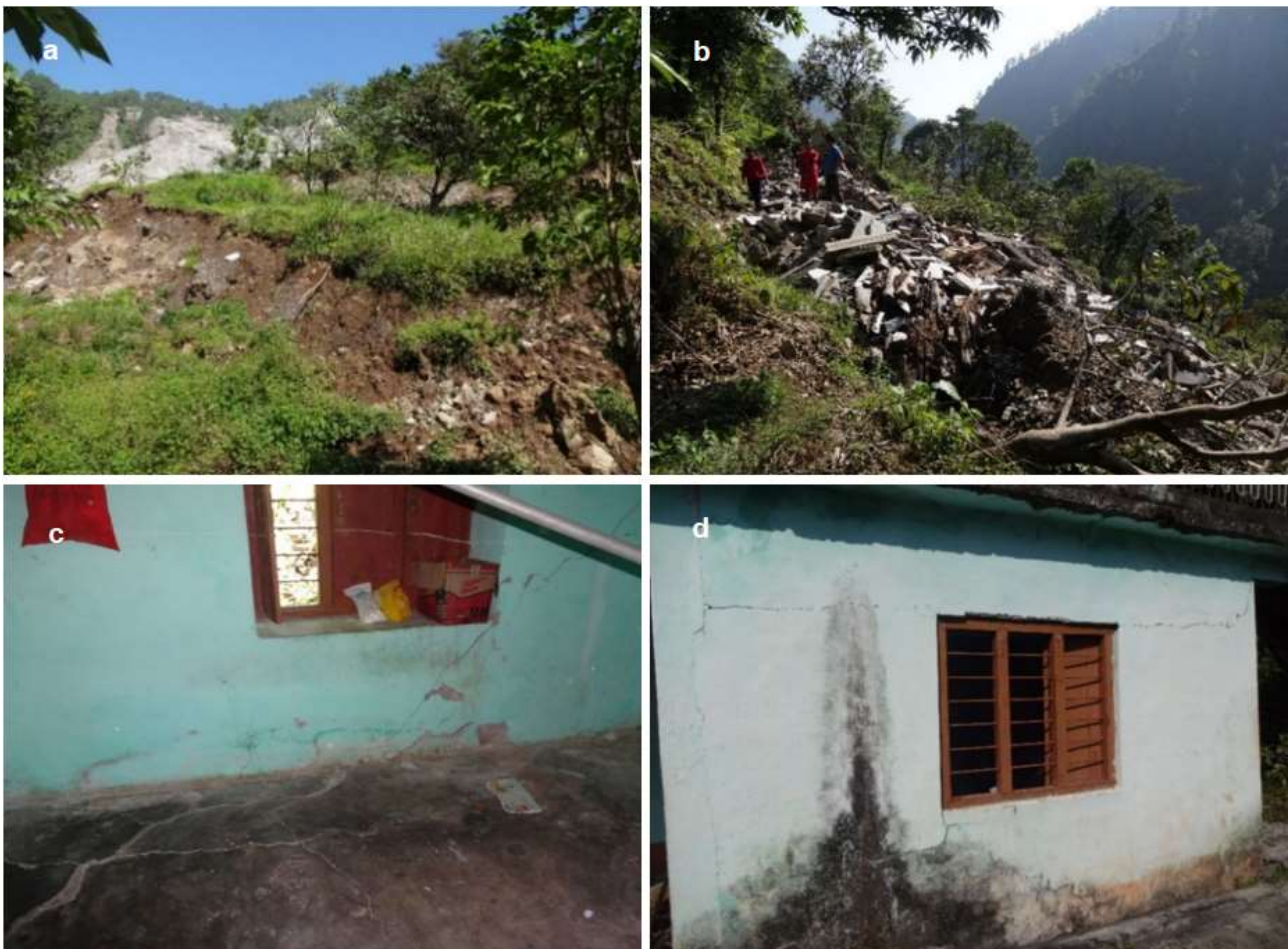
Fig. 15. Slope instability and associated damages in the Gat Tok; (a) ground fissures zone, (b) destroyed a house, (c) cracks on floor and wall of a house and (d) cracks on front portion wall of a house

in 3 houses which are situated in South proximity to slope failure and subsidised zone (Figs.15c and 15d).

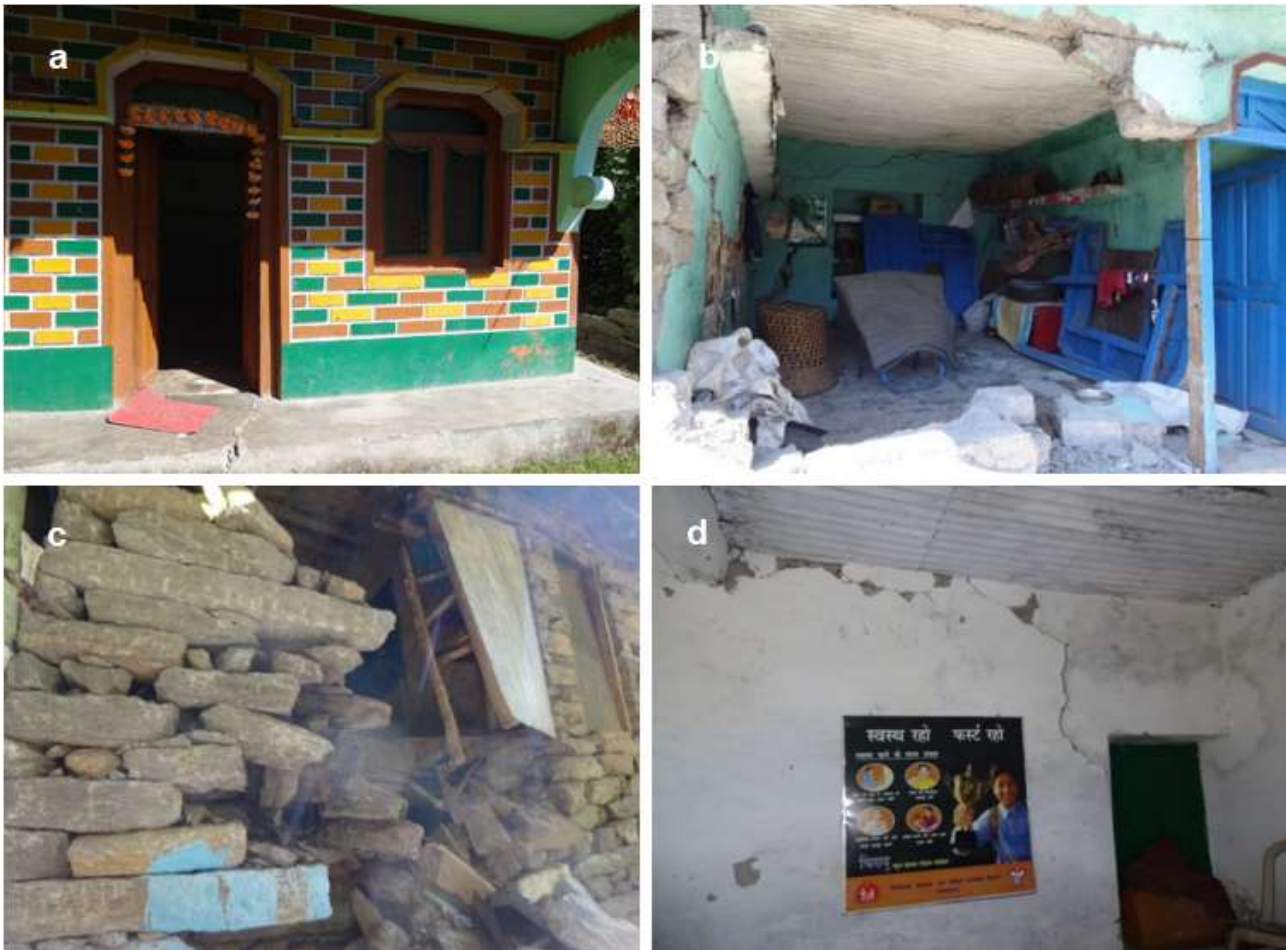
Fig. 17. Cracks in houses of Khela Village due to creep movement; (a) cracks in house at Ala Tok, (b) severally damaged house at Kolpani Tok, (c) damaged right-side wall of traditional house at Chetkala Tok and (d) cracks on roof column and wall of primary school at Chetkala Tok

Recommendations: Cracks were observed in the most of the houses that indicating active slope movement in the area. The hill slope around Khela Village is deduced to be highly susceptible to failure, particularly in the event of heavy or prolonged rainfall. The residents are therefore advised to stay away from the active creeping zone, especially during heavy or prolonged rainfall. The households of the all three toks are required to be shifted to alternate safer locations. Cracks on floor, roof column and walls of primary school at Chetkala Tok are indicating major settlements in the ground. It is highly recommended that the Primary School located in active creep zone be vacated and put to disuse immediately.

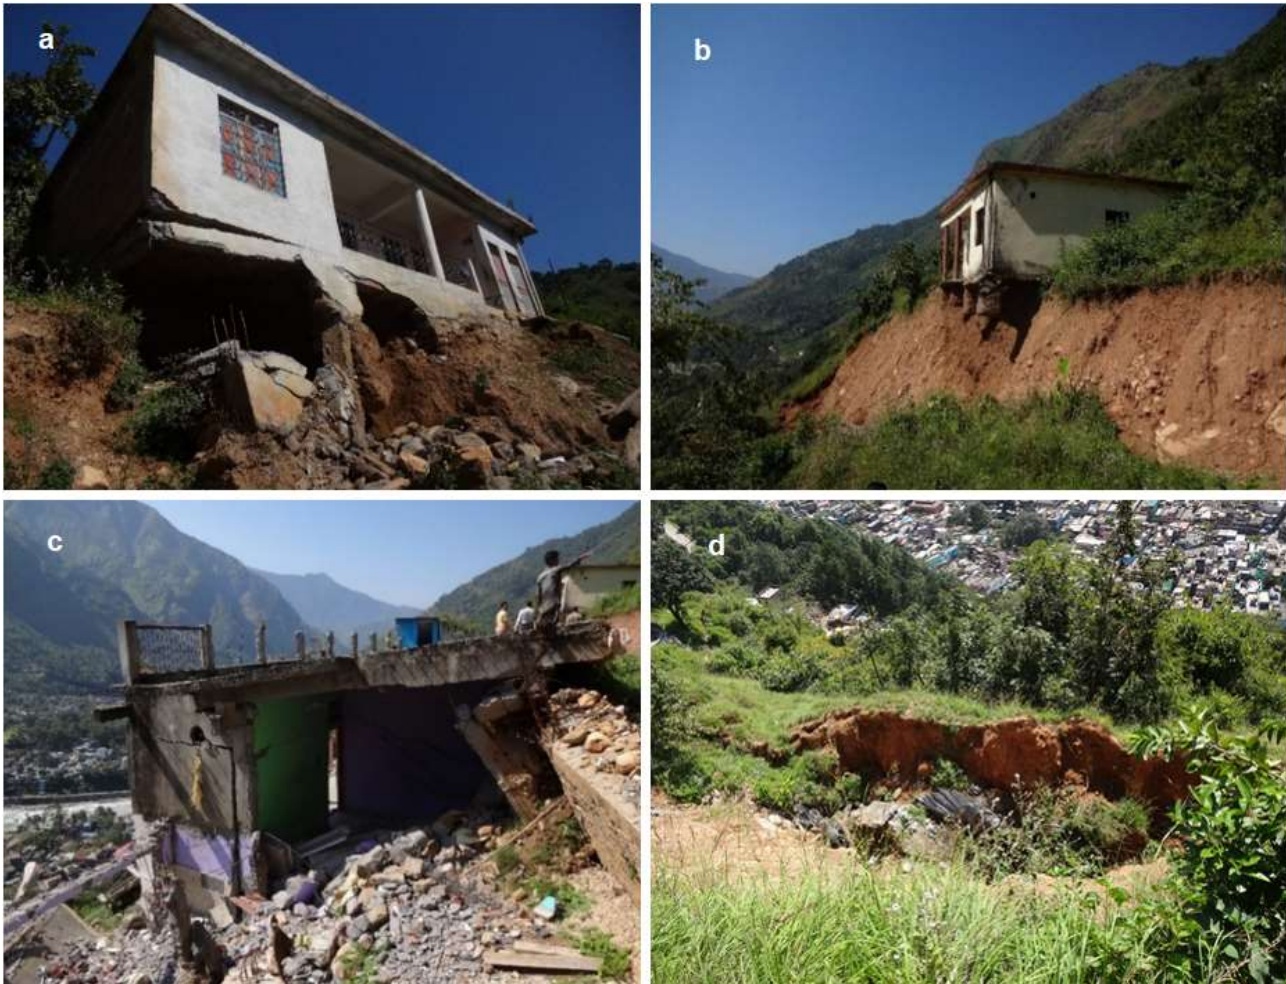
brown silty soil with rare big boulders and fragments of gneisses. Generally, overburden thickness including weathered rock zone was around 2-3 meters but at places thickness was observed to be as much as 5 meters during the field investigations. Cracks were observed in most of the houses of Chetkala tok, Kolpani Tok and Ala Tok (Fig. 17). These were attributed to active slope movement with local settlements of the loose overburden material.

Fig. 18. Damaged structures in Gwalgaon due to subsidence in loose debris materials during heavy rainfall; (a) scoring foundation of a house, (b) hanging foundation of a house in ground fissures zone, (c) damaged house over completely subsided loose debris mass and (d) a toilet was subsided in loose debris mass and deep sink hole was formed
