## Structural Analysis and Reinforcement of XVI Century Building in the Center of Naples, Italy

## 1. INTRODUCTION

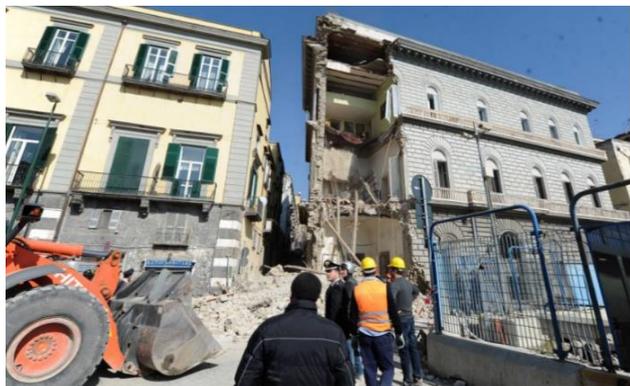
Among the anthropic damaging activity, we can remind the construction (2000-2015) of a new subway tunnel 15m in distance from the building and 20m in depth. On block more to the east, the “Guevara di Bovino” building (17th century) partially collapsed on March 4, 2013. “Fig. 9”.

**Figure 10.** Neighboring building partially collapsed in 2013. Next to it is the construction site of the metro station

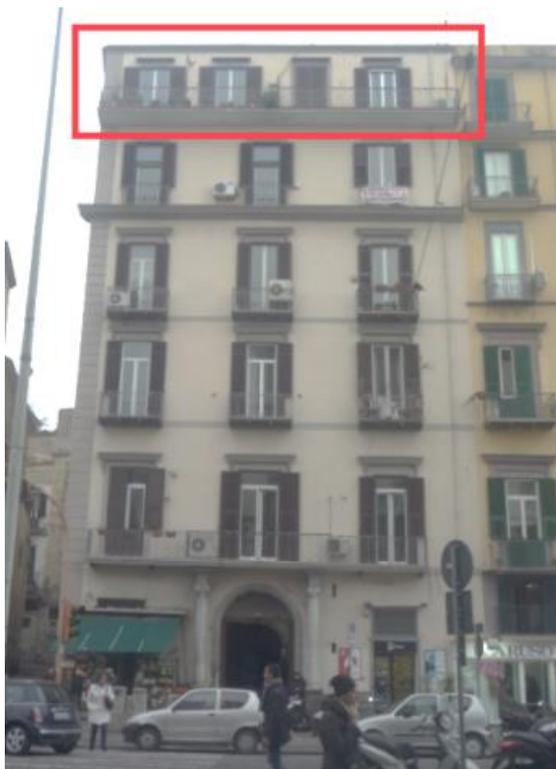
Figure 13. The main facade on the Riviera di Chiaia. In the red frame the last added floor made by r.c.

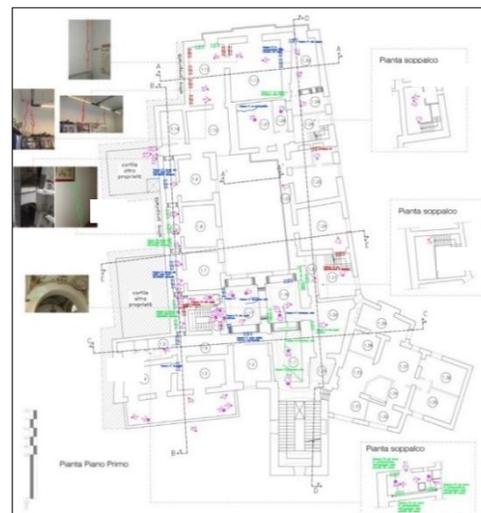
The first phase of investigations, started on 22 July 2011, in some rooms on the first and second floor of the building showed some vertical and horizontal cracks on the main structural wall, some of which probably related to previous settlement movements, dating back over ten or twenty years) and the lack of horizontality in some areas of the first floor.

The cracks and lesions found in the structural elements and due to recent movements led to the hypothesis of an increase of the loads. Furthermore, the non-horizontality of some floors or rooms can lead to the assumption that there has been foundational subsidence, now stabilized, with limited excursion due to the water table. The vertical cracks in some connection between two orthogonal walls lead to fear that the building is going to open toward the main street, at the main façade. The other conclusion after the flat jack measurements is that the lower part of the main wall, on the ground floor, is subjected to loads so high as to begin an irreversible phase of crushing due to unsustainable vertical load.

**Figure 18.** Cracking map at the first floor

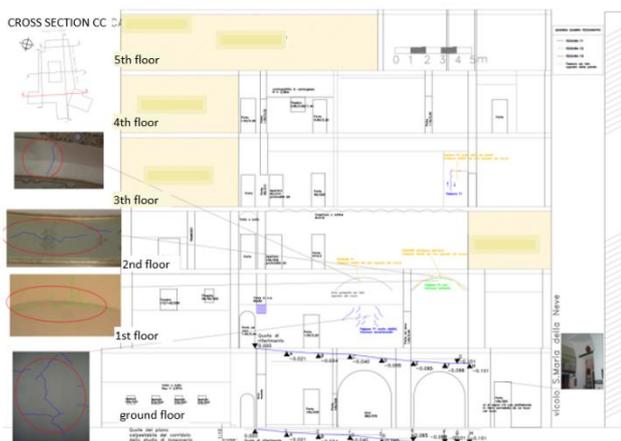
**Figure 20.** Crack map on the vertical wall in transversal cross-section C-C

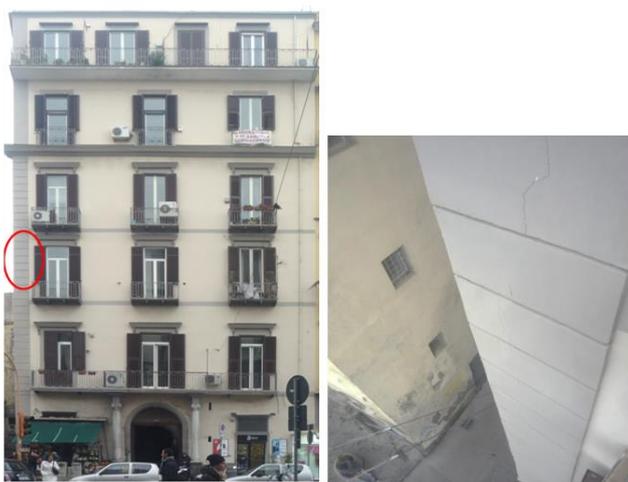
**Figure 21.** Crack on the corner of the main façade

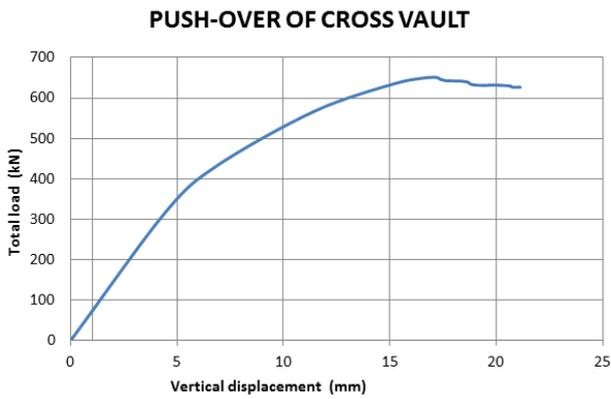
Figure 24. Result from vertical push over for cross vault

The results of the non-linear analysis give an ultimate load of 650 kN, while the operating load is about 583 kN. Then the safety factor is as follows:

We can conclude that the cross vault twin has a very limited structure safety factor, and probably some horizontal chain will help much to improve the resistance of the vault.

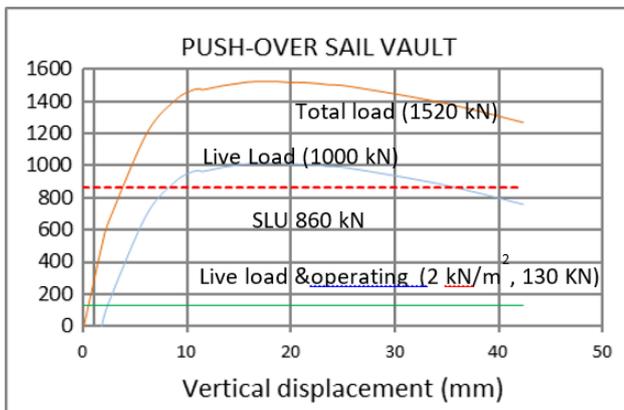
The numerical analysis gives a structural safety factor of the existing sail vault equal to:

The value apparently is higher than 1, but we should consider the variability of several parameters, which

**Figure 32.** Sail vault Push-Over curves for different load conditions, without chain bar.

As it can be seen in “Fig. 32”, the sail vault could collapse at a total vertical load of 1520 kN, above the requested 1000 kN. The added chain bar increases the ultimate load up to 1800 kN, as shown in “Fig. 33”.

could suddenly bring down the safety factor, and lead to the collapse. Then we decided to reinforce this double sail vault room with some chain bars which will increase safety. Two steel chain bars D=24mm have been foreseen for the common arch in the center of the room. In this case the new safety factor becomes:

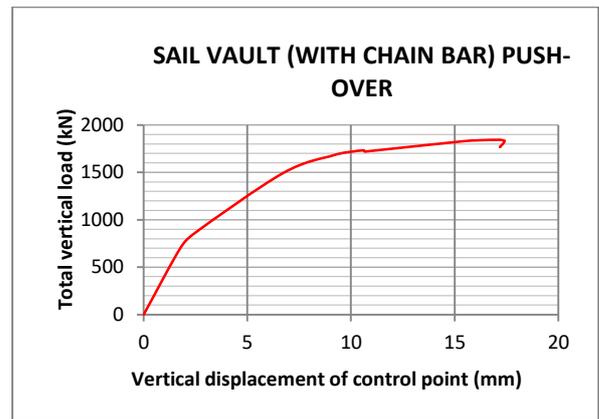
**Figure 33.** Pushover of the sail vault with the two chain bar. Total collapse load  $Q_u = 1800$  KN

which seems a satisfactory result. In “Fig. 33” the different curves of the limit analysis (pushover) are shown for the sail vault. The two chain bars will be installed at the extrados of the sail vault, as shown in “Fig. 31”, to minimize the visual impact.

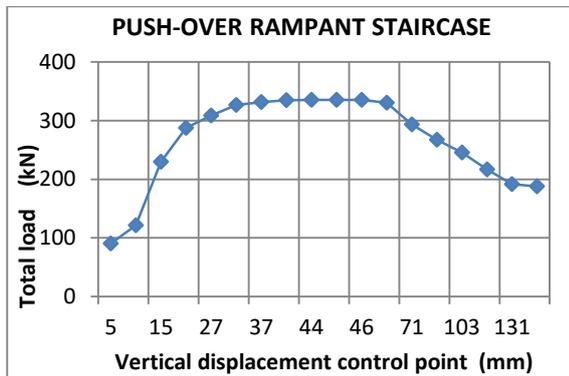
**Figure 37.** Pushover function for the load on the rampant staircase

The numerical analysis gives a total ultimate load of 335 kN, while the operating load (dead+live) is 128 kN. The ratio between ultimate live and operating live load is about

Since by code we need at least a safety factor of 1.9, it means that the staircase is safe enough, and doesn't need any reinforcement operation.

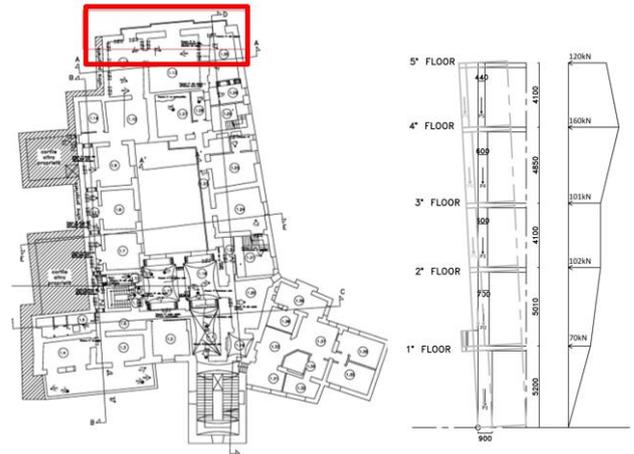
**Figure 38.** Overturning risk assessment of the main façade

So the wall overturns when the acceleration of gravity is greater than 0.348g.

In order to improve the masonry wall behavior, and reduce the overturning risk, we decide to put 2 pairs of chain bars on each cross wall. We foresee using a chain bar with  $D=24mm$ . The balance between internal and external work for virtual displacement, after considering also the contribute from the added chain bars at each floor, gives an interesting 30% increase of resistance for the overturning.
