## Documentation of Architectural and Textural Characteristics and Determination of the Problems of Eskişehir Seyitgazi District.

Özlem SAĞIROĞLU DEMİRCİ<sup>1,\*</sup>, Muharrem ŞANVER<sup>2</sup>

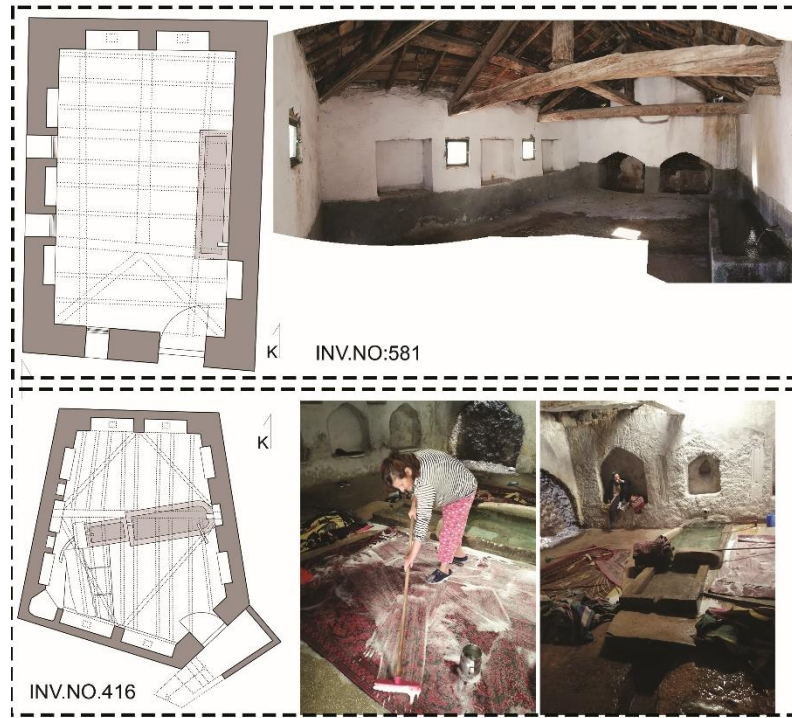
**Figure 2.** Plans and photographs of Seyitgazi sakana's

The first of these sakanas is 416 inventory number (Fig 2); It is the building located at the intersection of Odunpazarı and Hamamyolu streets. The structure is in the form of an irregular polygon and was built with masonry rubble stone and has a wall thickness of approximately 80 cm. It is covered with a roof made of wooden rough hewn timber logs and covered with terracotta tiles. There are 2 furnaces on each of the northern and southern walls of the building, and each furnace has a separate chimney connection. Niches in the western and eastern directions are positioned at a height of ~60 - 120 cm from the ground in order to store goods. The original stone tubs in the Sakana, into which the water is constantly transferred, consist of two interconnected parts. Mosaic screed was poured on the floor of the building, the floor of which was originally covered with raft stones. The building, which is still in intensive use today, does not have a structural problem in general [11].

The other sakana identified in the area is the building located at the intersection of Bardakçı street and Kurtuluş streets with inventory number 581 (Fig.2). The building is in the shape of a regular rectangle extending in the north-south direction and has a floor area of approximately 53 m<sup>2</sup>. Its entrance is from the south side and is positioned at the same level as the road. The floor of the building, which was built as brick masonry, is concrete mosaic, and the tub into which the water is transferred uninterruptedly with the help of a pipe is also made of concrete mosaic. Its roof is a snap-on roof, and it was formed with rough-hewn timbers. There are 2 hearths on the north wall of the building, and both have separate chimney connections. In the building, which has one niche at the beginning of the bathtub on the east wall and three niches on the west wall, there are also 3 separate windows measuring 50x60 cm and 140 cm above the ground. Although the building, which has no structural problems, was built as masonry, it was built recently and is not qualified [11].

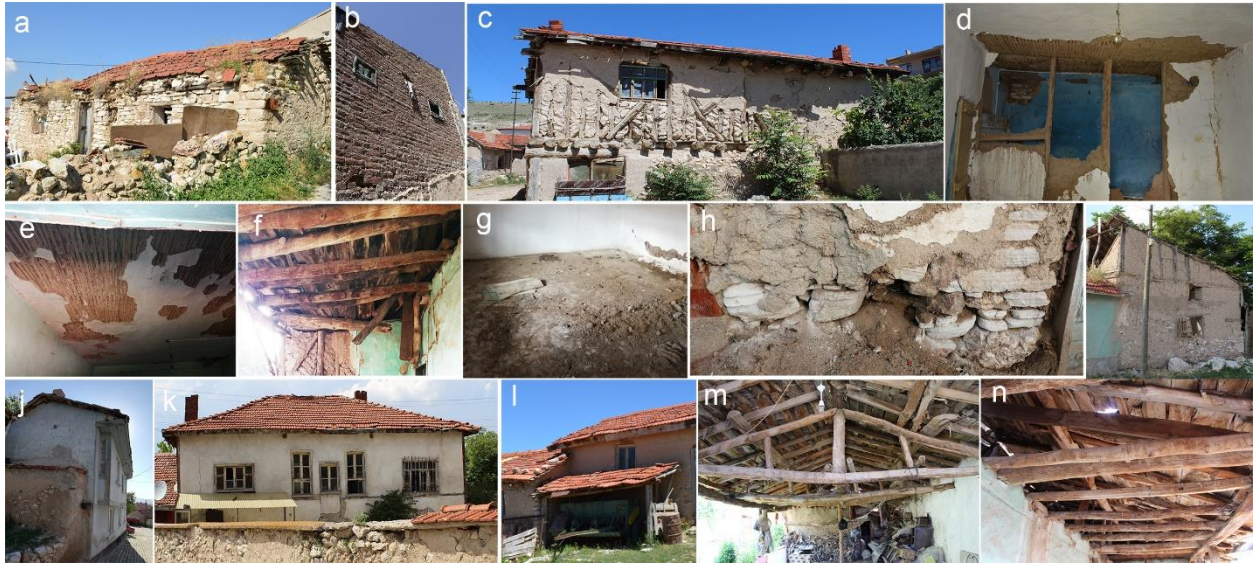
**Figure 7.** Examples of construction system

Masonry systems are grouped under three headings: brick, stone and adobe masonry structures. Brick masonry structures are dated to the late post-republic period. These buildings, which were built using solid bricks, are located on the island at the intersection of Uğurlu street and Öğretmen Nasuh Yayalan street, the majority of these buildings are abandoned and are not in use (Fig7b).

In the study carried out in the field, it was determined that most of the qualified buildings were constructed by timber framed system. The frame is generally on the first floor above the floor in 2-storey buildings; in single-storey buildings, it is used above the sub-basement. The struts, which are arranged at very different intervals, have different cross-section sizes, provided that they are the main carrier and the partition struts. Generally, rough cut wooden logs are used, and the distance between the carrier and the dividing struts varies between 30 and 45 cm. Stone or mudbrick was preferred as filling in these frames. In the examples where the stone is preferred as a filling, the stone used is rubble stone and has not been subjected to any processing. Mud mortar was used between the rubble stones, and the walls were plastered with mud mortar from the inside and outside. In the examples where adobe is used as a filling between the wooden carcasses, it is full adobe. Mud mortar was used between the adobe bricks, and the walls were plastered and painted inside and out (Fig. 7c).

The content of the mud mortar used in qualified buildings has been determined as clay soil, straw and water within the scope of the information received from the local people. Fine sand was also found in this mortar, which was especially used as plaster. The interior walls of the buildings are usually made of mudbrick filled between the wooden frames. The frame spacing on these walls is usually over 1 meter. Horizontal wooden elements are also used to prevent deflection between the frames (Fig.7d).

preventing the bad appearance. In the study conducted in the area, an example was found in only one house, where these bagdadi laths were driven continuously and painted without plastering. In the buildings in the district, all of the examples of wooden ceilings that are not covered with plaster are wooden ceilings with laths (rusty ceiling). The wooden laths used on the ceiling vary in the range of 1-2 cm, and the coating boards in the range of 15-25 cm. (Fig. 7e,f,g).

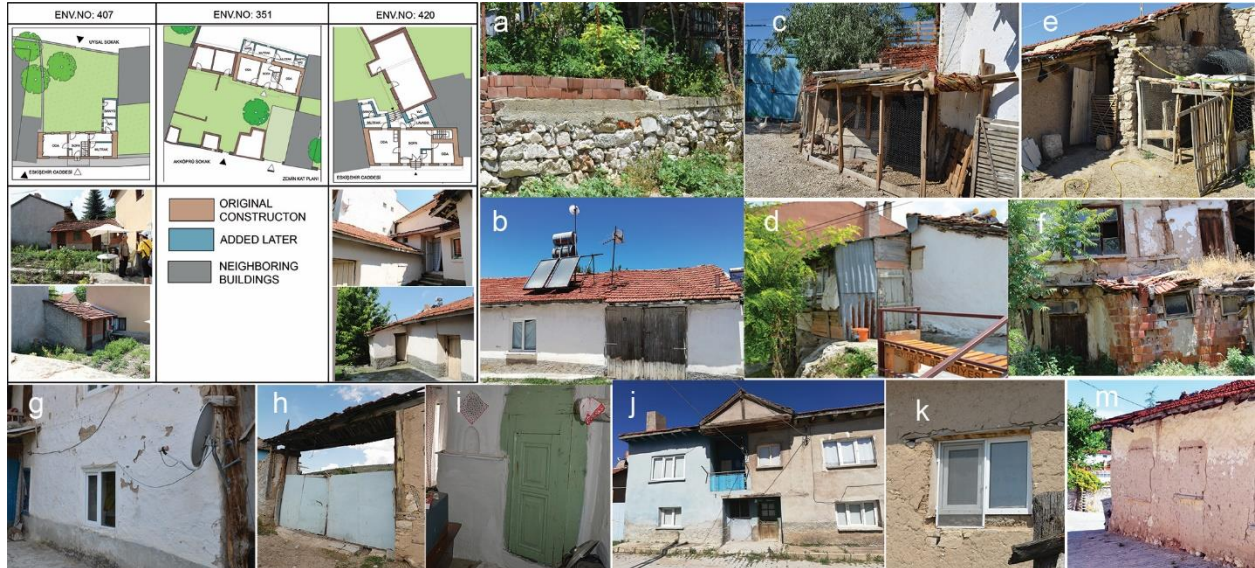
**Figure 8.** Problems encountered in buildings

In the context of the spatial configuration of the buildings, it has been determined that the most common problem is the addition of the toilet and bathroom functions into the building. These add-ons are generally obtained with unqualified workmanship, using materials such as briquettes and bricks with a masonry system and plastering with cement-based plaster (Fig. 8).

In the interior of the spaces, it has been determined in many instances that the furnaces, which have become dysfunctional, were closed. With the arrival of electricity, stoves became unnecessary for the lighting function and for the heating function with the establishment of the stove. Over time, the function of one of the rooms of the house as a kitchen, the establishment of sinks and countertops, the use of electric or gas stoves caused the furnaces to become completely dysfunctional and closed (Fig.8i).

One of the most important of the facade changes encountered in the area is the closing of the windows (Fig.8m). In connection with these examples, there are also many examples where old windows were removed and replaced with new ones (Fig.8k). In these examples, the pillars on the wooden frame walls

of the buildings are cut and the new window is placed in this space (because it is larger). In this context, in addition to the destruction of the original window of the building - thus the deterioration of its originality, changes are also brought about in the structure of the building that affect the stability, which is a factor that accelerates the deterioration of the structure.

Within the scope of changes in building material and technology, the most intense rate is the deterioration that occurs due to not using the original material (Fig.8a). Wood, stone, mudbrick and similar materials used in traditional houses and obtained from the immediate surroundings are expensive, difficult to reach and troublesome; Today, their use has become very limited due to the difficulties in finding the master and the fine workmanship in the details. It has been determined that the users prefer materials such as unqualified briquettes, block bricks, etc. for structures that will be used for a long time and are desired to remain in summer and winter, waste material for short-term structures such as poultry houses and the like, and reinforced concrete construction technique in cases such as additions or reinforcements to the structure (Fig.8 c,d,e,f).

The use of reinforced concrete causes both the deterioration of its originality in the context of additions to qualified buildings and negative results in terms of physical and chemical aspects. Additions made to the structure in the reinforced concrete system are negative in terms of added weight to the structure, as well as negative results because the adherence of both materials to each other, expansion and contraction coefficients are different. In addition, due to the salts in the cement, problems such as flowering or chemical metamorphosis are also seen in the original material, and the structure is damaged.
