# A RESEARCH FOR THE ELIMINATION OF PATTERN AND PRODUCTION DEFECTS ON THE MAN'S JACKET

Sevgi TÜRKMEN TURGUT, H. Erhan KIRTAY, M. Çetin ERDOĞAN

*Ege University, Department of Textile Engineering, İzmir, Turkey*

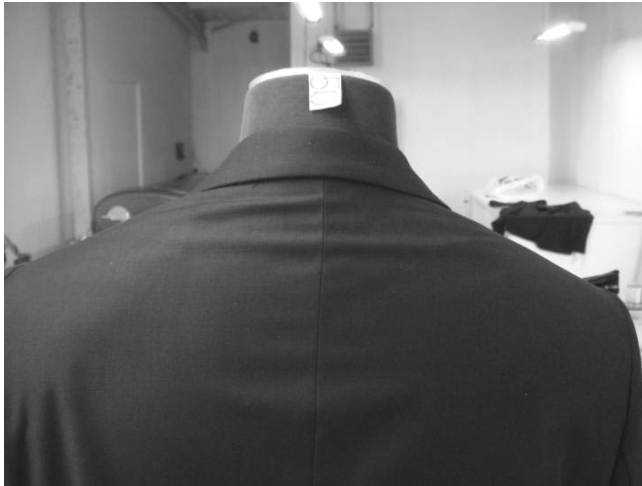
The data for the piling problem at the nape of the back body detected during the checks in control stations are given in Table 4.1 and the photo of the jacket with the piling at the nape problem of the back body is presented in Figure 4.1.

**Figure 4.1.** The Jacket Defect Related with Piling at the Nape Problem

The unconformity between the armhole heights of front and back body patterns' was investigated to cause the piling at the nape problem of back body in the analysis conducted to determine the source of the defect. For the elimination of the pattern defect with the known reason, the armpit, shoulder height in the back body was remedied by lowering the neck hole height and extending the circumference of neck hole, lowering the armhole line in accordance with the back body at the side part and equalizing the slope accordingly until the waist point. The corrections made in the pattern are shown in Figure 4.2

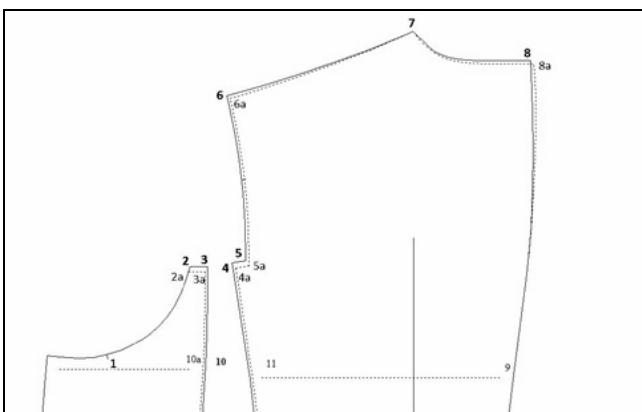
**Figure 4.2.** Pattern Correction Work Conducted for the Solution of Piling at the Nape Problem In the correction studies conducted at side patch and back body related with the defect points specified in the pattern;

At the side patches,

- Point 1 was maintained constant,

- At the side patch armhole region, point 2 was lowered to point 2a by 0.5 cm; point 3 was lowered to point 3a by 0.5 cm.
- Point 10 was dislocated inwards to point 10a by 0.2 cm.
- Correction Works were equalized at the waist line.

At the Back Body,

- Point 11 was maintained constant,
- At the back body armhole region point 4 was lowered to point 4a by 0.5 cm, point 5 was lowered to point 5a by 0.5 cm.
- At the back body armhole line shoulder point, point 6 was lowered to point 6a by 0.5 cm.
- Back body neck hole shoulder point 7 was maintained constant.
- Back body neck hole was lowered from point 8 to point 8a by 0.5 cm and dislocated outwards by 0.5 cm. The neck hole was enlarged by 1 cm.
- The pattern was equalized at point 9.

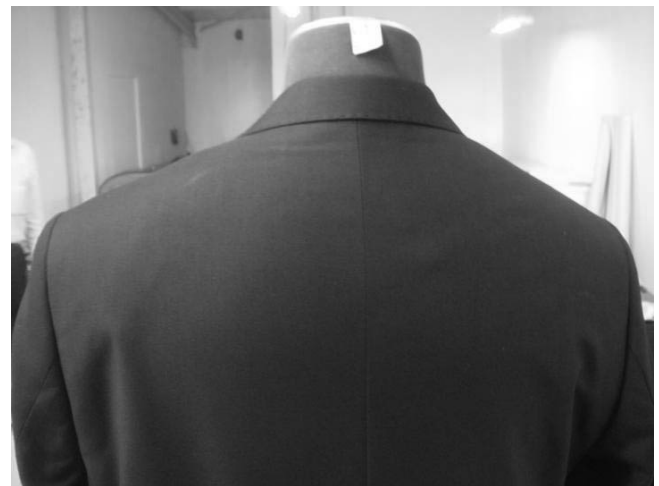
**Figure 4.3.** The jacket with corrected pattern

The photos of the jacket tailored as a result of the correction works related with the piling at the nape problem of back body are shown in Figure 4.3.

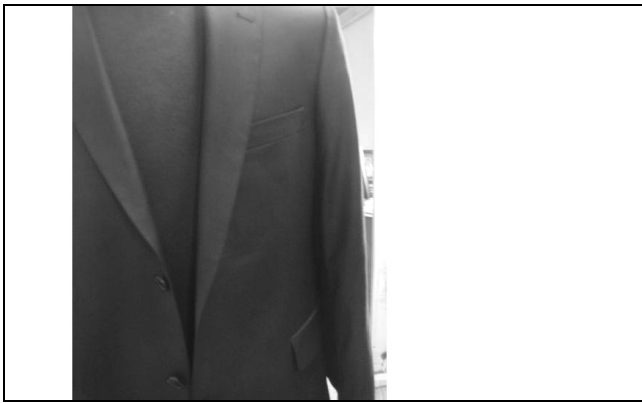
**Figure 4.4.** Jacket Defect Related with the Neck Breaking Line

The defect seen in Figure 4.4 was caused by the swirling line swirled not at the defined swirling line but swirled below (below the buttonhole-button horizontal line) the than that.

The defect occurred at neck-facing swirling line was investigated to be caused by the unconformity of hair insertion pattern and front body pattern and the tightness within the inner circumference of collar, at the studies conducted for the investigation of the source of the defect. The defect 1a-2a line that is defined as the swirling point of collar at front body of the hair insertion in hair insertion pattern was corrected and a new hair insertion pattern with accurate 1-2 line was made for the correction of the pattern defect with the known cause. Besides the tightness identified around the inner collar was recovered by giving expansion allowance of 0.5 cm –at half size- to each of collar, collar stand and lamination pattern. (This expansion work applied on the collar was applied on the back body neck hole simultaneously in Figure 4.2) The correction works applied on the patterns are given in Figure 4.5 and 4.6

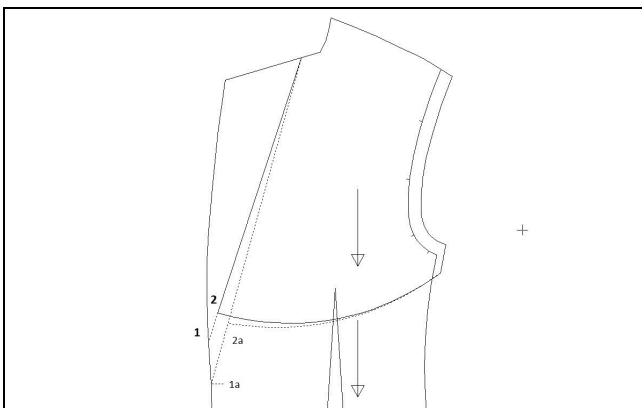
**Figure 4.5.** Hair Insertion Pattern Correction Work

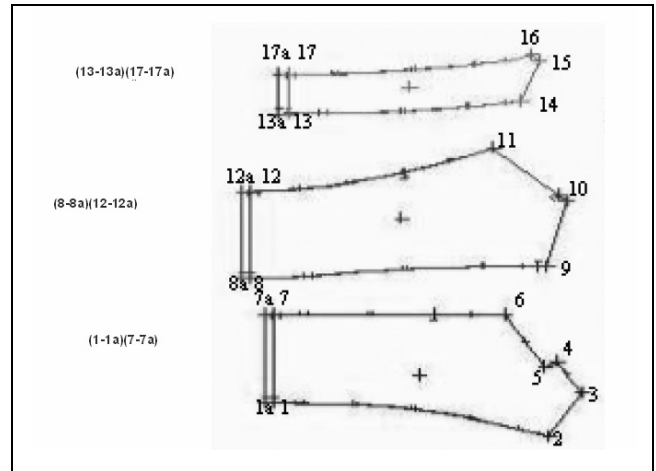
**Figure 4.6.** Neck Pattern Correction Work

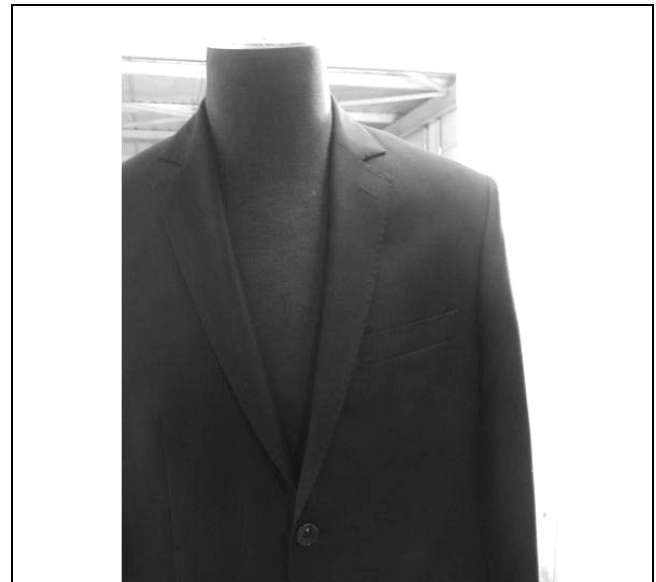
**Figure 4.7.** The Jacket on which Pattern Correction was applied

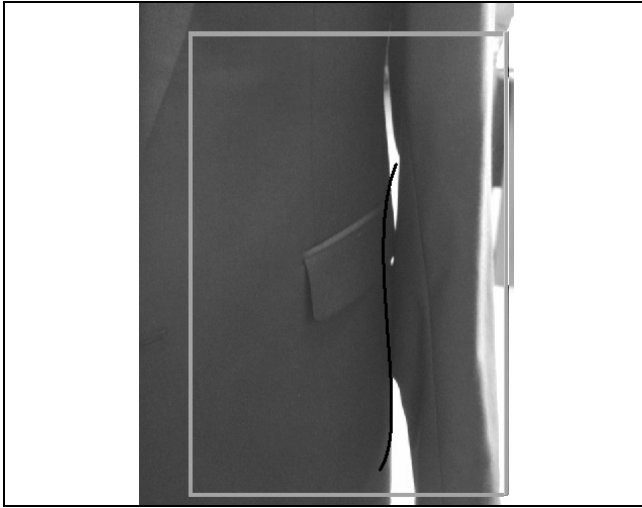
**Figure 4.8.** The Jacket Defect Related With the Failure in Fitting at the Inner Lower Part of the Arm

As can be seen in the photo in Figure 5.8 the sleeve doesn't stand sharply at the inner lower armhole region. It is in unconformity with the body, it has a balloon like appearance and the sleeve doesn't go sharply with the body.

The defects of sleeve cap pattern and back body and side part armhole pattern were identified to cause the sleeve not to stand sharply at the inner part of the sleeve resulting in the formation of a balloon in the analysis conducted for the investigation of the source of the defect. First of all the height at peak point slope in the sleeve cap pattern which was identified as the cause of defect, was recovered by reducing the peak point slope by 0.5 cm (In Figure 4.9 the point 5 was maintained constant, the sleeve peak point 4 was lowered to point 4 by 0.5 cm). The correction works conducted on sleeve cap pattern are given in Figure 4.9

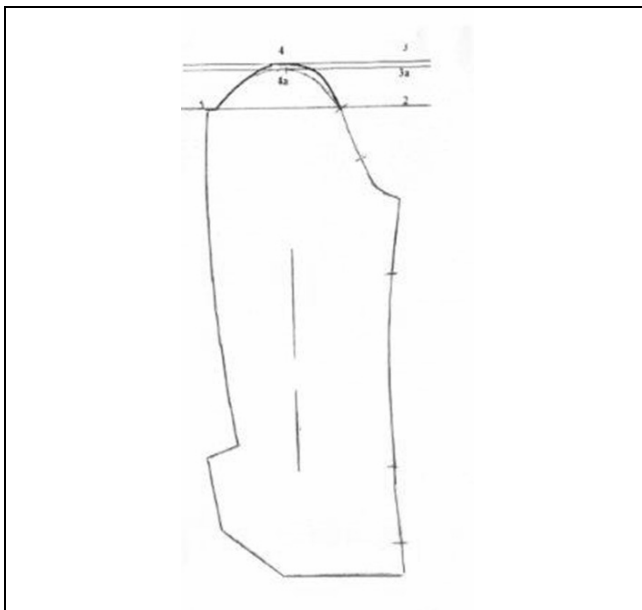
**Figure 4.9.** Correction Works on Sleeve Cap Pattern

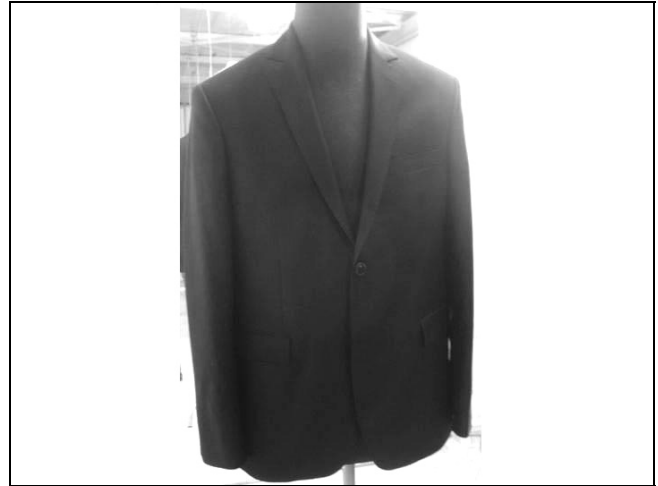
**Figure 4.10.** Lower Arm Fall Problem Solved Jacket

Armhole slopes at the back body and side part were trimmed as a second solution step.(Figure 4.2) As a consequence of correction works of pattern defects, the sleeve was observed to release and comfort itself by the reduction of sleeve peak height, the conformity of sleeve and armhole and adherence of the sleeve to the body were provided by lowering the scope on the body. The photo related with the jacket sewed as a consequence of correction works is shown in Figure 4.10.

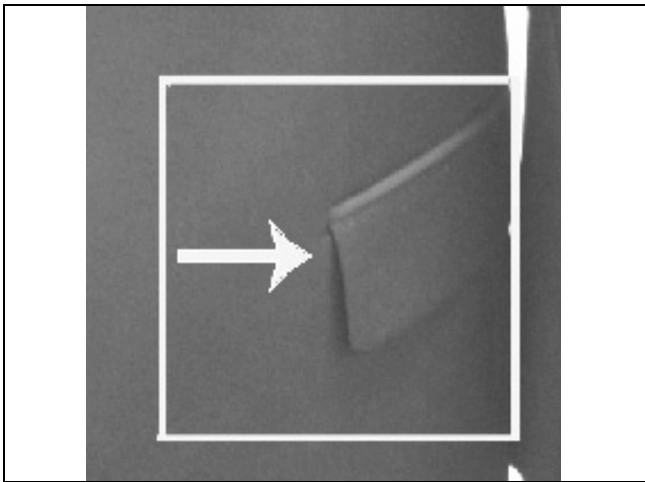
**Figure 4.11.** Jacket Side Pocket and Fillet Defect

In the side pocket flap and fillet defect in Figure 5.11, the size of the fillet being greater than the flap and a space of approximately 0.5 cm between the edge of the flap and fillet pinning line, are explicitly observed.

In the analysis conducted for the source of the defect, the side pocket and fillet defect was identified to be caused by the problem related with the machine maintenance. Laser lights that identify the start and end points for the side pocket fillet automatic machine, controls the stitch start and end commands. Resulting from the failure of routine cleaning controls in the system, the fillet stitch length that is supposed to be 16 cm., passed beyond the fillet stitch length marks (programmed) and caused the stitch to be 16.4 cm, due to the dust formation on photocell, as a consequence the fillet stitch happens to be 4 mm longer than the width of the flap. Occurrence of such a defect causes the formation of a gap beyond the fillet, as a consequence the fillet happens to be larger than the flap. The photo of the jacket sewed as a result of the correction of the factors that cause the defect is shown in Figure 4.12

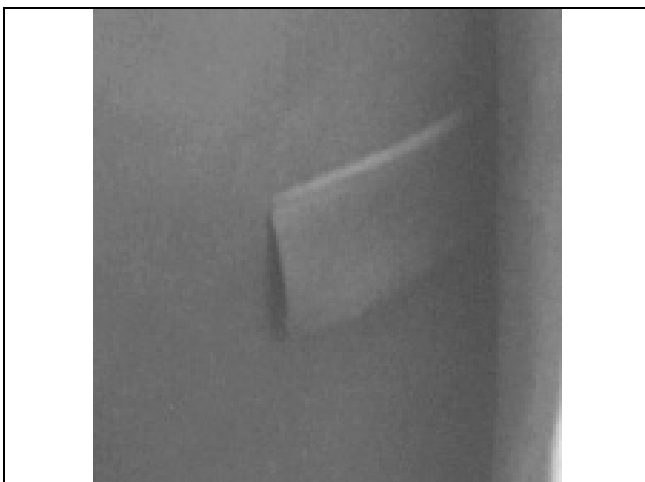
**Figure 4.12.** Jacket with Fillet and Flap Defect Remedied

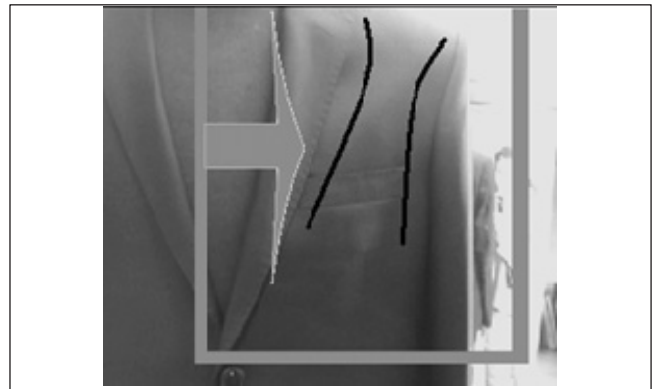
**Figure 4.13.** Tautening Problem at Jacket Chest Region

As can be seen in the figure above, the tautening defect at upper chest region of the chest which was coincided at the jacket production quality control station was identified to be caused by the hair insertion that was not suitable for the operational method and quality features during its mounting to front body and armhole.

The defect related with the tautening at the chest which was presented in the results section, was determined to be caused by the failure in stapling of the hair insertion during front body press operation, with the help of the studies conducted to identify the source of the defect. Therefore the source of the defect was identified to be caused by the lack of methodology and human factors.

Form imparted to the chest region during press operation, must be fixed to the armhole region by stapling provided that the front body of the jacket is not removed from the press table. Otherwise, following press operation, the allowance imparted by bending the collar according to the needs of operational method during the clamping operation of hair insertion to armhole at front body armhole section to the armhole by blade machine, would be insufficient. Such allowance is the allowance required by the collar due to turning after the form imparted by press at chest. The photo of the jacket remedied after eliminating the factors that cause defect, improving the operational method training and quality control studies, is shown in Figure 4.14 below.

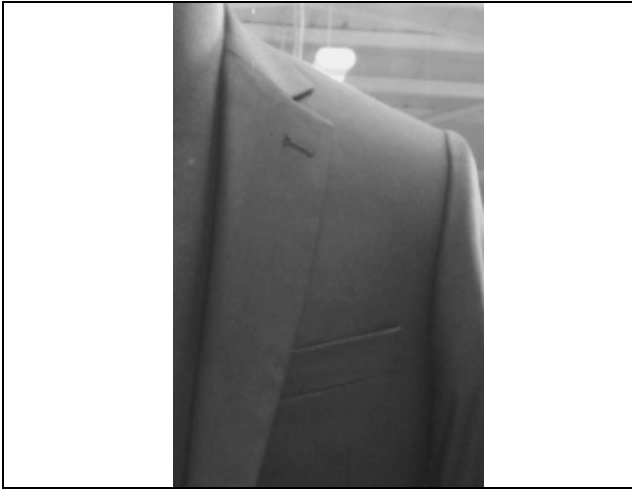
Figure 4.14. The Jacket Sewed Eliminating the Operational Defect

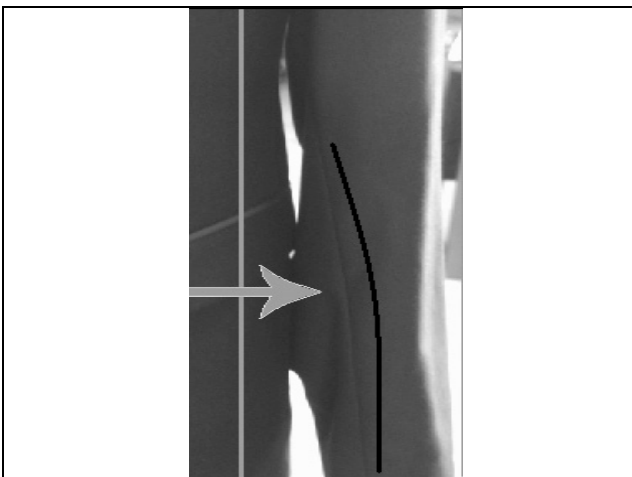
Figure 4.15. Turning Outwards Problem of Inner Sleeve Clamping Stitch

As can be seen in Figure 4.15, the defect caused by the sleeve inner clamping stitch turning outwards, which was coincided at jacket production quality control station, was identified to be based unconformity with the method and operational quality feature during sleeve attachment operation.

The defect related with the upper and lower sleeve clamping inner stitch turning outwards problem, which was identified in quality control stations, was determined to be caused by method and human based factors during sleeve fitting operations, in the analysis conducted to investigate the source of the defect.

Right fitted sleeve stand form meeting the requirements of sleeve fitting operation method definition; (Providing that the sleeve ham is folded in two from the aperture edge) it must stand in such a way to stand straight through sleeve straight line from the peak point and to center the pocket flap. In the meantime there must be no fitting defects at front armhole and no breaks on the stitch. The upper front part of the sleeve must be in form of balloon leaning on the Wall and there must be no Groove at the upper sleeve mirror region, the sleeve must stand flat and straight, the body and sleeve must be in conformity.

According to the definition of this method, providing the patterns of sleeve and armhole are right, the notches are well suited in cutting and method and quality features in all operations of preparation units are complied, one must start fitting the sleeve to body operation matching the point 1 on the sleeve with point 1 on the body. The following matters must be considered during operation; the notches must be in such a way that they match on body and sleeve, the stitch allowance stays within 1-2 mm margins through the entire armhole.

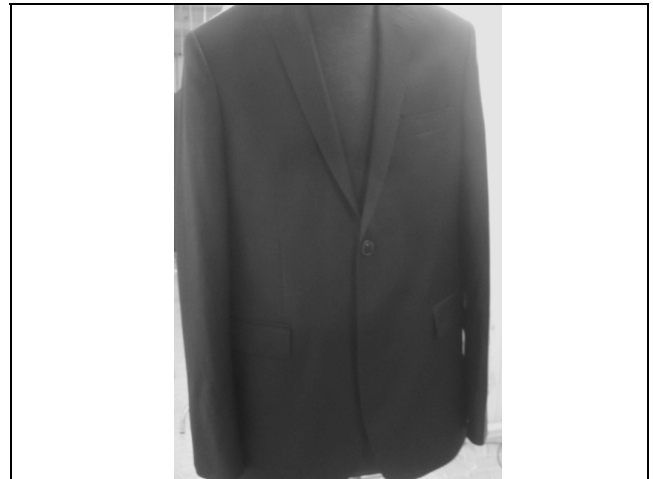
Figure 4.16. The Jacket Sewed Eliminating the Sleeve Fitting Operation Defect

The photo of the jacket remedied after eliminating the factors that cause defect, improving the operational method training and quality control studies, is shown in Figure 4.16 below.
