The Restoration Proposal for Mehmet Duruk Rural Dwelling in Akseki, Bucakalan Village

Muhammet ŞENOCAK¹, Özlem SAĞIROĞLU^{2, *}

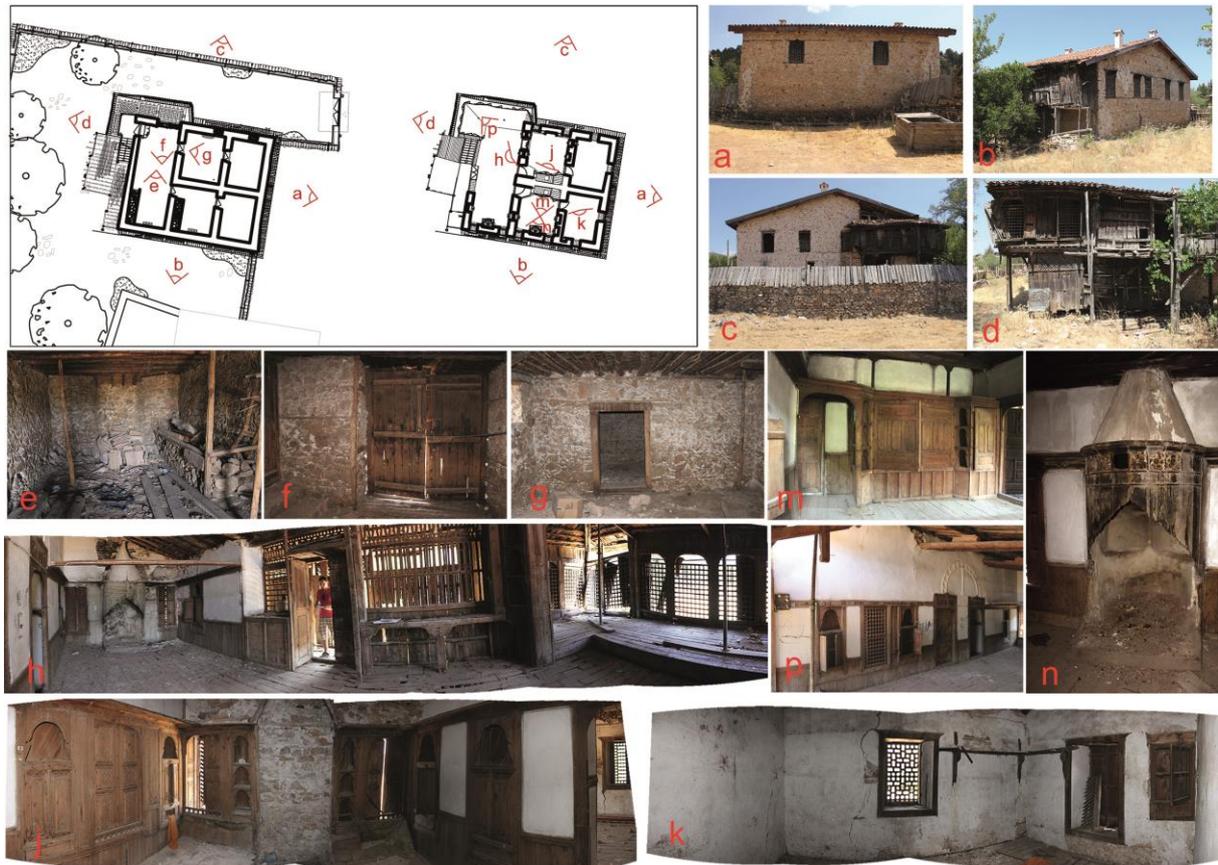
Figure3. Photographs of Mehmet Duruk Dwelling (2015)

- The building has been derelict for the last ten years. The building which is in the process of wearing off lost its architectural elements as it was not intervened in time, and this exposed the building to the atmospheric conditions. Due to losing its cover, there is a moisture problem in the building which has serious structural cracks. This situation causes the deterioration of wooden elements.
- Qualified wooden elements of the building which has no inheritors are being removed in order to be used or sold.

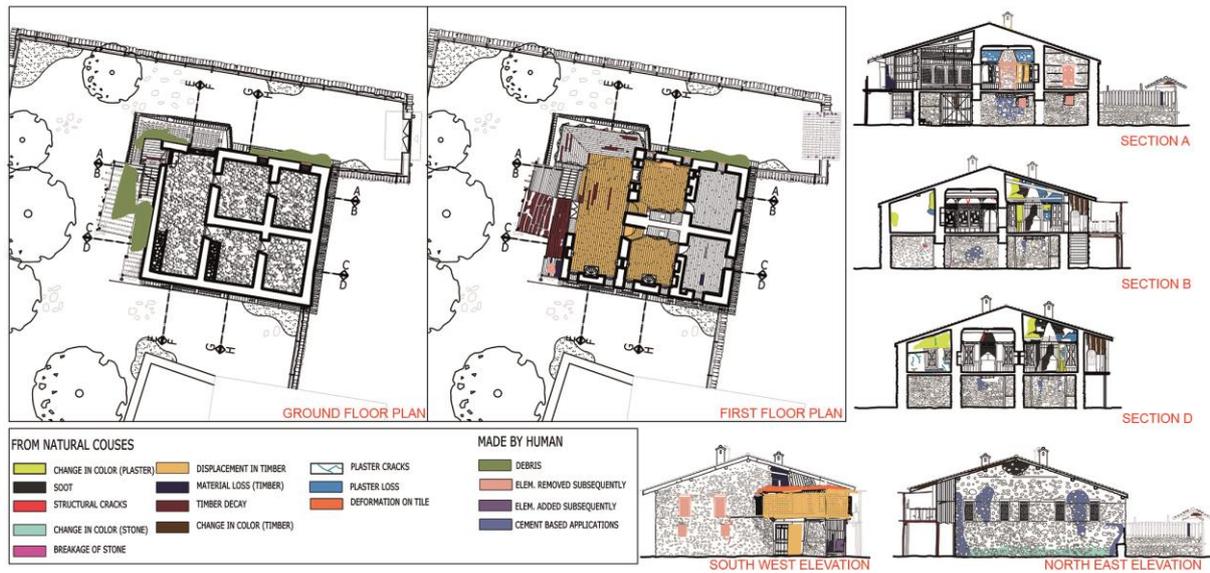
Figure 6. Deteriorations and corruptions

Deteriorations and corruptions in the dwelling are examined under two titles as deteriorations caused by nature and deteriorations made by human (Fig.6).

Among deteriorations caused by nature are structural and fine cracks on the load bearing walls and plaster, deflection and displacements, moistening, soot and change of color, decay and material loss in timber, plaster loss and tile deformations (Fig.6).

Among deteriorations caused by human are cement based applications, subsequently added or removed elements and debris.

- Supporting main walls will be completed with suitable sized stones where necessary,
- After necessary examination in the plasters, the plasters which lost their chemical properties will be rasped, and after examining and determining the contents of the plaster used in and outside of the building, they will be applied to where necessary,

- Thin cracks in the main wall will be repaired via injection system,
- For the structural cracks on the main wall, after the necessary project development is made, projects for repairs or reinforcements will be prepared, and suspension will be used during repairs in accordance with the situation,

- Roof tiles which are broken or which lost their physical or chemical specialties and roof boards will be repaired, and thus moisture that affects the spaces in the building will be eliminated,

- Concrete mortar applied subsequently on to the building will be removed and these parts will be remade via original materials,
- Dirt that occur on the main walls and wooden materials will be cleaned via non-ionic materials, and protective chemicals will be applied to the surfaces,
