A Proposal for the Restoration of the Satici Dwelling in Corum

Pınar KARAKURT¹, Özlem SAĞIROĞLU^{2,*}

ABSTRACT

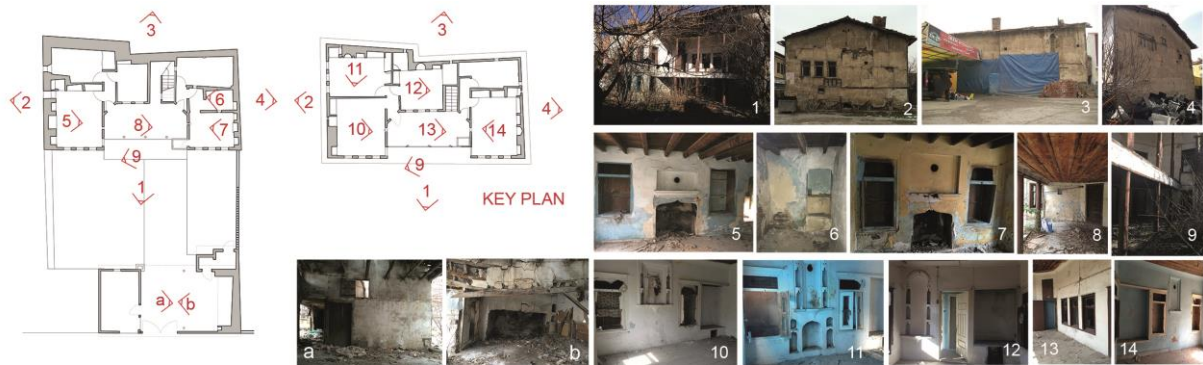
Figure2. Photographs of Satıcı Dwelling (2014)

The outdoor elements are located under the wooden *haymalık* roof. This part includes a barn and washing area (*çamaşır taşı*) on the west side, a *tandır* and an unqualified toilet on the east, and a courtyard door in between them (Fig. 2a, b; Fig. 3u, v, y, z). The courtyard occupies 150 m² between the entrance gate and the dwelling on firm ground and soil areas. The soil areas are used for recreational purposes, and a thick layer of trees was planted. In the north of the courtyard, the dwelling is situated on the west-east axis.

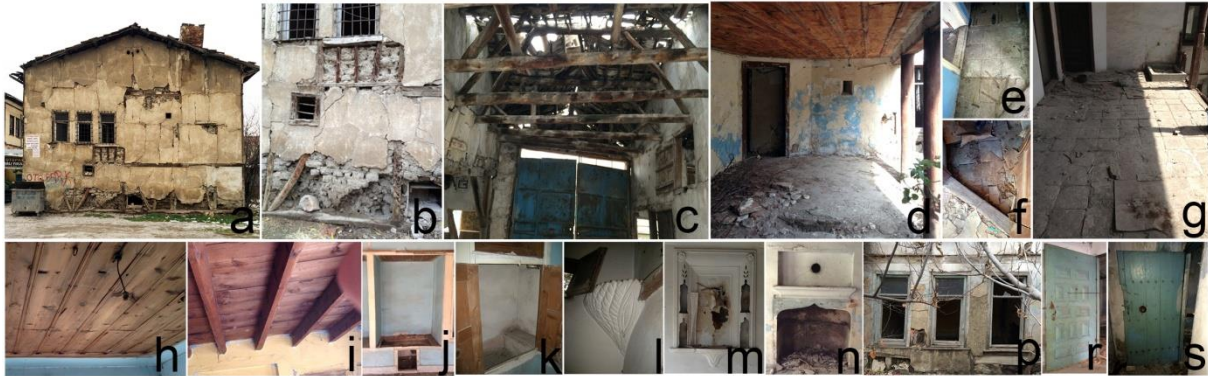
Figure 4. The detail photographs of the dwelling

In the *haymalik* section, the original barn and the façade of the *tandır* are designed as a wooden carcass filled with mud-brick. The inner side of the *tandır*, which faces the barn under the *haymalik* roof, is built with a brick furring technique. The *haymalik* section was coated with a lime-based mortar in its original condition. Today, most of this coating has fallen off. In this section, the timbers used in the bearing walls and

the roof construction are rough-hewn style. The roof is currently covered with Marseilles-type tile (Fig. 4c).

The dwelling differs from other examples in Çorum because its walls are not stone or brick masonry on the ground floor level. The main post and foot plates are rectangular in shape and made with fine-hewn timber. The sills, main braces (cross pieces), studs, bracings, and other posts are rough-hewn timber. The mud-brick tiles in between the wooden carcass are approximately $30 \times 17 \times 10 \text{ cm}^3$ (Fig. 4a, b).

The entrance floor rests on the earth. Except for the rooms, this part was originally covered with terracotta plaques. Today, most of these plaques are covered with a concrete layer (Fig. 4d). The floors of the rooms on the ground floor are covered with timber lining, and the walls are plastered. A lath-nailed wooden ceiling is used on the girders of the *taşlık* (Fig. 4d). The girders of the other room's ceilings on the ground floor are not covered and are made with rectangular fine-hewn timber (Fig. 4i). The rest of the ceiling girders are rough-hewn timber.

The stairs that connect the *taşlık* and the open sofa are made entirely of timber. The floors of the open sofa and the halls that connect the rooms to the sofa are covered with terracotta plaques (Fig. 4e, f, g). In the section where the sofa opens to the courtyard, three wooden poles carry the roof and the first floor pavement. There are 80-cm-wide hand rails with balusters in between the poles, and arches were made on the roof joineries over split wood with lime-based mortar. In all the spaces except the open sofa and the halls, floor girders are covered with timber linings. There is a lath-nailed wooden ceiling under the girders in all the spaces (Fig. 4h). The roof is a gable roof, and today, it is covered with Marseilles type tile.

Doors: The courtyard door has changed over time and is not original. Only the barn door is original among the doors in the *haymalık*. This door has the same features as the other doors on the ground floor. Doors on the ground floor are formed by fine-hewn timber linings that are 3 to 4 cm thick and 15 to 20 cm wide. These were constituted by locating them vertically next to each other. These parts are fixed together by bents, pegs, and nails. However, on the upper floor, the original doors are made by joining rectangular ornamented wood plates with the mortise and tenon method (Fig. 4r, s).

Windows: All the windows of the dwelling are made of wood and have been replaced over time, except for some of the loop holes. Today, the existing windows have single or double glass wings. It was determined from the traces on the window frames that there was

once a wooden *şebeke* grid system located in front of them (Fig. 4p).

Closets: All the closets in the rooms are located 25 to 30 cm over the floor and are designed with wooden shutters. The insides of the closets are covered with mortar. No original shutters are left today (Fig. 4j).

Abution niche: A sitting platform, a corner lamp stand, and a *mazgal* loop hole are present in every abution niche, which is found in every room. Wastewater is carried away from the building via pipes. The insides are also covered with mortar as in the closets, and privacy is maintained with two winged shutters. There are no shutters left today (Fig. 4k).

Lamp stands: Lamp stands are present over the furnaces or on walls and are ornamented or plain with various sizes in every room. The top of the lamp stands in the walls that lead to the hall are carved to make a hole in the wall for lightning both areas. They are made of gypsum (Fig. 4 l, m).

Furnace: A furnace is present in every room, but some of them have been closed up. They are designed to be rectangular, simple, and plain (Fig. 4n).

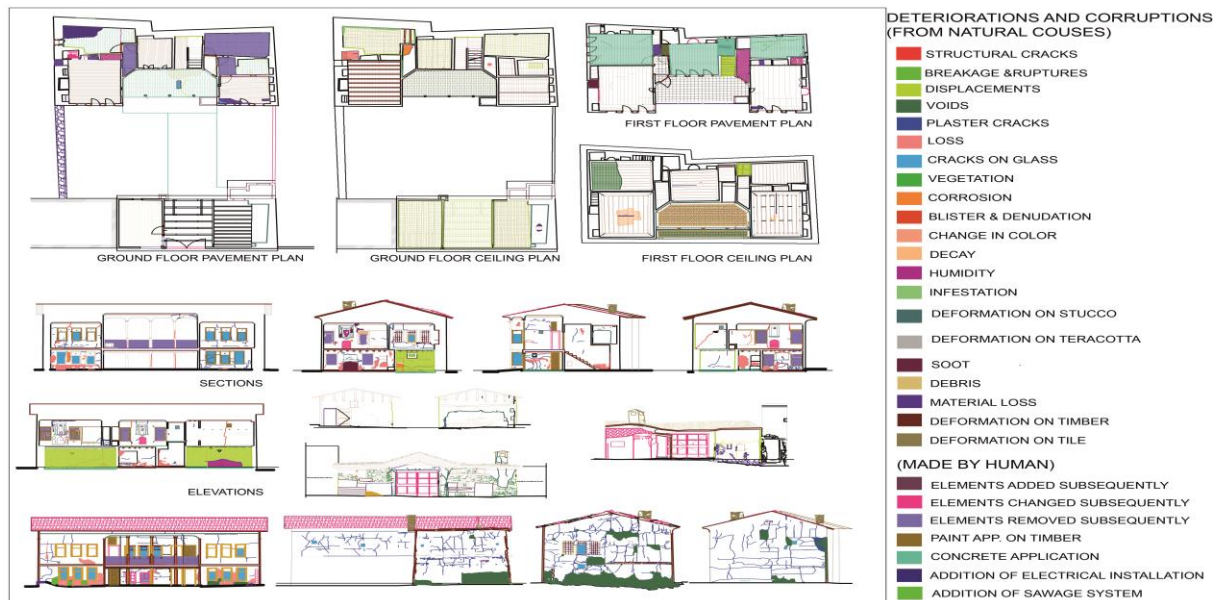
Figure 5. Deteriorations and corruptions determined in Satıcı dwelling

The structural condition of the dwelling requires urgent intervention. Deteriorations and corruptions in the dwelling were divided into those caused by nature and those made by people (Fig. 5).

Natural deteriorations include fine structural cracks in the wooden carcass system that carry the building. Other examples are deflection and displacements, moistening, rotting and change of color, erosion of the

mud-brick due to the swelling of mortar, breakage, rupture, moistening, and color change of the earthenware structural materials. Broken glass, moistening, shedding, denudation and swelling of the paint, molding, vegetation growth, and infestation are also included (Fig. 5).

Deteriorations caused by people are the removal of doors, shutters, door frames, railings, and balusters of the open sofa of the structural elements. Closing of the furnaces, changing some of the elements with unqualified versions, painting the wood with oil paint, separating the spaces via walls, addition of ceramics, linoleum, and carpet, and the addition of the unqualified toilet are other examples.
