# Elasto-Plastic Deformation of a Liquid Ammonia Storage Tank

Göksel Saraçoğlu<sup>1</sup>

## ABSTRACT

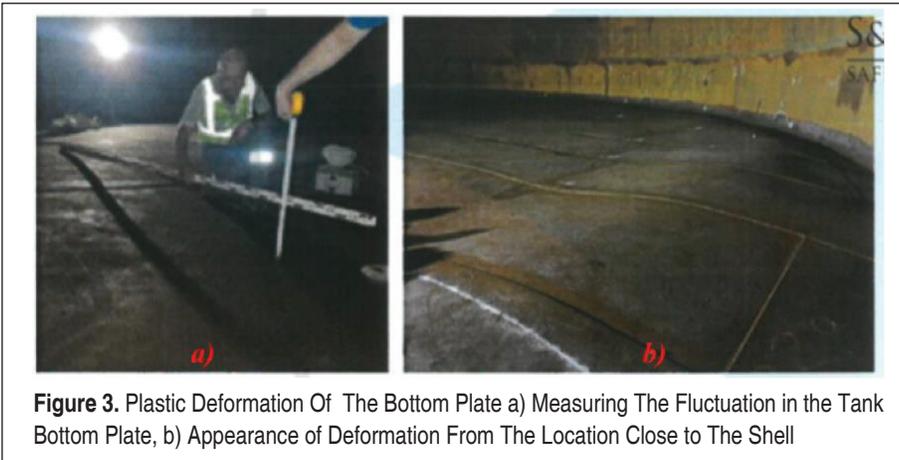
In the second inspection, unlike the first, fluctuations up to 240 mm in height were detected in the bottom plate of the inner tank with a diameter of 29,650 mm (Figure 3 and 4a).

First of all, the amount of plastic deformation was evaluated of the bottom plate of the inner tank according to Annex B-2 of the API-653 Code [15]. Accordingly, the maximum collapse value at the bottom of the tank was measured as 28 mm, the highest bulge value as 265 mm, and it was stated that it exceeded the limit value of 62 mm calculated according to the relevant Code.

In this case, a preliminary report was issued that the tank bottom plate cannot be used and the tank needs to undergo a rehabilitation.

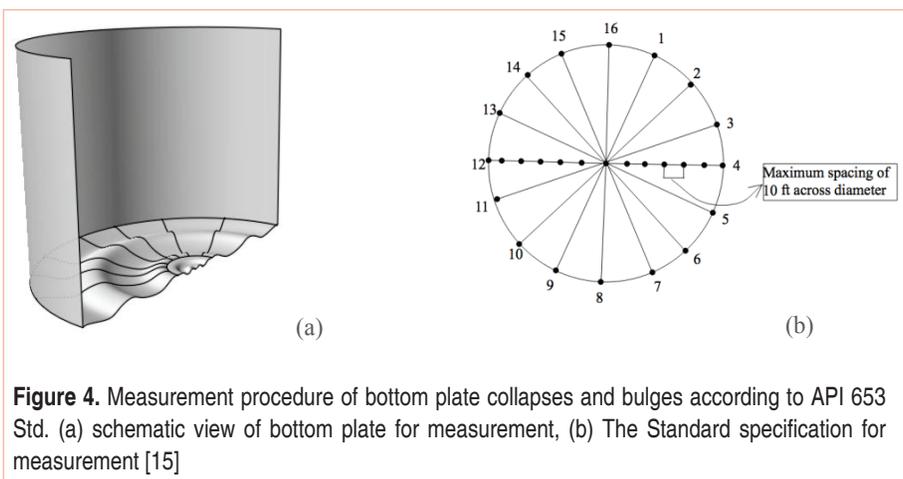
Considering the API Standard 653, the values in Table 1 were encountered when the heights of the wavy form of bottom plate were measured within a systematic as seen in Figure 4b.

**Table 1.** Bottom Plate Collapse Depth and Bulge Height Values (all collapses and the bulges above 50 mm are colored)

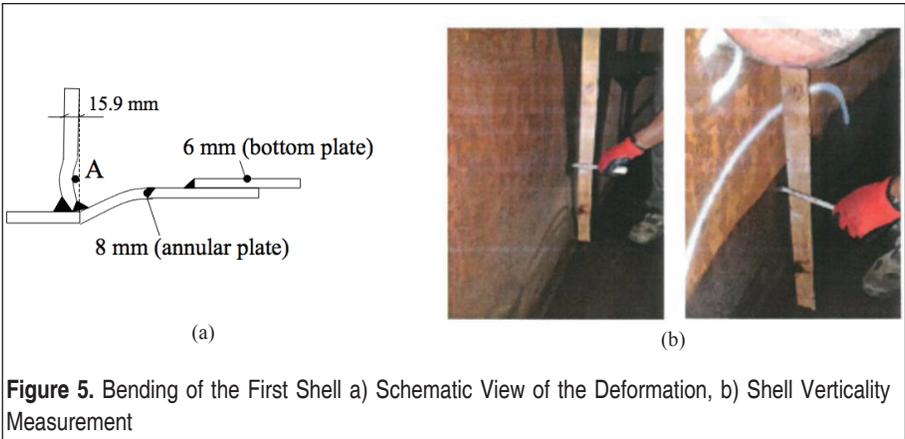
Another important result obtained from the field studies was that the inner tank (first) shell lost its verticality by bending (Figure 5). In the relevant (preliminary) report, it was reported that dishing occurred at the lowest level of 20 mm and the highest level of 38 mm during the verticality control along the tank perimeter, and it was stated that it was not suitable because it exceeded the limit level of 13 mm according to the API Standard 650 [12].

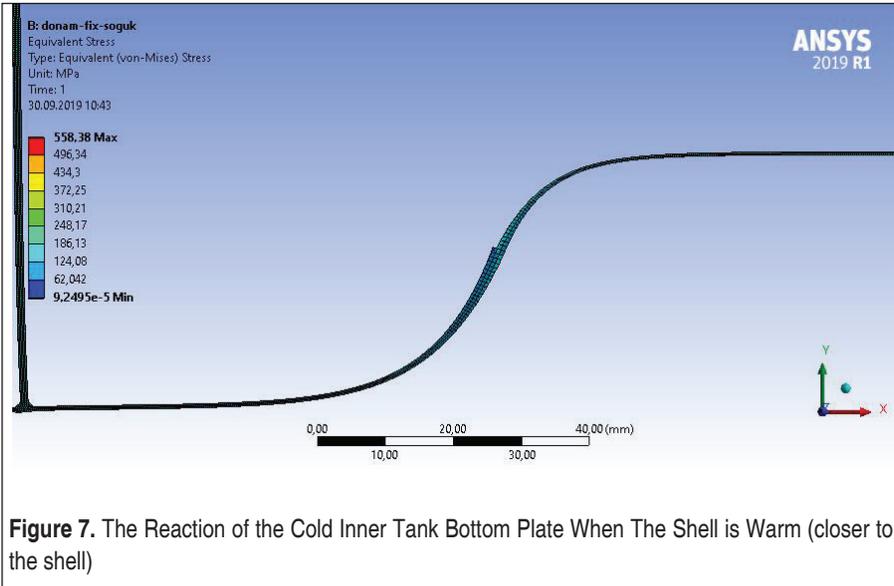
Figure 7. The Reaction of the Cold Inner Tank Bottom Plate When The Shell is Warm (closer to the shell)

When it was desired to verify the obtained values with the non-linear analysis of finite elements method, the close results were obtained as seen in Figure 7 if singularity values are filtered.

As a result of this calculation, it is seen that the stresses occurring in the bottom and the annular plate are different. These stresses are the maximum principal stresses occurring at the entire circumference of the tank. These stress values are emerging when the product-intake begins and only the bottom is wet by product and does not rise too

much at the wall (shell) level. The 157 MPa principal stress encountered in the 6 mm thick bottom plate or the 190 MPa obtained in terms of the von Mises stress is below the level that will cause plastic deformation, considering that the yield strength is 220 MPa.

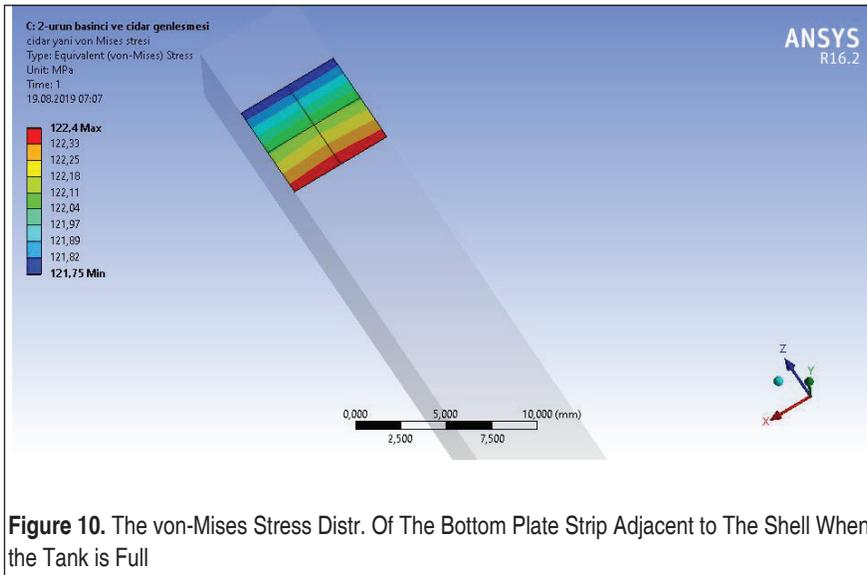
**Figure 10.** The von-Mises Stress Distr. Of The Bottom Plate Strip Adjacent to The Shell When the Tank is Full

The stresses encountered are below the yield stress when the tank is at full condition. As a result of the non-linear analysis based on this state, it is seen that the von Mises stress gives a result close to the calculated value as seen in Figure 10.

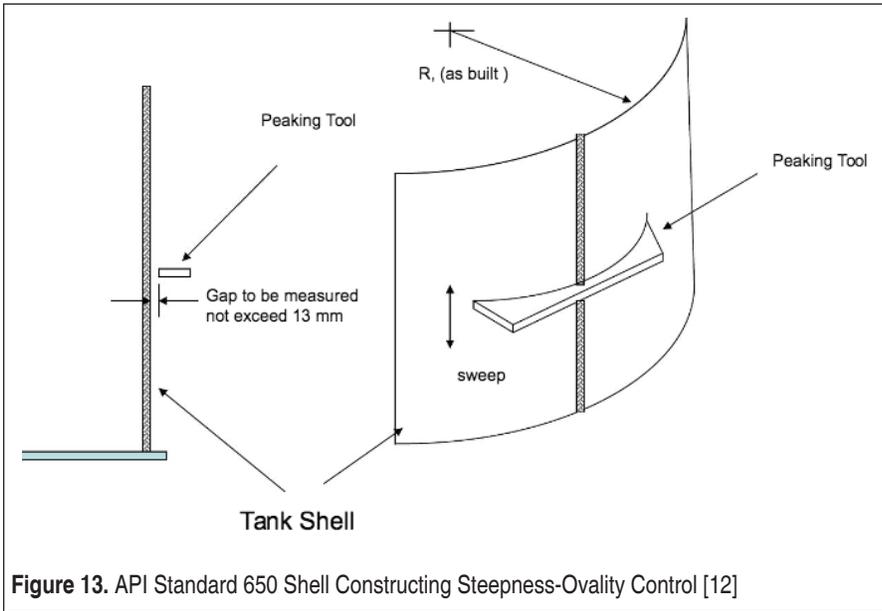
**Figure 13.** API Standard 650 Shell Constructing Steepness-Ovality Control [12]

When examining the verticality problem in the tank's shell, the steepness was thought as not suitable because it is more than 13 mm according to the API Standard 650 (Figure 13). But, in the standard, this issue is specified for the inspection of the shell that need to be bent according to the radius of the tank during construction. Hence, this issue was misunderstood. If there is a problem in the radius of curvature before the welding of the shell plates, it should be measured with the help of a gauge and if it exceeds  $\frac{1}{2}$  inch, the spot welding should be removed, the sheet should be straightened and put back in place. There is no such situation in the tank, because the thermal movements of the shell and the bottom plate cannot be synchronized due to rapid product intake into the tank, and in addition, the anchor rods and wind beams around the outer perimeter of the shell prevent the bending.

The yield strength of A516-70 material is 37,700 Psi (260 MPa). When the tank is full of product, the stress at the lower part of the first shell is 126 MPa. The stress caused by the weights of the above shell plates on the first shell is at the level of 0.93 MPa. It does not seem possible that a situation such as buckling or bending can occur in the first shell, which is supported by anchorages from the outside, with careful use after this point.
