Detection of Stone Material Deterioration in Historical Masonry Buildings by Observational Methods: Mardin Former American Missionary College

Lale Karataş¹

Mardin Former American College, which remains within the protected urban archaeological site in Mardin, is a unique cultural monument, which survives over the years, despite exposure to many environmental influences. A classification was made within the scope of the study, based on the deterioration patterns intended for the material deteriorations in the literature, to determine and document material degradation regarding the Former American College. Literature research, determination via observation, and documentation through photographing methods were used in the study. The information obtained was assessed via the descriptive and systematic analysis methods. The deterioration types obtained in the first stage of the study were obtained by carrying out an archive review regarding the stone material deterioration types. In the field research stage, Mardin Former American College was investigated and photographed. As a result of the observations, the deteriorations determined on the stone materials used in the building were

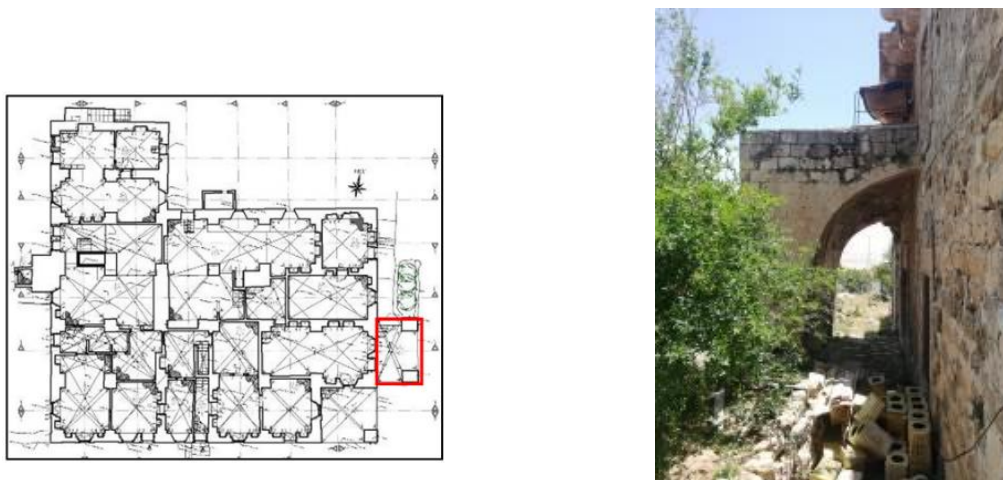
Defective repairs caused by the used of cement on the pillars, which have been made by using cut stone material and bear the upper cover, were observed ("Fig. 8")

Figure 8. Defective repairs caused by use of cement on the pillars (Karataş,2022)

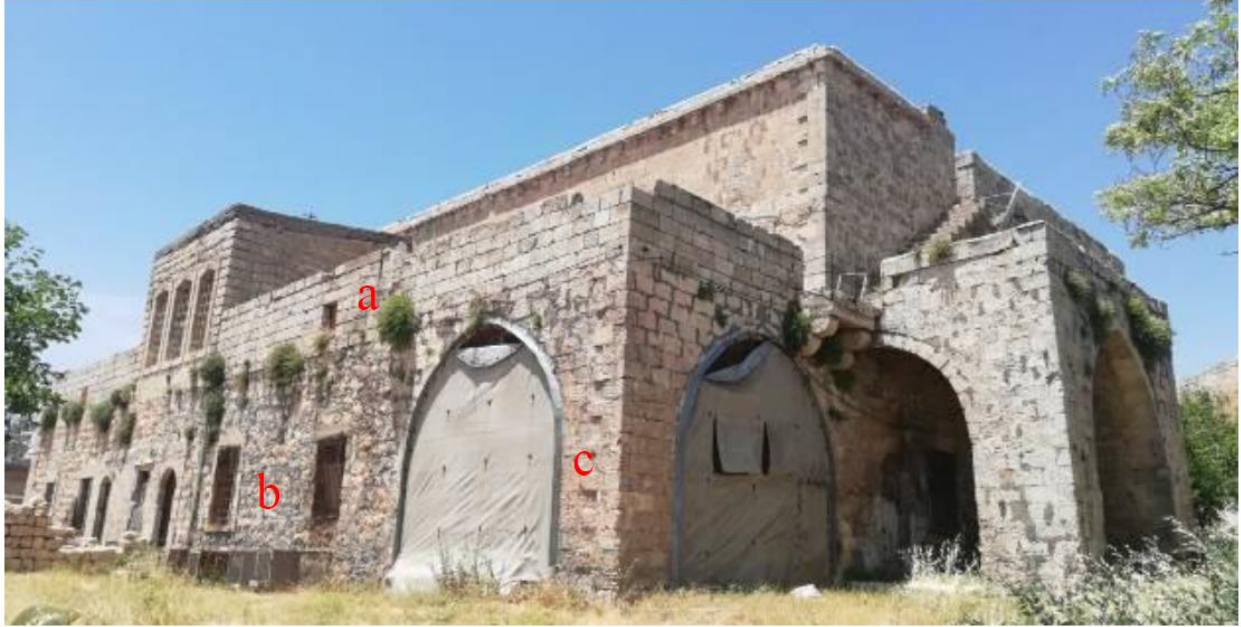
Figure 9. Material deteriorations of South Frontage (Karataş,2022)

Formation of plant, use of cement, and loss of surface were found on the South frontage (Figure 9).

a. Plant formation b. Use of cement c. Loss of surface

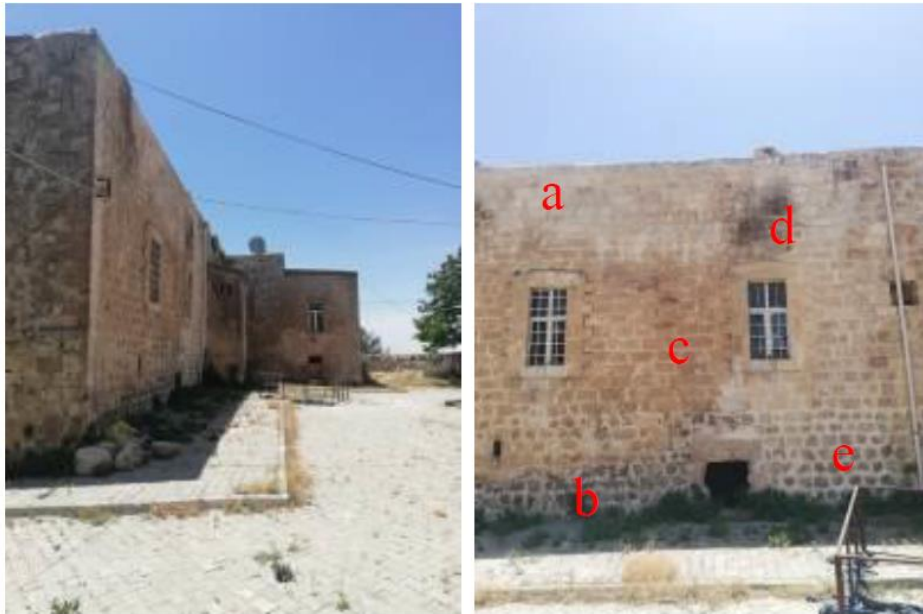
Figure 10. Material deteriorations of North Frontage (Karataş,2022)

Efflorescence, plant formation, colour change, surface contamination, use of cement was determined on the North frontage (Figure 10).

a. Efflorescence b. Plant formation c. Colour change d. Surface contamination e. Use of cement

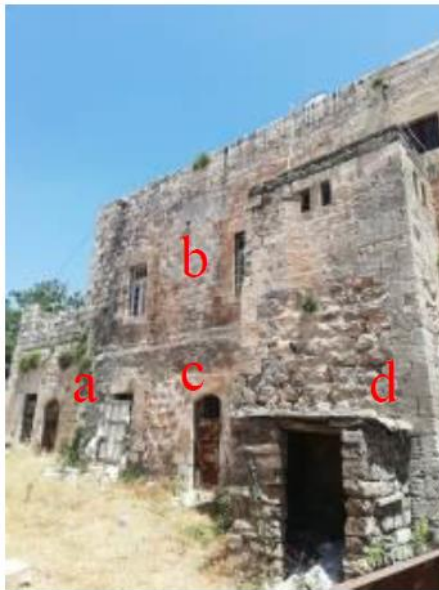
Figure 11. Material deteriorations of West Frontage (Karataş,2022)

a. Plant formation b. Efflorescence
c. Use of cement d. Loss of surface

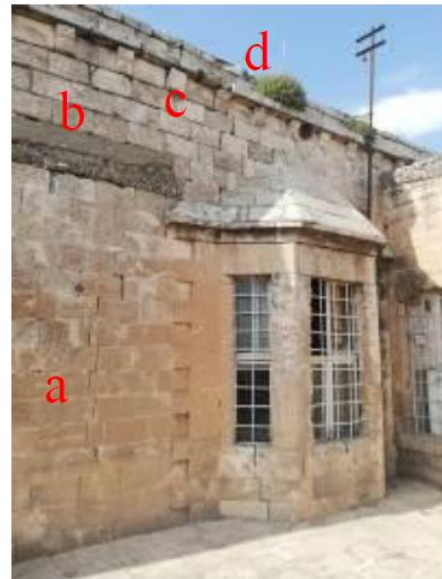
Figure 12. Deteriorations seen on the terrace wall (Karataş,2022)

a. Cracks b. Use of cement c. Discharge of jointing d. Plant formation

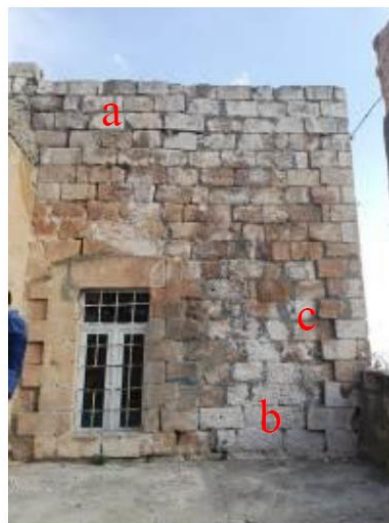
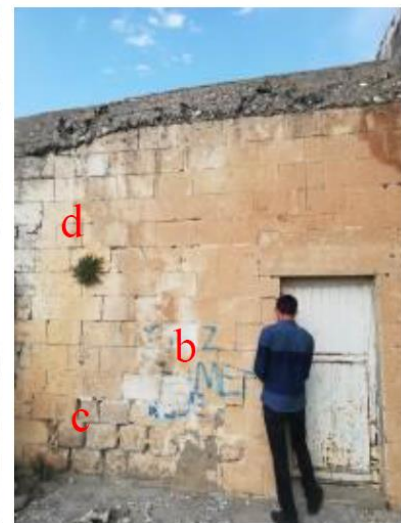
Figure 13. a. Efflorescence b. Use of cement c. Discharge of jointing d. Plant formation (Karataş,2022)

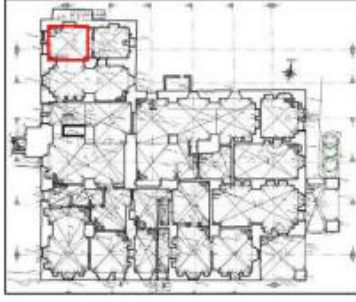
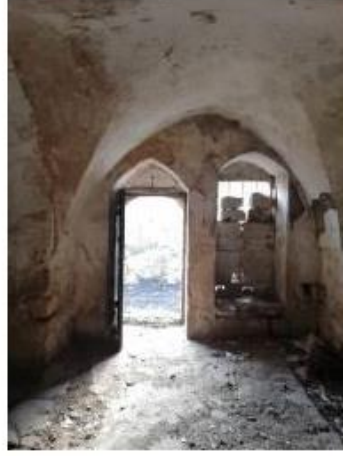
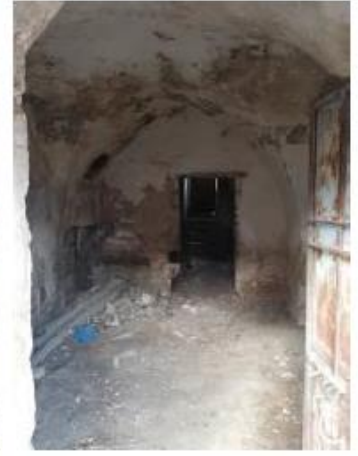
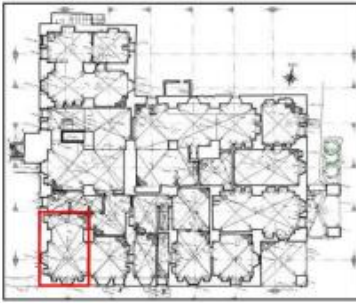
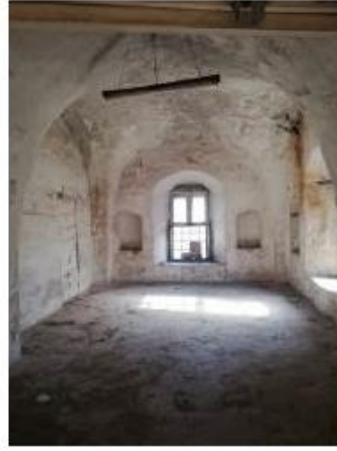
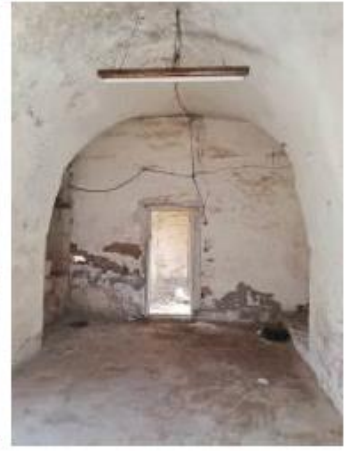
Damaged domes and vaults on horizontal carriers were examined. Fall of plasters and formation of moss due to humidity were not observed on the vaults, which are the horizontal bearings (Figure 14-15).

Figure 14. Examples of plaster fall on the vaults (Karataş,2022)

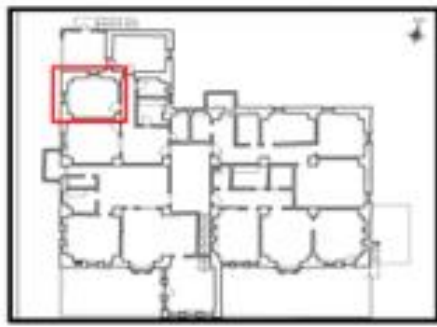
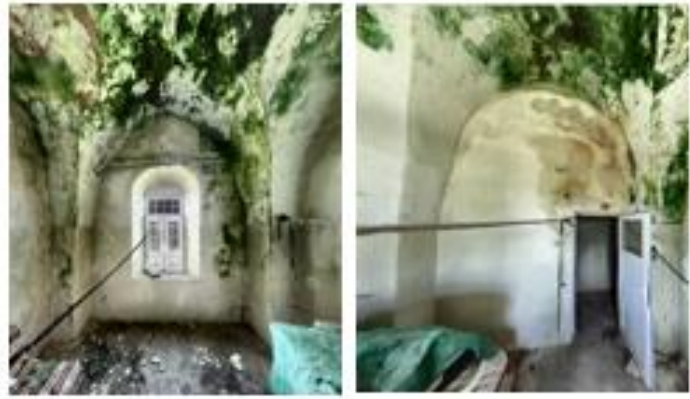
Figure 15. Examples of formation of moss caused by humidity on the vaults (Karataş,2022)

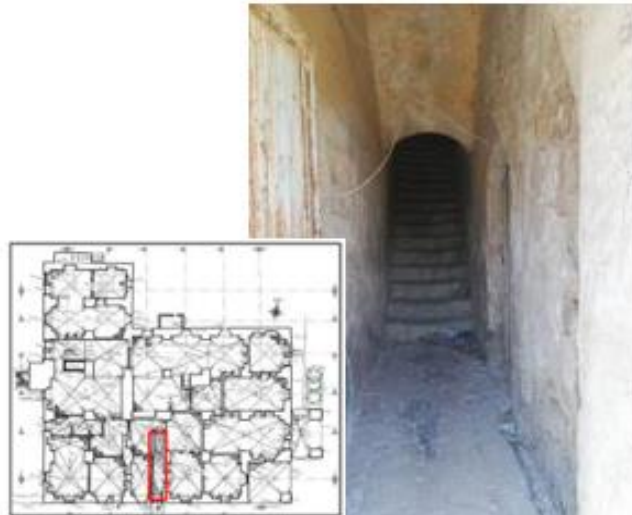
Problems of tear and colour change are seen on the stairs, which were made of smooth face stones (Figure 16).

Figure 16. Tear and colour change on the stairs (Karataş,2

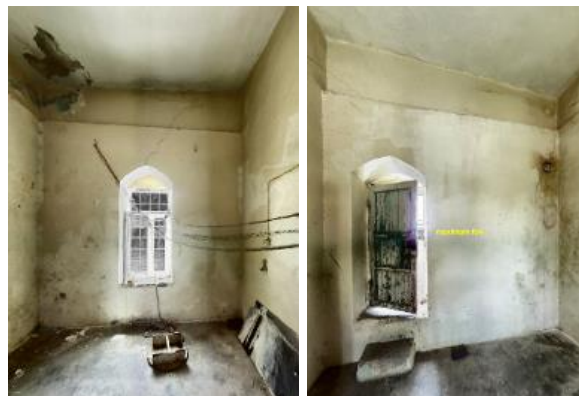
Windows, doors, and arches are seen as the wall openings in the building. Colour change on the arches, tear on the door sills, and colour change and loss of surface on the lintels over the windows were determined (Figure 17-20).

Figure 17. Colour change on the arches (Karataş,2022)

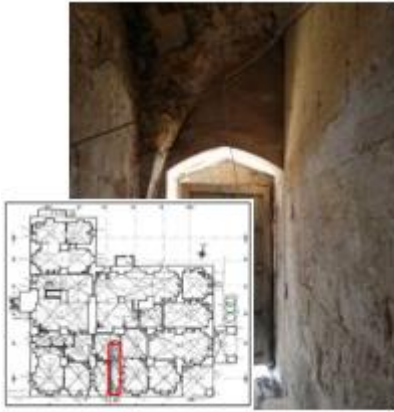
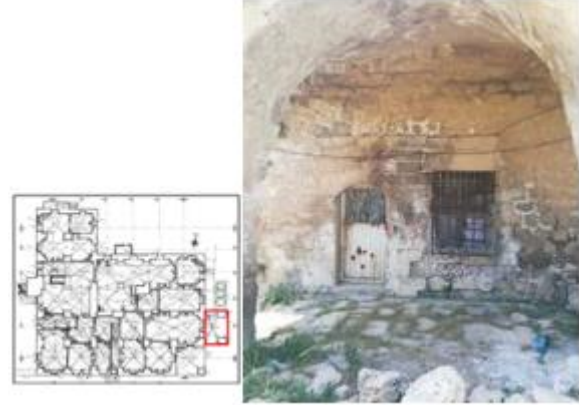
**Figure 17.** Colour change on the arch, tear on the sill (Karataş,2022)**Figure 18.** Colour change on the arch and lintel (Karataş,2022)

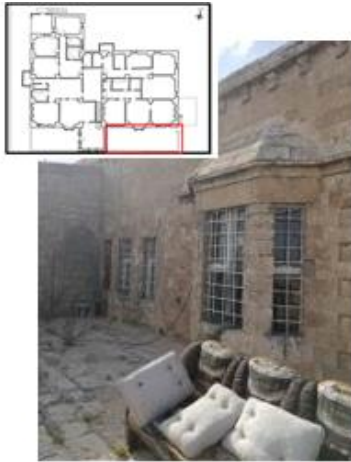
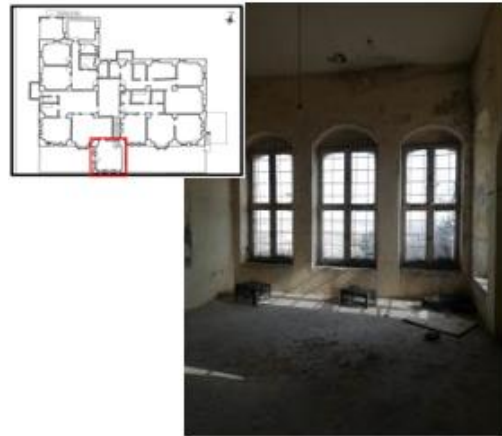
**Figure 19.** Surface loss on the lintel (Karataş,2022)**Figure 20.** Surface loss on the arch and lintel (Karataş,2022)
