## CORROSION OF INDUSTRIAL FRIT FURNACE REFRACTORIES: A POSTMORTEM STUDY

### ABSTRACT

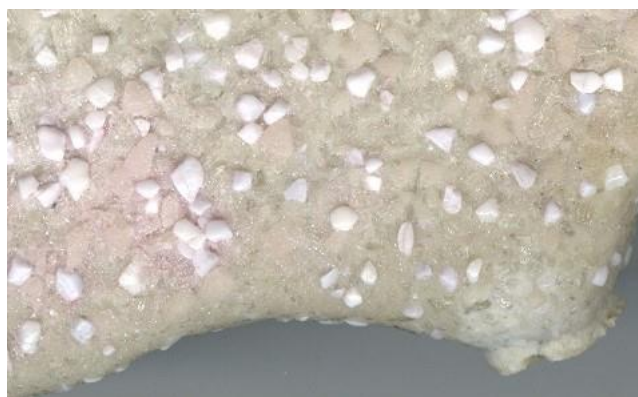
The examination with unaided eye of the corroded melt tank refractory brick as received (GS-M samples) showed that there were widespread white appearing granules embedded within a porous structure. In the refractory-molten glass boundary these white grains protruded, giving the impression that they had better corrosion resistance than the surrounding structure. Translucent type of grains also embedded and distributed diffusely in the structure. The rest of the refractory consisted of a homogeneous glassy matrix (Figure 1).

**Figure 1.** Photograph of corroded refractory brick (GS-M)

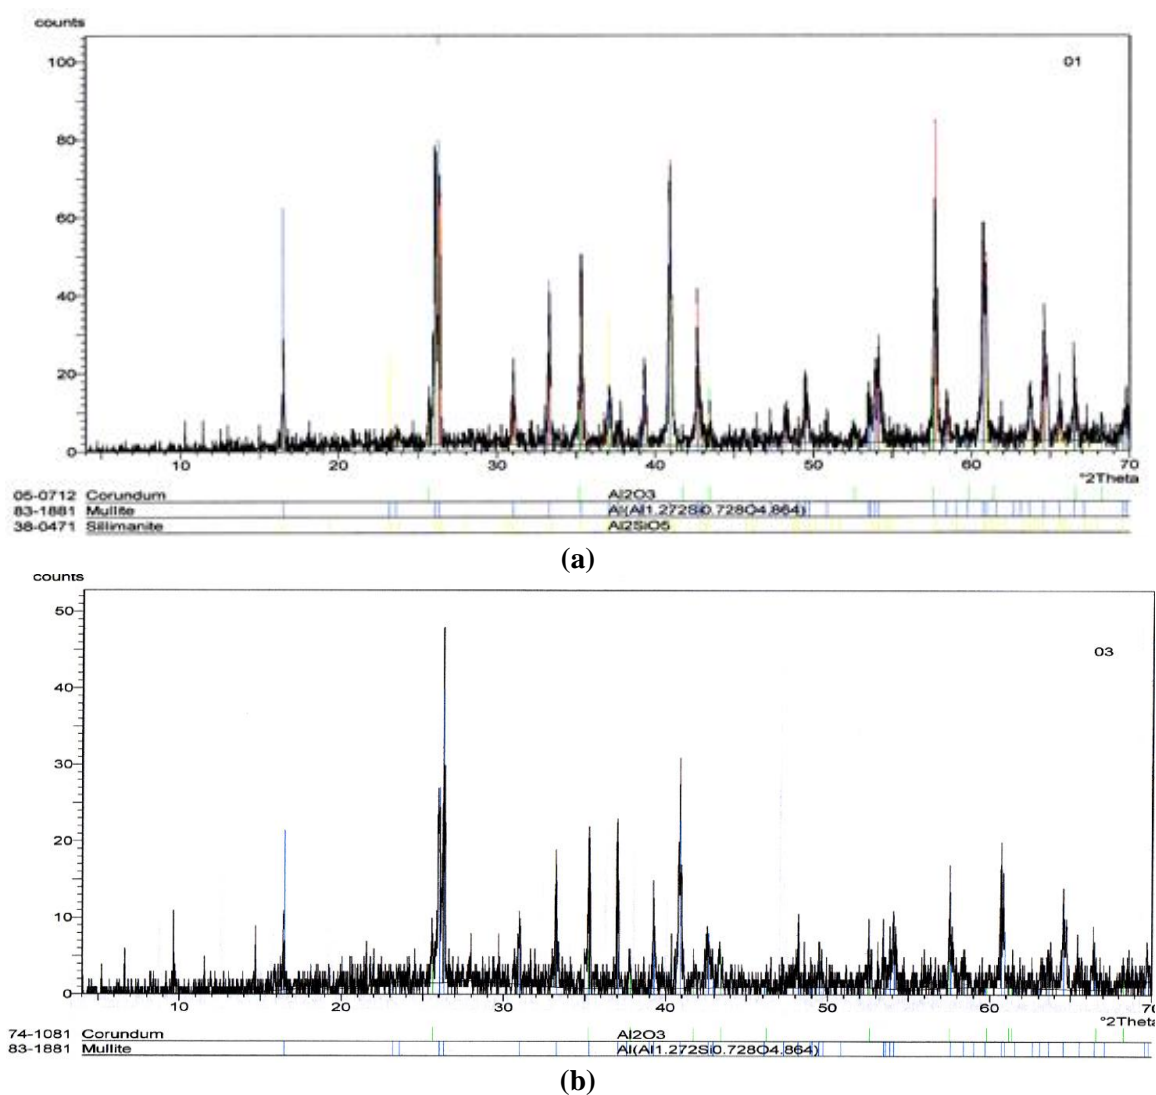
The XRD patterns of the unaffected inner bulk, and the corrosion interface of the corroded brick are given in Figure 2a, and Figure 2b, respectively. The results showed the existence of corundum, mullite and small quantities of sillimanite in the unaffected bulk portion, while corundum and mullite were the only existing crystal phases in the corrosion interface. The relative intensities of the peaks that belonged to corundum with respect to the mullite were greater for the corrosion interface as compared to the unaffected bulk pattern. This pointed out that the dissolution of mullite phase was more extensive than the corundum phase in the molten glass-refractory interface.

**Figure 2.** (a) The XRD pattern of the corroded refractory brick (GS-M sample), (a) the unaffected inner region, (b) the molten glass-refractory interface

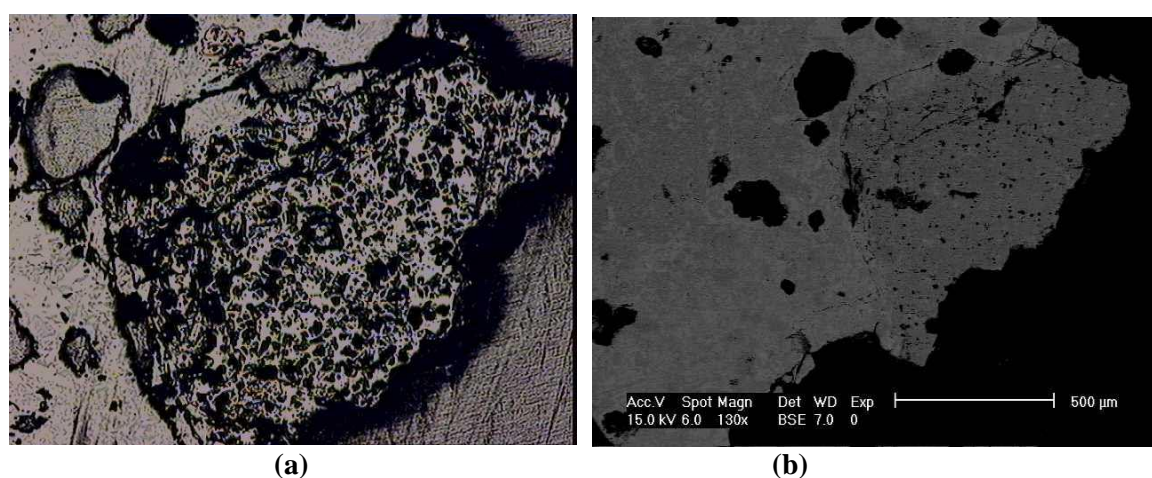
RL-OM and SEM were used for the microstructural examination of the described corroded refractory brick. The RL-OM and SEM images of the protruding grain on the corrosion interface are shown in Figure 3a and 3b. These grains were as large as 2 mm. The EDS analysis given in Figure 4 indicated 52 wt% Al, and 48wt% O, which was in agreement with the theoretical values for pure  $\text{Al}_2\text{O}_3$  (Al: 52.9 wt%, O: 47.1 wt%). Together with the XRD results these grains were identified as corundum. Most probably, these  $\text{Al}_2\text{O}_3$  grains had not formed or co-crystallized during the production of the brick, but rather preprepared corundum particles were mixed in the green composition of the refractory before firing.

**Figure 3.** (a) RL-OM image of corroded melt tank refractory brick; white color filler grain at the refractory-molten glass interface (magnification 150x), (b) SEM image of the same region

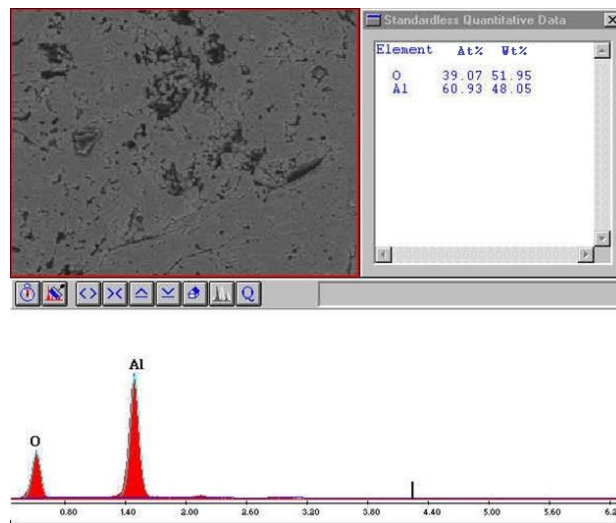
Figure 4. EDS zone analysis of the white color grain

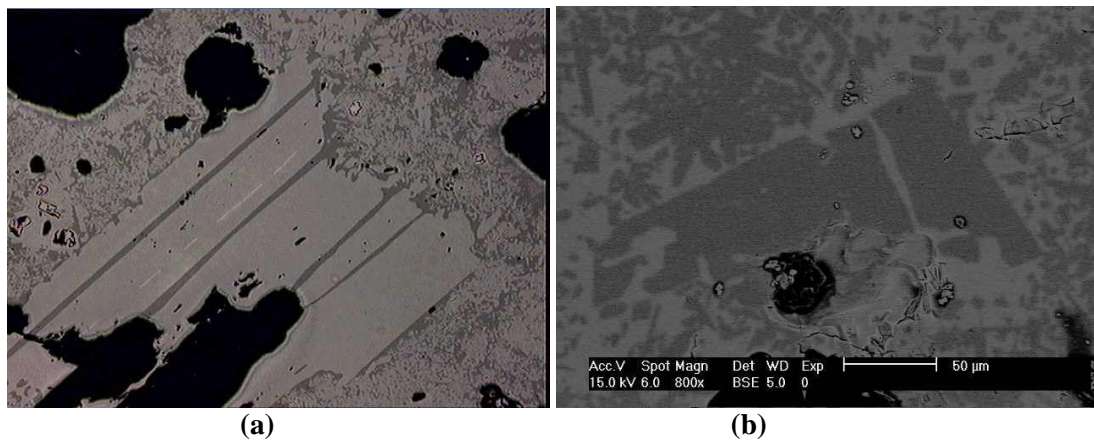
The widespread translucent grains in the structure were determined to be single crystals by the RL-OM and SEM images as shown in Figure 5a and 5b. The size of the grains could be as large as 2 mm. The point EDS analysis of the grain given in Figure 6 indicated that the elemental composition was 37 wt% Al, 11 wt% Si, and 52 wt% O, close to the theoretical values of mullite,  $3\text{Al}_2\text{O}_3 \cdot 2\text{SiO}_2$  (Al: 38.0 wt%, Si: 13.2 wt%, O: 48.8 wt%). The XRD patterns in Figure 2a and 2b showed mullite as the major crystalline phase for both of the inner bulk and corrosion interface regions, supporting the translucent grains to be mullite crystals. The slight discrepancy from the mullite composition in the EDS analysis might be due to the existence of embedded  $\text{Al}_2\text{O}_3$  crystals in small quantities. These were the crystals formed during the heat treatment step of the refractory production.

Figure 5. (a) RL optical microscope image of idiomorphic mullite crystals in the unaffected bulk of the corroded refractory (150x) (b) SEM image of idiomorphic mullite crystals in the bulk

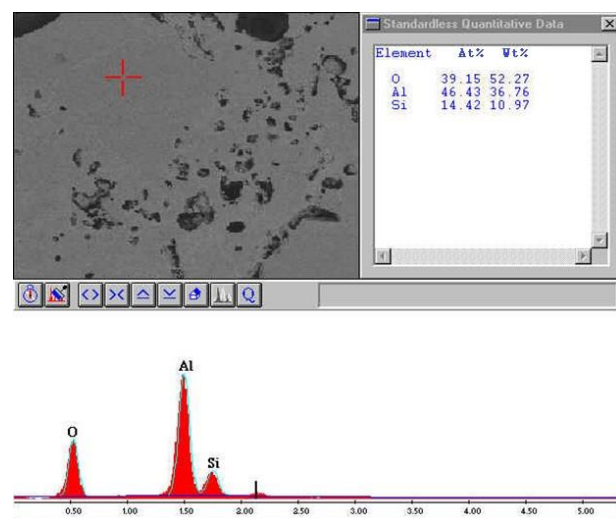
Figure 6. EDS point analysis of the idiomorphic grain

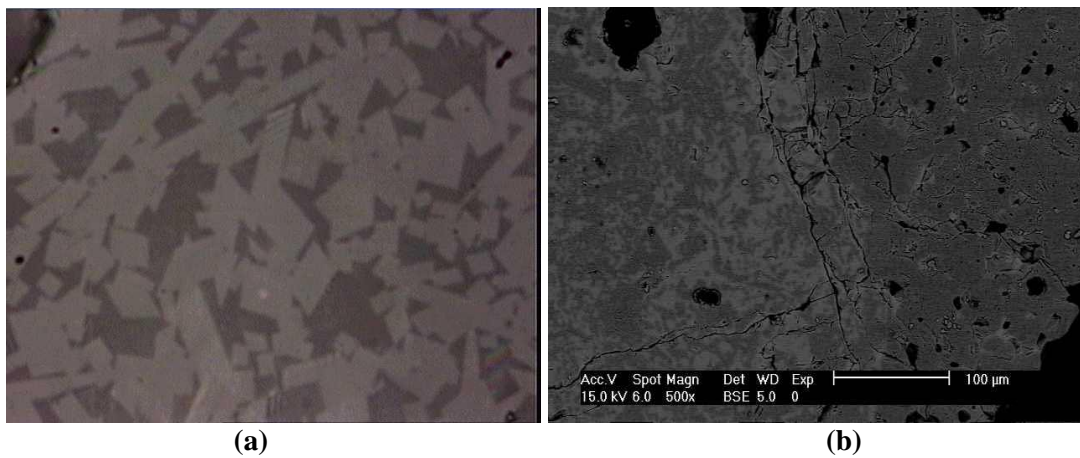
RL-OM and SEM images of the matrix surrounding the filler corundum and mullite grains are shown in Figure 7a and 7b. The elemental composition of the matrix was determined by EDS analysis as shown in Figure 8a and 8b. The structure that could be described as the dark gray portion of the matrix in the SEM images turned out to be mullite crystals with small amounts of glass phase (Figure 8a). The light gray portion of the matrix was found to be a glassy phase of majorly Si and Ca, with smaller amounts of Mg, K, and Na (Figure 8b). In RL-OM images of the mullite crystals there were light grey colored grains surrounded by the darker colored glassy matrix. The mullite crystal sizes on the average were  $\sim 7 \mu\text{m}$ . The glassy portion constituted about 35 vol% of the matrix as determined by SEM image analysis. The refractory structure was porous with pore sizes up to 1 mm.

The microstructure of the corroded refractory brick (GS-M) showed no change from the refractory-molten glass interface towards the inner bulk region. There was not a detectable freeze plane inside the refractory. This observation pointed out that the corrosion mechanism was direct dissolution of the refractory material.

**Figure 7.** (a) RL optical microscope image of glassy matrix incorporating mullite crystals in the unaffected bulk of the refractory (3000x) (b) SEM image of the glassy matrix incorporating mullite crystals in the unaffected bulk of the refractory

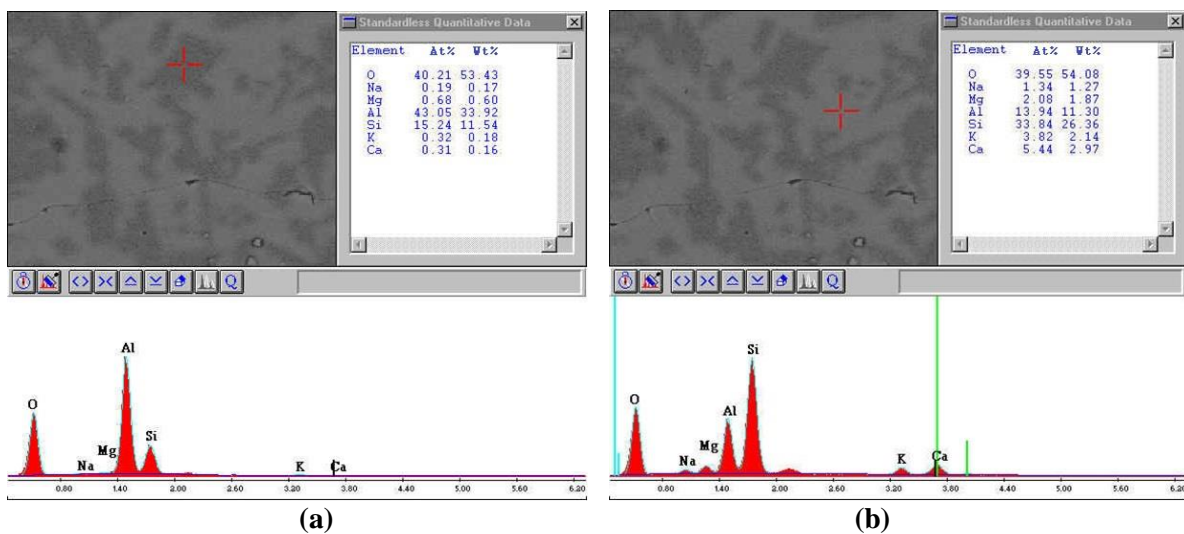
**Figure 8.** (a) The EDS point analysis of the dark gray portion of the matrix, (b) The EDS point analysis of the light gray portion of the matrix

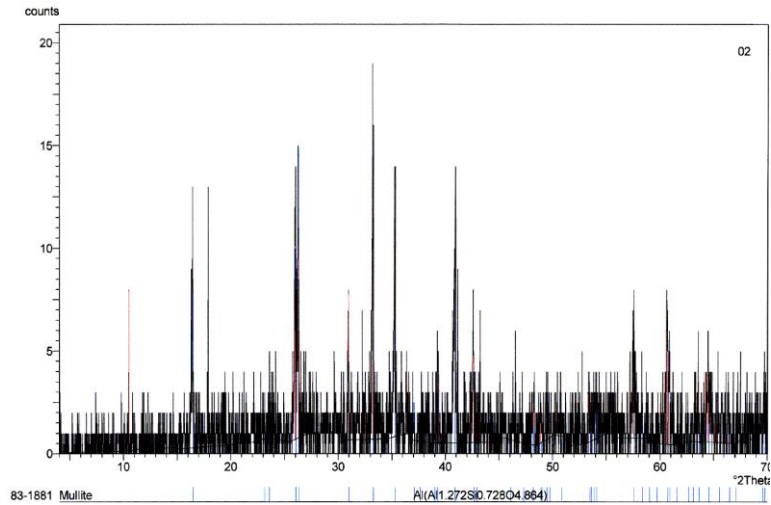
The XRD pattern of the mortar layer (Figure 12) showed that the crystalline phase was almost entirely mullite. The mortar layer was easily discernible by unaided eye as a dark gray region. The RL-OM image of the mortar layer is given in Figure 13. The crystal structure and the glassy matrix did not show any discernable differences for the regions near and far from the corrosion interface. There was not any detectable freeze plane also for the mortar. These observations further pointed out that the corrosion mechanism was direct dissolution of the refractory material in the molten glass. The mullite crystal sizes were ~14 μm on the average. The porosity of the corroded mortar layer was approximately 40% with pore sizes up to 1mm.

**Figure 12.** The XRD pattern of the corroded mortar connecting refractory bricks

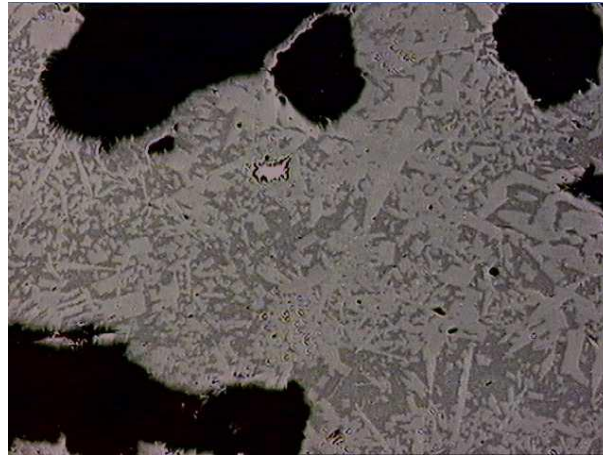
**Figure 13.** RL-OM image of the corroded mortar connecting the refractory bricks

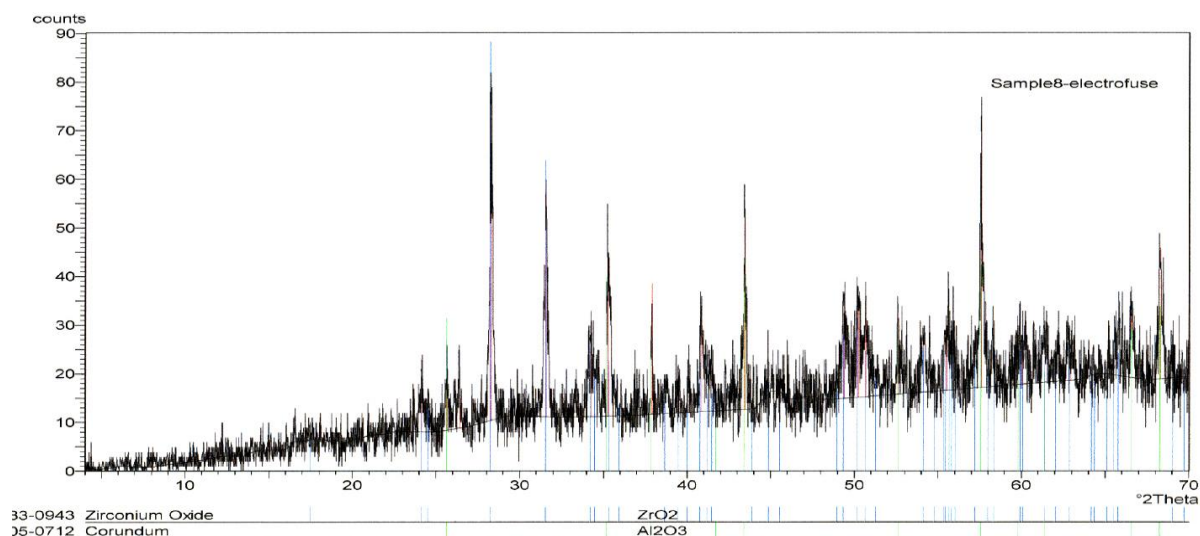
The XRD pattern of the corroded electrofused cast AZS block showed that the only crystal forms comprising the refractory were  $ZrO_2$  and corundum (Figure 14). This might point out to the possibility that the amount of mullite crystals was too low to be detected by the XRD.

**Figure 14.** XRD pattern of the corroded electrofused cast AZS refractory

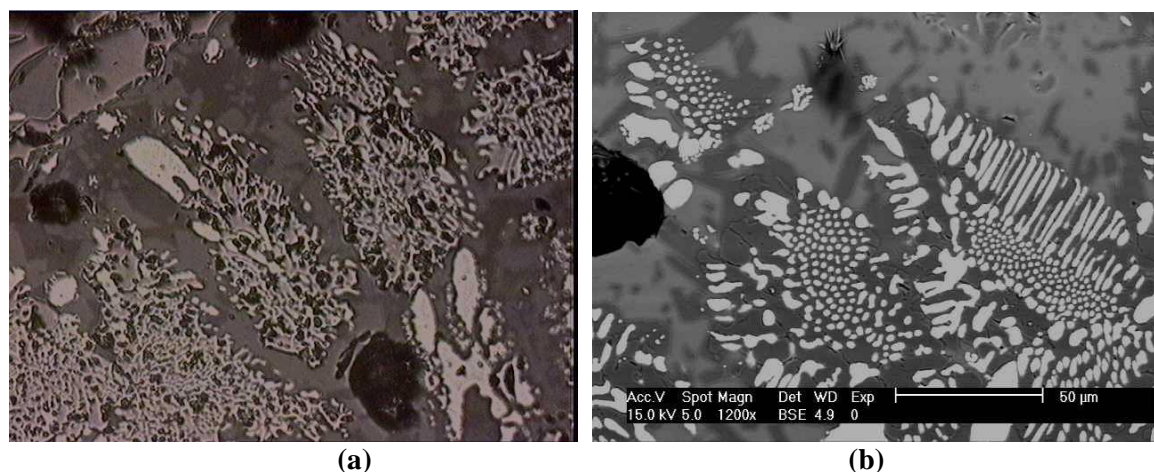
The microstructural analysis of the corroded electrofused cast AZS brick (GB-AZS) was carried out by RL-OM and SEM-EDS analyses. The related images are shown in Figure 15a and 15b. Although the grain structure of the molten glass interface was different from the relatively unaffected bulk, it was not possible to detect any freeze plane. The examination of the interface did not show any solid product accumulation, evidencing the direct dissolution mechanism.

**Figure 15.** (a) RL-OM image of the electrofused cast AZS refractory, inner bulk, (b) SEM image of the same refractory, inner bulk

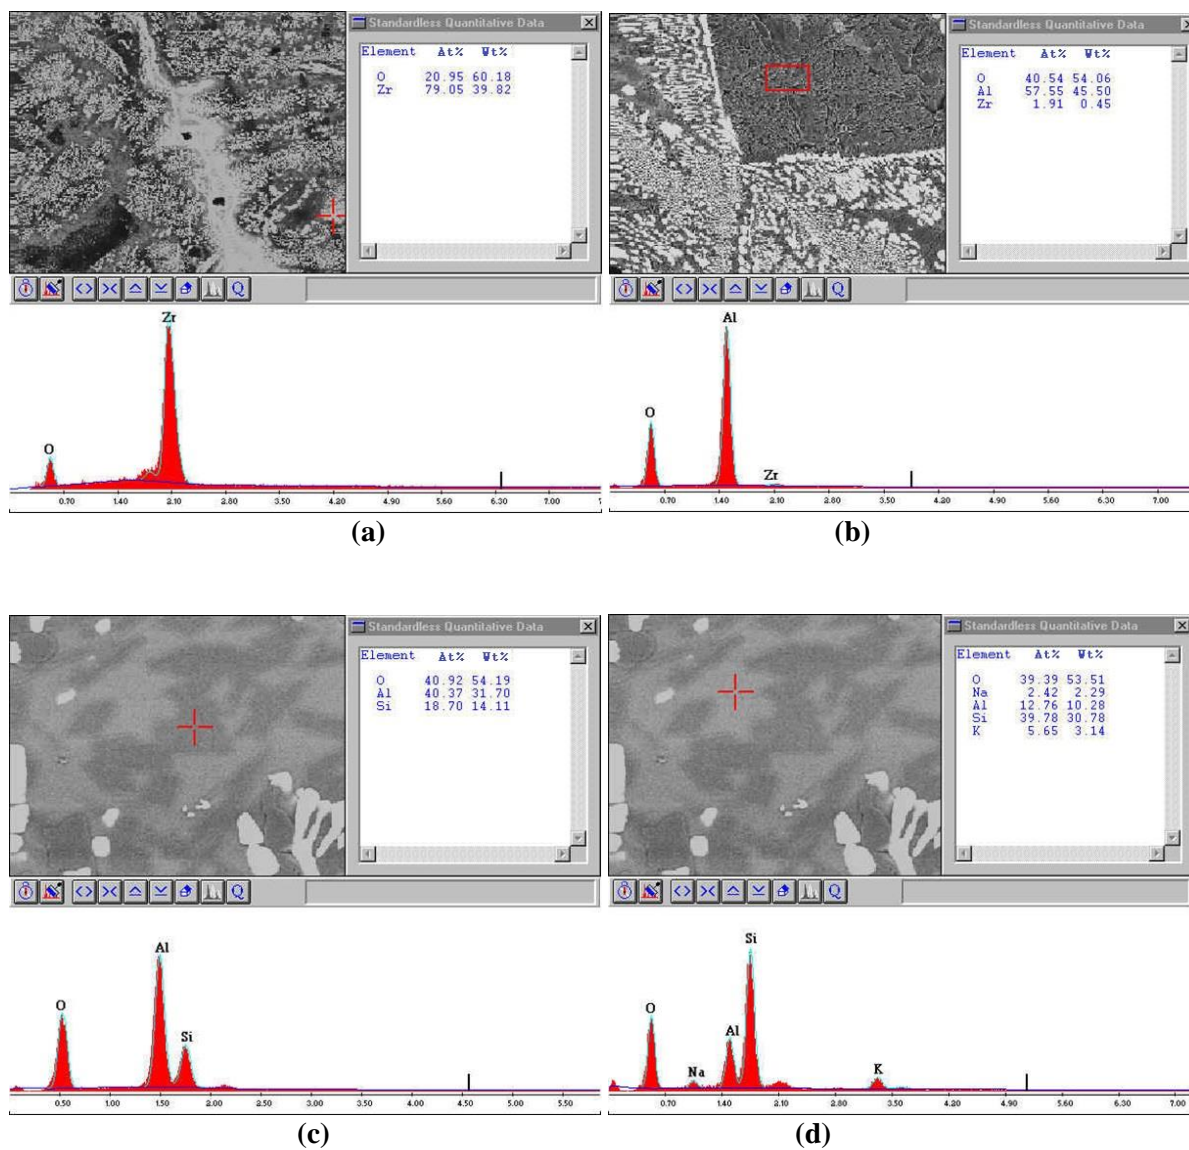
The EDS analyses of various features in the structure are shown in Figure 16. The refractory block contained  $ZrO_2$  crystals widespread throughout the body. Large corundum grains existed in little quantities. The matrix contained mullite crystals embedded in a glass phase of Si, Al, K, and Na. The service life of AZS refractory pavers was observed to be longer in comparison to the GS-M refractory bricks.

**Figure 16.** (a) EDS analysis of widespread  $ZrO_2$  crystal grains (b) EDS analysis of corundum grain (c) EDS analysis of mullite crystals (d) EDS analysis of glassy matrix

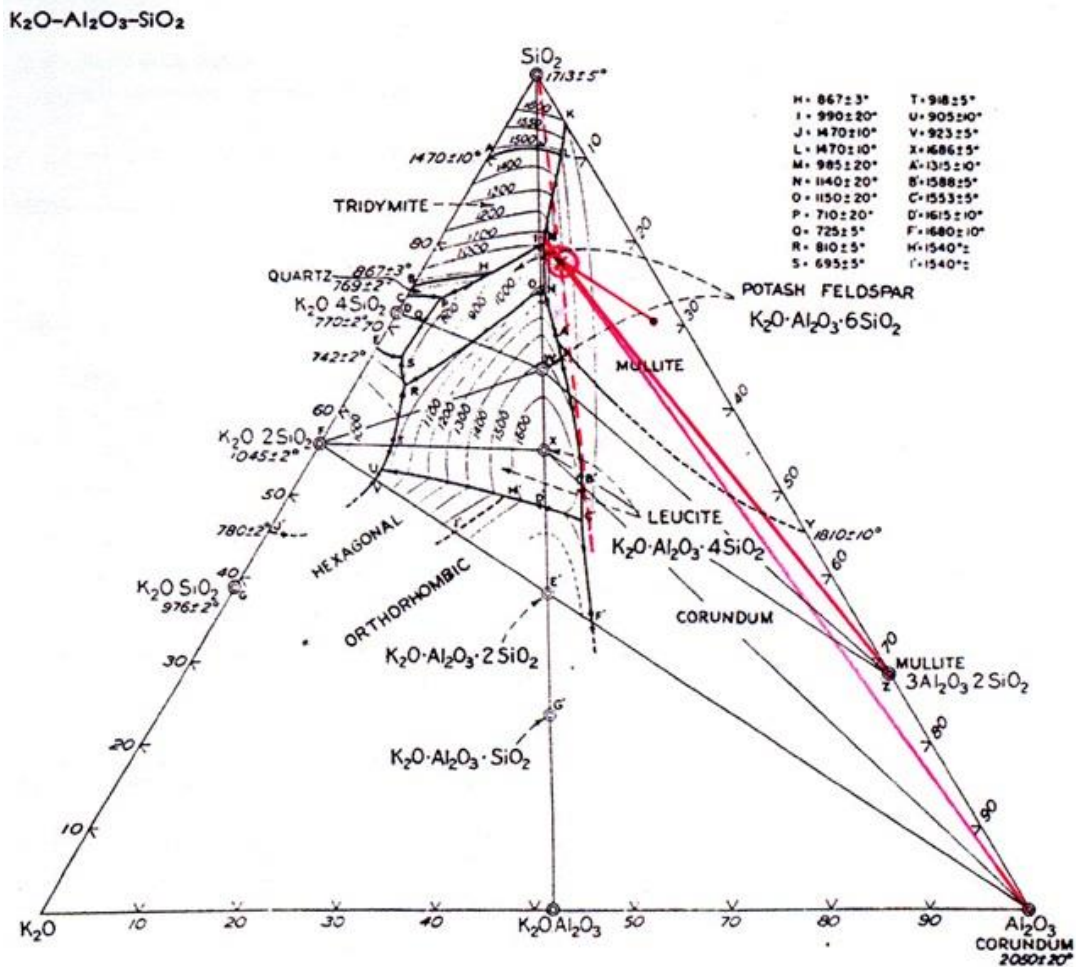
In the examined GS-M refractory the most abundant compounds were that of  $Al_2O_3$ ,  $SiO_2$ , and  $K_2O$ . Therefore, by predicting the effect of the molten glass on these compounds by the use of the ternary phase diagram of  $K_2O-Al_2O_3-SiO_2$  given in Figure 17, it would be possible to predict the corrosion behavior of the refractory in the molten glass environment.

The liquidus temperature for the transparent-1 molten glass composition which is in the primary crystallization field of mullite is 1340°C. Between 1040°C to 1340°C mullite will be fused from the refractory. Between the eutectic at 1000°C to 1040°C mullite and tridymite (SiO<sub>2</sub>) will be fused together. At 1000°C potash feldspar (K<sub>2</sub>O.Al<sub>2</sub>O<sub>3</sub>.6SiO<sub>2</sub>), tridymite, and mullite fuses to the molten glass. Corundum in contact with the given molten glass will fuse at 1050°C. Only SiO<sub>2</sub> can survive before fusing slightly over 1600°C. The glassy phase of the refractory, the EDS analysis of which is given in Figure 8b, had the relative composition of 3.1 % K<sub>2</sub>O, 26.3% Al<sub>2</sub>O<sub>3</sub>, and 70.6% SiO<sub>2</sub>. Alarmingly, this composition is in equilibrium with the molten glass at slightly lower than 1000°C.

Given the operating temperature as 1470±20°C the glassy phase, mullite crystals, corundum grains will fuse into the molten glass. Since the concentration of SiO<sub>2</sub> in the molten glass is higher as compared to Al<sub>2</sub>O<sub>3</sub> and K<sub>2</sub>O, the driving force for the dissolution of both Al<sub>2</sub>O<sub>3</sub> and K<sub>2</sub>O (depending on their saturation solubilities at 1470°C) is higher as compared to SiO<sub>2</sub>. Chemical corrosion by direct dissolution into the molten glass is the dominant mechanism of wear. The rate of wear is increased by the first push exudation, causing erosion in the form of mechanical spalling.
