Failure mechanism of a soil slope and stabilization method: a case study

Mustafa KANIK¹*^(D)

Received: 10.10.2022 Accepted: 25.10.2022 Revision: 22.10.2022	doi: 10.5505/fujece.2022.35744 Case Report
--	---

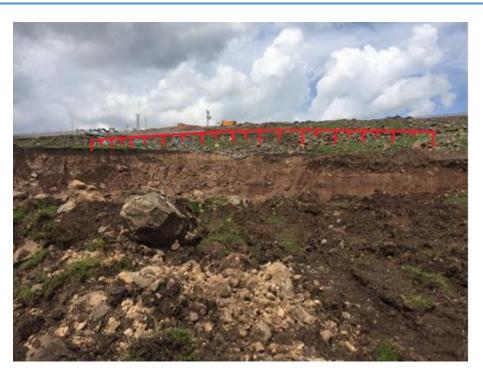
It is desired to build a water treatment plant in the region where failure occurs. Excavations were started in this area, but after the excavations have started, a failure occurred (Figure 1). Before seeking for the reasons of the failure the data about the soil should be collected. In the study area is formed of Miocene-Pliocene aged Şelmo Formation, first defined by Bolgi [25]. The Şelmo Formation starts with fine grained conglomerate at the bottom. It consists of cross-bedded, dough-supported, magmatic grains, limestone, sandstone, and the matrix consists of sand and clay [26]. The Şelmo Formation bears traces of flovial deposits in its upper parts. Therefore, if the Şelmo Formation is considered as a whole, it can be named as fan deposits [27, 28].

Figure 1. The area where the failure in the study area occurs

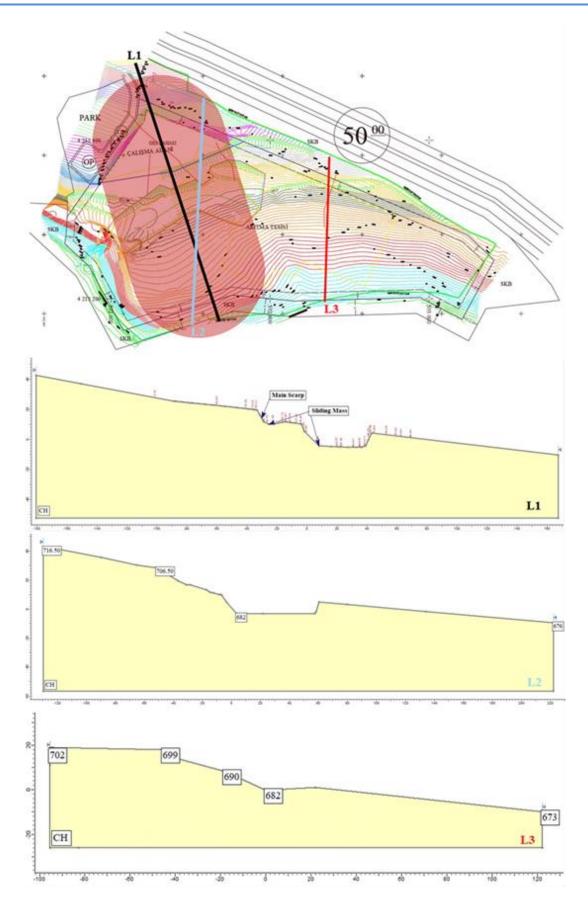
Figure 2. Instable area red circled and studied lines (L1, L2 and L3)

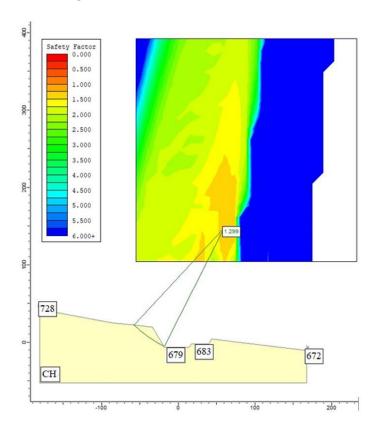
As a result of the analysis, the static state safety factor for the natural slope was obtained as 1.299 (Figure 4). This indicates that the factor of safety of the slope is sufficient for the given condition.

Figure 4. The minimum factor of safety (1.29) obtained for the static condition for Line-I

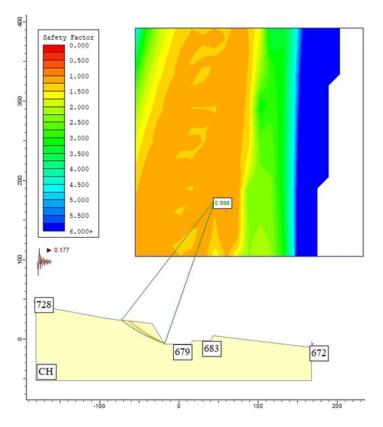
Considering the seismicity of the region, the same slope was remodeled under dynamic conditions and analyzes were carried out. The PGA value of the region in which the study area is located was specified as 0.177 g (Figure 3). When the results of the analysis are examined, the lowest safety factor for the slope is 0.998 and the structures to be built are within the effect limits of the possible failure shown in Figure 6.

Figure 5. The minimum factor of safety (0.998) obtained for the dynamic condition for Line-I

Although the failure seems to have occurred after the excavation works started, considering the factor of safety values obtained as a result of the analyzes performed by considering the laboratory test data, it does not seem likely that any failure problem will arise under these conditions. However, there was a failure occurred in this line. In order for the stability to occur, changes in soil parameters (physical and mechanical) must have happened. This parameter change could only be possible by the precipitation that occurred before the failure in that region. Many researchers [29 - 35] revealed this with their studies in different regions. Since precipitation cannot be prevented in the region or anywhere, it is necessary to carry out studies to increase the factor of safety value.

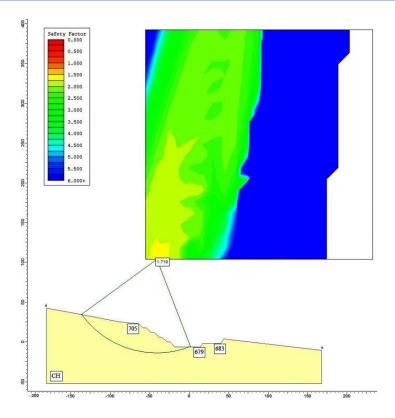
Figure 6. The minimum factor of safety (1.710) obtained for the static condition after the benching process of Line-I

The variation of the factor of safety value for the same conditions was examined by reconstructing a model for the benching process, which is one of the economical solutions that can be envisaged in order to increase the factor of safety value. For this purpose, 6V/6H (Bench Height/Bench Width) and 4 meters of step width were modeled and analyzed (Figure 6-7). The reason for choosing these values is to prevent possible sliding movements on slopes where mass movement does not occur, since, in the end, the entire working area where excavation works will be performed will actually be one slope. The analysis determined that the minimum safety factor of the slope in this state is 1.710 for the static situation and 1.063 for the dynamic situation. It turns out that the factor of safety of the slope in the dynamic case is close to the critical limit value. Since the dynamic conditions represent the most unfavorable conditions, the value of 1.000 to be obtained from here is sufficient for slope safety. According to TDBY [36], for the dynamic conditions safety coefficient should be greater than 1.10, but the S_{DS} (spectral acceleration coefficient) value is lower than the PGA (peak ground acceleration) value used in the analyzes; thus, 1.000 for the factor of safety value is applicable.

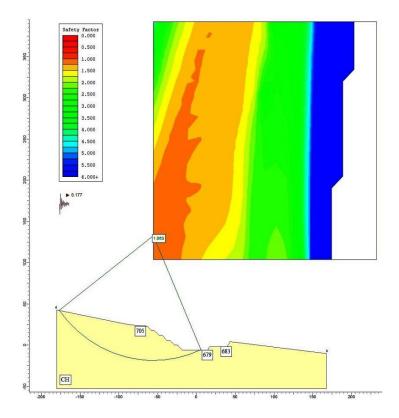
Figure 7. The minimum factor of safety (1.063) obtained for the dynamic condition after the benching process of Line-I.
