Engineering Geological Assessment of a Slope Instability: A Case Study in the Guzelyali Region (Canakkale, Turkey) *Bir Şev Duraysızlığının Mühendislik Jeolojisi Değerlendirmesi: Güzelyalı Bölgesinde Bir Vaka Çalışması (Çanakkale, Türkiye)*

Guzelyali village, 20 km southwest of Canakkale city, is located on the shore of the Canakkale Strait (Dardanelles). The residential area located at the entrance to Guzelyali village has experienced landslides at different times since November 2001. In February 2013, the Güzelyalı landslide was triggered again due to severe rainstorms. As a result of the landslide, deformations and cracks formed in buildings, garden walls and the Canakkale-Guzelyali road. In this study, the aim was to determine the most appropriate improvement method to prevent landslides by determining the depth of the slip surface that caused the Guzelyali landslide and the geotechnical properties of the units. For this purpose, field observations, drilling, obtaining appropriate samples from these works for index and mechanical tests and monitoring studies by using inclinometers were carried out in order to evaluate the instability. As a result of inclinometer measurements,

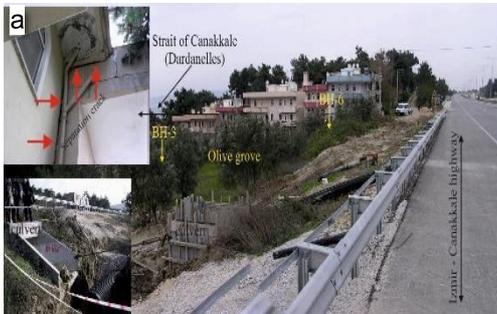
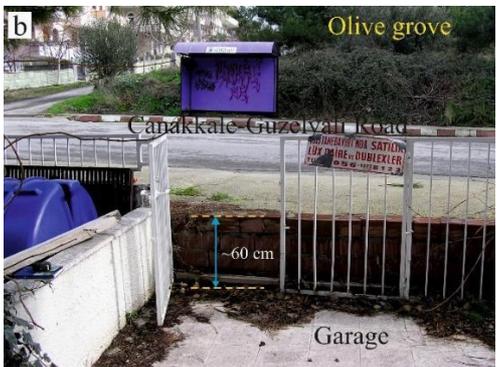
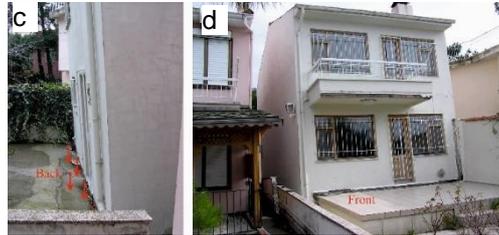
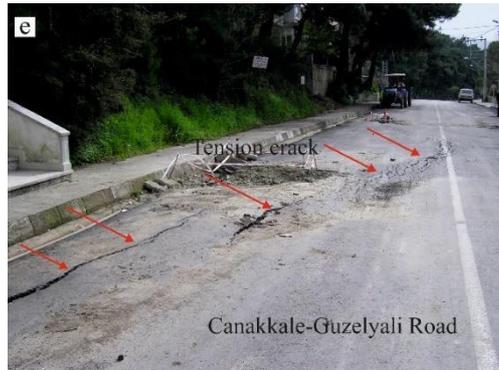
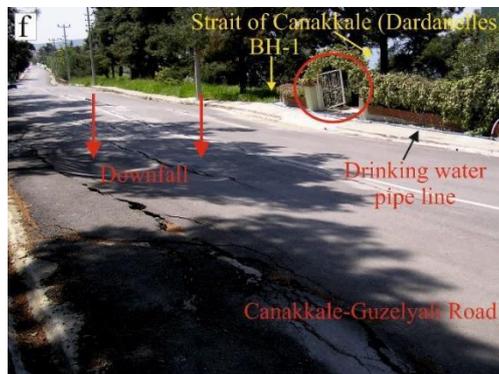
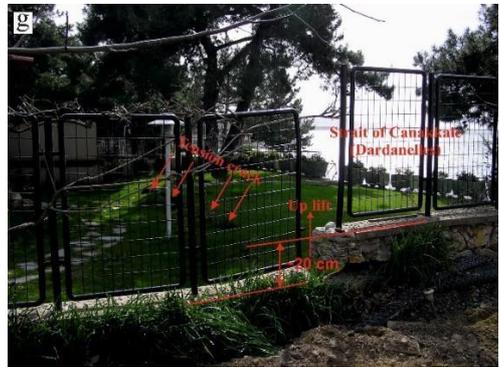
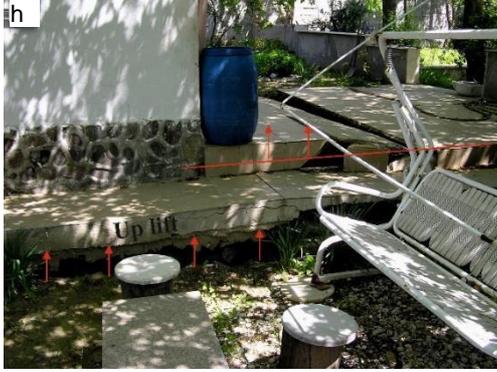
landslides caused separations in adjacent buildings and vertical displacements between 60 and 80 cm from the road level of garage entrances (Figure 5a,b). In addition, some structures in the toe region of the mass movement were tilted backwards close to 7°, and there was settling (15-20 cm) of the building foundations (Figure 5c,d). In February 2013, the Guzelyali landslide reactivated as a result of severe rainstorms and incorrect infrastructure works carried out during the Canakkale-Izmir highway construction (Figure 5a). The drainage of the highway was directed to the landslide area through a culvert in an uncontrolled manner. As a result of the landslide, the Canakkale-Guzelyali road was closed due to settlement and cracks, the drinking water pipeline burst, and deformations occurred in structures and garden walls (Figure 5e, f, g, h).

Figure 5. a) Separations in adjacent buildings and incorrect infrastructure, b) vertical displacement of garage entrance from the road level, c-d) building tilted backward by landslide, e-h) deformations of the road, garden walls and structures.

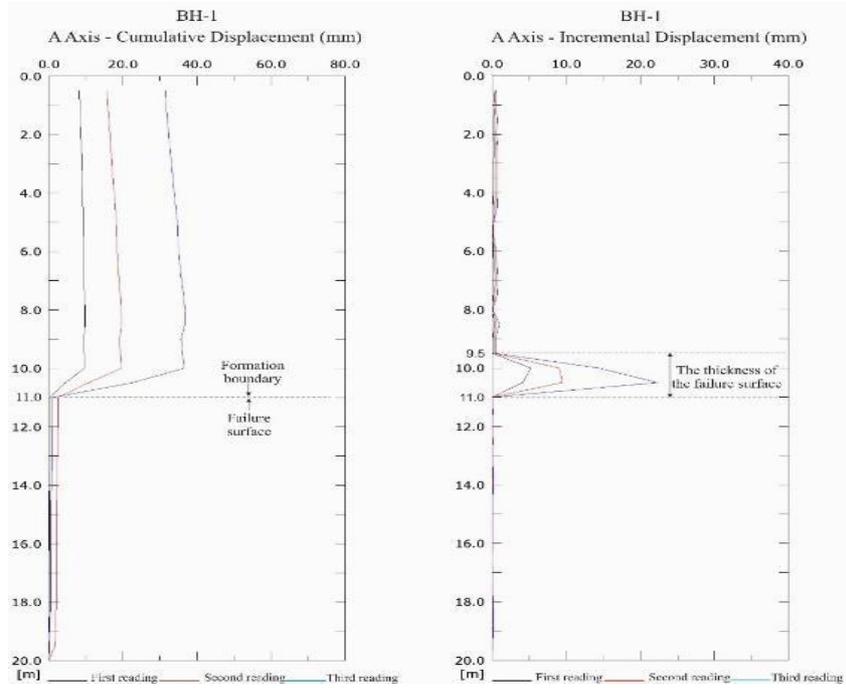
Inclinometer measurements were taken at regular intervals in all boreholes and graphs of depth versus cumulative displacement and graphs of depth versus incremental displacement were plotted. The cumulative and incremental displacement data for BH-1 are given in Figure 6. The results of the inclinometer measurements are given in Table 2. From the inclinometer measurements, the landslide progressed slowly (0.16-0.08 mm/day) in the upper sections of the Canakkale-Guzelyali road, but accelerated (1.58-1.74 mm/day) in the lower sections of the Canakkale-Guzelyali road. In addition, the slip surface for the landslide passed through the contact between the Kirazli Formation and Gazhanedere Formation, which is thought to be the path followed by groundwater. As a result of the evaluation of inclinometer measurements, the landslide had a non-circular slip surface.

Figure 6. Cumulative and incremental displacement graphic in BH-1.

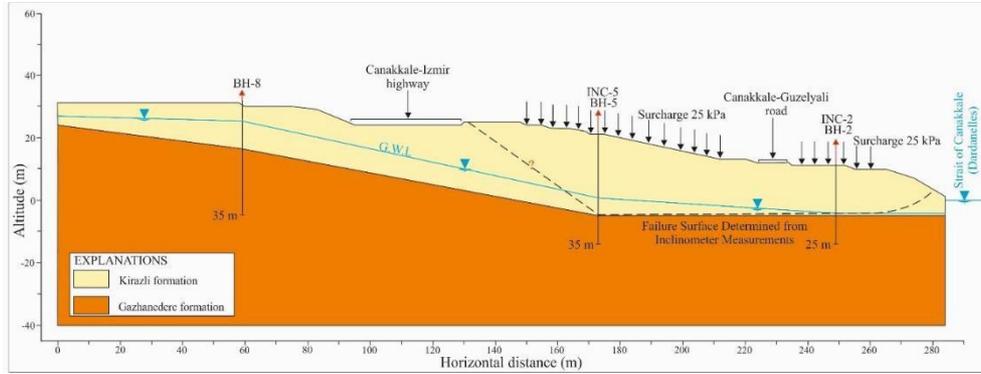
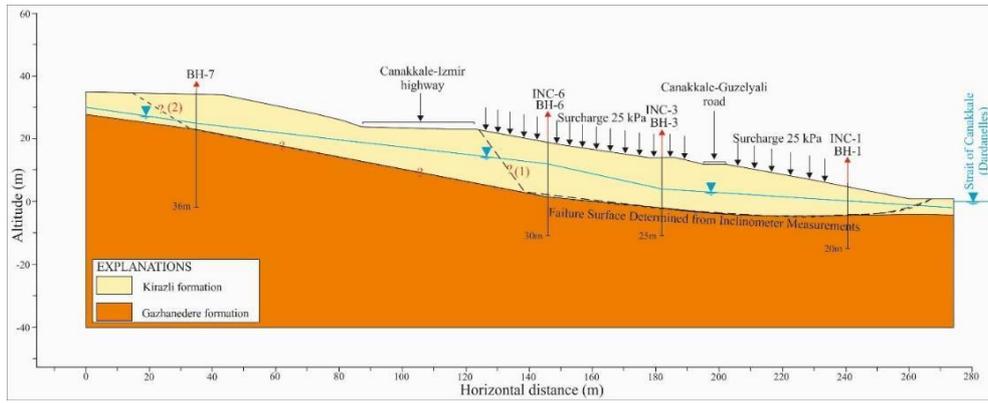
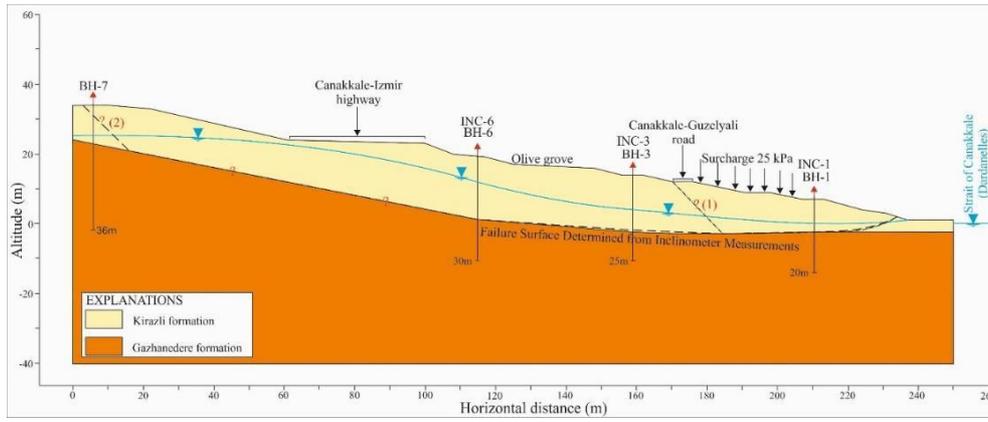
area. For this purpose, three different cross-section lines were drawn to define the landslide area. On the cross-sections, the position of the slip surface determined from inclinometer measurements, formation transitions and groundwater level were shown (Figure 7a-c). In addition, due to the presence of two-story buildings

in the landslide area, the building load was defined as 25 kN/m² for limit equilibrium analysis. As a result of the evaluation of the inclinometer measurements, the slip surface continues along the contact of the Gazhanedere Formation and Kirazlı Formation, which is located below the groundwater level.

Figure 7. Cross-sections of landslide along section lines a) 1-1', b) 2-2', c) 3-3'.

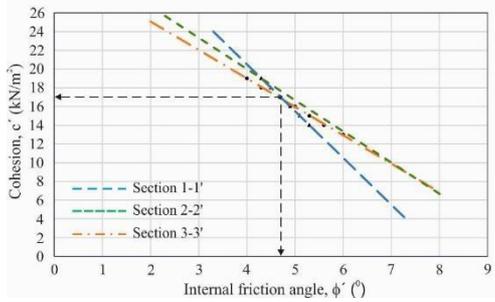
(Factor of Safety, $F=1$) are determined. In order to determine the shear strength parameters along the failure surface at the time of the failure, back analyses were performed using three parallel slope sections in the direction of the landslide movement (Figure 2). The position of the slip surface in the sections was determined from the inclinometer measurements. The Janbu method was used for back analysis. The $c-\phi$ pair ($c=17$ kN/m², $\phi=4.7^\circ$) obtained as a result of back analysis (Figure 8) and the peak and residual $c-\phi$ pairs obtained as a result of the direct shear strength test in the laboratory (Table 4) were compared.

The cohesion value, one of the shear strength parameters calculated by back analysis, was compatible with the cohesion values for the residual shear strength parameters, but the internal friction angle value was different. This is explained by the fact that the undrained friction angle (ϕ) value of the clayey soil, which cannot be drained due to excessive precipitation and where pore water pressure increases, is smaller than the effective internal friction angle value (Craig 1992; Parry 1995; Bowles 1996; Teoman et al. 2004). Consequently, the Kirazlı Formation in static conditions had a safety coefficient of 1.0 as a result of the limit equilibrium analysis using the shear strength parameters ($c=17$ kN/m², $\phi=4.7^\circ$) determined by back analysis (Figure 9).

Figure 8. c' - ϕ' pairs at the time of failure with back analysis.

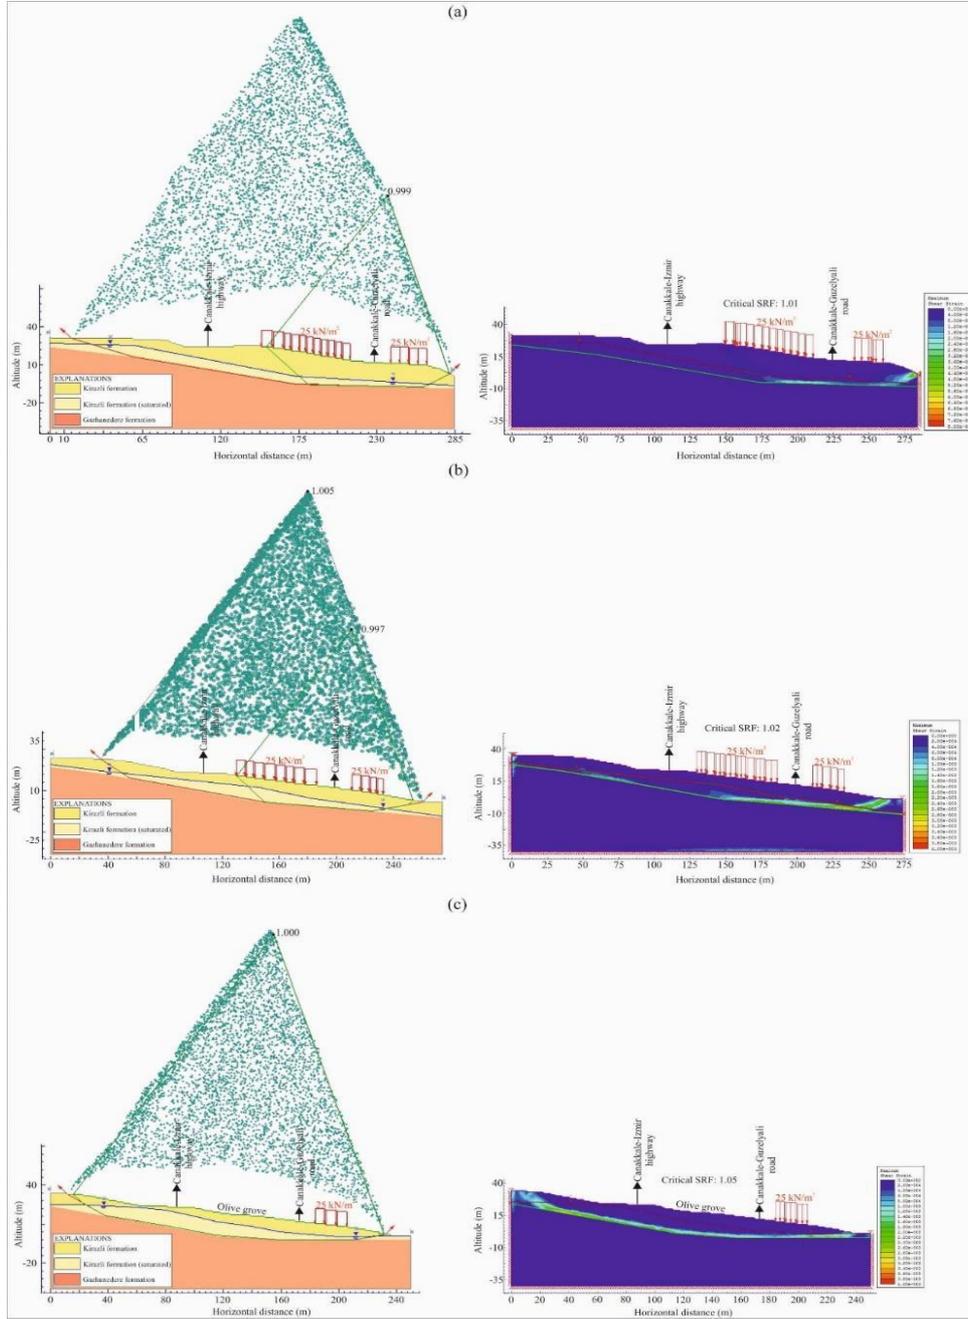
In this study, it is assumed that the material in the landslide area will have elasto-plastic strength and will fail in accordance with the Mohr-Coulomb failure criterion. In the analyses made using the FEM-SSR method, the SRF value was found to be 1.01-1.05 (Figure 9).

Figure 9. Back analysis results for a) 1-1', b) 2-2' and c) 3-3' cross-sections using LEM and FEM-SSR methods.

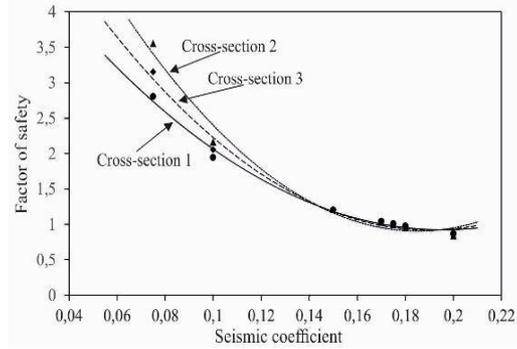
stability analysis. Isik et al. (2004) used 1/3 of the PHGA value. However, Topal and Akin (2009) used 1/2 of the PHGA value, staying on the conservative side in long-term slope stability analyses. The PHGA value determined for the study area in the Turkey Earthquake Hazard Map prepared by AFAD (2018) is 0.296 g. In this study, 0.15 g, half of the PHGA value, was used for the long-term slope stability analysis by staying on the conservative side. Although the PHGA value determined by AFAD was used in this study, sensitivity analyses were also performed using different PGHA values for each cross-section line. According to the sensitivity analysis results given in Figure 10, if the values of 0.175 g for cross-section-1 and cross-section-2 and 0.173 g for cross-section-3 are exceeded, the shear strength capacities of the micro piles will be exceeded and failure will be possible.

Figure 10. Sensitivity analysis results for the three slope cross-sections stabilized in dynamic conditions by micro-piles.

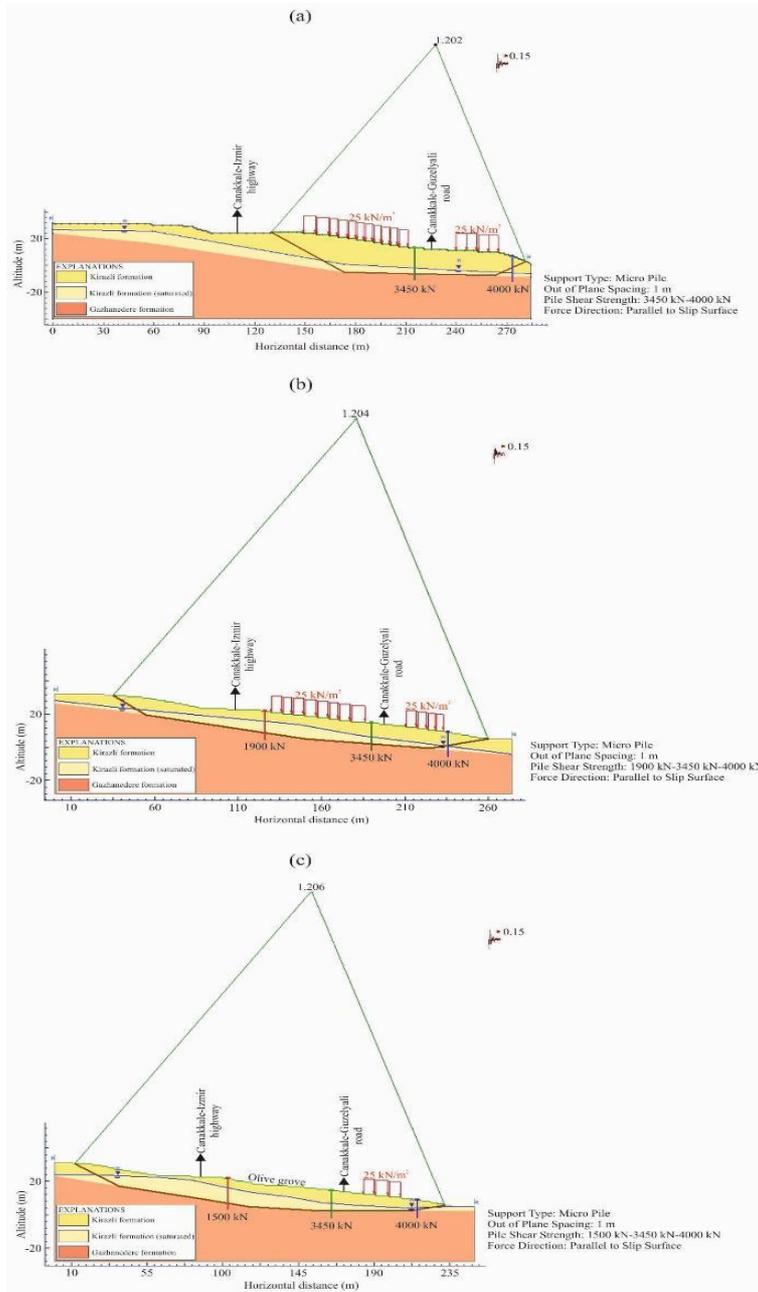
Figure 11. Remediation of the landslide area with micro piles by performing LEM analysis under pseudo-static condition a) 1-1', b) 2-2' and c) 3-3' cross sections.

Due to the intense construction in the landslide area, land use is extremely limited. In addition, the slip surface passes an average of 18 meters below the surface. For these reasons, it was decided that strengthening with micro piles would be a more reliable and economical reinforcement method in order to stabilize the landslide area. Limit equilibrium (LEM) analyses were used to ensure the stability of the region by safely countering the lateral active forces with micro piles.

In order to ensure the stability of the landslide zone, the LEM analysis method was performed under dynamic conditions by using three cross-section lines. As a result of the LEM analyses for cross-section 1-1', the shear strength capacities of the micro piles designed for the Canakkale- Guzelyali road and the toe region of the landslide should be at least 3450 kN and 4000 kN, respectively. As a result of the LEM

analyses for cross-section 2-2' and cross-section 3-3', the region will be stable if the shear strength capacities of micro piles designed for the Canakkale-Izmir highway, the Canakkale-Guzelyali road and the toe region of the landslide are at least 1900 kN, 3450 kN, 4000 kN and 1500 kN, 3450 kN, 4000 kN, respectively (Figure 11).
