Deterioration analysis of historical village house structure in Mersin Kanlıdivane archaeological area by UAV method

The village house located in the Mersin Kanlıdivane archaeological site is one of the oldest settlements in the ruins, built in the second century. The house is mainly built of a yellowish beige limestone. This stone, which is the main material of the building, shows many deterioration patterns today. The aim of the study is to determine the dominant deterioration pattern of the stones in the village house structure in the Mersin Kanlıdivane archaeological site and to investigate the source of the deterioration. In order to investigate the deterioration patterns in the structure, the images obtained by UAV photogrammetry were interpreted and the types of deterioration were mapped. In the study, it is seen that even the types of material problems based on the smallest detail can be determined based on virtual visual inspection, thanks to UAV photogrammetry, without observing the structure in situ with UAV photogrammetry. The findings obtained in the study shows that the color change and surface loss deterioration on the stone surfaces has reached advanced levels as a

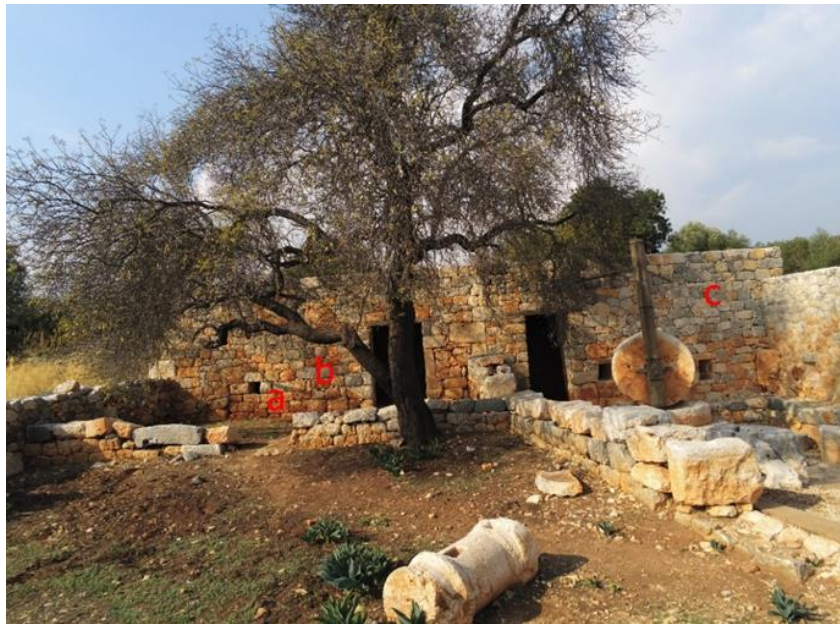
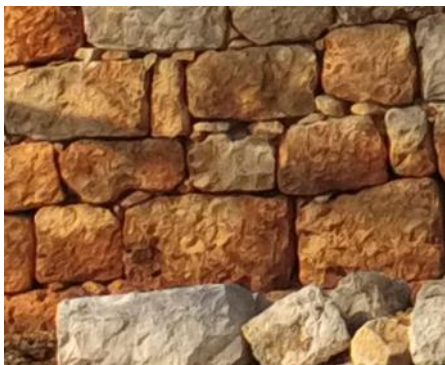
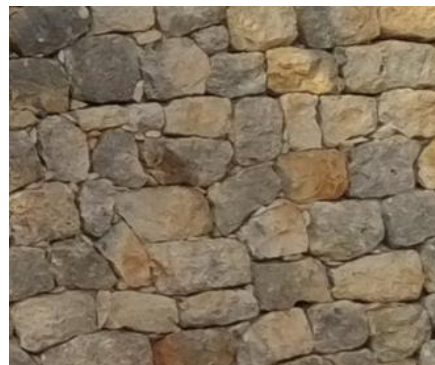
In the literature, vertical carriers of building elements in masonry structures are defined as feet, columns and walls. There is no use of pillars or columns in the building. The deteriorations seen in the walls in the building were determined as change of colour, surface loss and pollution of surface. Change of colour due to water effect was observed in the parts close to the ground on the south façade of the building. On the upper parts of the façade, pollution of surface, which is a gray dirt layer formed on the stone as a result of the air pollutants created by the fires in the environment, can be seen (Figure 3).

Figure 3. Change of color on the south facade (a), contamination of surface (b), contamination surface (c)

On the east and west surfaces exposed to strong winds, mainly stone material occurs damage. It is seen that the change of colour problem, which is advanced on all façades, is more common on the south façade. It is predicted that this situation is due to the long sunbathing period on the south façade. The rapid evaporation of the water entering the inner surface of the wall caused color changes due to the structure of the stone. Winkler [5] supports that the exposed side of the limestones shows significant erosion, while the erosion occurs less on the protected side. For this reason, there are problems related to the corrosive effects of water, especially on the north facade. This finding supports studies that indicate erosion in stones exposed to water [3,14,70].

Another result is that the gray layer, which is seen in the form of surface pollution on the façades, may be caused by the fires that people set to clean the bushes. It is known that the residents of the area carried out stubble burning in order to clear the bushes around the building. This situation caused the formation of a gray layer on the walls of the building. It is remarkable that the gray layer is excessive on the façades except the south façade, where the water stays on the wall for a long time. This situation shows that the water evaporates faster from the wall of the building due to the sunshine duration on the south façade, causing a change of color. On the north façade, as the water stays in contact with the body

To clean surface pollution deterioration, to increase the stone's resistance to environmental pollution and to prevent subsequent exposure to weathering, treatment should be considered. Firstly, stubble burning processes in the environment, which will eliminate the main reason for this process, should be prohibited and prevented.

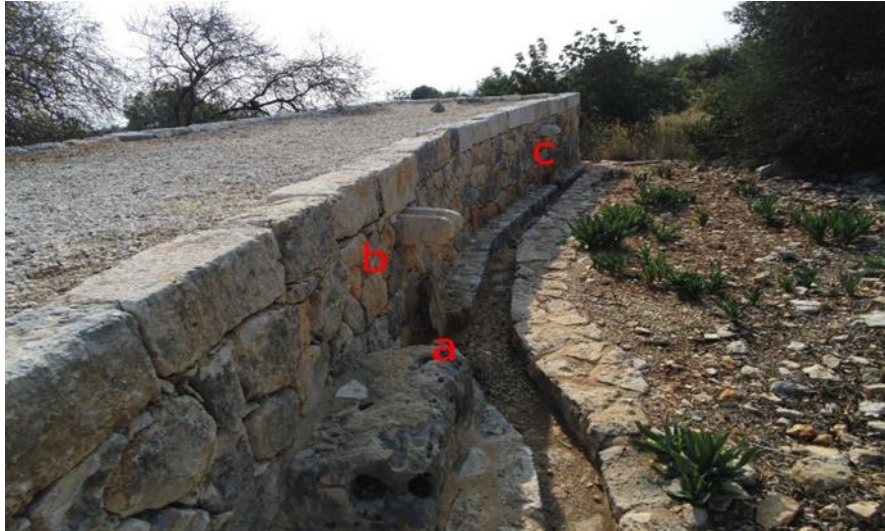
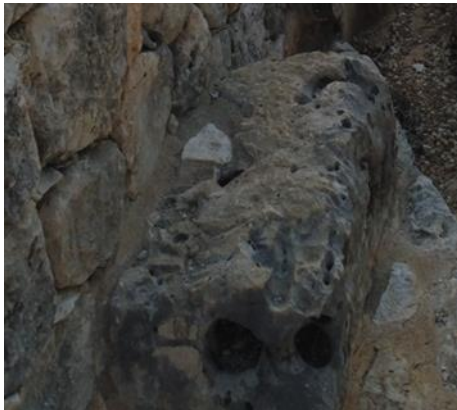
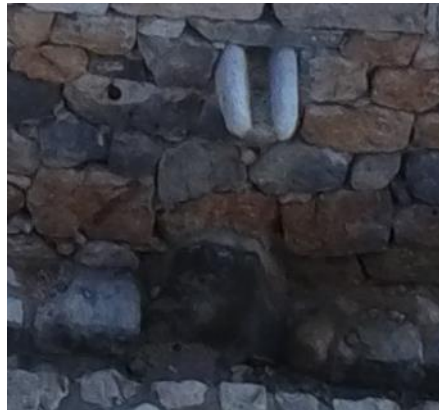
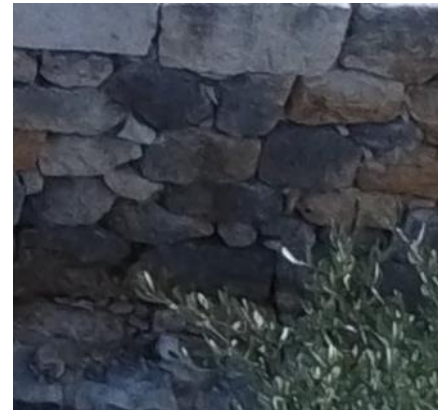
There is a gargoyles on the northern façade of the building. This gargoyles is the system that collects the rain water reaching the structure and removes it from the structure. Since the sunbathing time is shorter on this façade of the building compared to the other façades, the rain water that comes into contact with this façade remains in the inner body of the stone for a longer time without evaporation. For this reason, the color change in

the structure of the stone caused by rain water on this façade is more than the other façades, and it formed as an orangish color (Figure 4).

Figure 4. Stone material problems on the north facade: a) pitting, b) change of color c) contamination of surface

In addition, the water flowing from the gutters on the north façade caused pitting problems by damaging the stone material at the points of direct contact on the façade. Waragai & Hiki [70] confirms the phenomenon of pitting in stone materials in direct contact with water, which they obtained in their study results. The results confirm the findings of various studies that the stone material causes erosion, especially in fountains built of carbonate stone, as a result of constant contact with running water [6-8].

wall more and evaporates slowly, the black layer caused by the fire smoke on the façade is less cleaned and forms a crust. This determination was made by de Azcona et al. [25] support the fact that the acidity of water tends to increase over time due to the atmospheric pollutants obtained in the results of the study, which further increases the erosion and change of colour in the stones.

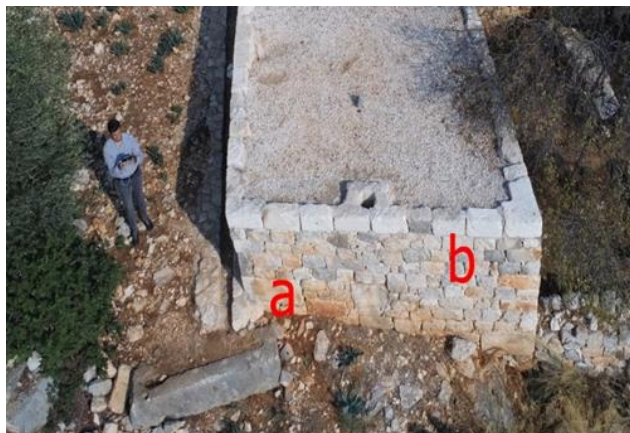
Change of color and contamination of surface material problems were encountered on the western façade of the building (Figure 5).

Figure 5. Change of color on the west facade (a), surface contamination (b)

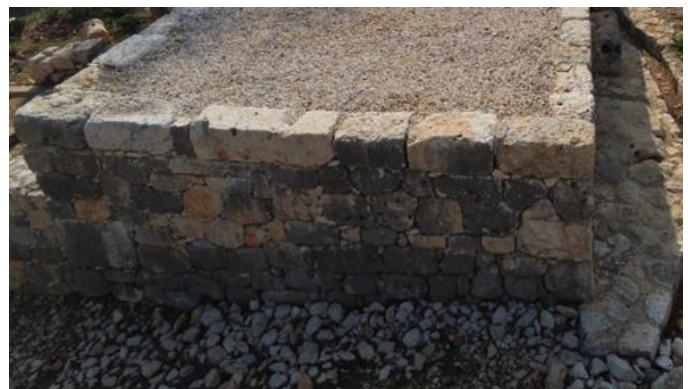
Pollution of surface was detected on the eastern façade of the building (Figure 6).

Figure 6. Pollution of surface

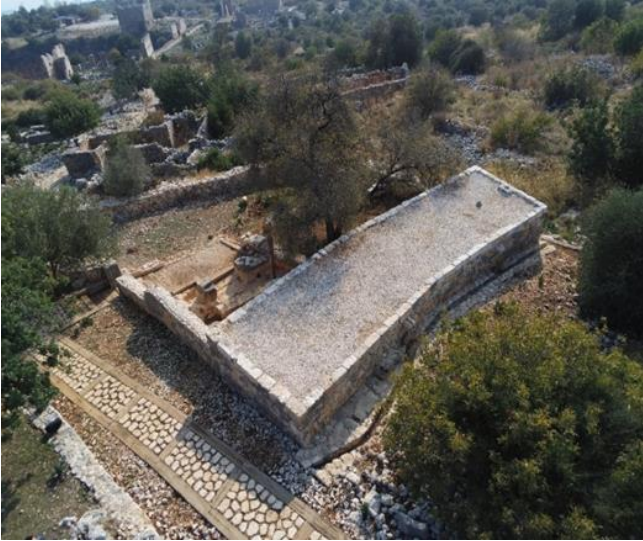
In the literature, horizontal carriers from building elements in masonry structures are defined as floors. Flat flooring is used in the building. There is no deterioration in the flat floor (Figure 7).

Figure 7. The flat floor seen in the building

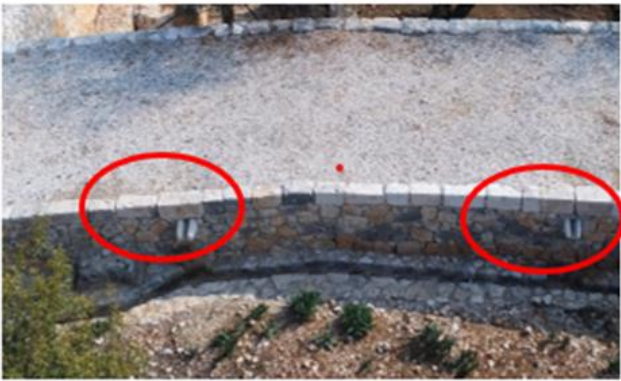
In the literature, auxiliary elements of building elements in masonry structures; gutters are defined as ornaments and moldings. There is surface loss in the gutters seen on the facade of the building (Figure 8).

Figure 8. Surface loss in gutters in the structure
