Analysis of Stone Deterioration on the Facades of Hatuniye Madrasah

Citation: Biçen Çelik, A., Ergin, Ş., Dal, M. & Ay, İ. (2023). Analysis of stone deterioration on the facades of the Hatuniye Madrasah. *Journal of Architectural Sciences and Applications*, 8 (1), 355-369.

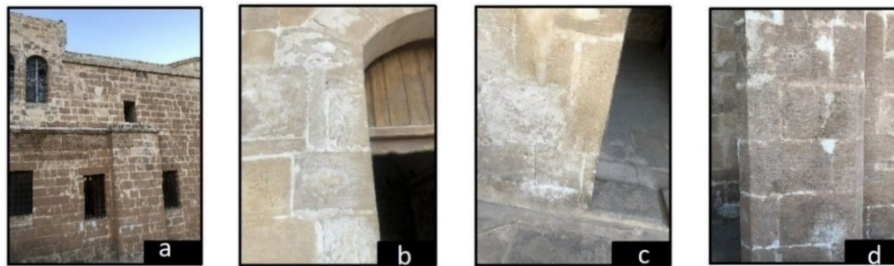
Figure 4. Physical deterioration of Hatuniye Madrasah (Biçen Çelik, 2019)

The deterioration of the Hatuniye Madrasah consists of physical, chemical, biological and anthropogenic deterioration. Due to the environmental and internal conditions of the limestone used as the main material of the building, the structure suffered from fragmentation, joint discharges (Figure 4a), capillary cracks (Figure 4b) and abrasions due to the effect of dust carried by the wind (Figure 4c, 4d).

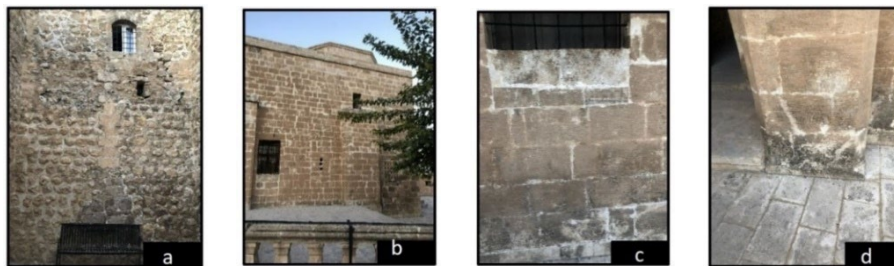
Figure 5. Chemical degradation in Hatuniye Madrasah (Biçen Çelik, 2019)

Chemical deterioration types such as salination, discolouration and bacterial growth were observed in Hatuniye Madrasah. The discolouration was observed on the inner courtyard façade (Figure 5a) and the main façade (Figure 5b). Salting (Figure 5c) and bacterial growth (Figure 5d) were also observed.

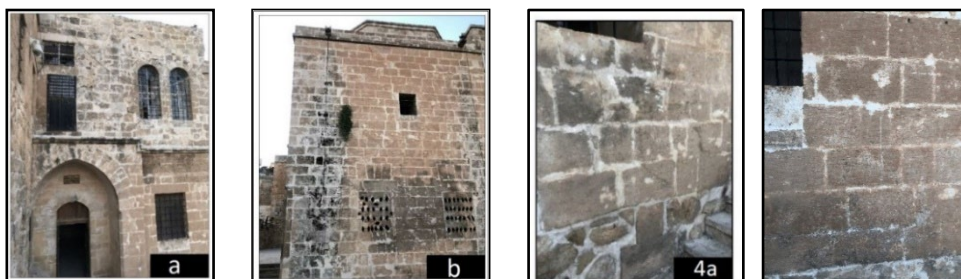
Figure 6. Biodegradation in Hatuniye Madrasah (Biçen Çelik, 2019)

Plant formation is encountered as biological degradation in Hatuniye Madrasah. The plant formations on the south and east facades of the building are shown in Figure 6.

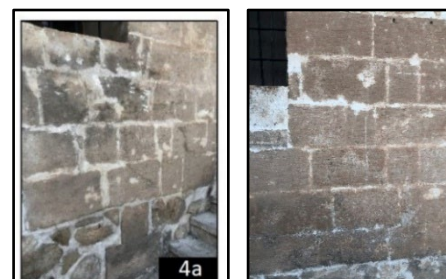
Figure 7. Anthropogenic degradation of Hatuniye Madrasah (Biçen Çelik, 2019)

As a result of anthropogenic effects, degradation due to the use of sharp tools was observed in Hatuniye Madrasah (Figure 7).

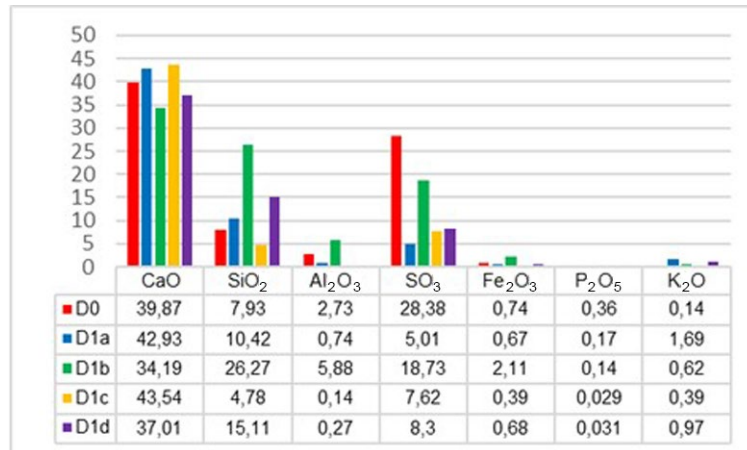
Table 7. XRF and chemical analysis results of the physical deterioration observed on the facades of Hatuniye Madrasah

The results of the analysis of the physical deterioration in Hatuniye Madrasah according to XRF analysis method are given in Table 7. According to the results of the analyses, while the SiO₂ ratio in stone D0 was 7.93%, this ratio was 26.27% in stone D1b. In addition, while the SO₃ ratio in D0 stone, which is determined as clean stone, is 28.83%, this ratio is lower in other stones. The high rate of SO₃ causes damage to the stones as a result of air pollution. No serious changes were observed in other components. In stones with different mineral contents, physical degradation such as joint failure,

hairline cracks, surface abrasion, fragment breakage and fracture have been observed due to the expansion and contraction of stones due to daily and annual temperature differences (Karataş, Alptekin & Yakar, 2023).

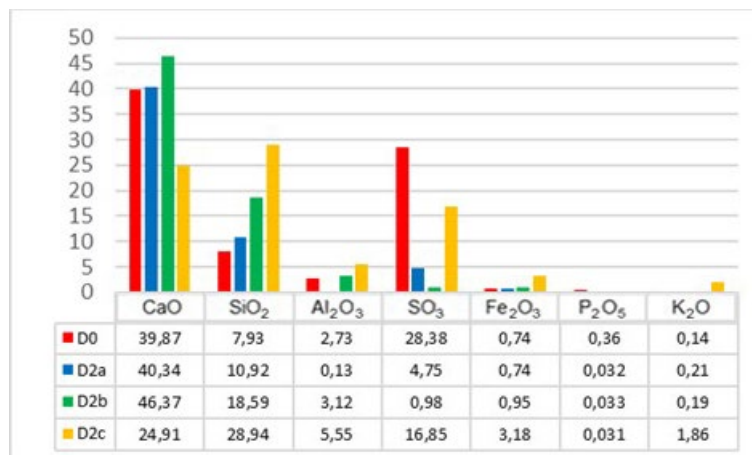
Table 8. XRF chemical analysis results of the chemical degradation observed on the facades of Hatuniye Madrasah

The results of XRF chemical analyses of the chemical degradation in Hatuniye Madrasah are shown in Table 8. According to the results obtained, it was observed that the stone with the lowest SO₃ value was D2b (0.98%). While the CaO ratio is 39.87% in D0 stone, it is 24.91% in D2c stone. Another remarkable change according to the analysis results is in SiO₂. While the SiO₂ ratio was 7.93% in D0 stone, this ratio was 24.91% in D2c stone.

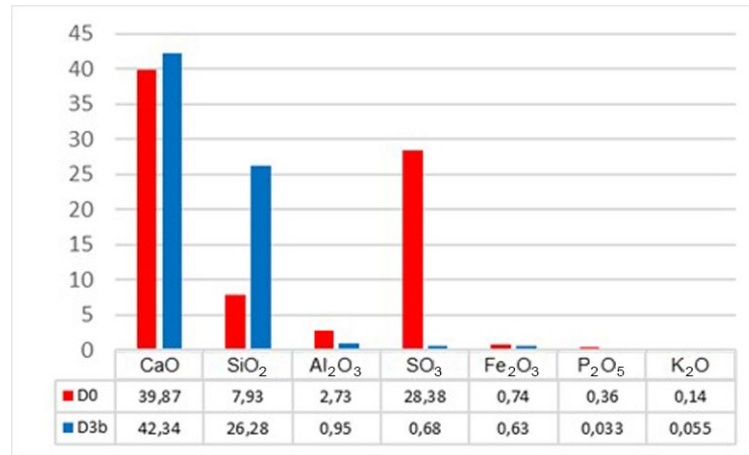
Table 9. XRF and chemical analysis results of biodegradation observed on the facades of Hatuniye Madrasah

The analysis results of the biodegradation in Hatuniye Madrasah are given in Table 9. According to the results of the analyses, while the SiO₂ ratio was 7.93% in stone D0, it was 26.28% in stone D3a. Silicification of clay minerals and the development of hard layers on the surface of the stone cause the increase in the SiO₂ ratio in D3a stone.

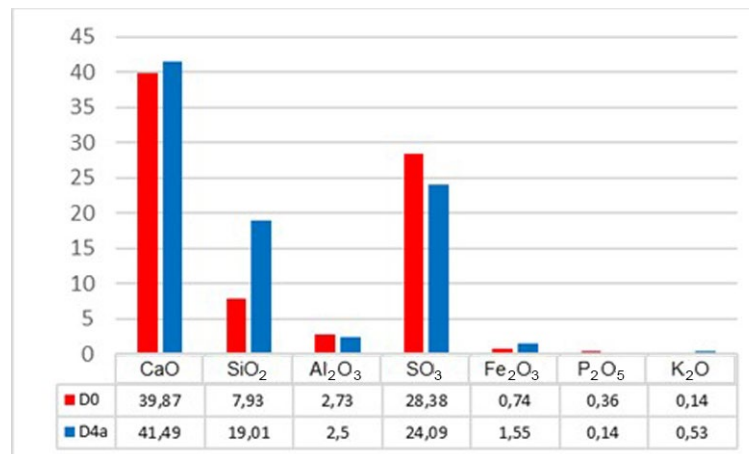
Table 10. XRF chemical analysis results of anthropogenic degradation observed on the facades of Hatuniye Madrasah

When the anthropogenic degradation of Hatuniye Madrasah is analysed by XRF chemical analysis method, the ratios of CaO, SiO₂ and SO₃ components stand out. There is no significant change in the ratios of other compounds. While SiO₂ ratio was 39.87% in D0 stone, this ratio increased to 19.01% in D4a stone. While the SO₃ component was 28.38% in D0 stone, it was 24.09% in D4a stone (Table 10).
