## Geomorphological deformation examples induced by the February 06, 2023, Pazarcık earthquake (Kahramanmaraş, Türkiye)

Hüseyin Turoğlu<sup>a</sup>

Osman Sarıgül<sup>b</sup>

DOI: 10.17211/tcd.1313551

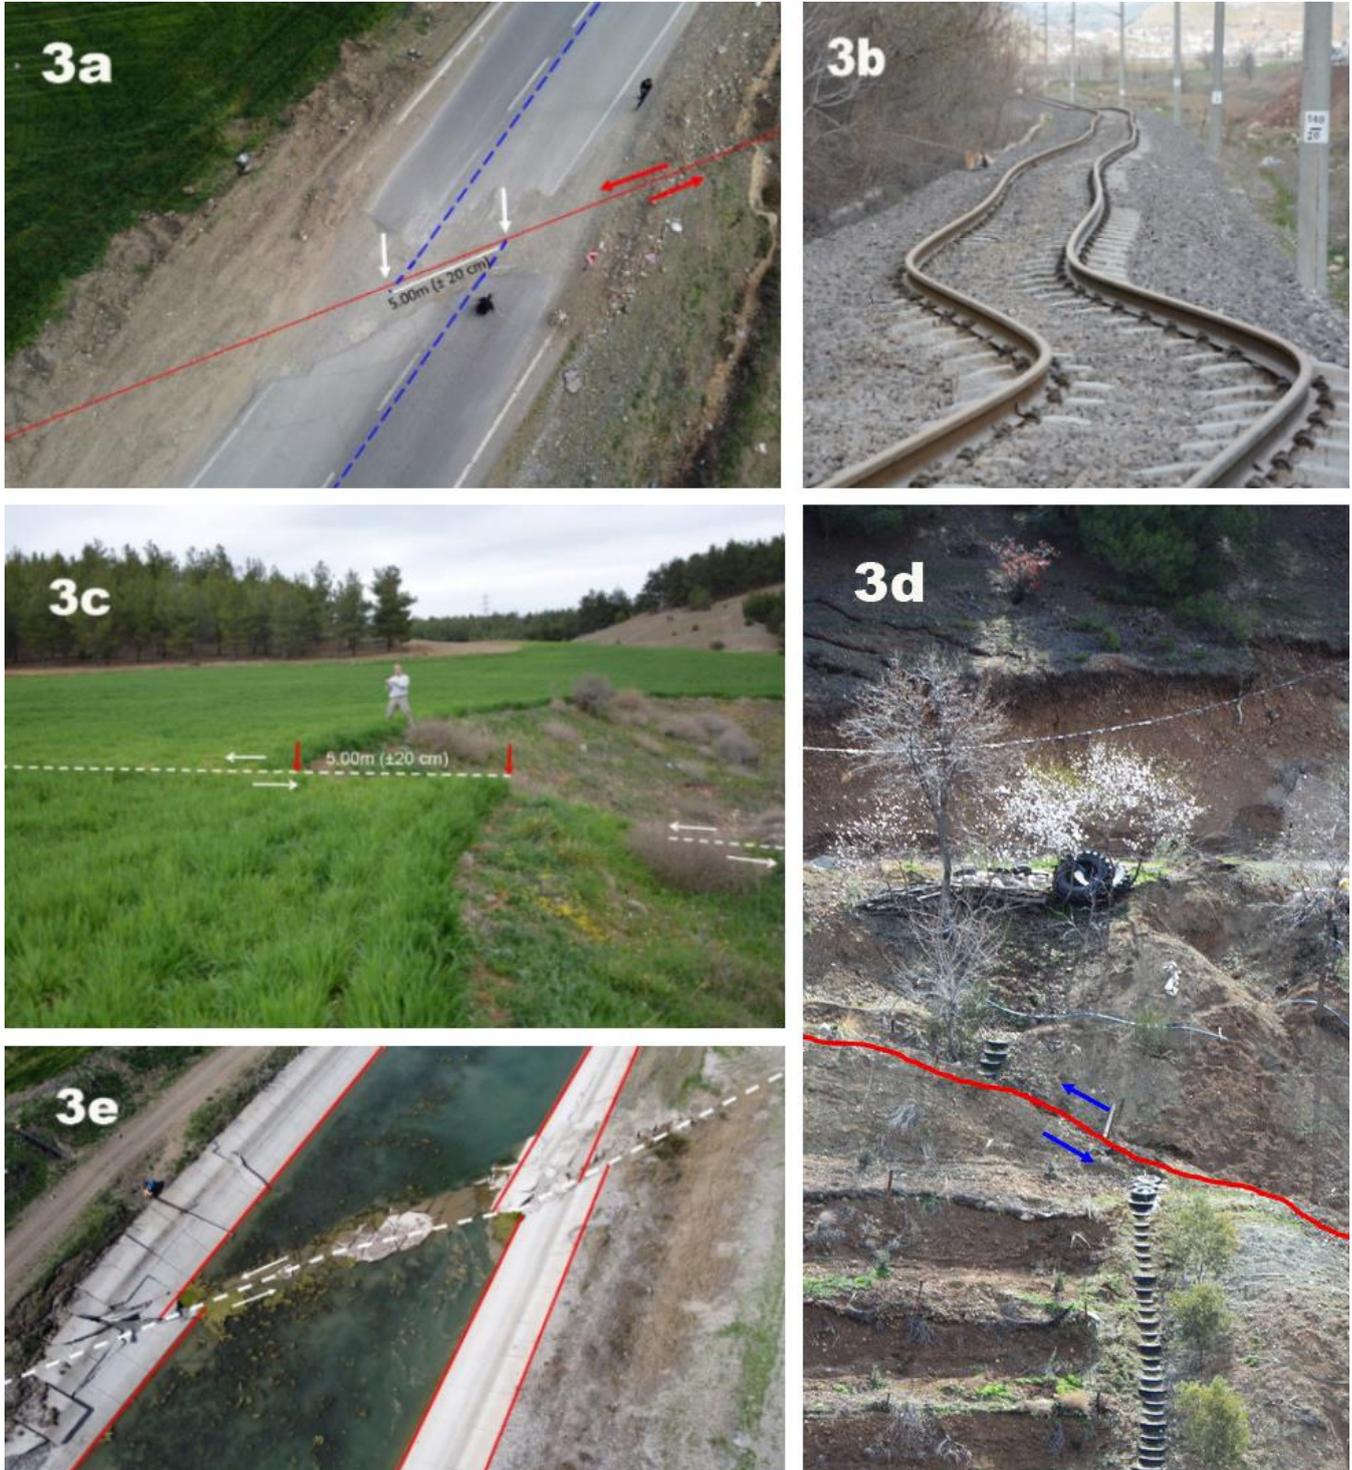
roughly SW-NE. Large and small-scale curvatures of the fault caused morphological deformations such as a transtensional extension by releasing a bend in the alluvial plain in the NE Türkoğlu section, and a transpressional ridge by restraining the bend in the alluvial plain in the NE Sakarkaya section. The offset distances on the Pazarcık fault are unequal throughout the surface rupture, and offsets between 4.0-6.30 m were

measured. However, the typical offset distance is approximately 5m.

Measurable displacement deformations in natural and artificial structures with distinct boundary features, such as roads, natural drainage channels, water channels, land boundaries, and railways, were considered the defining evidence of the sinistral strike-slip fault (Figure 3).

**Figure 3:** Evidence of offset that occurred on the sinistral strike-slip Pazarcık fault with the February 06, 2023 earthquake (3a: The offset on Gaziantep-Kahramanmaraş highway, 3b: Gölbaşı town, 3c: East of Çiğli village, 3d: Kartal village, 3e: Southeast of Kılılı) (Figure 2).

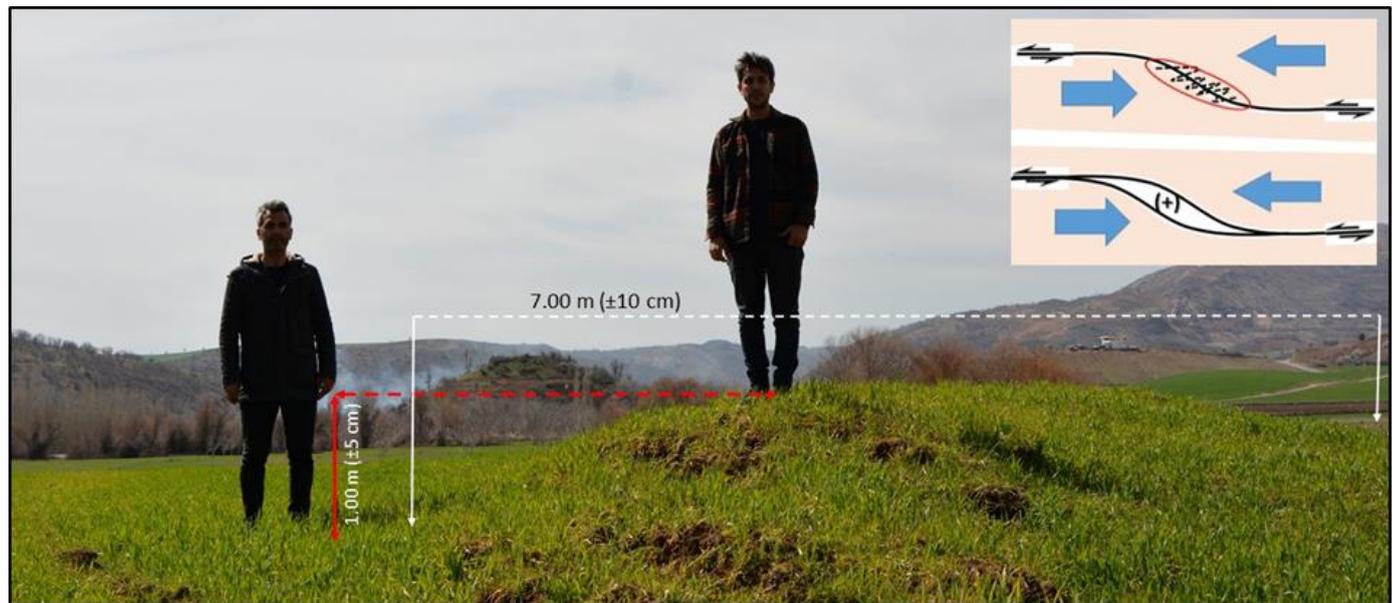
ridges (linear uplifting heave structures) were observed on the flat and almost flat, young alluvial accumulation morphologies in the Sakarkaya region of the surface rupture between Sakarkaya and Gölbaşı (Figure 3). These deformation structures are reliefs in a fan cross-section shape rising from the surface and continuing along the surface rupture of the fault. Although dimensions vary, heights between 0.70-1.50 m and widths between 3.50-7.00 m were measured in the field. The ridge surface is characterized by longitudinal cracks forming stepping, with elevation differences (Figure 4) (Turoğlu & Sarigül, 2023). The ridge's fractured and irregular surface structure is within the boundary of the fan-shaped relief surface. These morphologies are also described as classical, positive flower structures (Huang & Liu, 2017). The compression structures forming a linear ridge were formed where the parabolic curve in the surface fracture was restricted or prevented to the left. The relationship between the inhibition of the left offset and the compressive stress determined the rise and ridge formation dimensions. This is because, while the compression structure did not develop within the eastern part of the Gölbaşı depression, the compression ridge starts to form within the western part of the Gölbaşı depression, in the alluvial plains near Sakarkaya. The dimensions of the compression ridges continue to increase in the direction of Mount Sakarkaya.

**Figure 4:** Dimensions of the transpression zones (height, width, length) were formed under the control of the compression process (Figure 2). Depending on the compaction pressure, the deformation dimensions change.

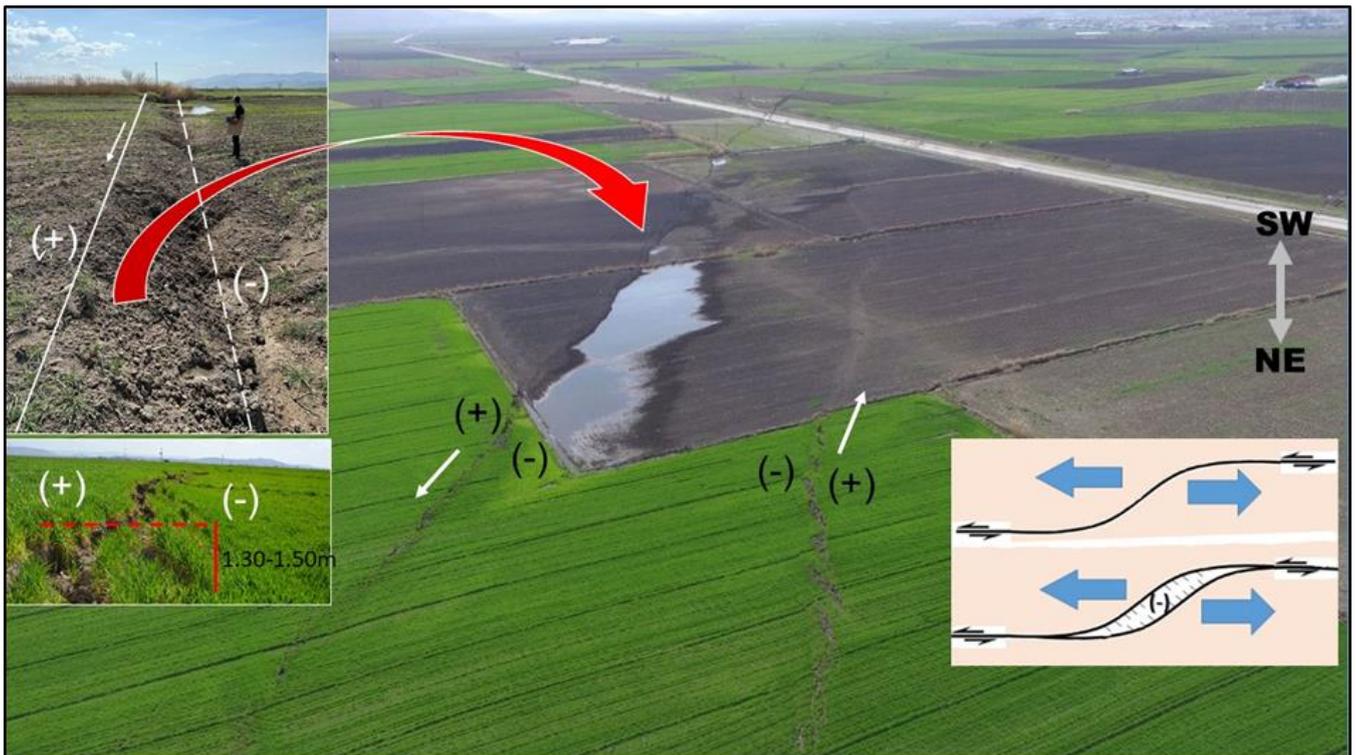
(Figure 4), and the surface ruptures approach each other in the direction of Türkoğlu (Figure 5).

The releasing bend depressions on the Pazarcık fault also contain oblique displacements. Oblique displacement in a depression (Figure 5) was measured up to  $\pm 1.7$  m during field studies. The local ponding developed on the deeper SW surface fracture side of the depression (Figure 5) is one of the largest ponds on the surface rupture. But in most cases, the morphological deformations that occur with vertical and horizontal displacements of a few meters on these accumulation plains, and agricultural areas are rapidly erased from the topography surface by the interventions of farmers with tractors.

**Figure 5:** This depression near Türkoğlu is one of the depressions caused by blocks moving away from each other on the curvilinear left-lateral strike-slip fault (Figure 2).

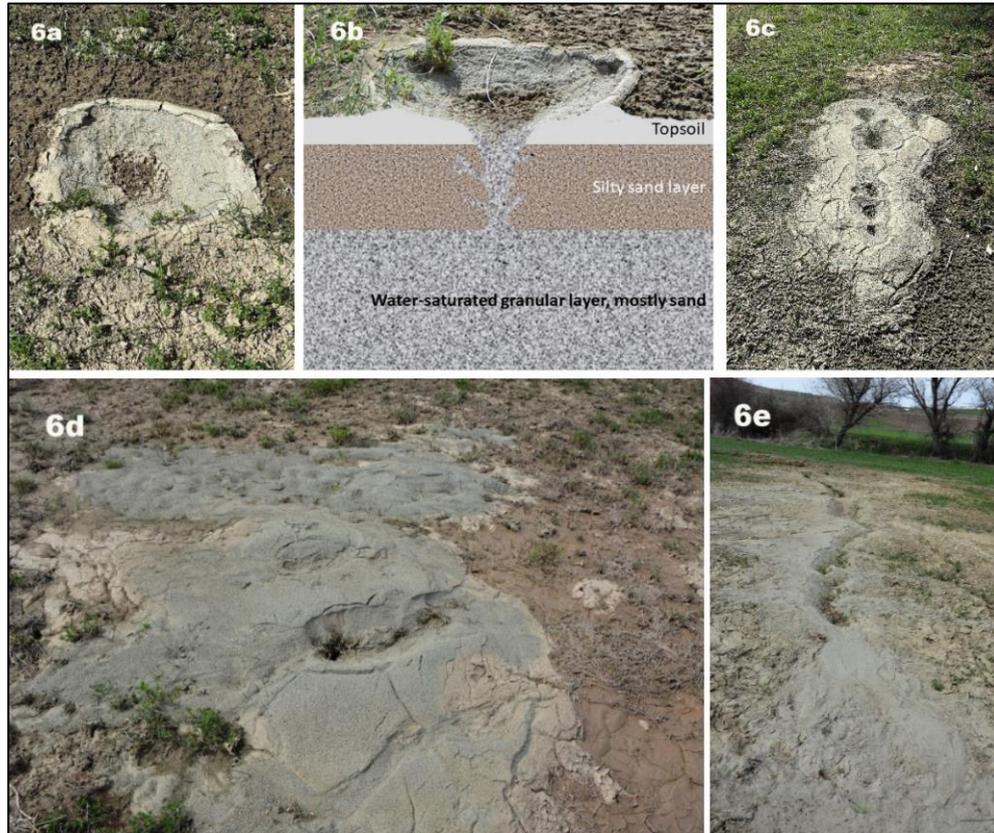
The Sakarkaya-Gölbaşı section of the Pazarcık fault passes through a water-saturated, young, detrital, alluvial accumulation plain belonging to Quaternary lake/marsh and river deposits (Figure 2). Typical liquefaction structures formed by the February 06, 2023 earthquake were observed along the compression ridge within the Quaternary Sakarkaya alluvial plain. Liquefaction structures have developed individually (Figure 6a) or several together (Figure 6c), or several clustered together (Figure 6d). Another liquefaction morphology observed in this region is liquefaction fissure. The

surfacing of the fluid containing fine-grained elements such as clay, silt, and sand due to liquefaction occurred in such a way to form a linear fissure (Figure 6e) (Turoğlu & Sarigül, 2023).

**Figure 6:** Examples of liquefaction structures. (a) Fine sand and silt blow, (b) Cross-sectional properties of a sand and silt blow, (c) Multiple grains of sand and silt blow arrays, (d) A cluster of multiple sand blows, (e) Sand and silt blow fissures (Figure 2).

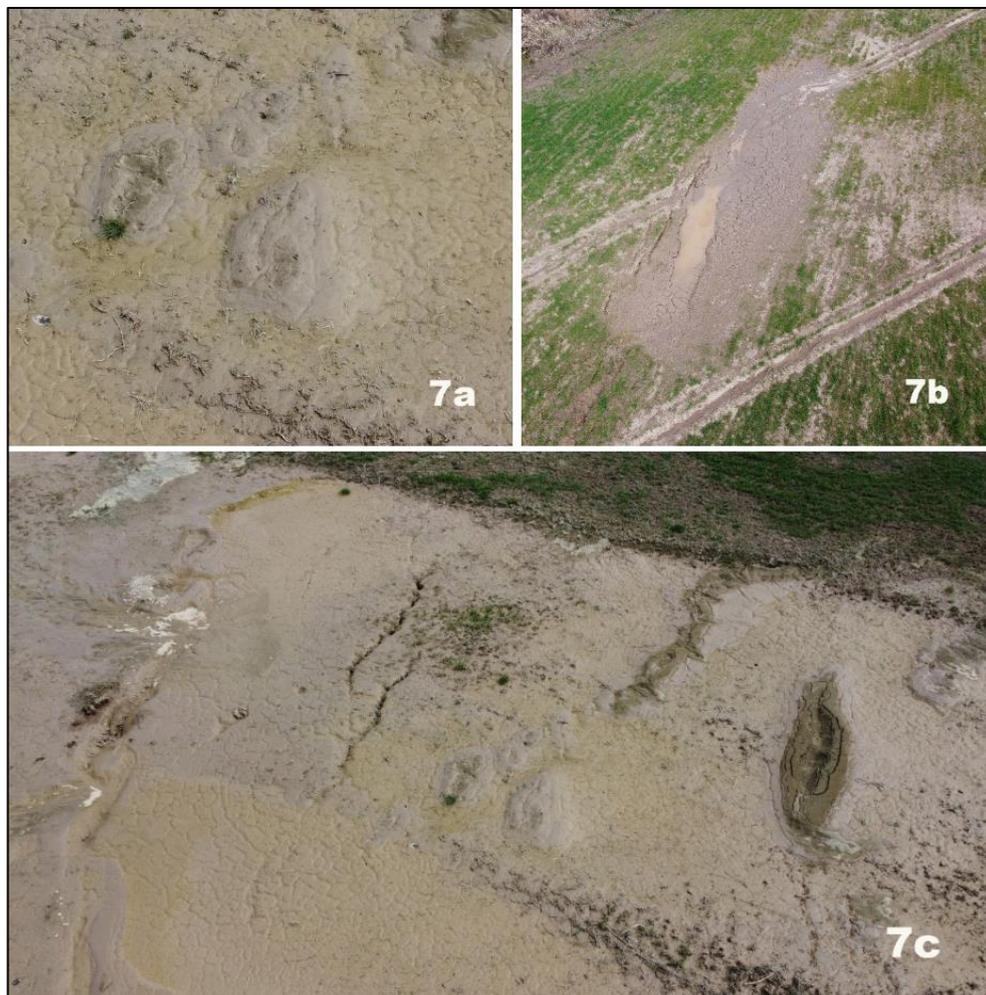
The liquefaction structures observed in the Sakarkaya-Gölbaşı section of the Pazarcık fault are a natural result of restraining bends stress in the curvilinear surface fracture of the fault. The compressive stress causes fine sand and silt fluid to rise through the alluvial ground to the surface and spread out in blowing. Single liquefaction cones are 50-150 cm in diameter, with cone edge heights of 20-50 cm (Figure 6a). Multiple combined liquefaction cone forms and sizes vary according to the number of fluid stacks and sand accumulation volumes (Figure 6). The liquefaction structures within the Sakarkaya alluvial plain are remarkable for their alignment in the same direction with surface rupture and compaction structures in the form of ridges. Despite removing water in the fluid after the surfacing of fluid, the clay and silt it contains accumulated at the mouth of the fine sand cone or along the fissure (Figure 6). Liquefaction sludge bubbles, liquefaction sludge flow and ponding, and liquefaction sludge blankets are other examples of liquefaction morphologies observed on or near the surface fracture after the earthquake (Figure 7).

**Figure 7:** (a) Liquefaction sludge bubbles, (b) liquefaction mud flows and ponding, and (c) liquefaction sludge blankets (Figure 2).

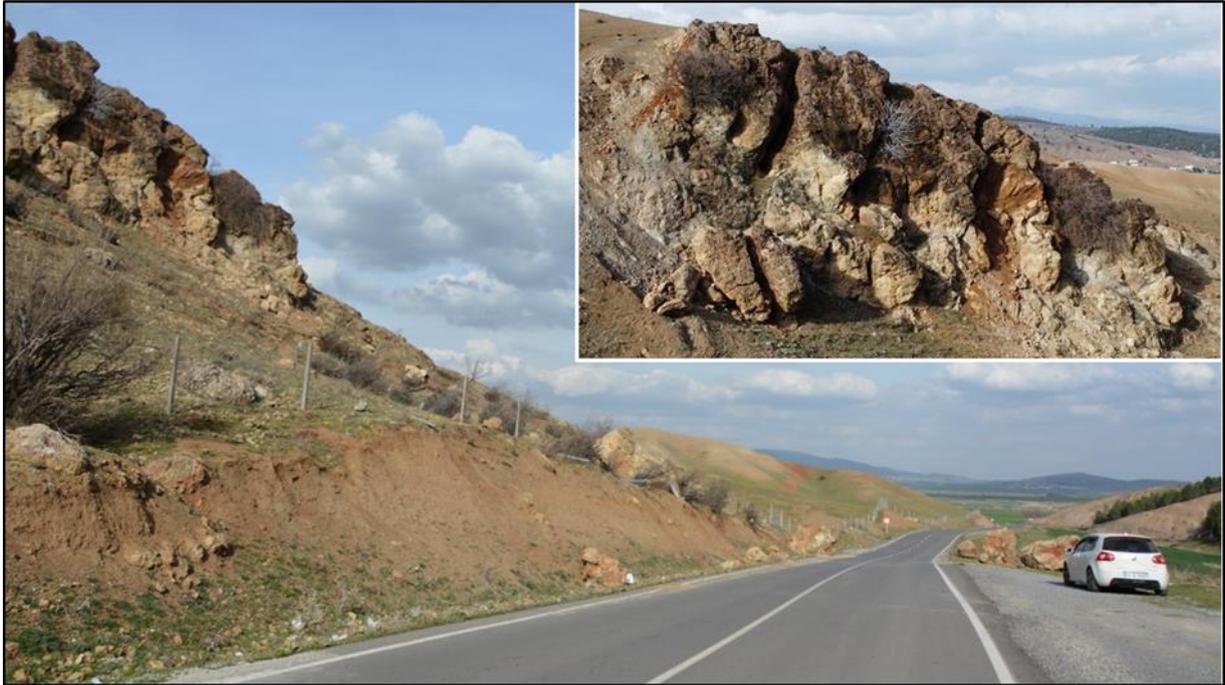
earthquake-induced rockfalls are inevitable (Moore et al., 2012; Aydan, 2016; Tang et al., 2021; Massey et al., 2022; Singeisen et al., 2022; Zheng et al., 2022). Examples of rockfalls occurred on the slopes along the surface rupture in the roughly WSW-ENE trending pressure ridge high mass between Kartal and Sakarkaya (Figure 2). The sandstone, mudstone, and especially limestone outcrops in the Sakarkaya section of the high mass consist of rocks with intense discontinuities. These discontinuities can be traced by cracks and fissures on rock surfaces devoid of soil and vegetation (Figure 8). Previous tectonic activities were primarily effective in forming and intensifying cracks and fissures in the rocks. Compression, shortening, and uplift deformation due to the curvilinearity of the left lateral strike fault is the leading cause of discontinuities in the rocks of Çataldağ, Mount Sakarkaya. It is also recognized that physical weathering processes such as freeze-thaw cycles and daily and seasonal temperature changes play an essential role in developing these cracks and fissures. The fracture and fissure systems were formed and developed by previous earthquakes on the slopes of Çataldağ and Mount Sakarkaya have prepared favorable conditions for forming rock blocks, and rock falls. The February 06, 2023 earthquakes played a triggering role in the fall of these rocks. Earthquake-induced falling blocks range from 1.00 m to several meters (Figure 8) (Turoğlu & Sarigül, 2023).

**Figure 8:** Kuyumcular-Kapıçam motorway, the surface rupture of February 06, 2023, Pazarcık earthquake crossing the left slope, causing large limestone blocks to break off and fall from this slope (Figure 2).

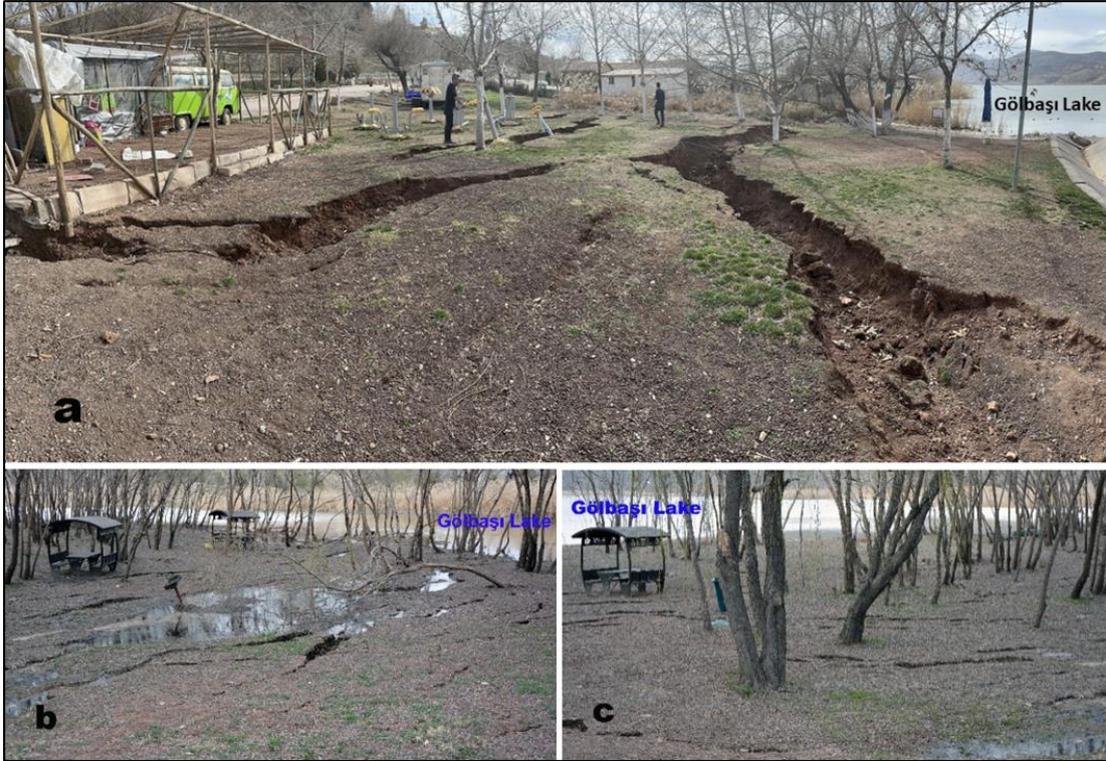
roughly parallel to the lake shore, are morphological deterioration and changes caused by the shaking effect of the February 06, 2023 earthquake. Examples of this type of geomorphologic deformation developed on the northern block of the surface fracture of the fault on the shores of Gölbaşı Lake (Figure 9) (Turoğlu & Sarigül, 2023). Deformation is widespread on the southern shores of Gölbaşı Lake, on a very young, unconsolidated accumulation plain sloping 2-10° towards the lake. On the lake shores where the slope is between 7-10°, the lakeward sliding, cleavages are deeper (1-1.5 m) and wider (0.5-1.5 m), and the lakeward displacements

are pronounced (Figure 9a). Where the degree of slope decreases (for shores between 2-5°), these dimensions are

also reduced, and the number of linear deformations increases, while the continuities become shorter (Figure 9b, 9c).

Figure 9: Lateral spreading on the shore of Gölbaşı Lake induced by the earthquake ground shaking (Figure 2).

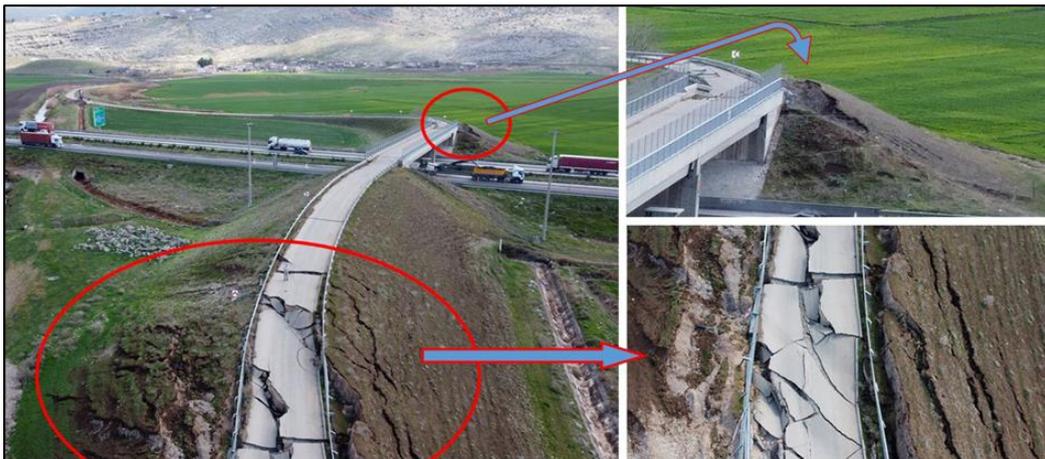
The purpose of a road embankment is to raise the road platform, and this is made by compacting unconsolidated granular materials in general. The shaking force of an earthquake, however, easily weakens the cohesion between the grains in such embankment structures, destabilizing the stability of the embankment and causing cleavages, lateral spreading, and sinking deformations. In the February 06, 2023 earthquake, the shaking effect of the earthquake caused cleavages and lateral spreading deformations in the road embankment at the Çöçelli junction of the Gaziantep-Kahramanmaraş road (Figure 10). These surface deformations in anthropogenic ground structures do not have the characteristic of being close to the surface fracture of the fault. On the other hand, the intensity of the earthquake-induced shaking is decisive for such surface deformations. Two main

processes were influential in the occurrence of this earthquake-induced deformation. One of them is that the shaking force of the earthquake directly destabilizes the embankment, causing cleavages, lateral spreading, and sinking deformations. The other process is indirect impact. This intersection embankment was constructed on water-saturated, detrital, alluvial, and unconsolidated weak ground. Such grounds have a high risk of liquefaction, sinking, and collapse during earthquakes. In addition, these types of soils are poor conductors for earthquake waves. In such soils, seismic waves travel more slowly, and this causes more damage. The road embankment at the Çöçelli intersection was built on this type of ground. Therefore, due to the magnifying role of the ground on the shaking effect of the seismic waves, the cleavages, lateral spreading, and sinking deformations of the intersection embankment were more magnified.

Figure 10: Gaziantep-Kahramanmaraş road Çöçelli intersection, cleavages, lateral spreading, and sinking deformations in the intersection road embankment (Figure 2).
