Examination of Interventions and Defects on Façades: The Case of Selamsız Low-Cost Mass Housing in Istanbul, Türkiye

Citation: Çakır Uzelli, H. Y. & Gür, N. V. (2023). Examination of interventions and defects on façades: The case of Selamsız low-cost mass housing in Istanbul, Türkiye. *Journal of Architectural Sciences and Applications*, 8 (2), 847-864.

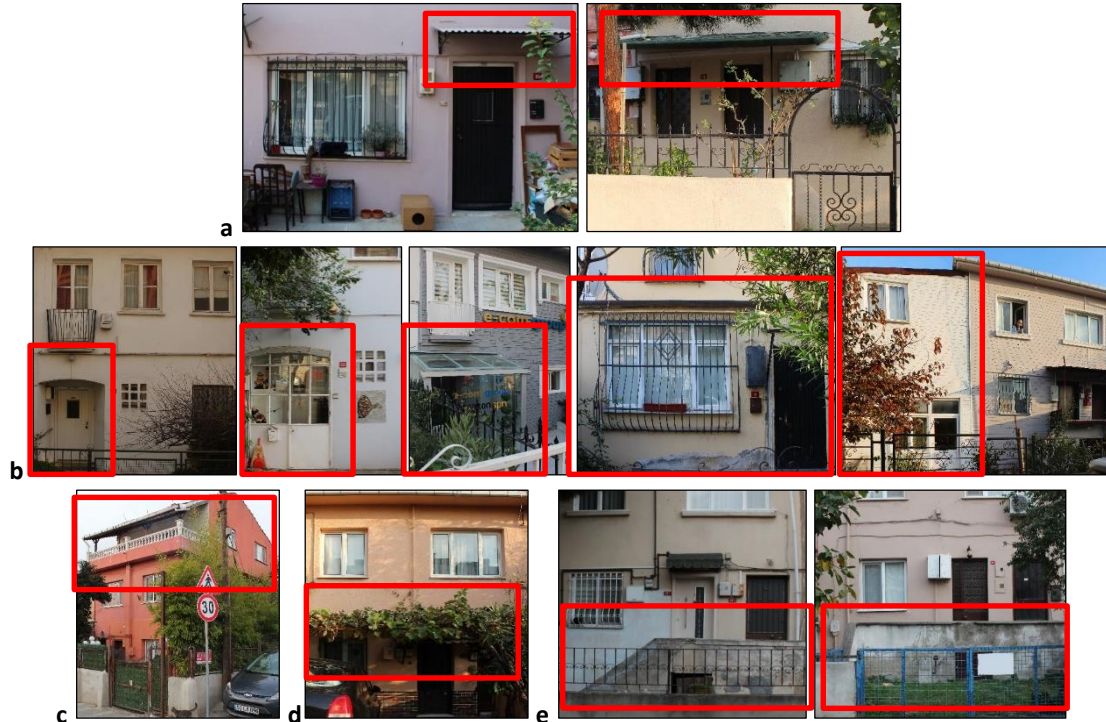
- BS – Interventions at Building Scale: Among 79 building that intervened at building scale, in 29/79 buildings, intervention types to create only open spaces (BS1, BS2, BS3), in 23/79, interventions to form closed additional spaces (BS4, BS5), and in 27/79 buildings both were preferred. The most common intervention type is BS1 – Addition of entrance canopy (53/108) and was generally preferred to create a covered area in front of the entrance door, regardless of building type (Figure 2-a). The second line is BS4 – Expansion of the floor spaces (in single floor/through the whole building) horizontally (34/108) and specifically implemented in T2 to include the empty spaces in front of the entrance door to the interior space as an entrance hall (Figure 2-b). In addition, there are examples where the floor area is expanded only on the ground floor or throughout the building side façade, especially in the buildings located at the corner. However, the expansions made on a single floor (32/34) were observed to be preferred more than the expansions made through the whole building (2/34). BS5 – Addition of floor in vertical direction (22/108) is the third in line, and generally was applied in T6, since this type of building is multi-family house, and the usable area is considerably small in comparison to the single-family house (Figure 2-c). Intervention types BS2 - Addition of pergola (connected with the building) (Figure 2-d) and BS3 - Changes in the form of entrance terrace (lengthening, widening, reorientation) were applied relatively less according to others (Figure 2-e). Although many pergolas have been built in the gardens, very few of them are connected to the building which are excluded from the scope of the study.

Figure 2. Examples for BS (Hatice Yasemin Çakır, 2021); **a)** BS1 (S1_T1_B13, S3_T6_B10); **b)** Entrance that close to original version (left) (S1_T2_B46), BS4 (the others) (S1_T2_B45, S1_T2_B39, S1_T1_B02, S3_T6_B12); **c)** BS5 (S3_T6_B39); **d)** BS2 (S3_T4_B06); **e)** entrance terrace that close to original version (left) (S3_T6_B30), BS3 (right) (S3_T6_B42)

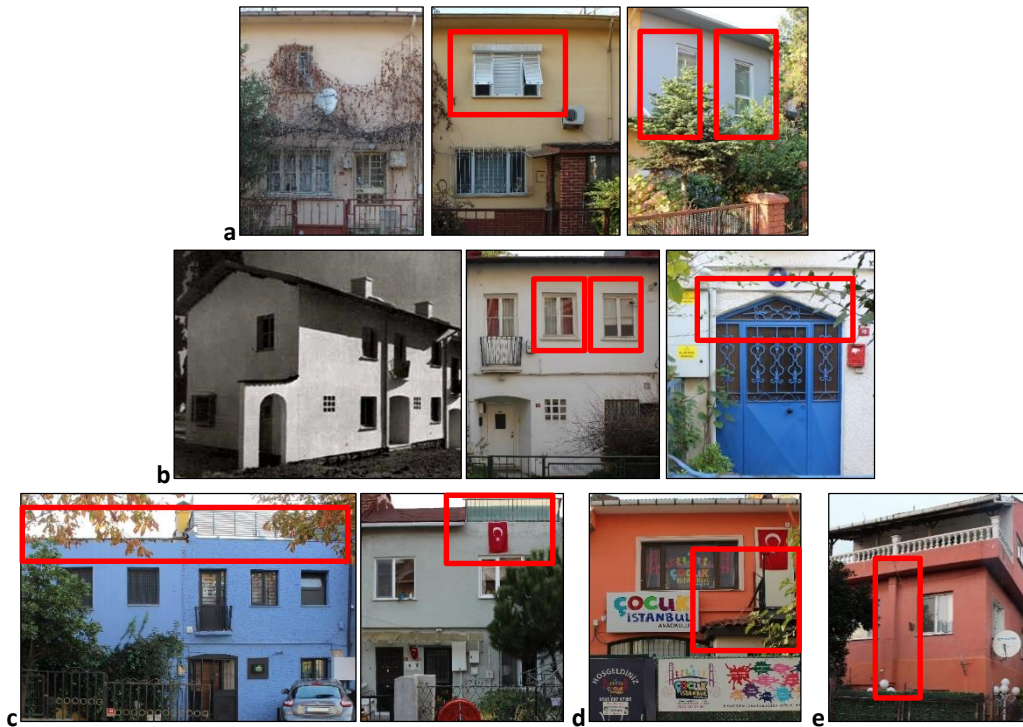
- **ES – Interventions at Element Scale:** Among the intervention types at the element scale, the ones that affect external masonry wall, and window/door were applied mostly (33/38), according to other ones that related to other elements (5/38). ES1 – Changes in the size/form of the window/door (22/108), and ES2 – Changes in the number of window/door (20/108) have been determined relatively high compared to others. These two intervention types were generally preferred in T1 and T2 (Figure 3-a, b), since they are single-family houses which have one decision maker, and also on the first-floor, the number and dimension of the windows are not adequate. These are followed by ES5 – Intervention to the roof (3/108) with relatively less frequency (Figure 3-c). It is thought that to create a usable flat roof, the roof was removed partially/fully. The least common intervention types are ES3 – Addition of circulation element, and ES4 – Addition of skeletal structural member, and both were made in only one building (1/108). In one of the reused buildings as a kindergarten, steel fire escape stair was added to the front façade (Figure 3-d), while in the other one that was still used for housing purposes, the vertical skeletal structural member was added to support an additional floor (Figure 3-e).

Figure 3. Examples for ES (Hatice Yasemin Çakır, 2021); **a)** façade that close to original version (left) (S1_T1_B03), ES1/ES2 (the others) (S1_T1_B04, S1_T1_B09); **b)** original photographs of T2 (left) (Uskudar Municipality Plan and Project Directorate Archive, n.d., as cited in Öztürk, 2020), ES1/ES2 (the others) (S1_T2_B46, S1_T2_B44); **c)** ES5 (S1_T2_B33_B34, S3_T3_B23); **d)** ES3 (S1_T1_B23); **e)** ES4 (S3_T6_B39)

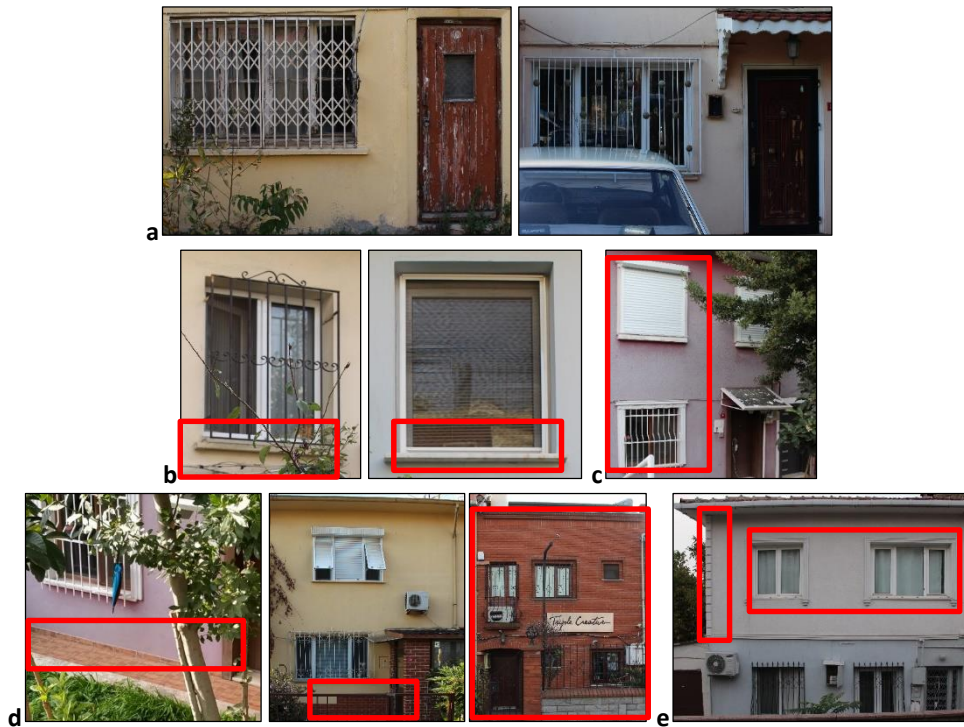
- **CS – Interventions at Component Scale:** Interventions at components of both window/door and masonry wall are detected in 57/108 buildings, while in 51/108 of them only interventions on window/door are determined (CS4, CS5, CS6). In short, interventions at component scale were only implemented in the window/door of the buildings. CS4 – Material changes in the window/door frame, which is the core of the window/door, is the most common intervention type, observed in almost all buildings (105/108). The wooden window/door were renewed with PVC in the window, iron/steel in the door, and their original partitions were not preserved (Figure 4-a). The reason of this intervention is probably insufficient thermal insulation, water leakage, and security problems. The second line is CS5 – Intervention to the sill one of the complementary components of the window/door (96/108) and probably was made with similar reasons as the previous one. CS5 is seen in two different ways as changes of the sill with a new one (81/96), and the addition of a new sill on top of the existing one (6/96) (Figure 4-b). The third mostly seen intervention is CS6 – Addition of protective elements in front of the window (92/108), which is the complementary component (Figure 4-c). Due to the security reasons, generally, window security bars were added on the ground floor, and sometimes on both floors. It is followed by, CS2 – Changes of finishing layer which is the intervention to the finishing layer of the masonry wall (39/108). CS2 is seen in three different ways, as changes in the material of the entire wall surface (18/39), socle region (8/39), and skirting (13/39) (Figure 4-d). In 6 of the 11 reused buildings, the façade finishing material observed to be changed with stone, brick, etc. However, it would not be directly associated with the reuse, because it has been determined that PVC cladding is widely preferred in some of the buildings that still maintain residential function. In short, it is thought that material changes in socle region, and skirting is made to protect buildings from water infiltration and splash water. While for the material change in entire surfaces thermal performance could be the important factor, besides water infiltration. The fifth line is CS1 – Addition of thermal insulation and CS3 – Addition of decorative elements to the façade which are related to the protective layer and complementary component of the masonry wall and are the least implemented (31/108). It is estimated that decorative elements located around the window and on wall edges were added during the application of thermal insulation material (Figure 4-e).

Figure 4. Examples for CS (Hatice Yasemin Çakır, 2021); **a)** window/door that close to original version (left) (S1_T1_B12), CS4 (right) (S1_T1_B05); **b)** CS5 (S1_T2_B43, S1_T2_B45); **c)** CS6 (S2_T3_B05); **d)** CS2 (S2_T3_B05, S1_T1_B04, S1_T2_B37); **e)** CS3 (S3_T3_B56)

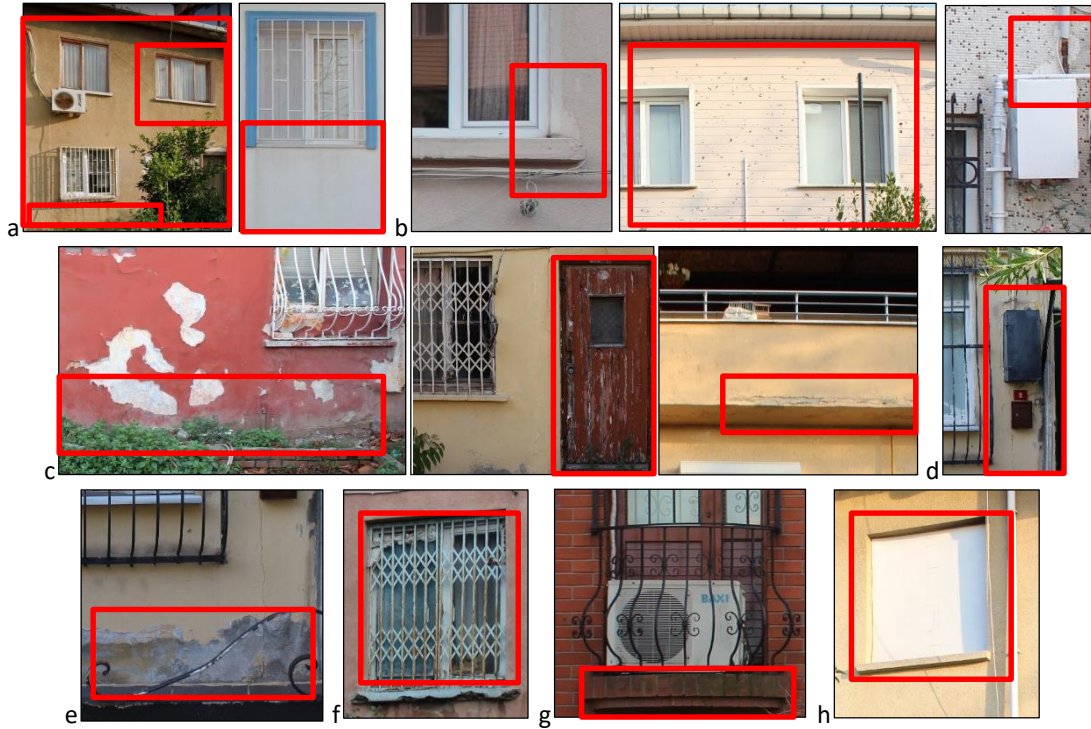
DE6 – Discoloration/colour changes (79/232) is the most common defect, and generally, seen on the entire wall surface (38/79), followed by surrounding of the window/door (16/79), and socle region (11/79) respectively (Figure 5-a). DE6 on the entire wall surface and socle region consist of natural factors, while on the surrounding of the window/door related to intervention to the sill. It is thought that incorrect workmanship, and detail design during CS5 – Intervention to the sill, caused water leakage under the sill, and in turn, DE6 occurred. The second in line is DE7 – Surface irregularities (60/232), and mostly seen on the surrounding of the window/door (28/60), followed by entire wall surface (22/60), and plumbing-related surface (7/60) respectively (Figure 5-b). DE7 on the entire wall surfaces are observed as point holes, generally on the buildings facing south-east, and north-west which are caused by natural factors (hail). The ones that are on the surrounding of the window/door, and plumbing-related surfaces are originated from material (i.e., plaster and paint) applied to cover mistakes made during interventions (e.g., material changes in window frame/sill, assembly of mechanical elements, material applied to cover interventions, etc.). The third in line is DE5 – Bubbling-spalling (41/232), and unlike others, it is located mostly on the socle region (16/41), and followed by window/door frame (7/41), and additional/adjacent building-related surface (5/41) respectively (Figure 5-c). It is thought that the defects on the additional/adjacent building-related surface occurred due to different seismic characteristics of the structural system of existing and additional parts (i.e., masonry and skeletal structural system). DE5 is observed due to groundwater in the buildings where the socle region or skirting is not covered (i.e., CS2 – Changes of finishing layer is not applied) which can be considered as a design fault. In the buildings where the original window/door frame is preserved (i.e., CS4 – Material change in window/door frame is not implemented), defect has occurred in the

paint layer of the wooden frames because of natural factors. DE5 on additional/adjacent building-related surface is generally caused by natural factors. These defects are followed by DE4 – Cracks (28/232), DE2 – Efflorescence (12/232), DE3 – Corrosion (7/232), DE1 – Biological formation (3/232 – 1.29%), and DE8 – Material loss (2/232 – 0.86%), respectively (Figure 5-d, e, f, g, h). DE4 occurred due to the mounting of mechanical system elements. DE1/DE2 are related to the water leakage problem in the socle region and can be regarded as an advanced level of DE5. DE3/DE8 are specific to the window/door which is seen on the complementary component (i.e., window security bar), and core (i.e., window frame, infill) respectively, and generally seen on the buildings that are not used, and the material of the window was not changed with PVC.

Figure 5. Examples for CS (Hatice Yasemin Çakır, 2021); **a)** DE6 (S3_T4_B01, S1_T2_B38); **b)** DE7 (S2_T3_B03, S3_T6_B12, S1_T2_B29); **c)** DE5 (S1_T2_B31, S1_T1_B12, S3_T6_B19); **d)** DE4 (S1_T1_B02); **e)** DE2 (S1_T1_B02); **f)** DE3 (S3_T6_B40); **g)** DE1 (S1_T2_B37); **h)** DE8 (S3_T6_B18)
