## Investigation of the Damages Due to Heavy Earthen Roofs on Masonry Buildings during the Kahramanmaraş Earthquakes

### ABSTRACT

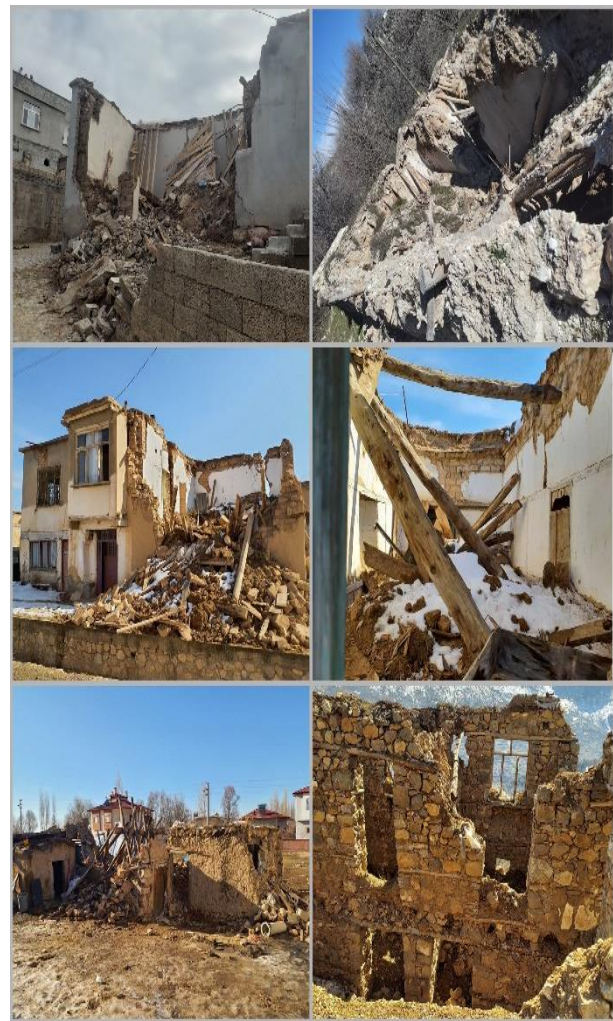
As a result of the observations made in rural areas after the Kahramanmaraş earthquakes, the fall down of the heavy earthen roofs made the structures unusable. Such heavy earthen roofs, in conjunction with the vertical acceleration part of the earthquake, push the load-bearing walls in/out of the plane during the earthquake. Thus, these walls, which have poor in/out-of-plane stiffness and insufficient connection to the roof, are unable to transfer the load appropriately, suffer an abrupt loss of strength, and collapse together with the roof. In buildings with lightweight cover or metal material on the roof and used for warehouses/barns etc., the collapse was relatively less. Completely collapsed earthen roofs are shown in Figure 6.

**Figure 6.** Examples of completely collapsed earthen roofs

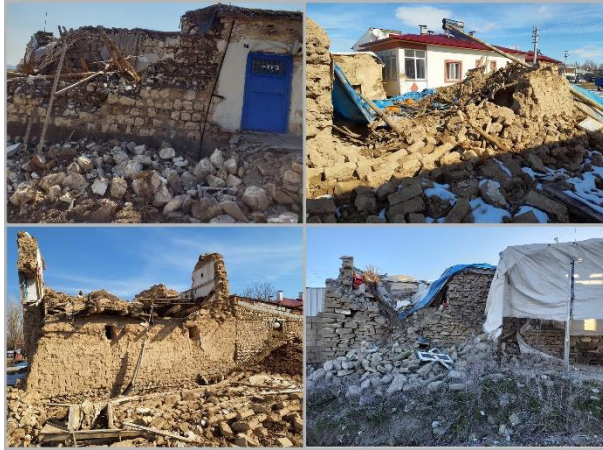
It has been researched that heavy earthen roofs increase the lateral forces by 10-15% during the earthquake [31] and due to collapses on weak roofs, it has seriously damaged the load-bearing walls. The area's hefty clay roofs were constructed from wooden logs and a substantial coating of soil. Due to the impact of climatic and environmental factors, earthen roofs are compacted by adding new soil layers each season to protect them from rain and melting snow. As a result, the already-heavy clay roof becomes even heavier, which causes the walls to be forced in and out during the earthquake with considerable force and causes the walls on the building's vulnerable side to fall. In the examinations made in rural areas after the Kahramanmaraş earthquakes, it was observed that the roof collapsed due to the earthquake and the walls displayed out-of-plane failure (Figure 7). Another damage observed in structures with heavy earthen roofs is the partial collapse of the roofs (Figure 8).

**Figure 7.** Example of load-bearing wall damages

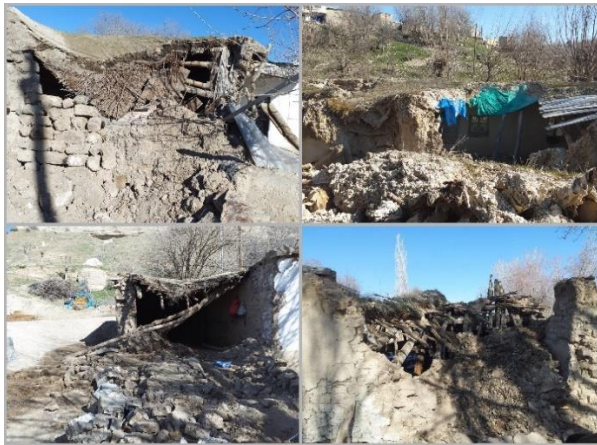
**Figure 8.** Example of partial collapse damage of heavy earthen roofs

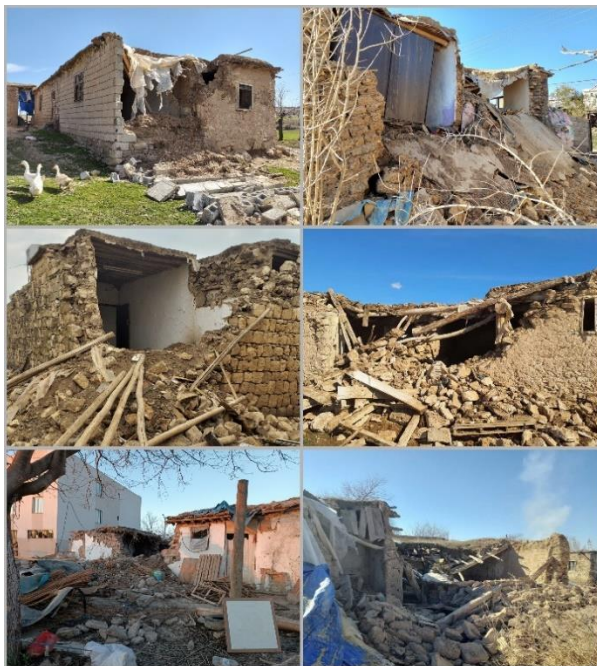
In structures with heavy earthen roofs, the collapse of a part of the roof forced the wall on the collapsed side to out-of-plane behavior and it was observed that the wall in that area also collapsed (Figure 9).

**Figure 9.** Load-bearing wall damages due to partial collapse of heavy earthen roofs

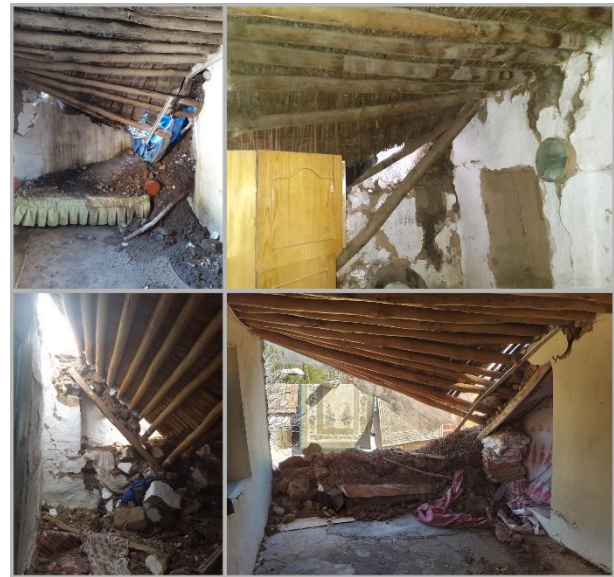
Wooden beams are positioned at specific intervals on the underside of the soil layer in buildings with earthen roofs. The aged wooden logs are gradually replaced by fresh ones. The wooden girders, which are subjected to heavier loads during earthquakes and wear out over time, reducing their bearing capacity, are unable to handle the additional horizontal load and are prone to varying degrees of damage as a result of the increased roof mass. Furthermore, increased loads will harm beams that are not properly supported on the roof and load-bearing walls, perhaps causing them to perform at levels that would cause a collapse. Examples of such damage are shown in Figure 10.

**Figure 10.** Damages due to insufficient support of wooden beams on heavy earthen roofs

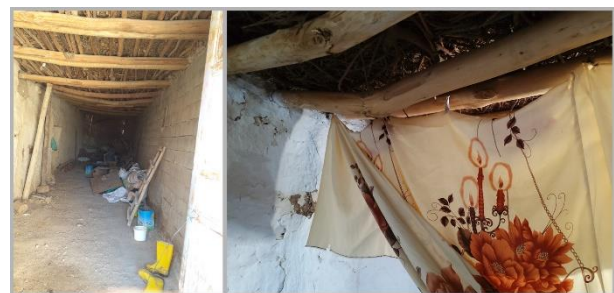
Examples of damage to structures that were forced by the additional forces from heavy earthen roofs but did not reach the collapse mechanism are shown in Figure 11. The reason for this is that the wooden beams are well supported on the walls they sit on, but with the addition of a new soil layer to the building during the season transitions (with the additional roof load), deflections have occurred due to the insufficient size of the wooden beams.

**Figure 11.** Examples of wooden beams forced to collapse

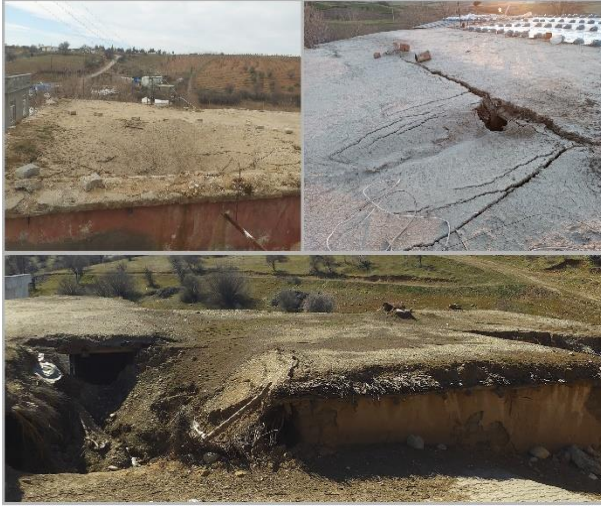
Heavy earthen roofs in the earthquake zone are constructed in two different ways. Examples of cracking

and partial collapse damage occurring on flat heavy earthen roofs are shown in Figure 12.

**Figure 12.** Example of the structural damage on flat earthen roofs

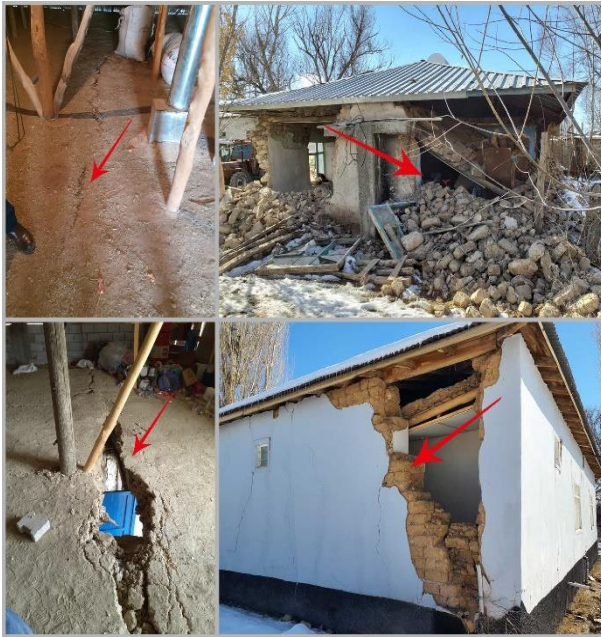
Another application used in the earthquake zone is to build wooden roof rafters on heavy earthen roofs. Different levels of damage have occurred on earthen roofs in such structural systems (Figure 13).

**Figure 13.** Examples of damage to earthen roofs with wooden roof rafters

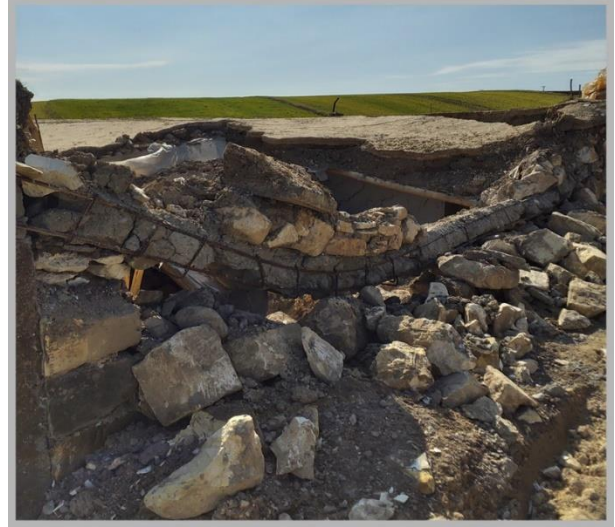
In some masonry structures, reinforced concrete bond beams are used under the earthen roofs. The lack of sufficient interlocking between this bond beam and the earthen roofs and insufficient reinforced concrete strength, which was built without any engineering service, caused damages. An example of this type of damage is shown in Figure 14.

**Figure 14.** Structural damage despite the use of reinforced concrete bond beams

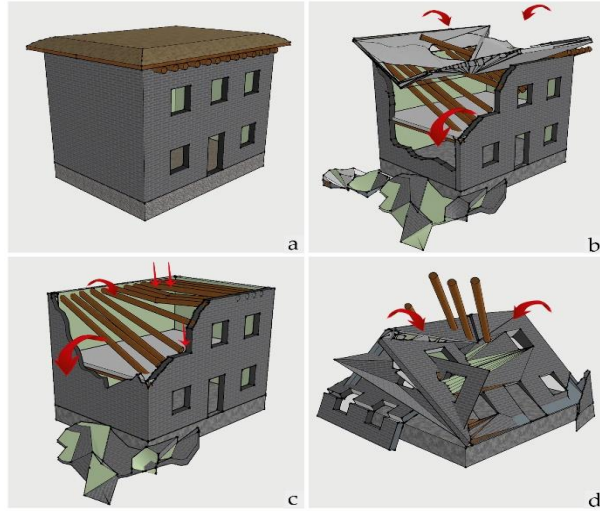
The schematic representation of the structural damage caused by heavy earthen roofs as a result of the field investigations is given in Figure 16.

**Figure 16.** Schematic representation of structural damage observed in heavy earthen roofs. a) Undamaged masonry structure b) Heavy earthen roof damage and resulting damage to walls c) Insufficient support in wooden beams and forced to collapse d) Complete collapse
