ISSN: 2667-8764 , 5(2), 248-271, 2023

Analyzes of Stone Deterioration on the Facades of the Şehidiye Madrasah in the Central District of Mardin Province

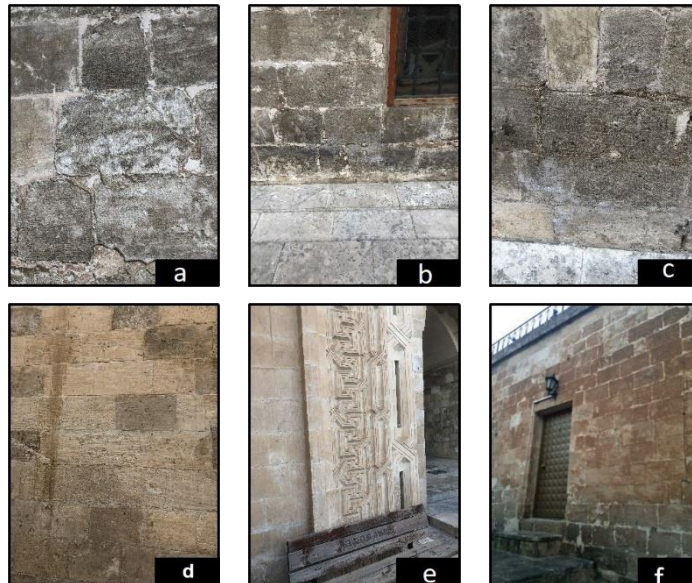
Figure 6. Physical deterioration of Şehidiye Madrasah

Based on the visual analyzes, Figure 6 illustrates the physical deterioration of the building. The structure displays several physical deterioration types such as capillary cracks, joint discharges, fragment rupture and surface abrasion.

Cracks in stones can result from weather conditions and petrographic properties. Additionally, vibrations arising from natural catastrophes like earthquakes, fires and frost may also lead to cracks on stone surfaces (ICOMOS, 2008). As a consequence of the weather in Mardin province, the structure experienced thermal shock, resulting in capillary cracks in the limestone which comprises the primary material of the structure (Figure 5a). The façade of the building exhibited joint failure (Figure 5b and Figure 5c) and fragmentation (Figure 5d and Figure 5e), likely due to surface abrasion caused by dust grains carried by the wind (Figure 5f) over an extended period.

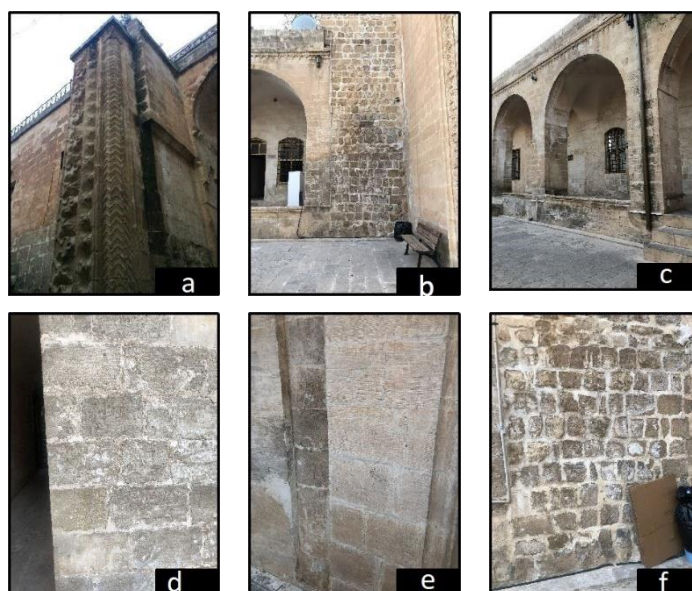
Figure 7. Chemical deterioration in Şehidiye Madrasah

The limestone, which forms the primary material of Şehidiye Madrasah, has undergone significant chemical degradation over time due to both internal and external factors. Figure 7 demonstrates these deteriorations. Discoloration is noticeable on the primary access portal of the edifice (Figure 7a).

Changes in the stone surfaces can be attributed to the effects of salt, metal corrosion, microorganisms or fire exposure (ICOMOS, 2008). Discoloration is visible on the facade that faces the inner courtyard of the building which also houses the women's masjid (Figure 7b). The Şehidiye Madrasah reveals that limestone is salted as a result of interaction with air (Figure 7d and Figure 7e). Additionally, bacterial formations are observable on the limestone (Figure 7c and Figure 7f).

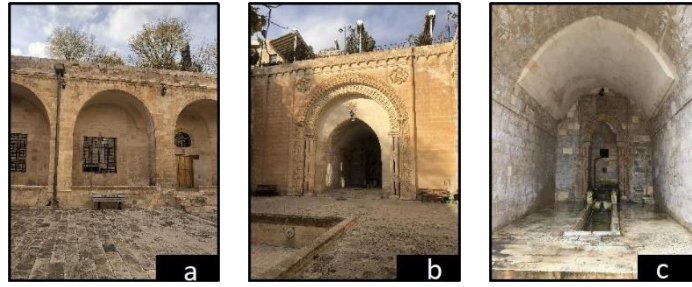
Figure 8. Biological deterioration in Şehidiye Madrasah

Figure 8 illustrates the biological deterioration in Şehidiye Madrasah. Plant growth has been detected on the façade of the women's masjid (Figure 8a) and the façade of the selsebil (Figure 8b). The root systems of these plants can expand joints and cracks in the stonework, thereby accelerating physical degradation processes.

Furthermore, they may also increase the rate of chemical degradation by promoting salinization due to the persistent moisture in these areas. Moss was observed along the water fountain-facing façade, specifically in areas exposed to water (Figure 8c). Moss generally flourishes in stone crevices or gaps, and moist or wet stone surfaces accelerate its growth (ICOMOS, 2008). Buildings in contact with water often experience biological decay (Dal & Yardımlı, 2019).

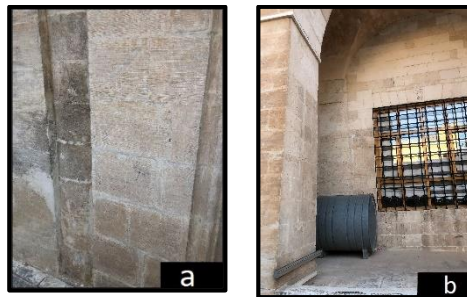
Figure 9. Anthropogenic deterioration of the Şehidiye Madrasah

Figure 9 illustrates the impact of human activity on the deterioration of Şehidiye Madrasah. The north-facing interior façade of the building shows evidence of deterioration caused by sharp tools, as demonstrated in Figure 9a and Figure 9b.

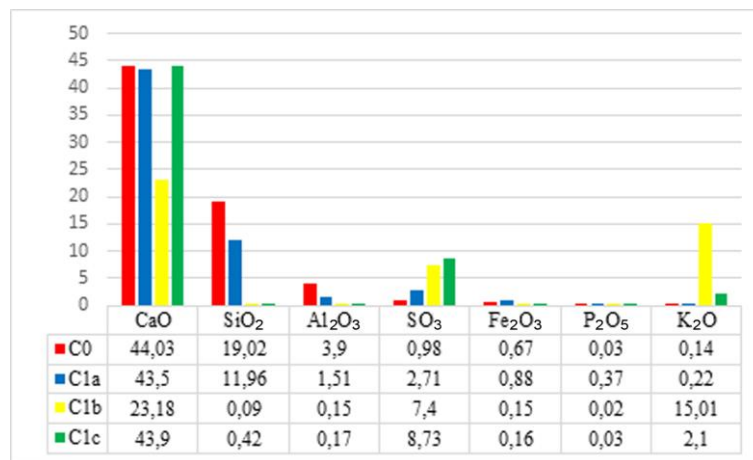
Table 8. XRF chemical analyze results of physical deterioration observed on the facades of Şehidiye Madrasah

Table 8 presents the findings from the XRF analyze on the physical decay detected in Şehidiye Madrasah. Results reveal that the SiO_2 ratio was 19.02% in C0 stone, while C1b stone presents a mere 0.09% of this element. Thus, the C1b stone exhibits lower strength than C0. In addition, while the SO_3 ratio was 0.98 in the C0 stone, it reached 8.73% in the C1c stone, and an increase in SO_3 was also observed in other stones. There were no significant differences in the values of other components. Physical deterioration is evident on the stone surfaces due to variations in the stone material components and temperature differences (Karataş, Alptekin & Yakar, 2023).

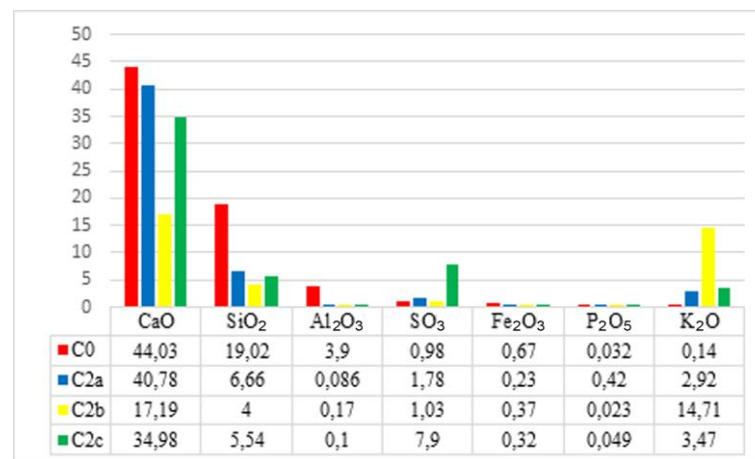
Table 9. XRF chemical analyze results of chemical deterioration observed on the facades of Şehidiye Madrasah

Table 9 presents the results of XRF chemical analyzes of chemical deterioration in Şehidiye Madrasah. The obtained results indicate an increase in SO_3 in all of the stones due to city air pollution. The rise of the SO_3 ratio in C2c stone is noteworthy. In the C0 stone, the SiO_2 ratio was at 19.02%, whereas in other chosen stones, it declined. For instance, the SiO_2 ratio in C2b stone was only 4%.

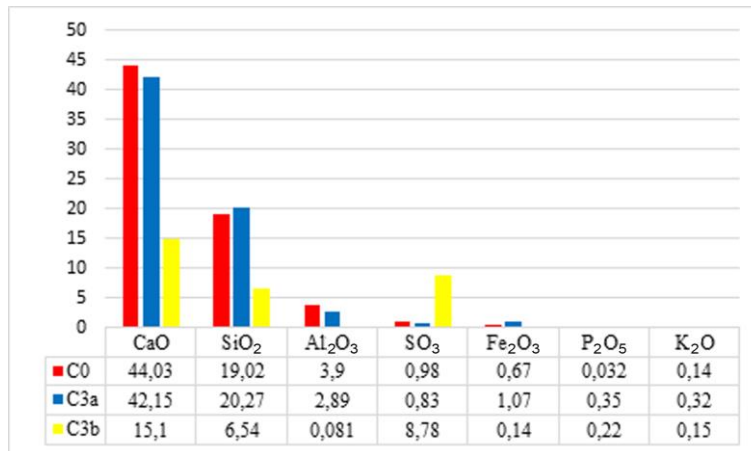
Table 10. XRF chemical analyze results of biological deterioration observed on the facades of Şehidiye Madrasah

Table 10 presents the findings of the analyze concerning the biodeterioration that occurred at Şehidiye Madrasah. The results of the analyze indicate that the value of the SiO₂ component in C0 stone is 19.02%, while it is 20.27% in C3a stone. Clay minerals were hardened and silicified as a result of atmospheric weather conditions' interaction. This process led to the creation of a protective layer on the surface of the stone. Furthermore, C3b stone has the highest SO₃ value attributable to air pollution.

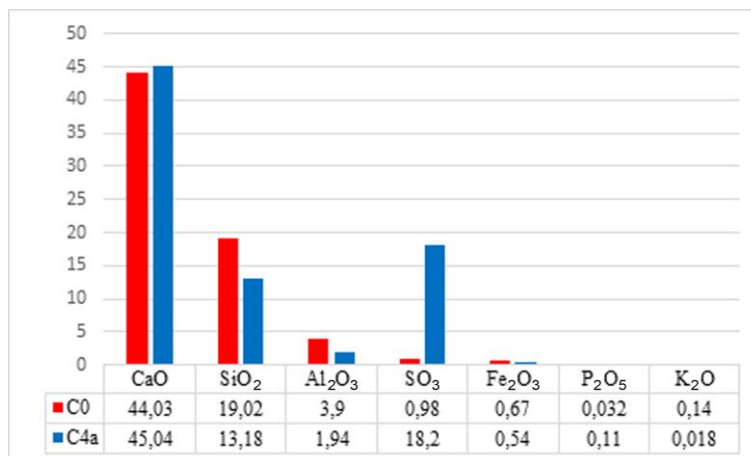
Table 11. XRF chemical analyze results of anthropogenic deterioration observed on the facades of Şehidiye Madrasah

The findings from the XRF chemical analyze method on the anthropogenic deterioration in Şehidiye Madrasah are presented in Table 11. Upon comparison of the selected stone with the clean stone, a significant increase in SO₃ stone was observed, indicating air pollution as the cause. The SiO₂ ratio in C0 stone was found to be 19.02%, while C4a stone exhibited a rate of 13.18%.
