Academic Platform Journal of Natural Hazards and Disaster Management

Seismic Damages in Masonry Structural Walls and Solution Suggestions

Key words: Masonry, Earthquake, Load-bearing wall, Damage, Kahramanmaraş

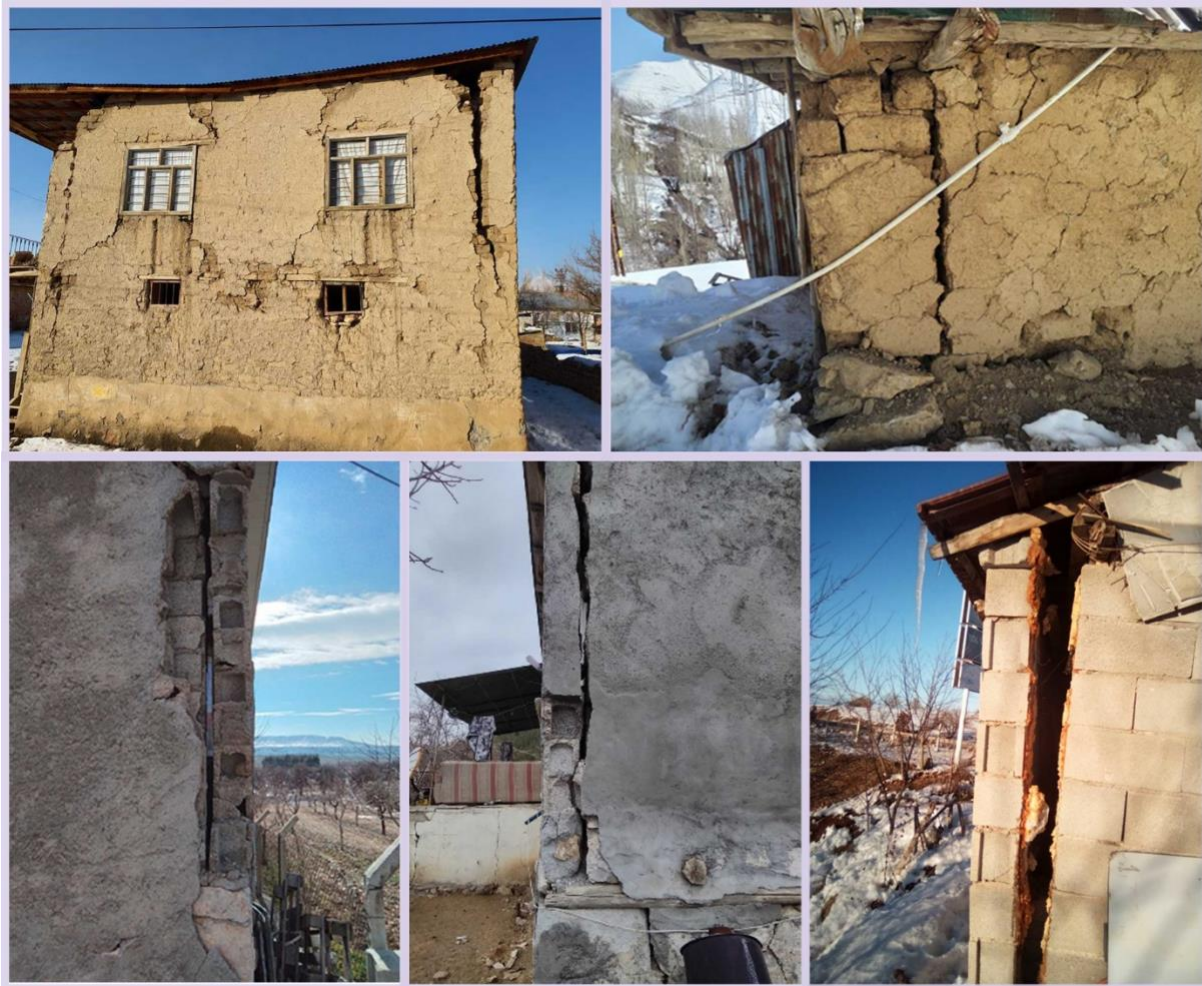
One of the elements that will affect the earthquake performance of masonry structures is forming the corner connections rigid and strong. One of the damages observed after earthquakes, especially in rural areas, is separation damage in the wall-corner joint areas. The level of damage was negatively affected by the lateral stresses resulting from heavy earthen use

in the masonry structures built in these regions. Additionally, during earthquakes, forces are exerted on structures in both principal directions. Under this two-way loading, the condition of the corner of the masonry structure shows different movements and pushes each other. If the walls are not well connected at the corner and there is no bond beam or roof slab, the walls will push each other at the corner, causing wall separation damage [4, 58]. Examples of such damage are shown in Figure 6.

Figure 6. Wall separation at corners of the structures

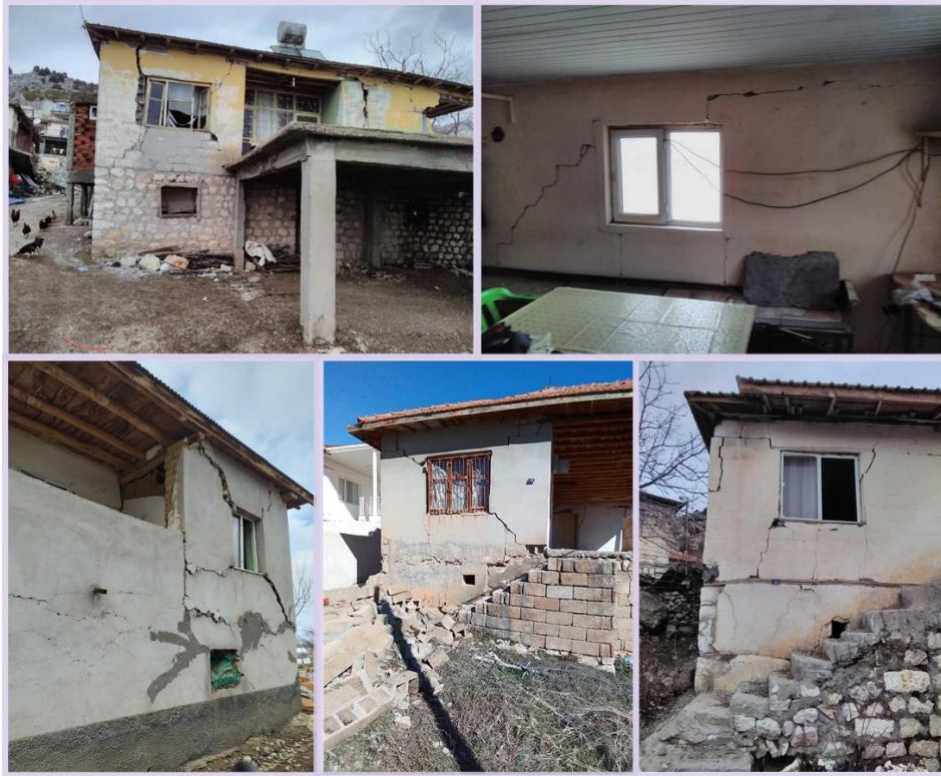
It is known that window and door gaps in masonry structures intercept the load-bearing walls from appropriately transferring bending and shear stresses [59-61]. Door and window openings reduce the cross-sectional area of load-bearing walls in masonry buildings, causing shear and bending stresses to increase. This situation reduces the capacity of the wall and reduces the strength of the structure under the influence of forces such as earthquakes. Such damages are frequently encountered because gaps do not meet the boundary conditions specified in earthquake codes. Examples of such damage are shown in Figure 7.

Figure 7. Damages at window corners

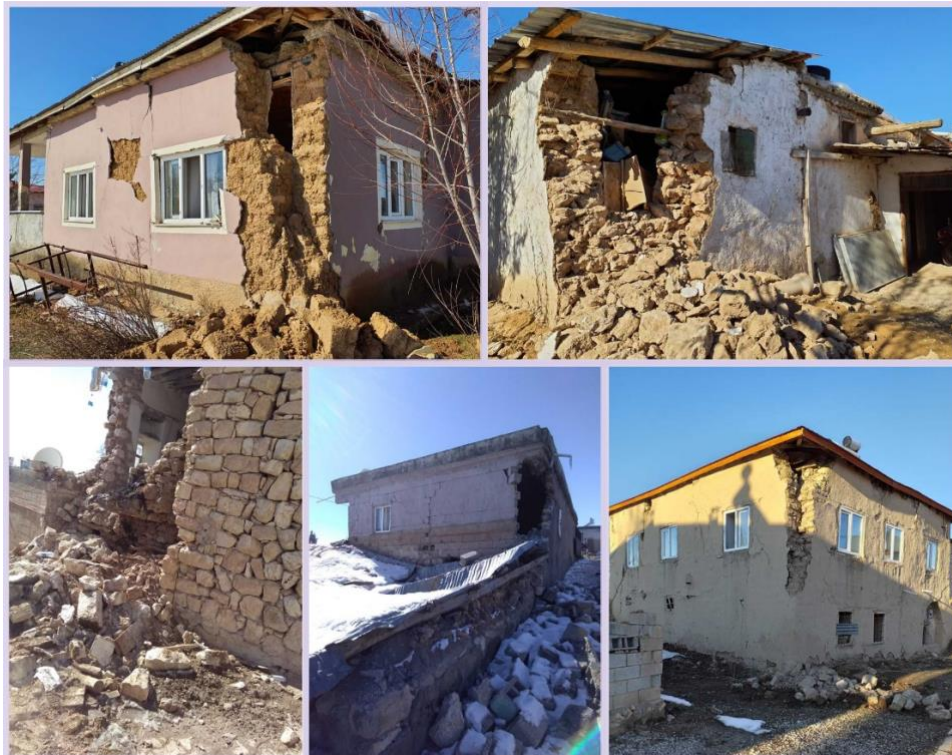
Failure to create appropriate joints in both directions at the corners of the load-bearing walls may reduce the rigidity of the walls and lead to further damage to the buildings. As a consequence of the observations made in the field after the Kahramanmaraş earthquakes, the failure to create appropriate joints in these areas caused out-of-plane wall damage at the corners. Examples of such damage are demonstrated in Figure 8.

Figure 8. Examples of out-of-plane wall corner damage

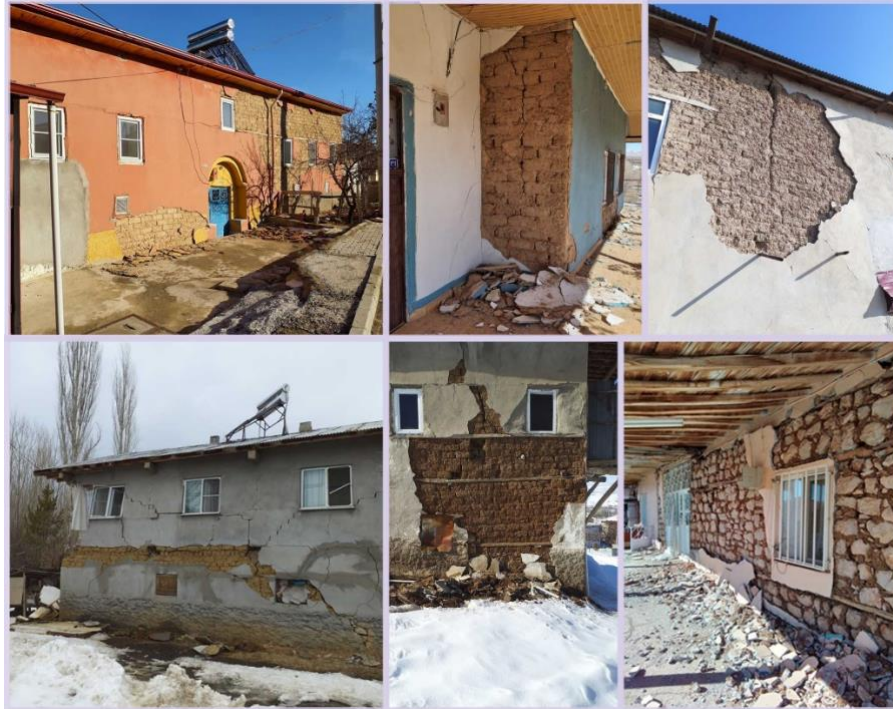
One of the other types of damage encountered is the falling of the outer coverings of the wall materials used in masonry structures, which are used to make their appearance smoother. It has been determined that exterior coatings made using low-strength mortar are generally subject to out-of-plane behavior. Examples of such damage are shown in Figure 9.

Figure 9. Falling of exterior materials

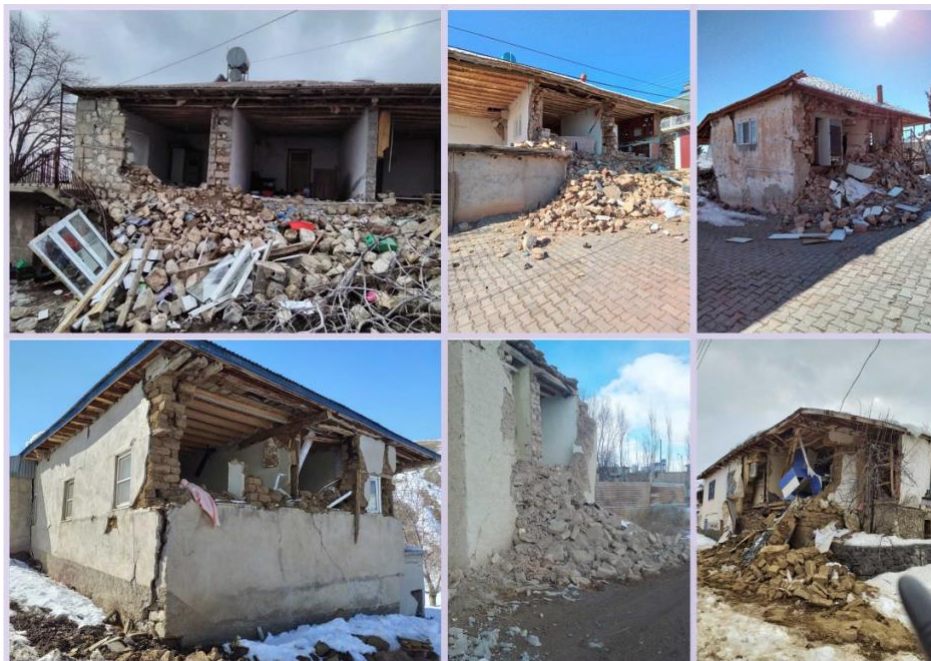
One of the damages frequently observed in masonry structures in earthquake zones is the out-of-plane movement of load-bearing walls. In addition to the low mechanical properties of the wall and connection material used, inadequate wall-wall connections cause out-of-plane movements on the walls, causing damage. Examples of such damage are demonstrated in Figure 10.

Figure 10. Example of out-of-plane movement on load-bearing walls

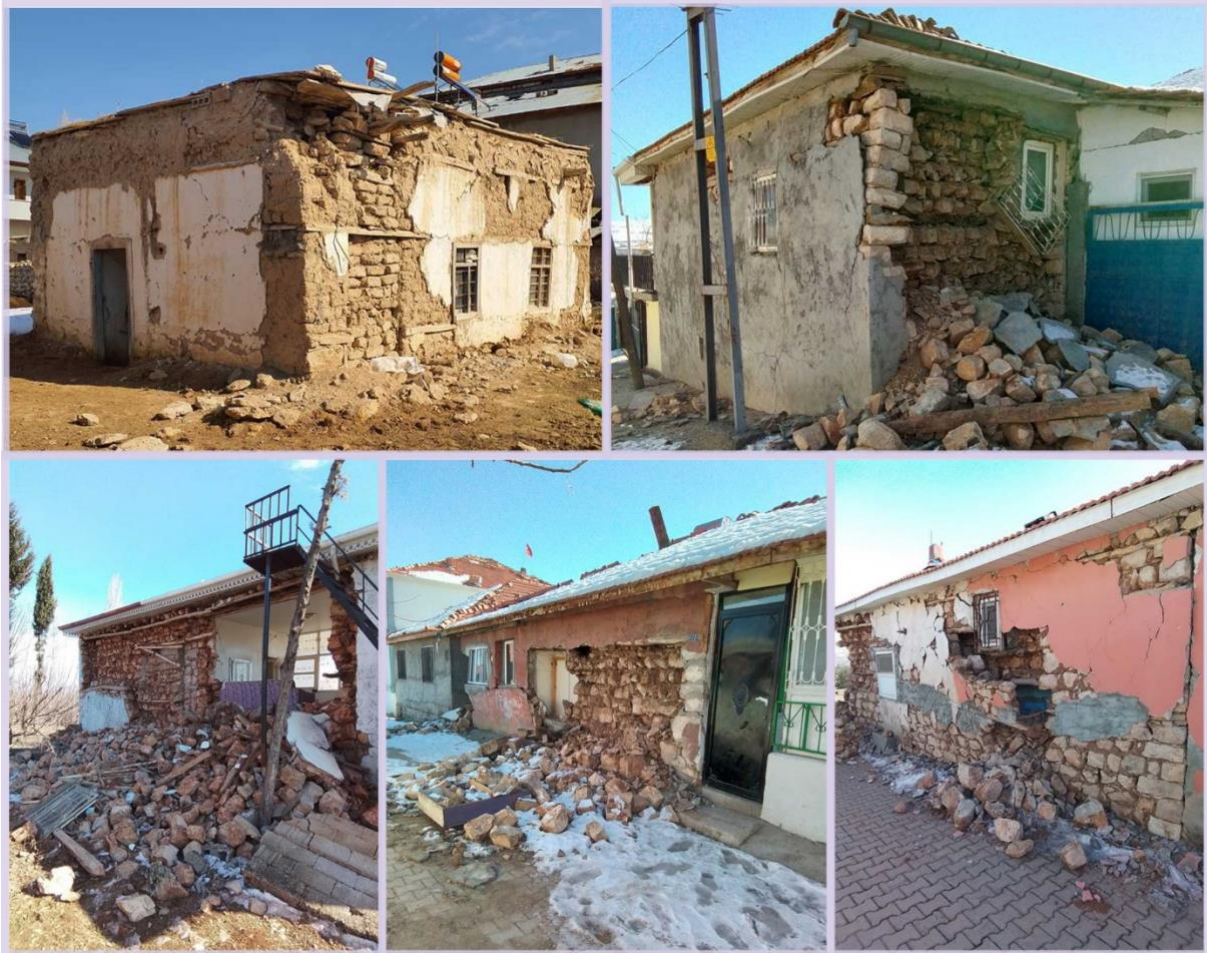
Due to the fact that masonry buildings do not have any frame system and the low strength properties of the materials used in the construction of the walls, their wall thickness increases significantly compared to reinforced concrete structures. Wall layers are created to provide this thickness. Inadequate connections between layers and the combined use of wall materials with different properties caused these layers to separate under the earthquake effect and receive damage at different levels. Examples of such damage are shown in Figure 11.

Figure 11. Examples of damage caused by inadequate connections between layers

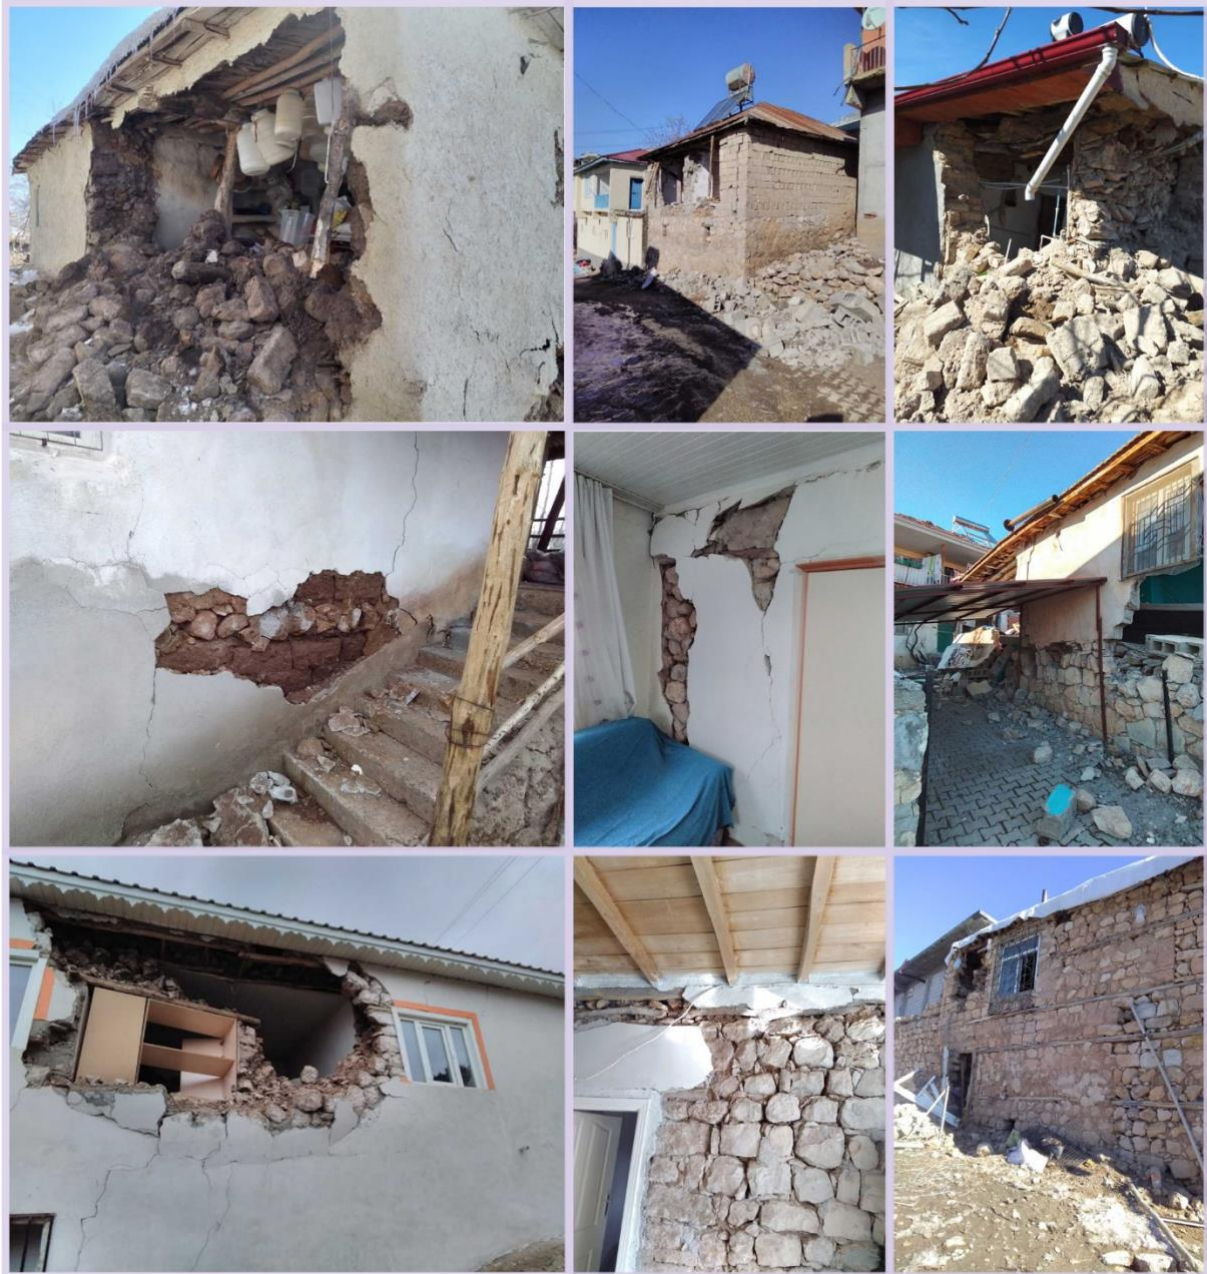
In masonry structures, using wall materials that are not regular in shape, incorrect wall material placement, poor masonry workmanship, and unsuitable connection mortar have also caused various levels of damage to the load-bearing walls. Examples of such damage are demonstrated in Figure 12.

Figure 12. Examples of wall damage caused by various reasons

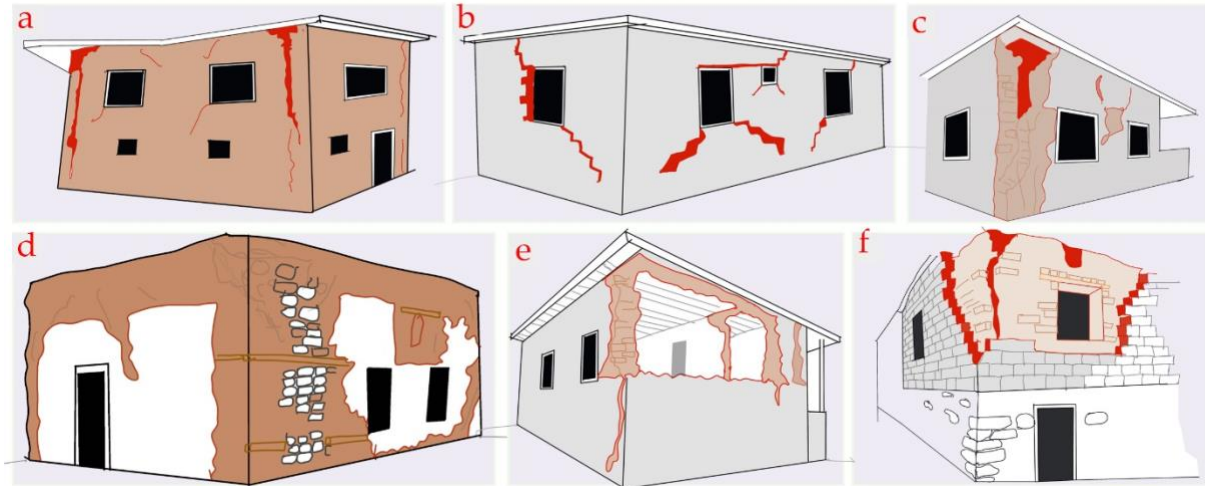
The Kahramanmaraş earthquakes of February 6, 2023, called the disaster of the century for Türkiye, caused great destruction in a very large region. Significant damage has occurred in buildings with different structural systems. Various levels of damage have occurred in masonry structures, which are widely used especially in rural areas. This study focused on the damages occurring in masonry walls located in the earthquake zone and the damages occurring in load-bearing walls, which are the most important elements of masonry structures. As a result of field observations, the damages occurring on these walls were evaluated. It is thought that photographs taken from the region provide an important resource to provide a general understanding of these damages. Damages have been observed in various forms such as out-of-plane deformations at corner points, irregular use of wall materials, low or insufficient strength

of the wall materials used, and out-of-plane movements on the walls. These results emphasize the importance of measures to be taken to improve the earthquake resistance of masonry structures in rural areas exposed to earthquakes and to make them durable after the earthquake. Schematic representations of the structural damages resulting from the evaluations are shown in Figure 113.

Figure 13. Schematic representation of load-bearing wall damages in masonry structures a) separation at corners b) window corners damages c) out-of-plane wall corner damages d) Falling of exterior materials e) out-of-plane movement f) inadequate connections
